**KNOXVILLE HISTORIC ZONING COMMISSION
STAFF REPORT - CERTIFICATE OF APPROPRIATENESS APPLICATION**

PROPERTY ADDRESS: 101 E Fifth Ave 37917

FILE NO.: 5-D-16-HZ

LEVEL OF WORK: Level II. Major repair or replacement of materials(windows)

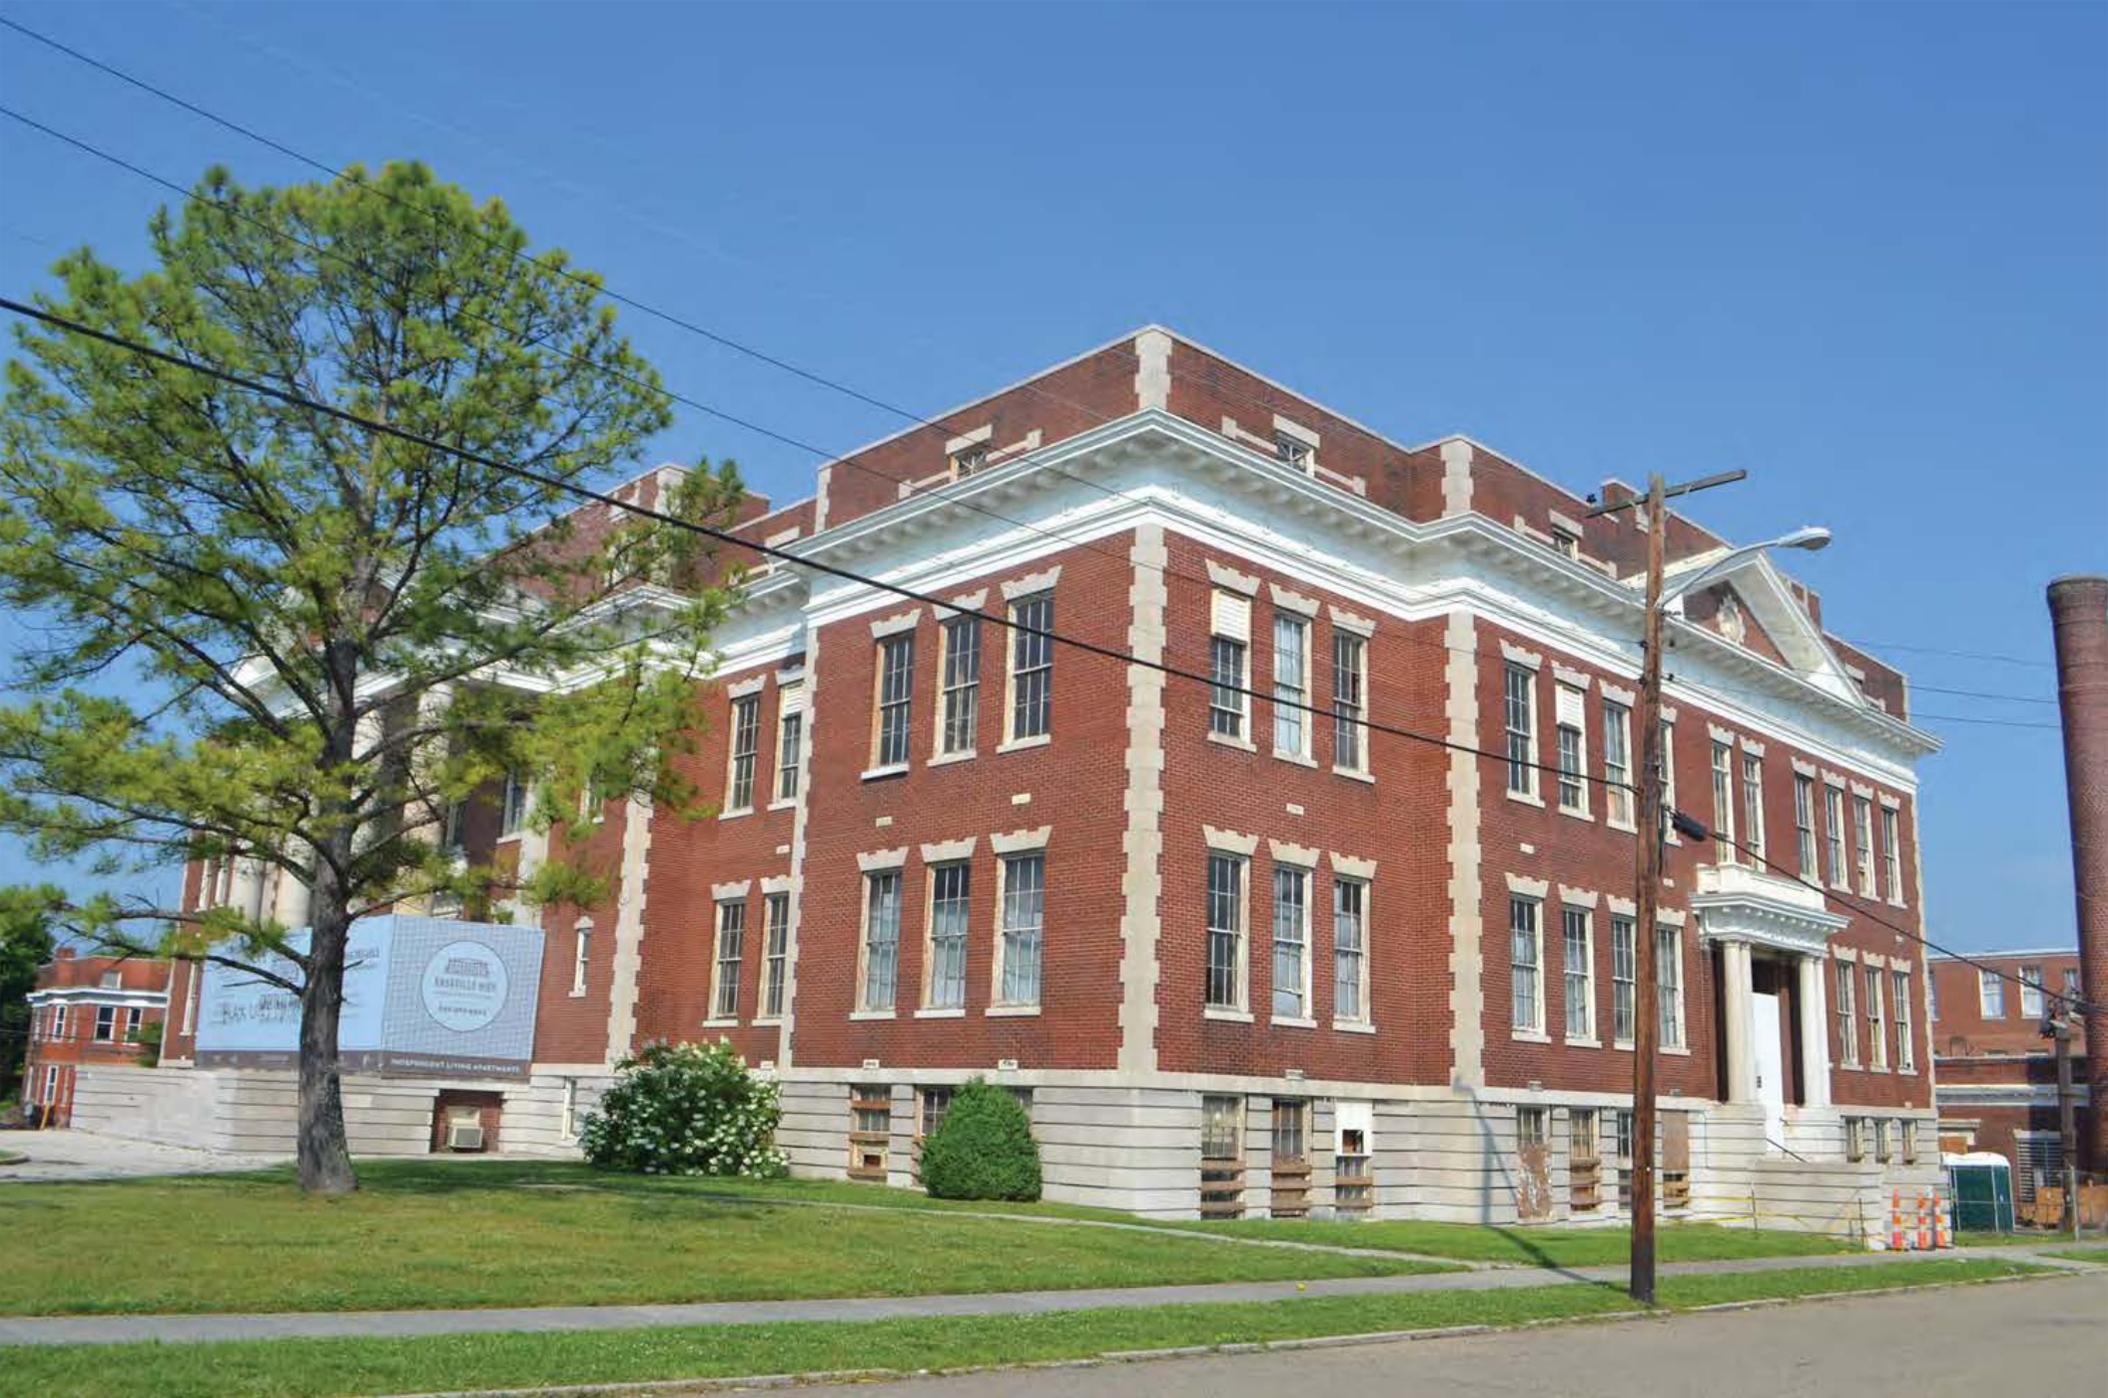
Lamar Street facade looking northwest (missing sashes on bottom level)

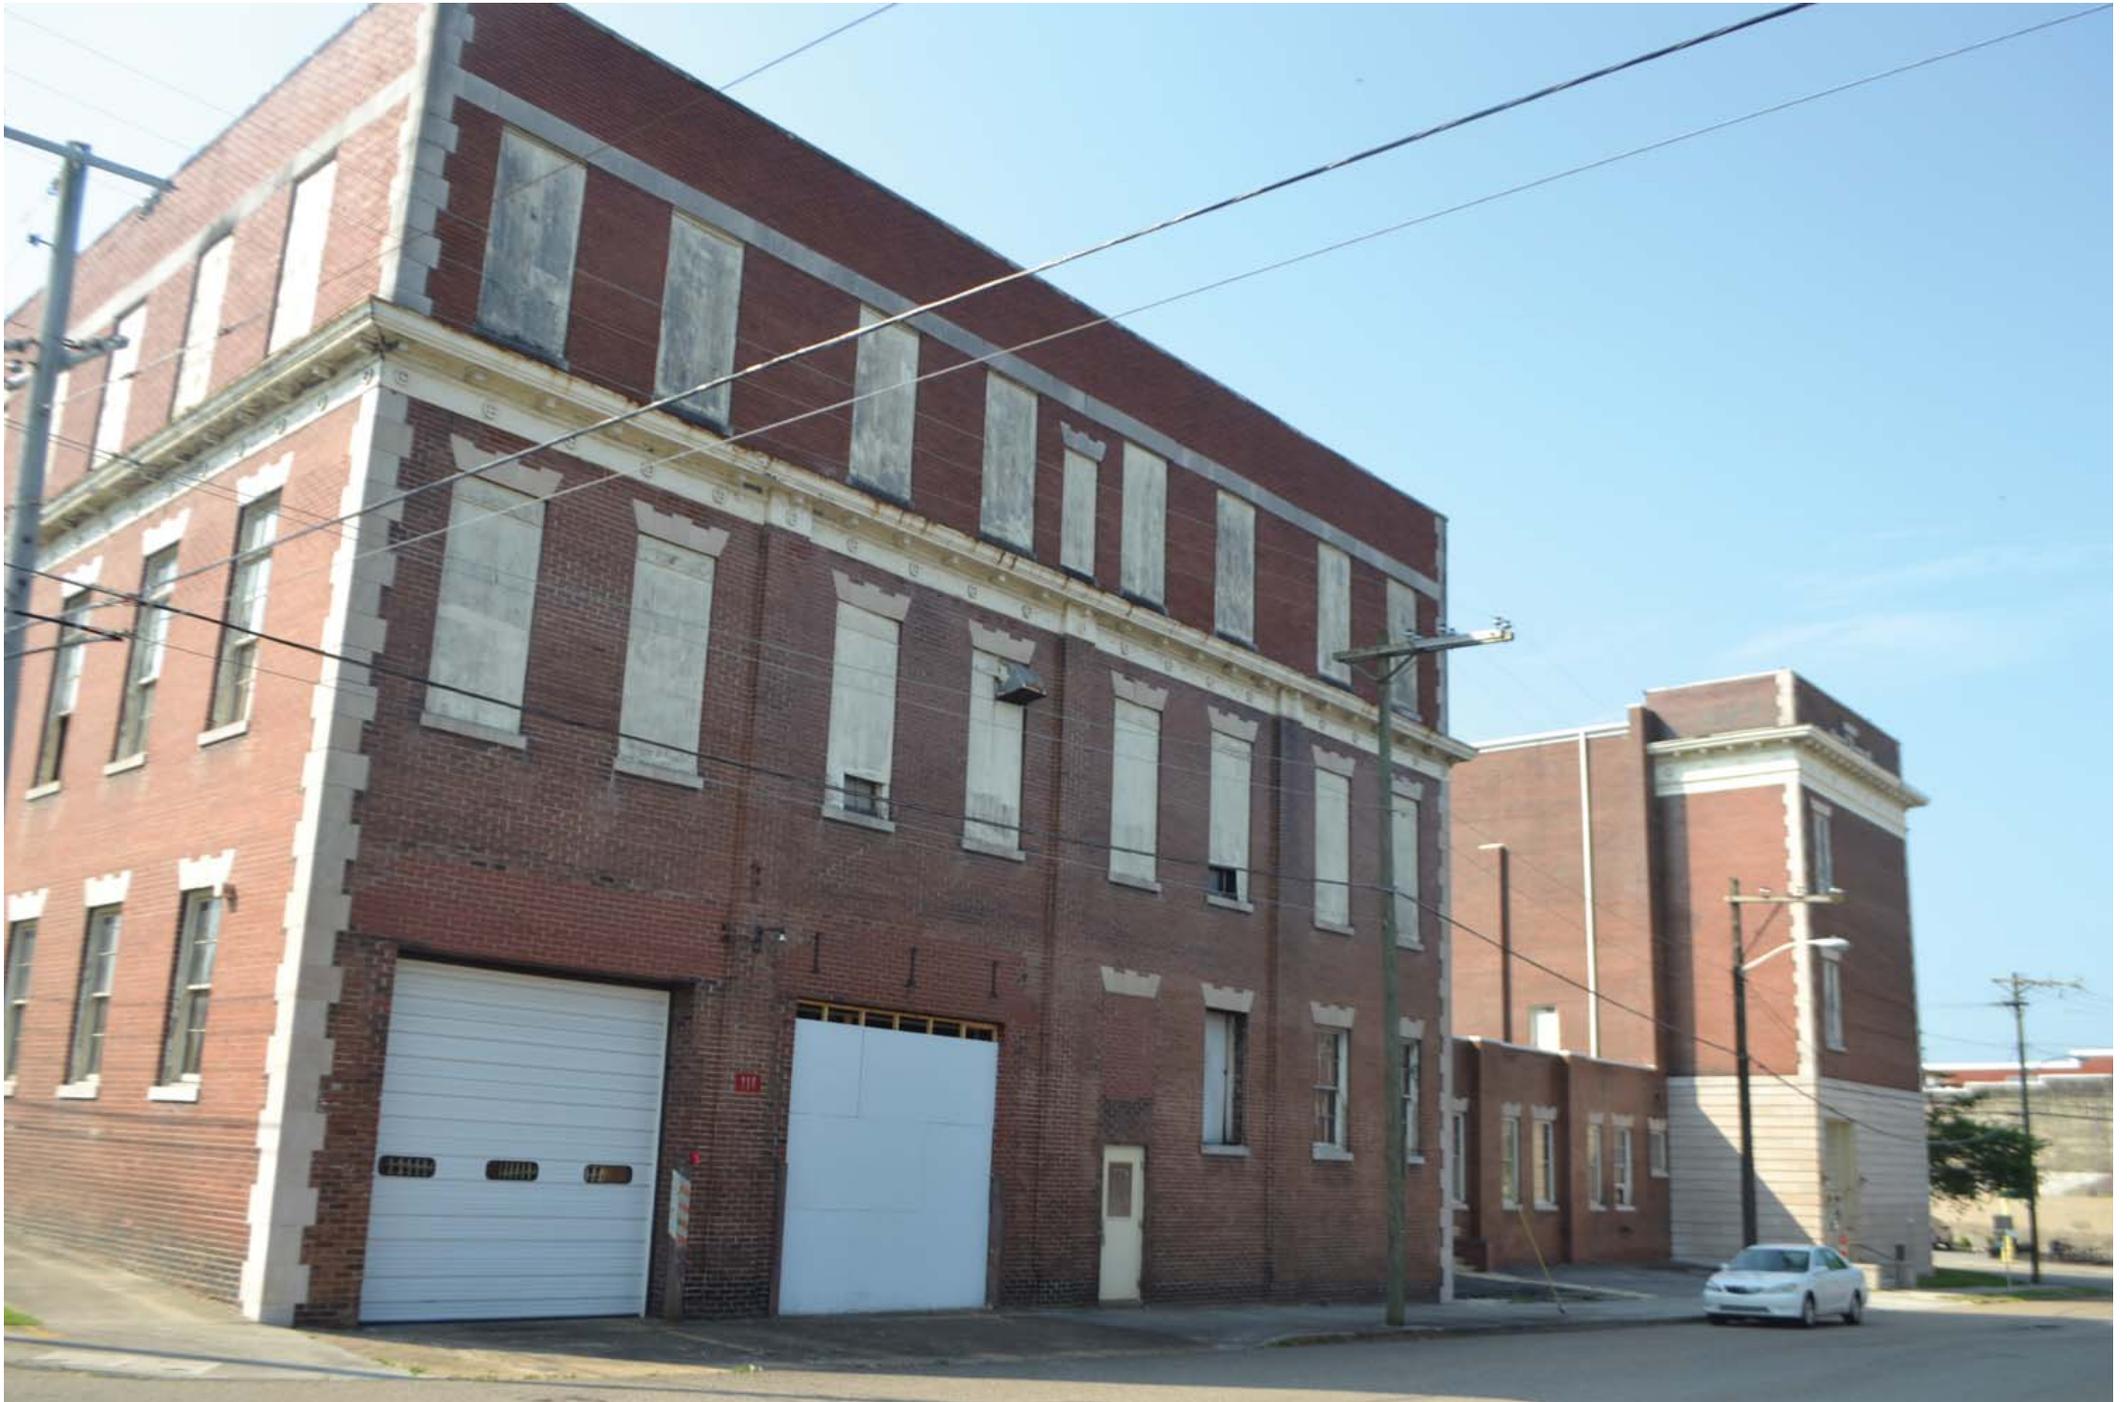
- 6) The windows on the three-story section of the E. Fourth Avenue side are mostly missing or covered due to damage. The windows on the one-story connector on that side are later-installed windows of newer wood material that have extensively decayed.

E. Fourth Avenue facade looking southeast (missing/covered windows)

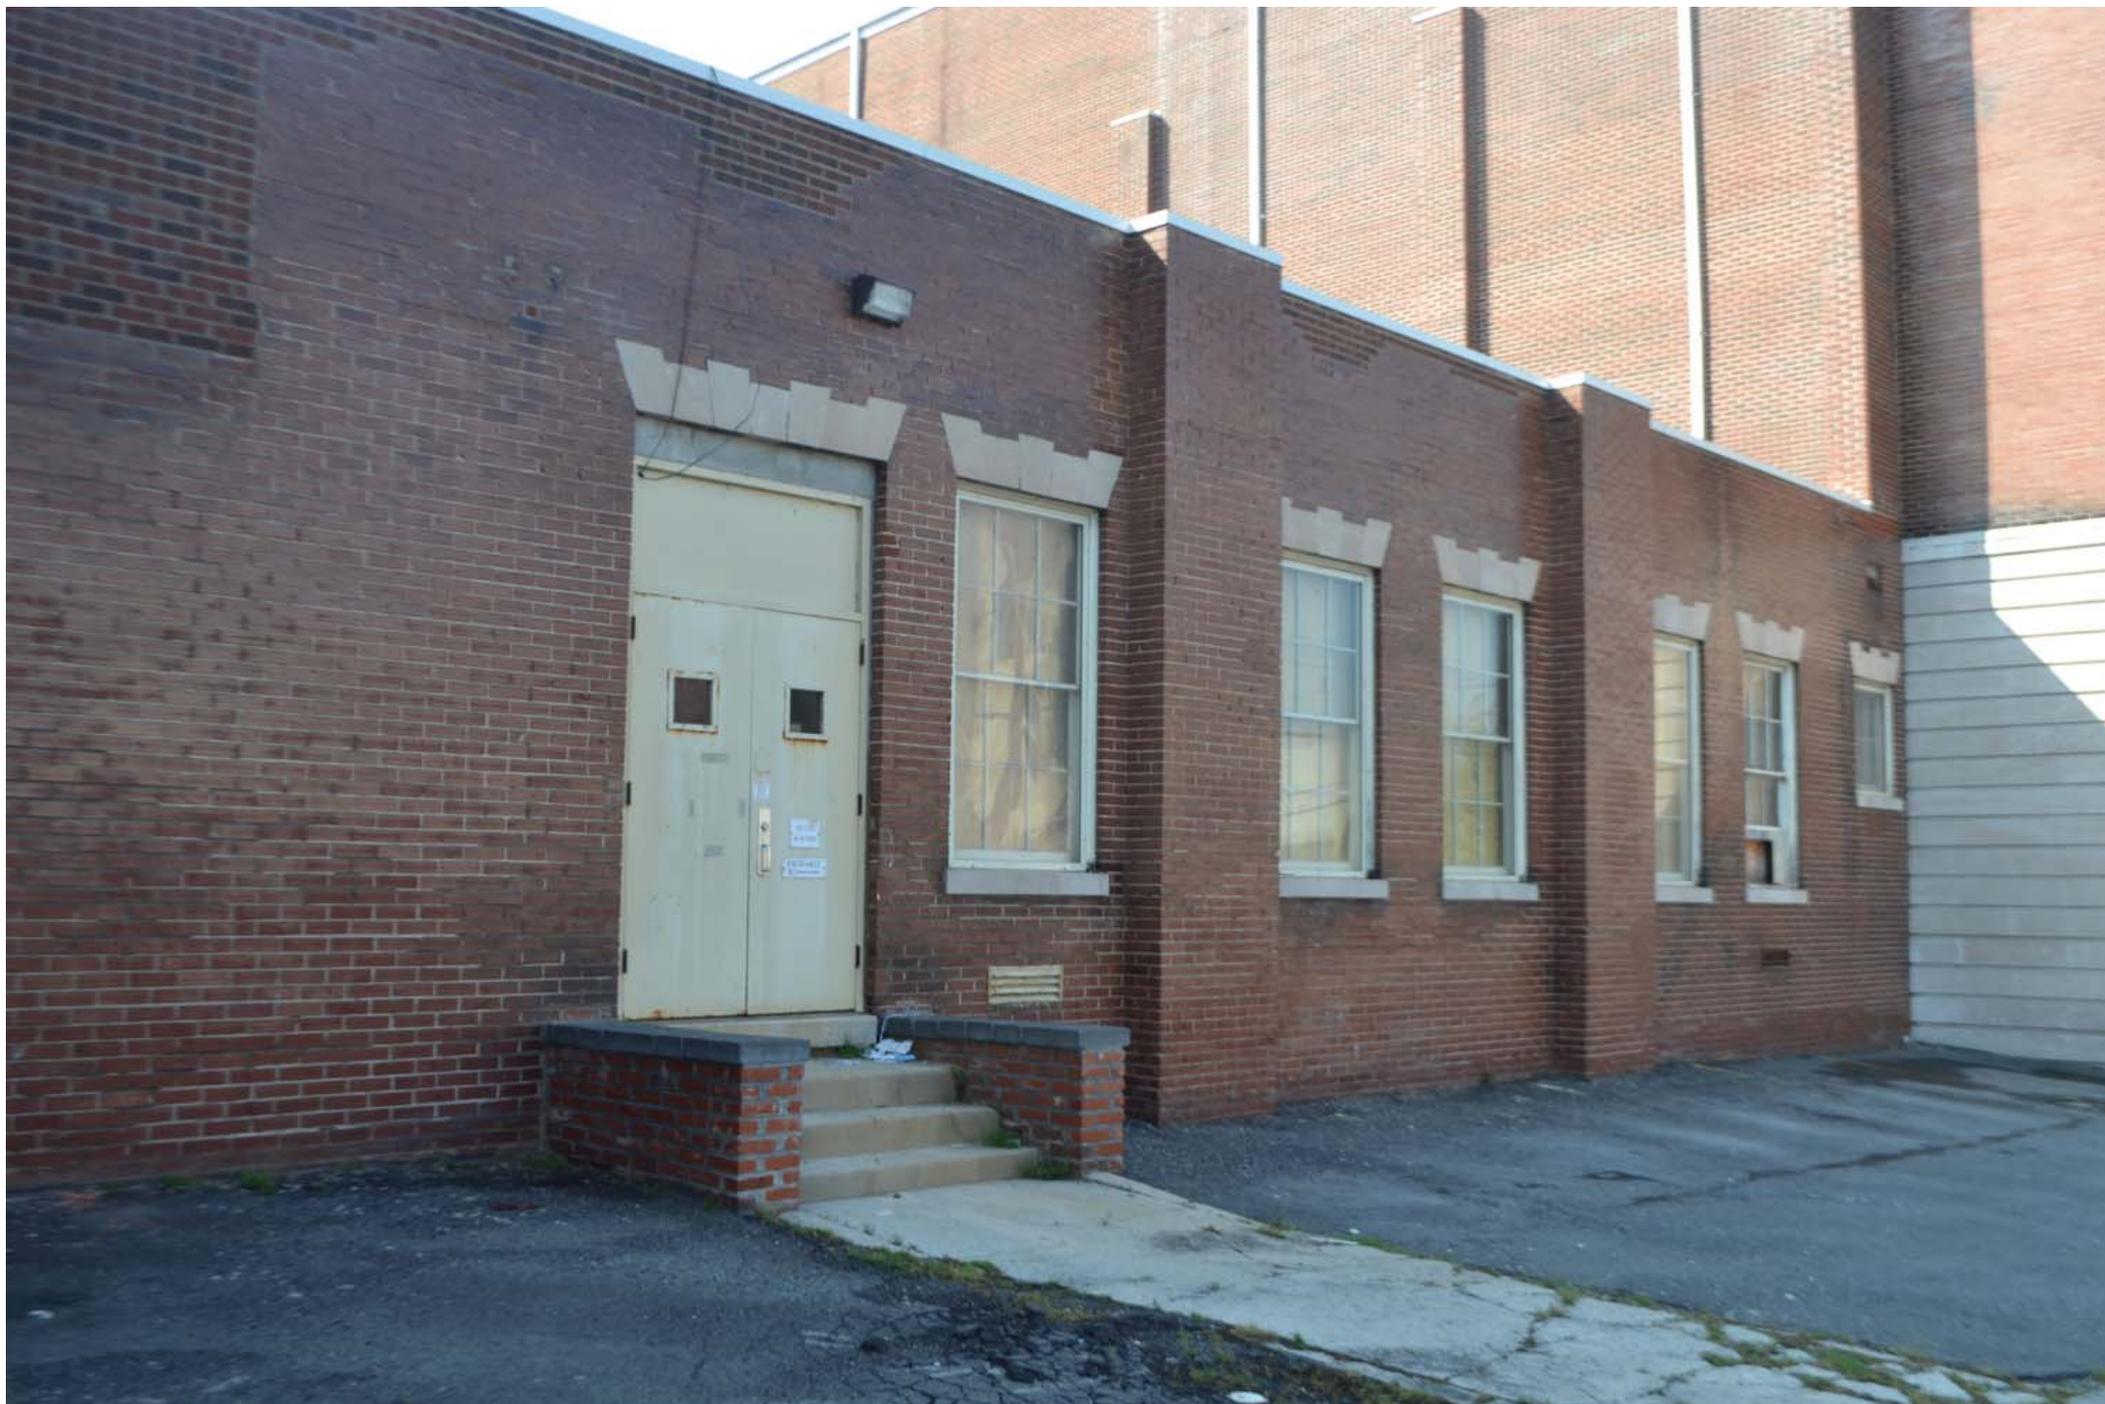
One-story connector on SW side - later windows

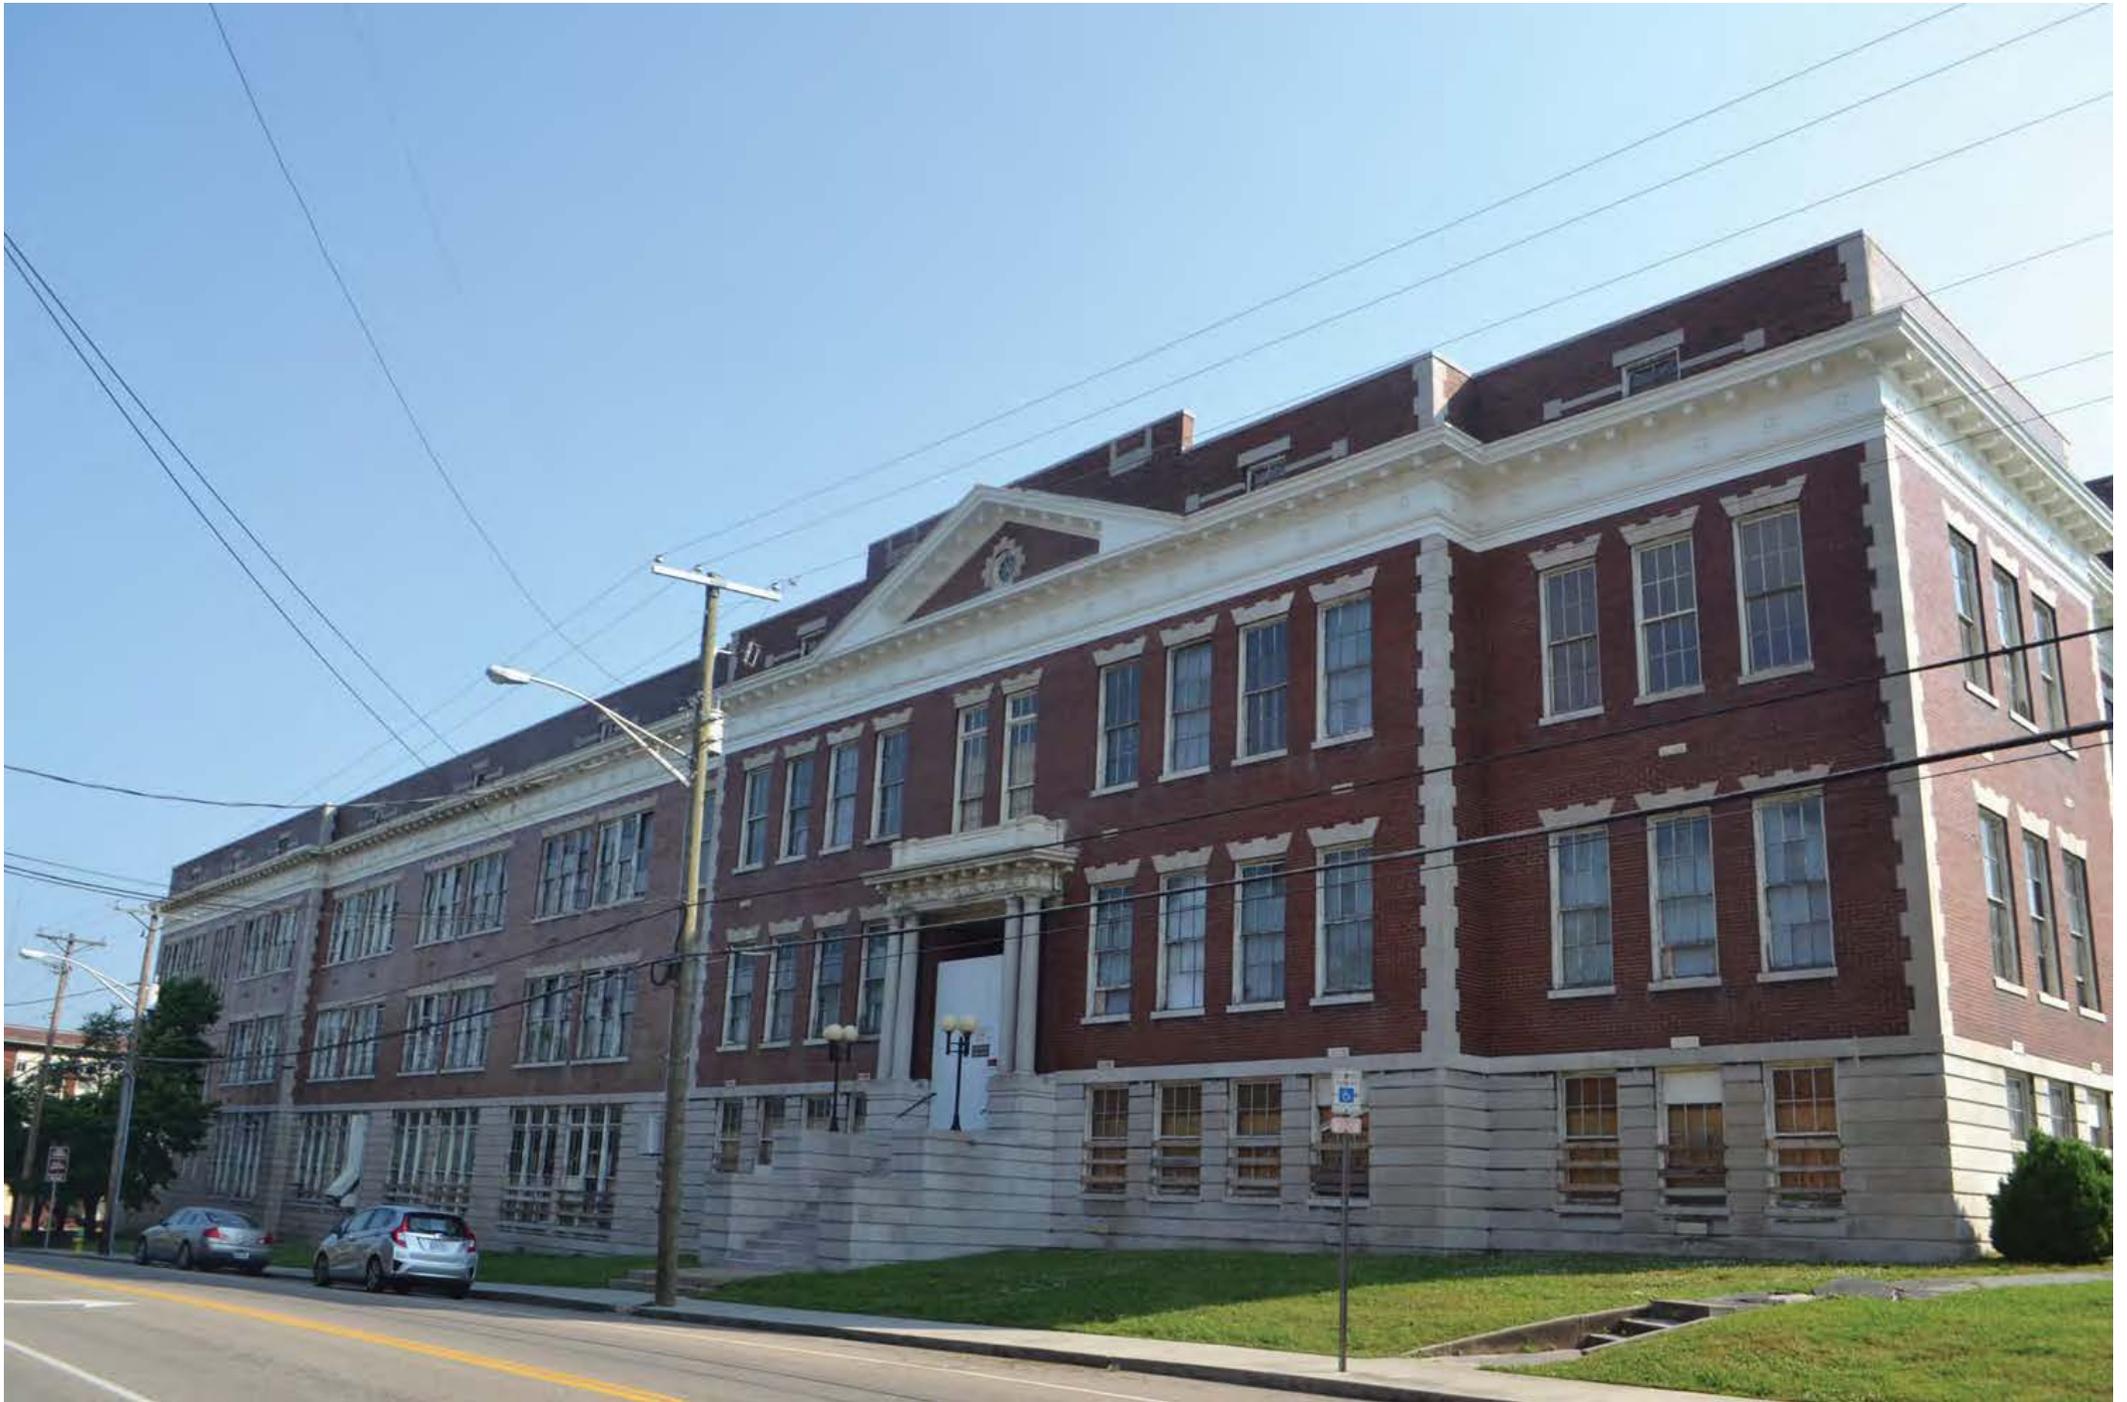
Northwest facade of building along N. Central Street where most damage has occurred

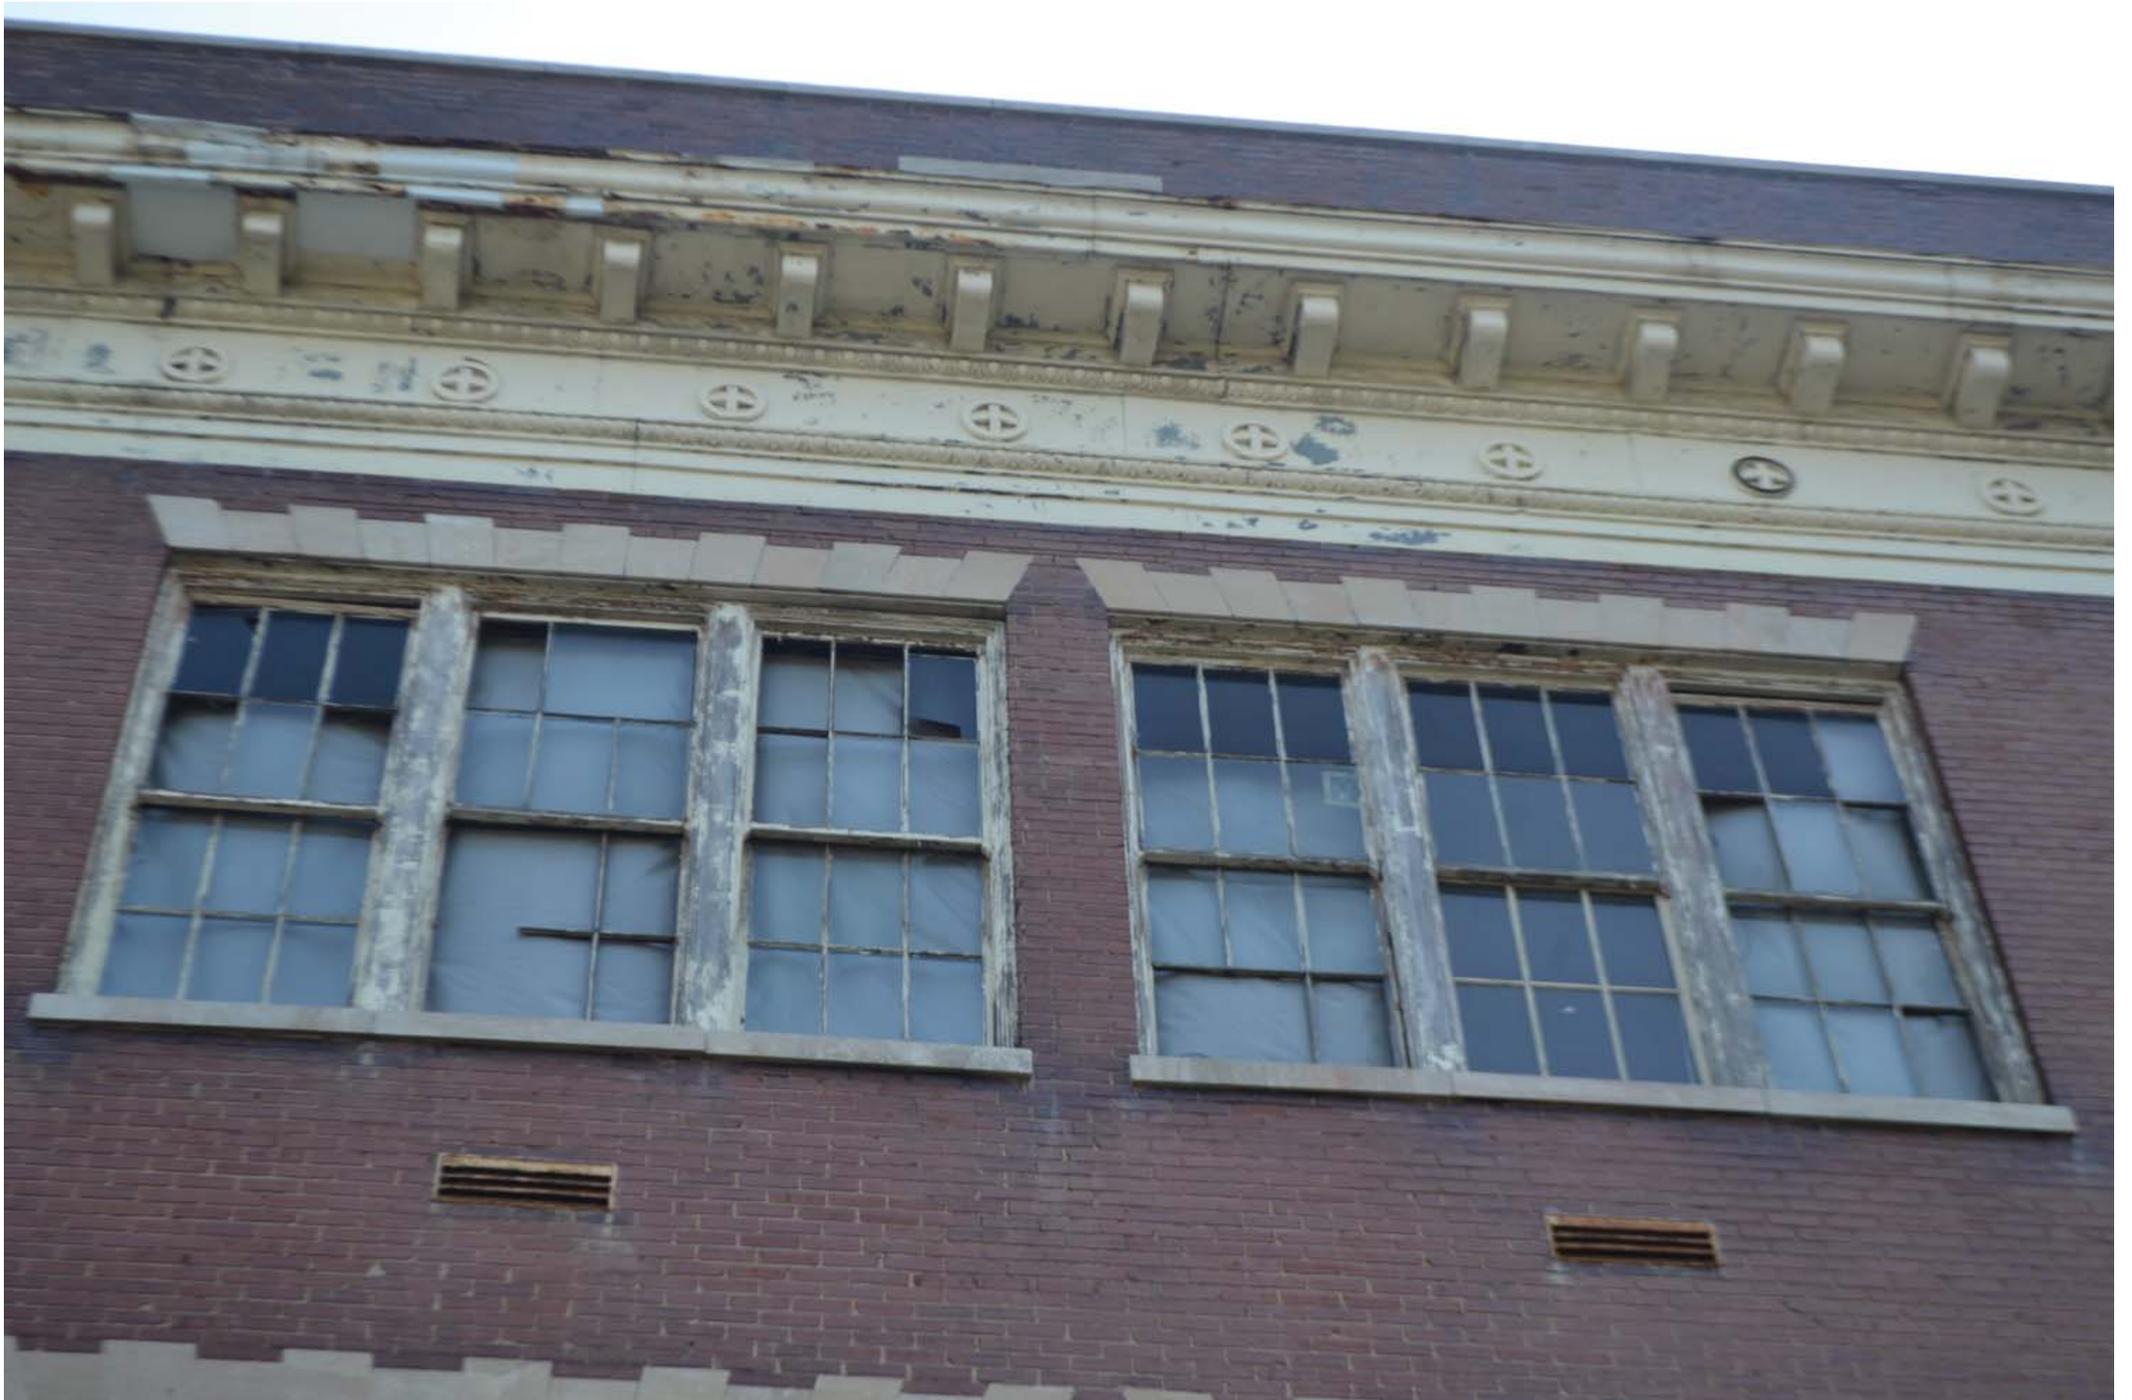
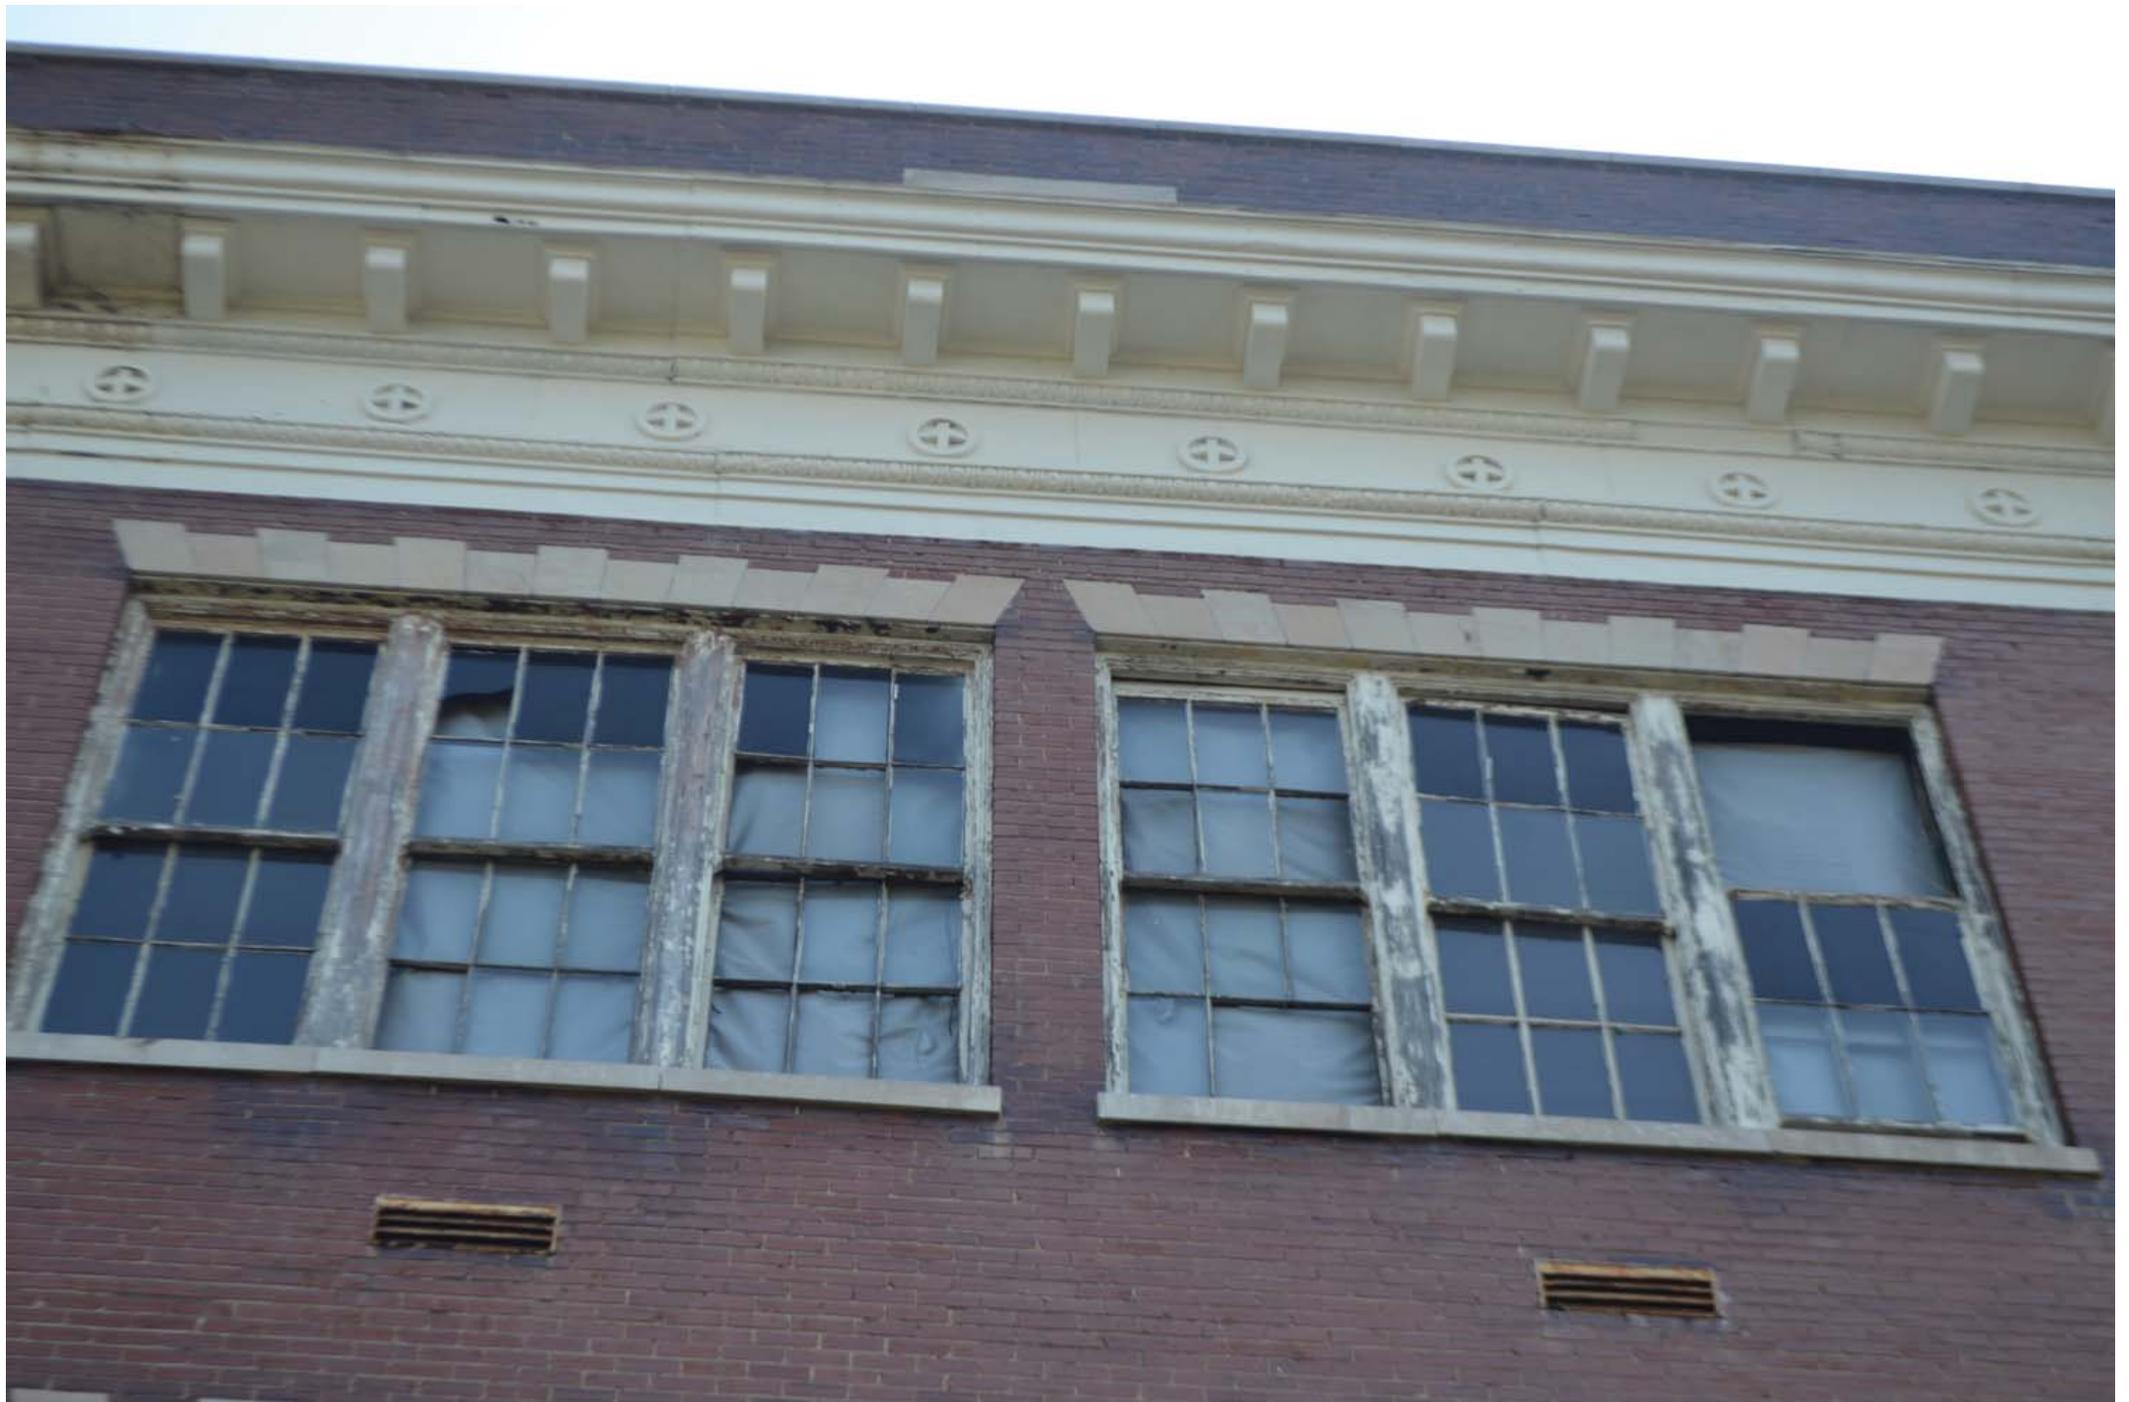
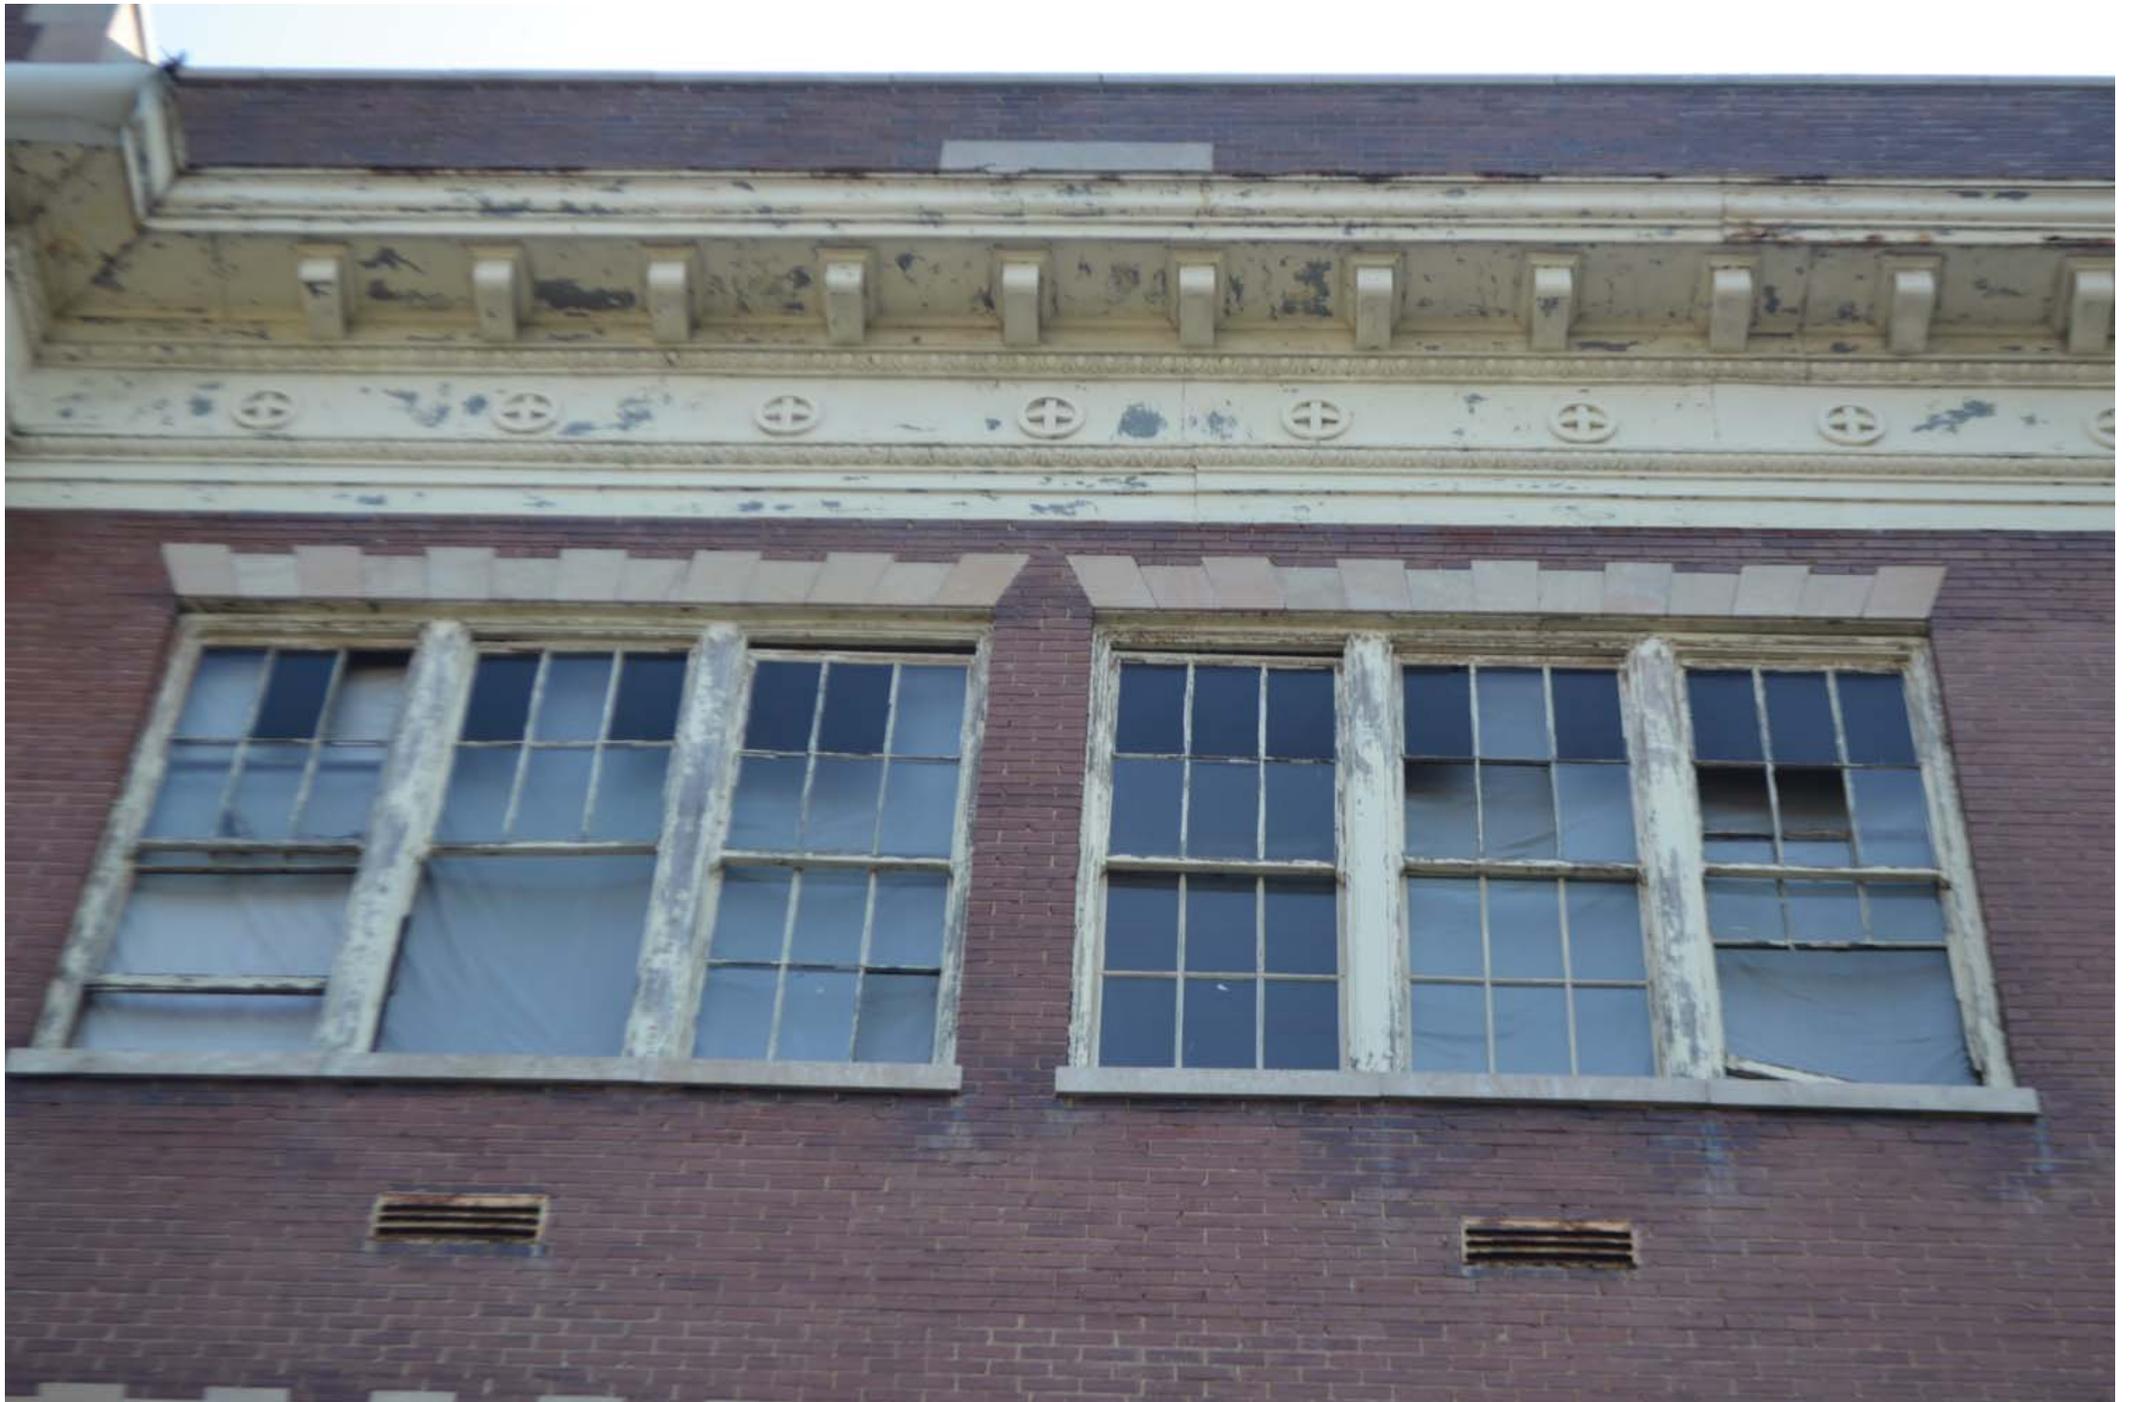
- 8) Most of the muntins have lost their profile through decay, scraping, or over-glazing of replacement glass.
- 9) The tendons and tongues on the majority of the windows have severely deteriorated.

Missing sashes and muntins on N. Central Street upper level

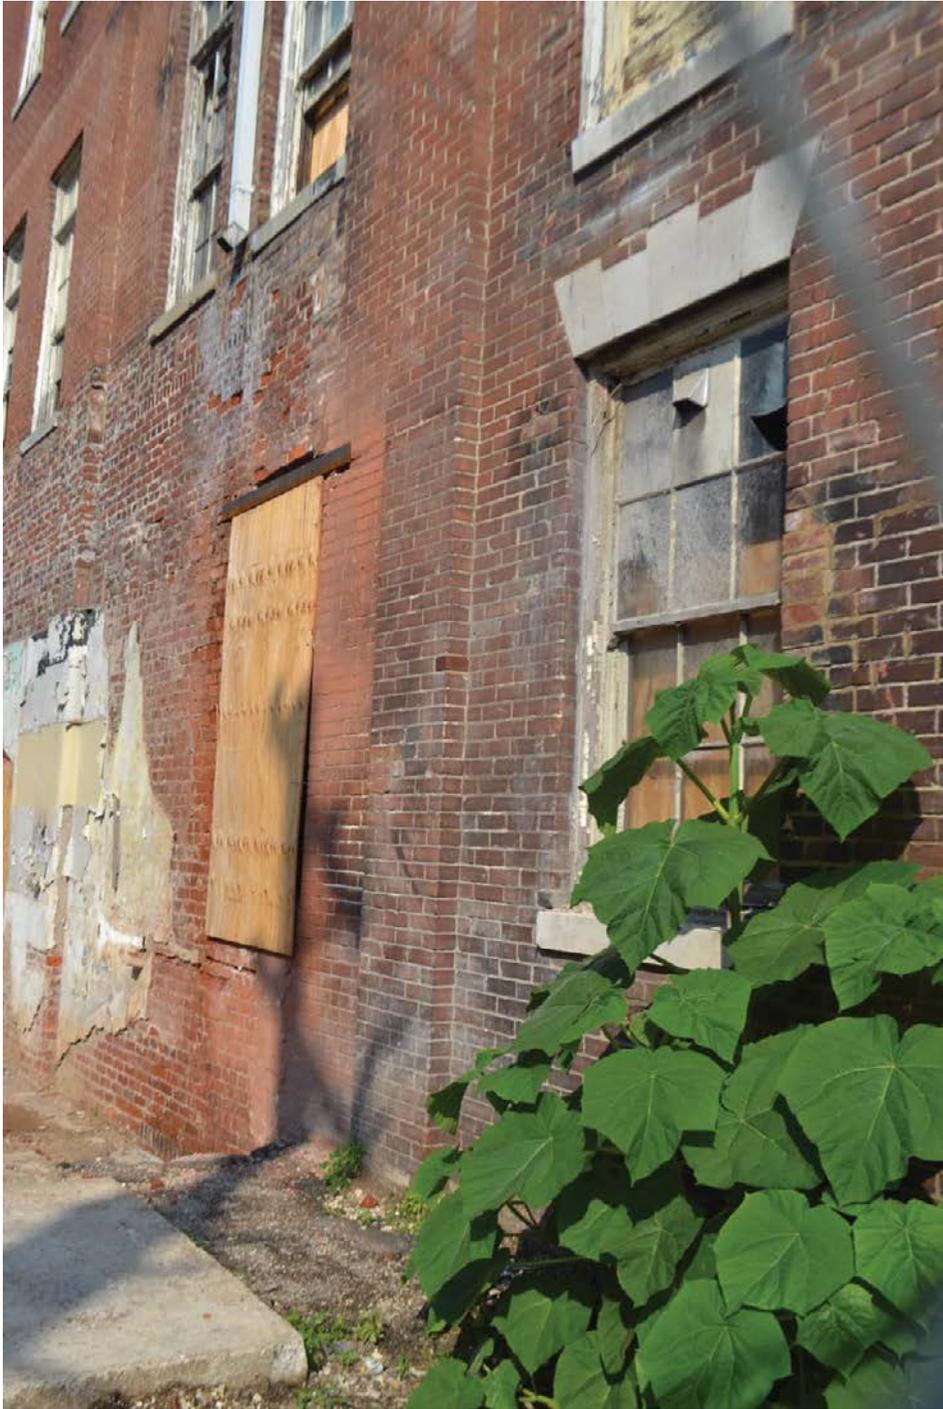
Missing windows in courtyard
