**KNOXVILLE HISTORIC ZONING COMMISSION
STAFF REPORT - CERTIFICATE OF APPROPRIATENESS APPLICATION**

PROPERTY ADDRESS: 101 E Fifth Ave 37917

FILE NO.: 5-D-16-HZ

LEVEL OF WORK: Level II. Major repair or replacement of materials(windows)

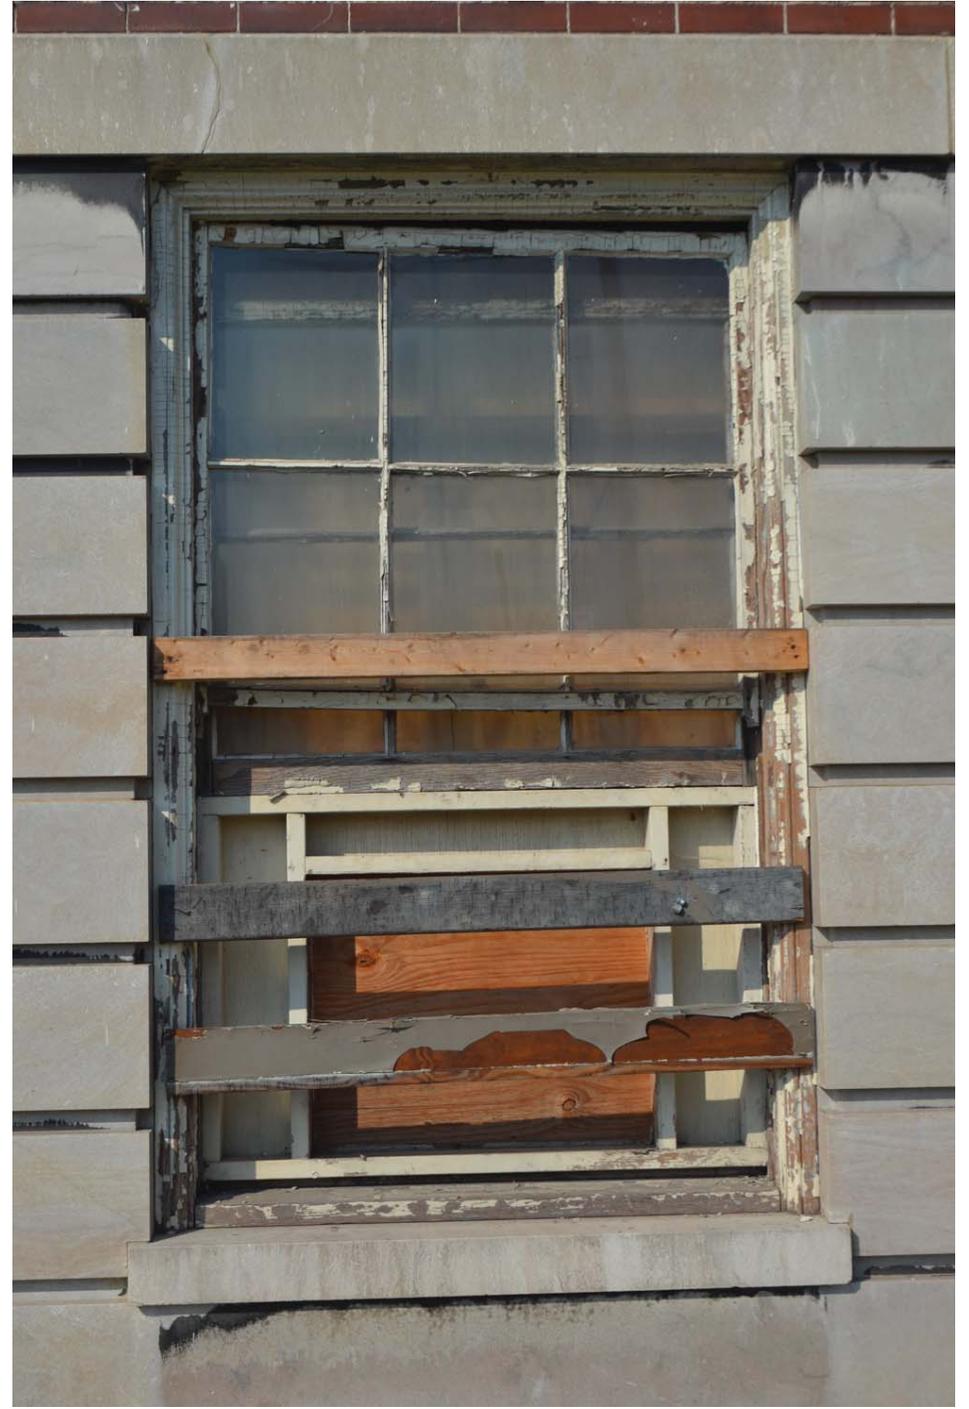
- 3) Lack of maintenance and incorrect repair techniques over the years has caused extensive damage to the windows, frames, sills, and surrounds.
- 4) Many top or bottom sashes are missing or have been altered to accept window air conditioning units.

Bottom window sash missing

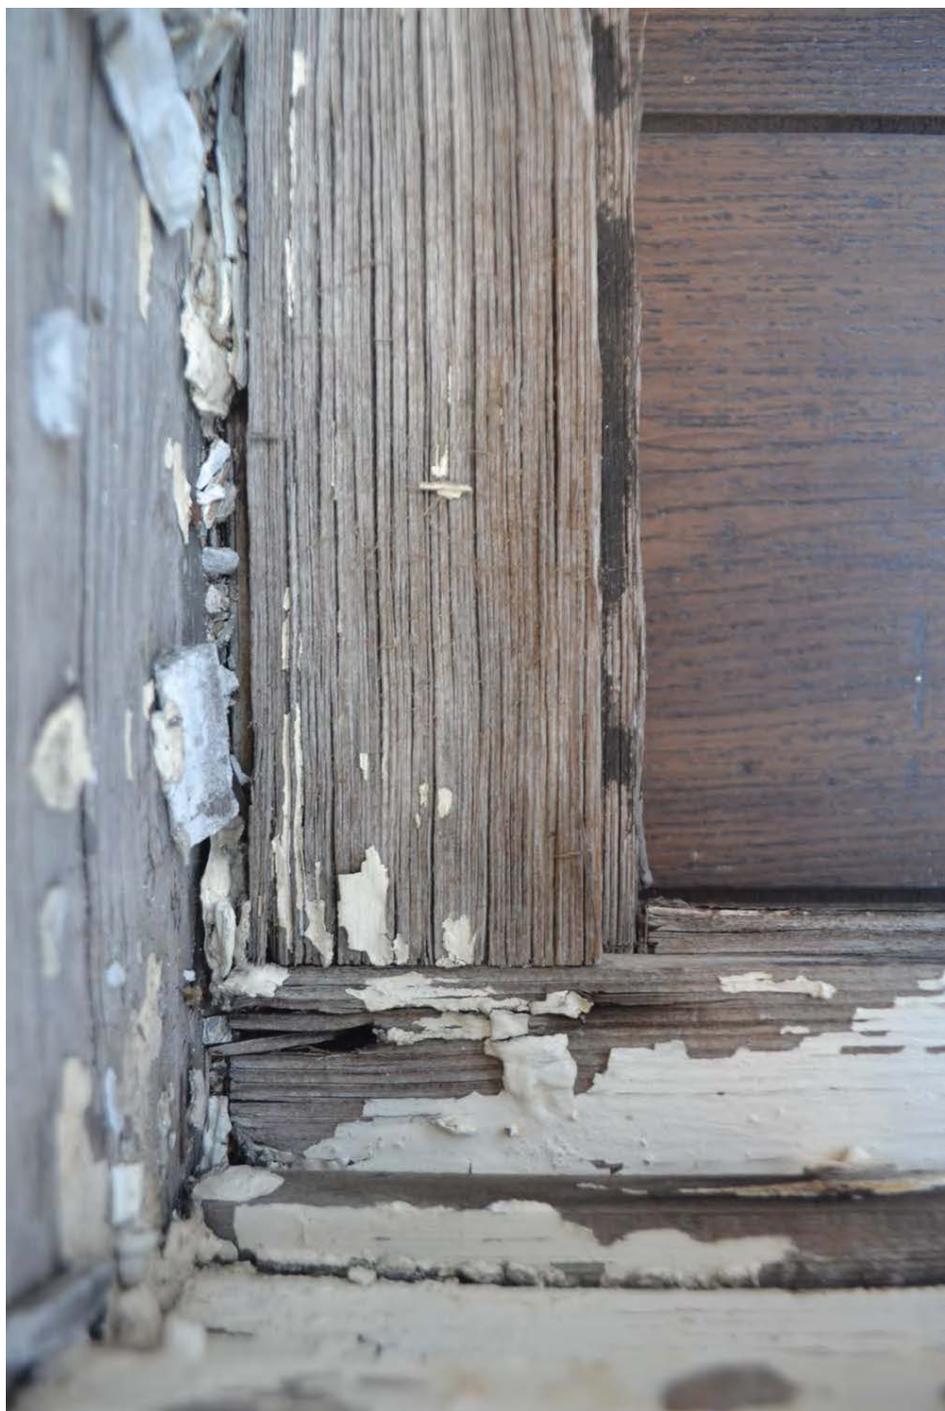
- 4) Many top or bottom sashes are missing or have been altered to accept window air conditioning units.
- 5) The window sills are mostly intact, but they exhibit ¼" to ½"- wide cracks, and the wood grain is severely routed.

Deteriorated sash and sill

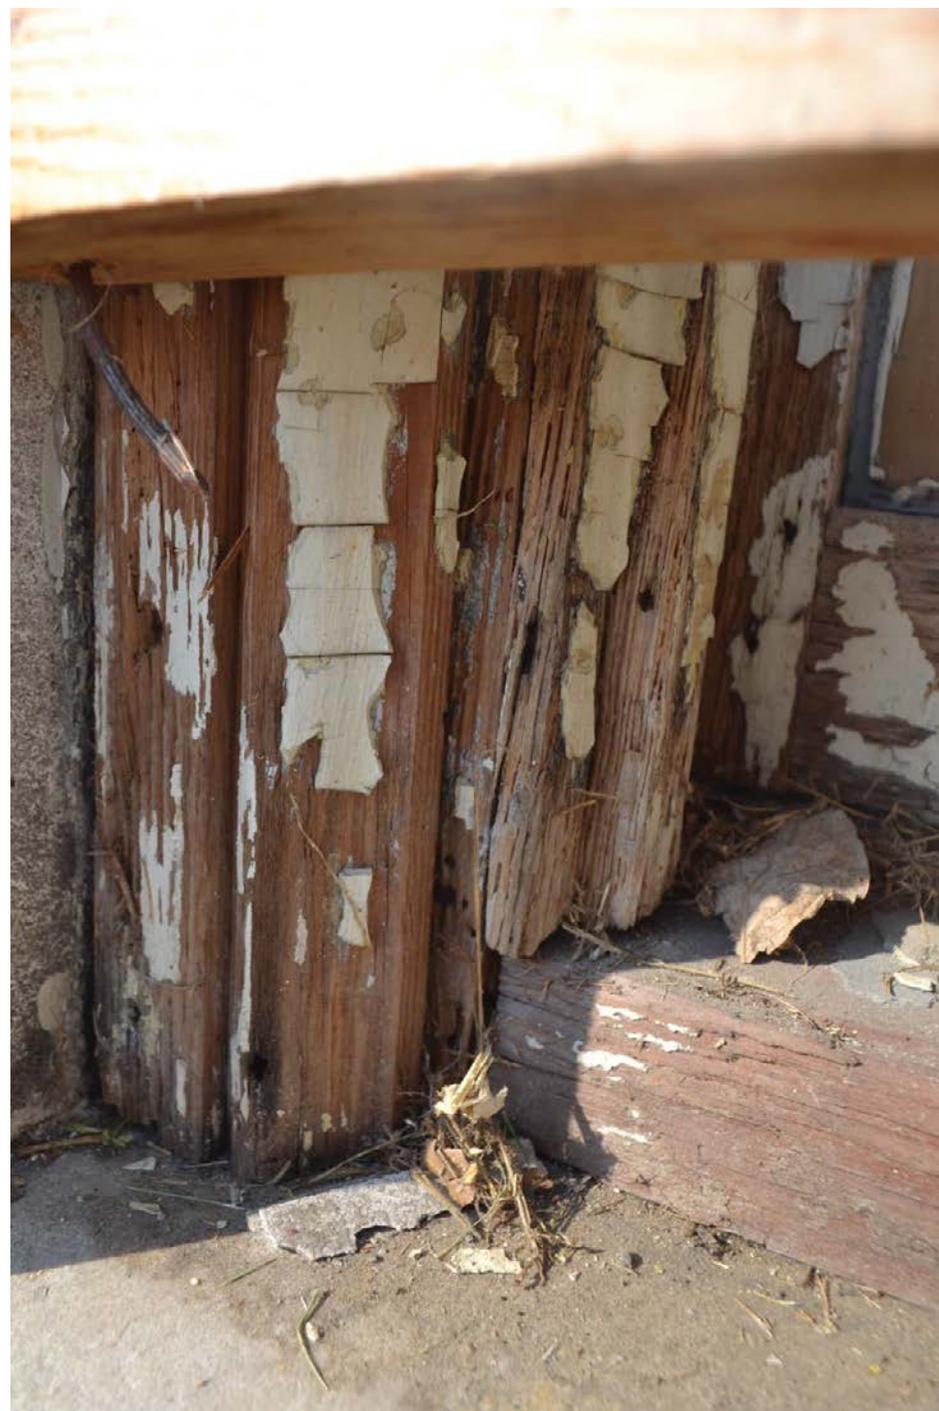
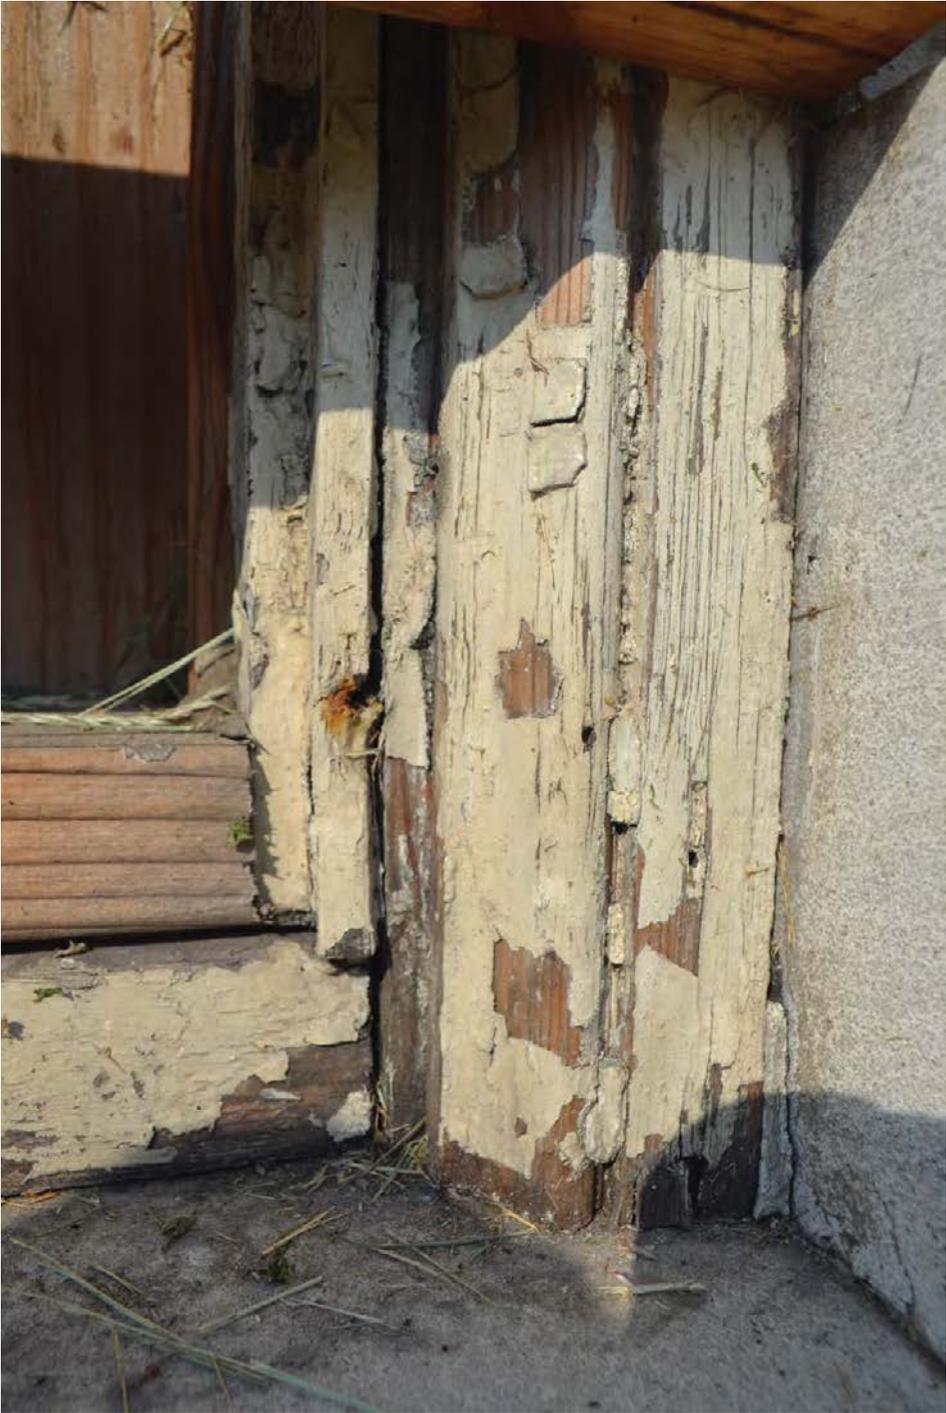
Rot at bottom of frame

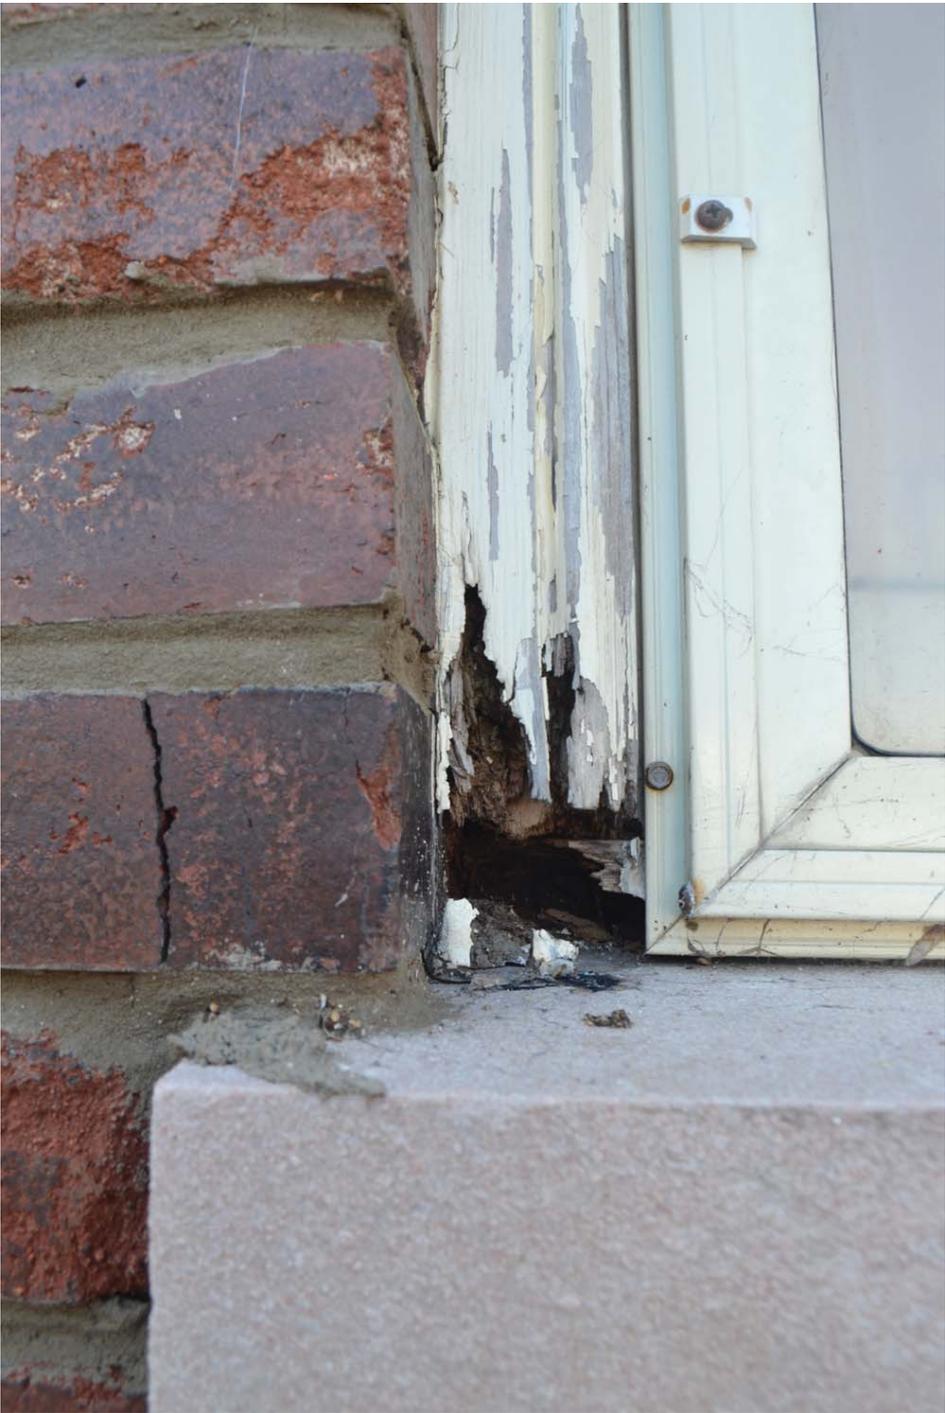
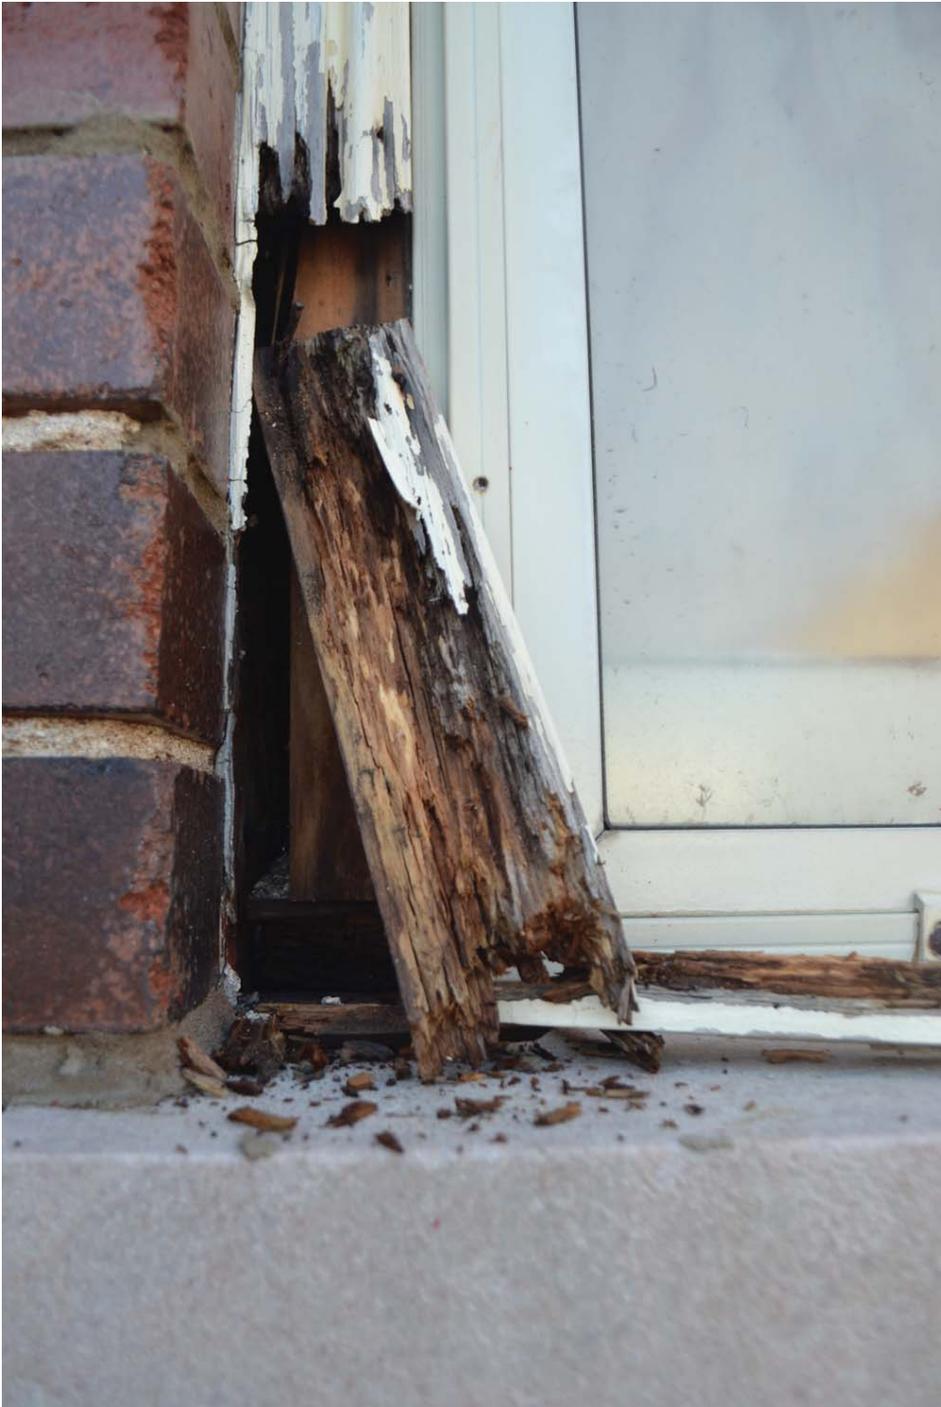
Rot on SW side window frame

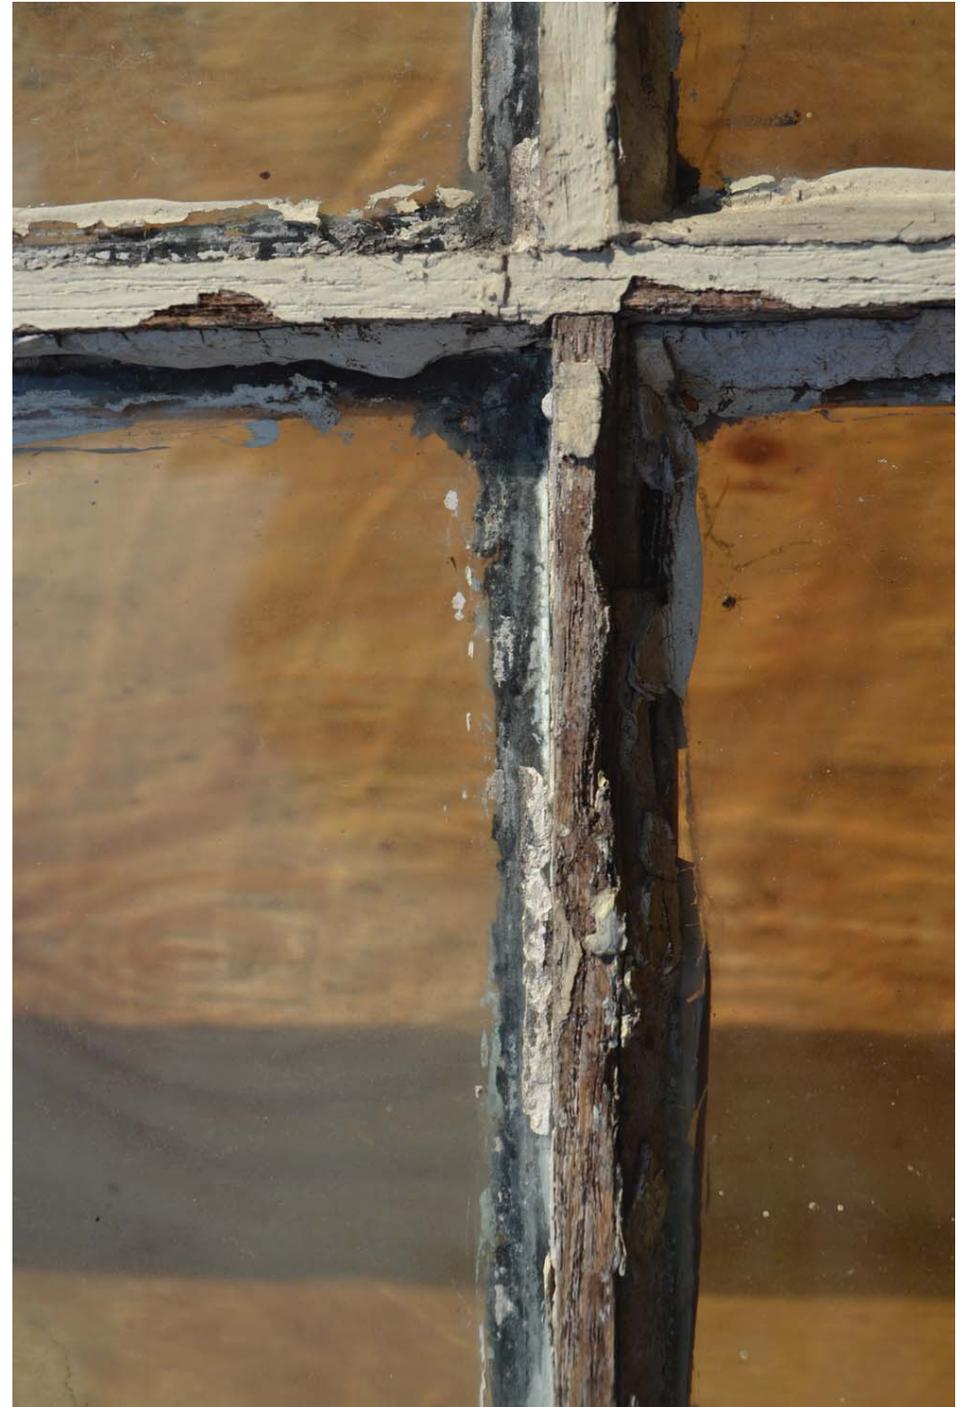
- 8) Most of the muntins have lost their profile through decay, scraping, or over-glazing of replacement glass.
- 9) The tendons and tongues on the majority of the windows have severely deteriorated.

Deteriorated muntin
