**KNOXVILLE HISTORIC ZONING COMMISSION
STAFF REPORT - CERTIFICATE OF APPROPRIATENESS APPLICATION**

PROPERTY ADDRESS: 1424 Fremont Ave

FILE NO.: 6-F-17-HZ

PROPERTY DESCRIPTION: Craftsman Four-square (c. 1915)

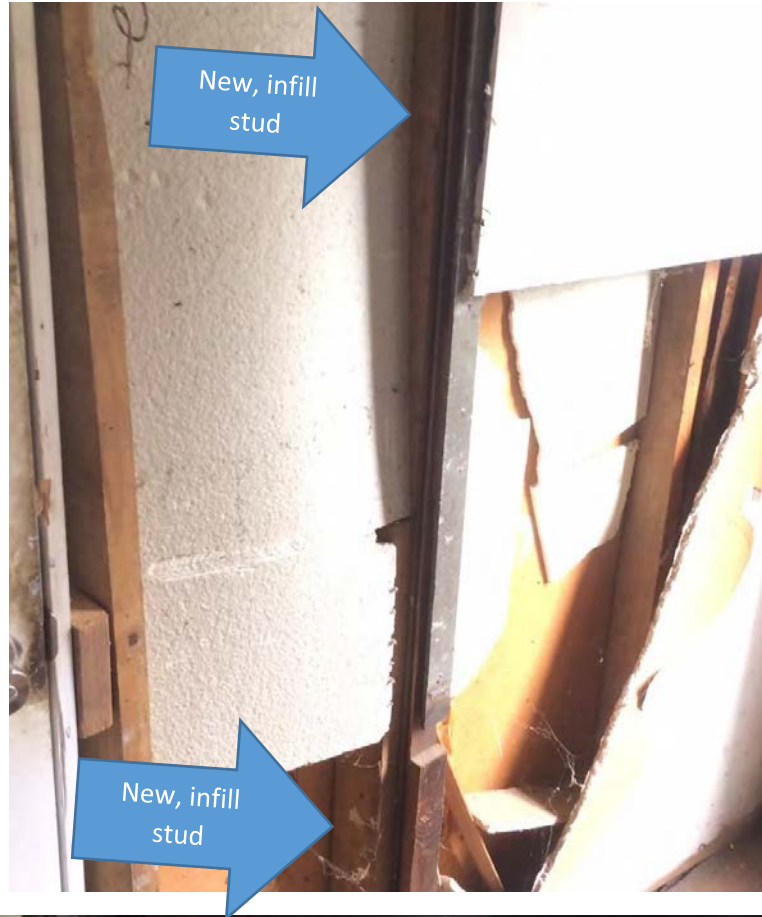
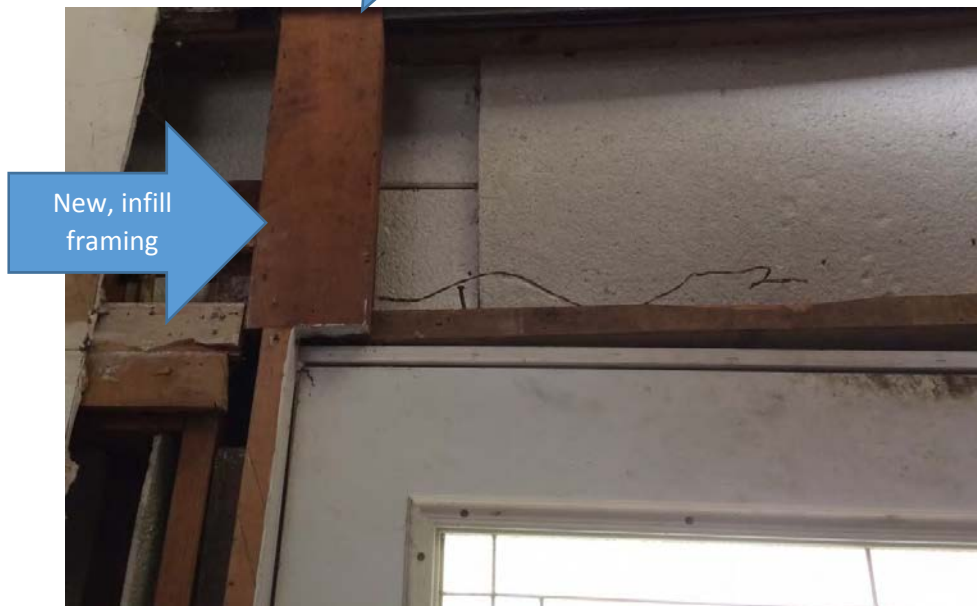
Infill framing above, and on the sides of the non-original front door, prove that the front entry has been drastically reduced in size; supporting the replacement with an entry with sidelights and a transom.

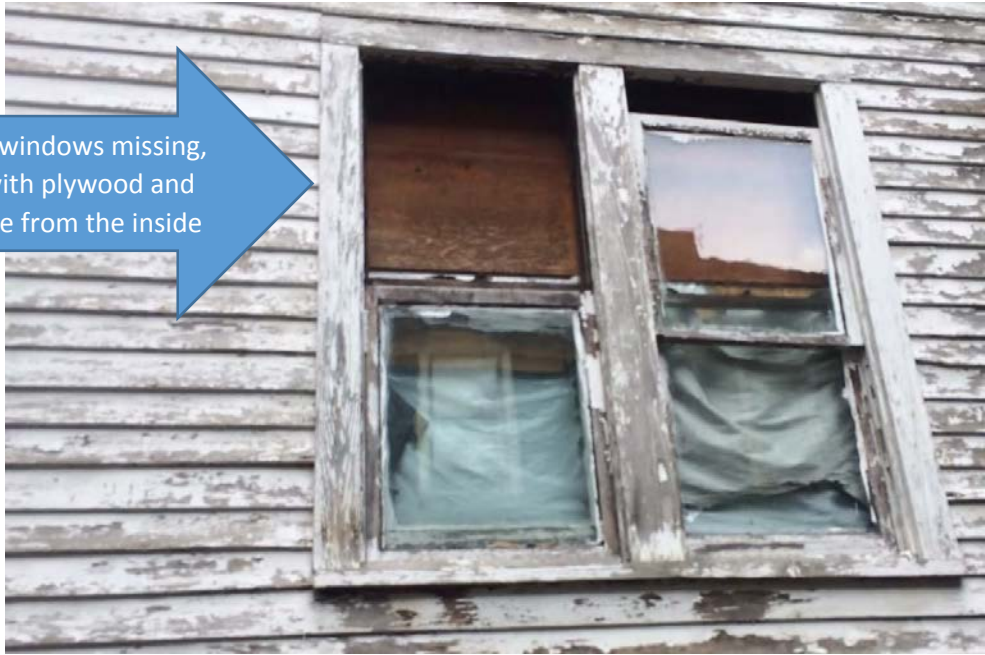
North side windows missing, covered with plywood and inaccessible from the inside

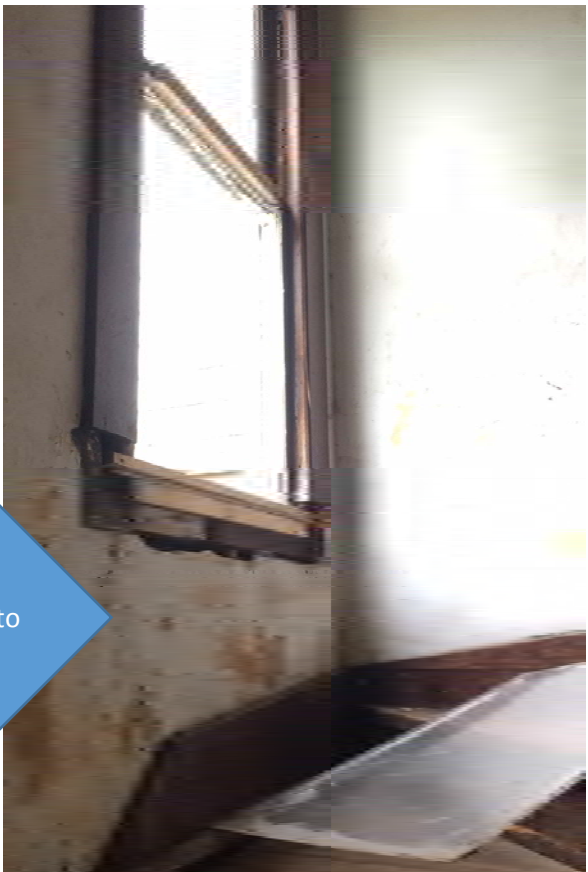
Staircase window Plexiglas blown out. Missing sections to the window (north side).

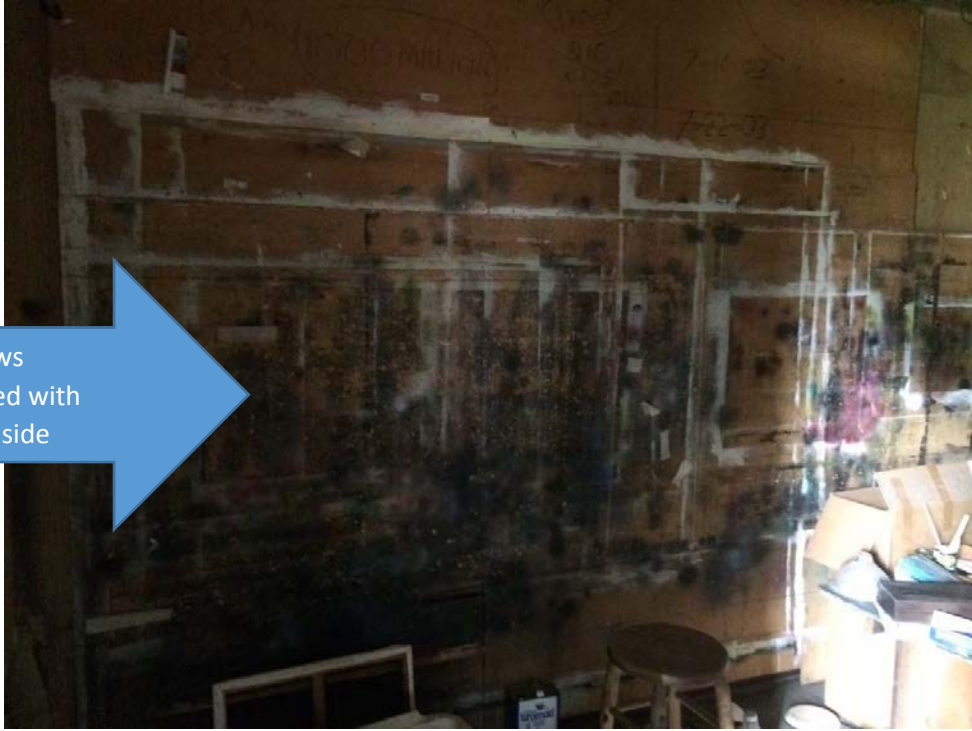
South side windows completely covered with plywood on the inside

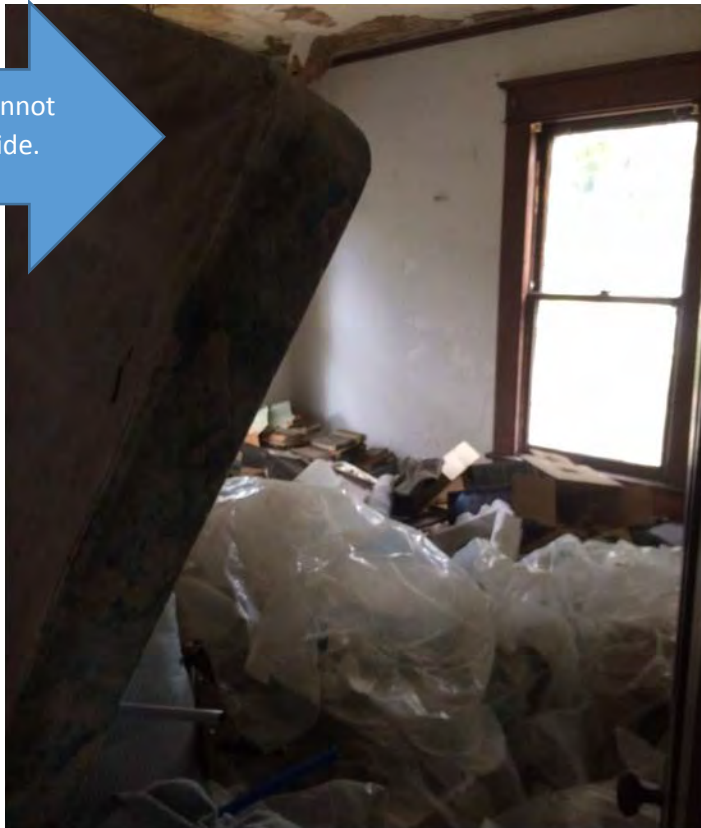
Many windows simply cannot be accessed from the inside.

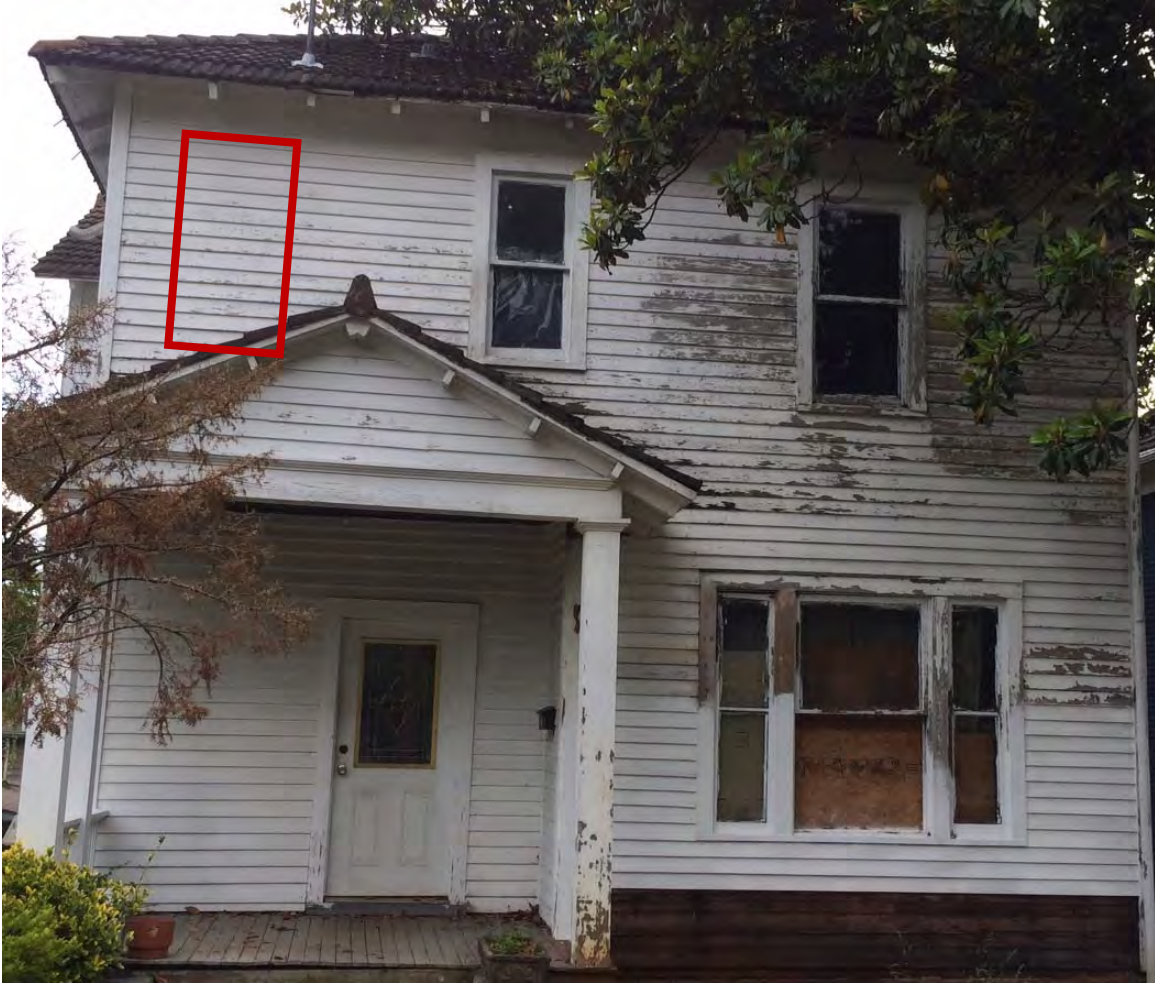
The imbalance of windows on the front of the house gives the impression that a window was covered at some point in time. We would like to reinstall it with a replacement window if, through discovery with internal demolition, we can prove that a window was indeed there originally. Since we cannot demolish the inside at the moment we would like the HZC to approve the concept if we can *prove* the existence to staff at a later date.

- 1) A double-hung wood replacement window may be installed on the front second level as shown in the submitted drawing/photo if internal demolition indicates that a window originally existed in that location;
- 2) Replace windows in-kind on a case-by-case basis if their condition is found to be such that repair is not feasible -- as approved by staff ;
- 3) Replace the front door with a wood door with a 2/3 or 3/4 unembellished beveled glass panel and sidelights with dimensions as indicated by original framing -- as approved by staff and;
- 4) Install two wood double-hung windows on each side of the addition that match the typical size of the larger historic windows on the house.

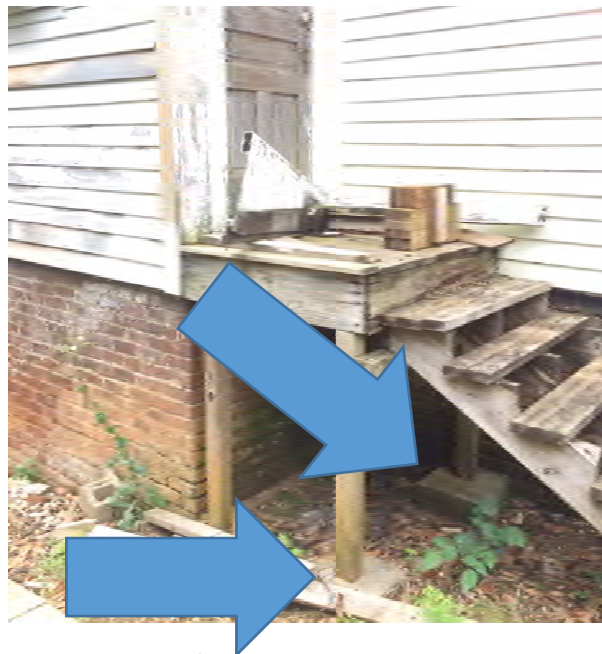
A wrap around porch (which would support a side door) would have traversed the lower staircase window.

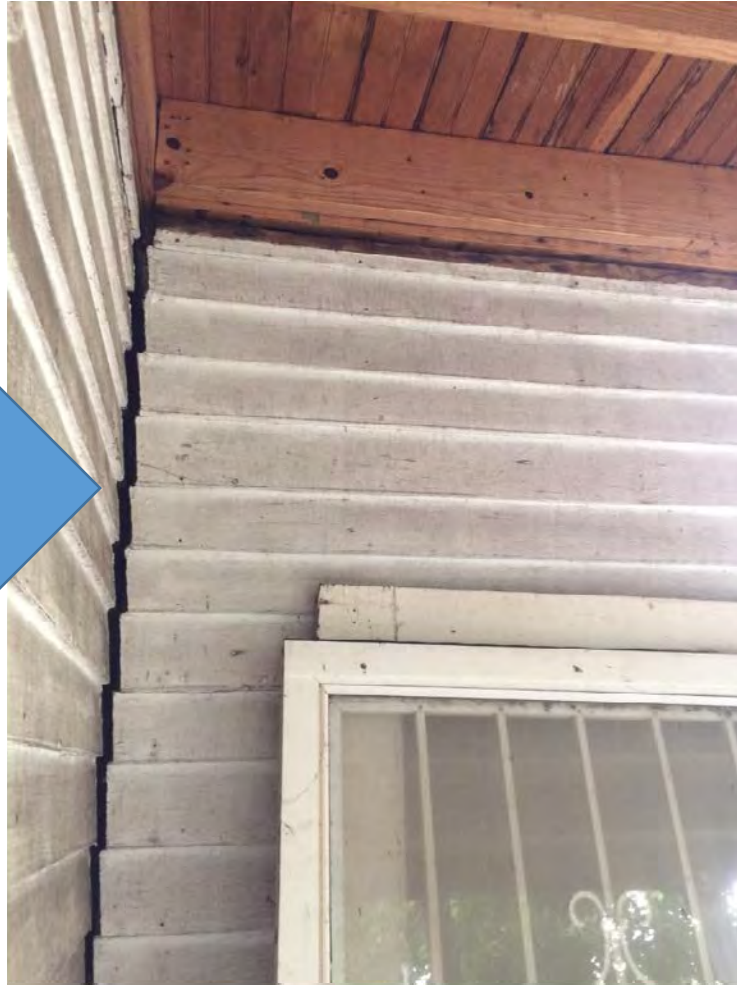
The rotting floor and supports have caused the addition to pull away from the house.

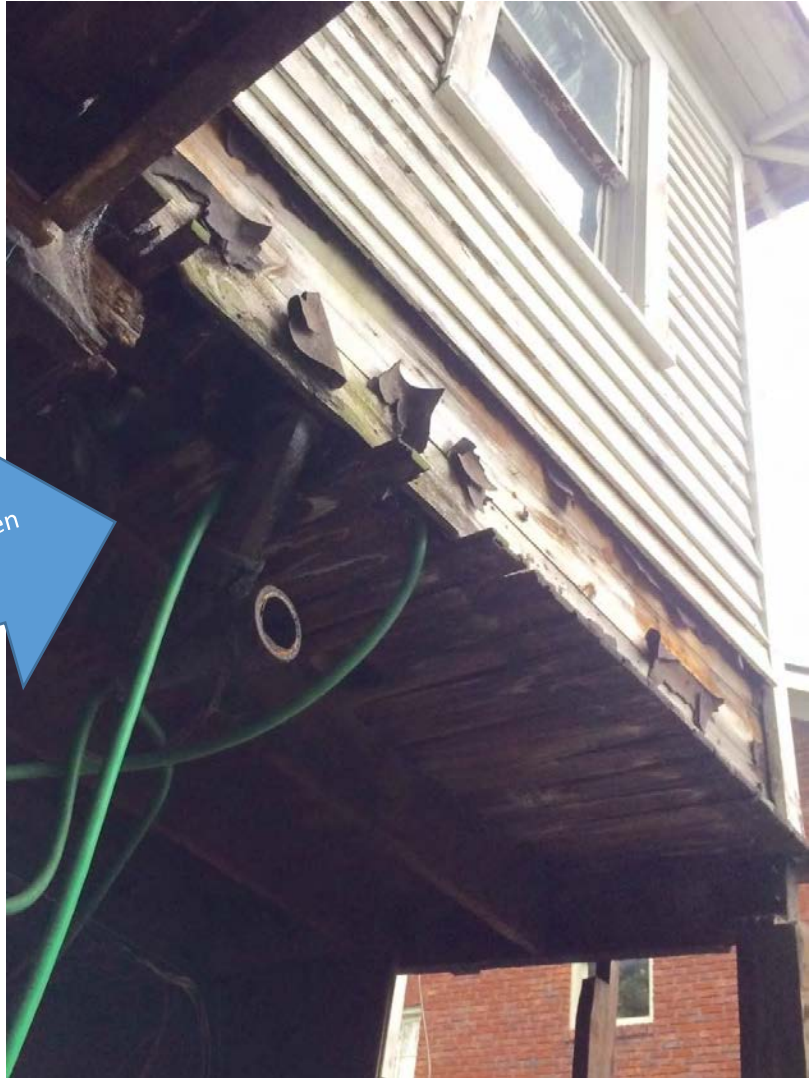
6) The 1917 Sanborn map footprint indicates the 6'x7' rear frame addition is not original. Its structure is pulling away from the main house. Joists are missing, and the vertical supports have rotted, so it is not feasible to repair.

Joist missing and rotten supports

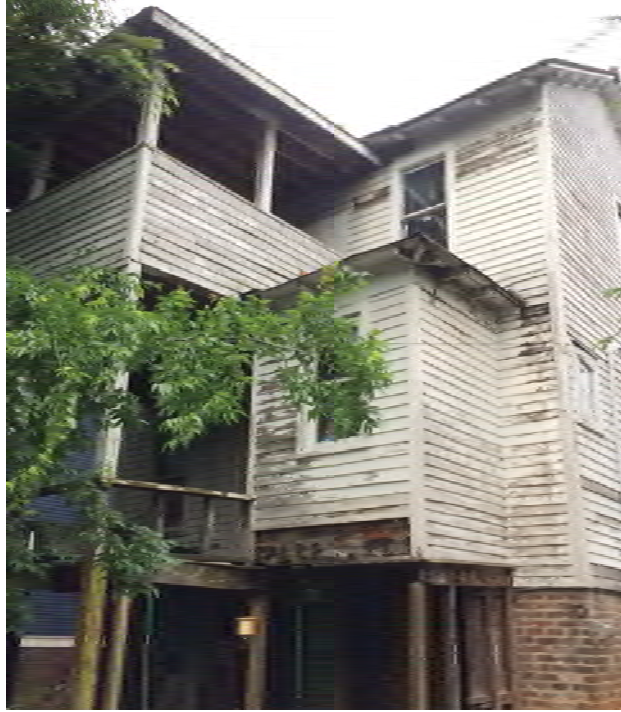
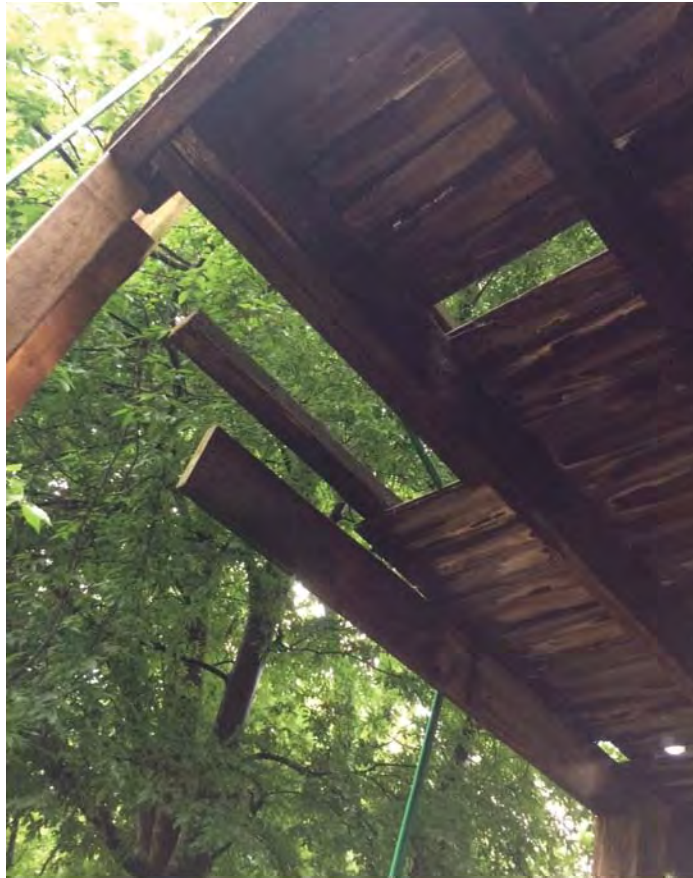
The deck's joists are not all tied to supports and it is inherently unstable and beyond repair. Simply put the current deck is unsalvageable.

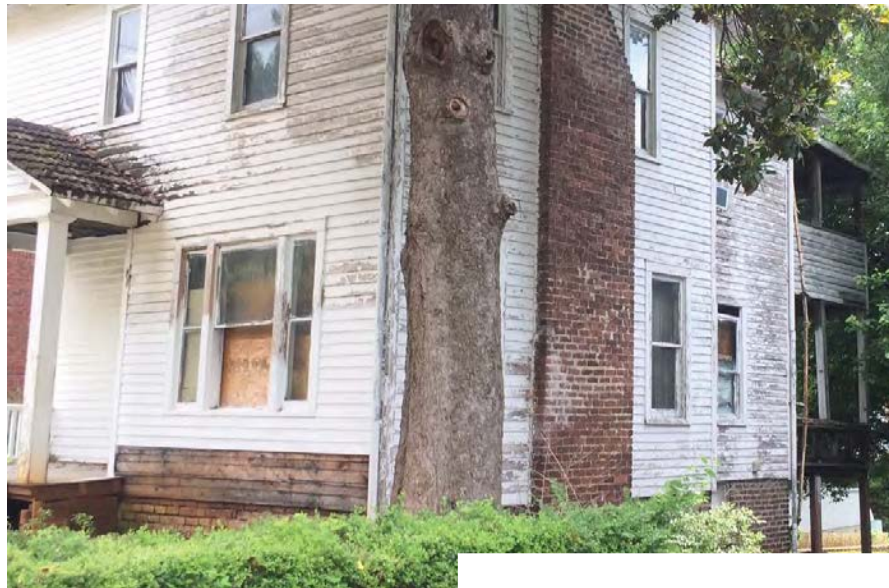
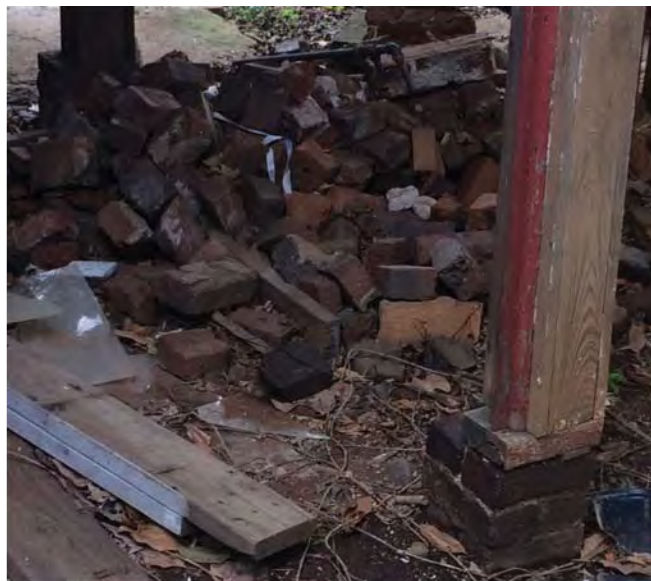
Original brick supports show us the dimensions of the original rear porches.

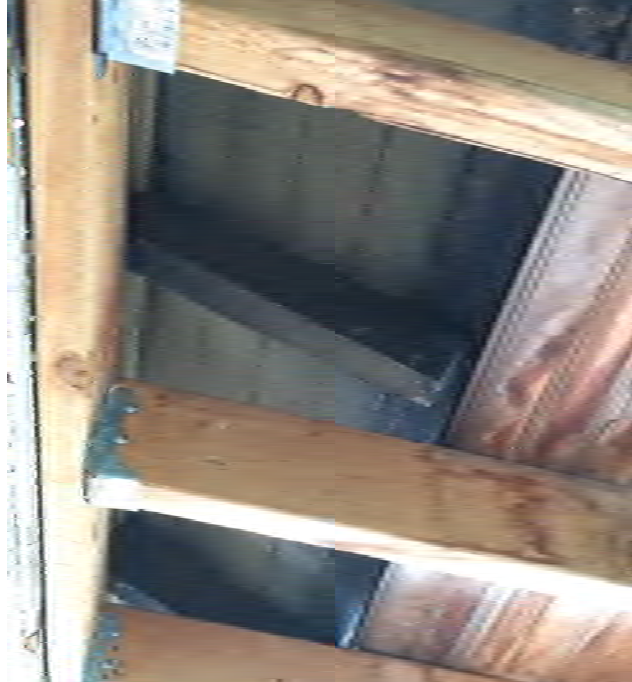
In this view of the existing upper porch roof we can see how they joined new and old construction. It's worth noting that this photograph also shows the 100 year old roof, with exposed rafter tails, has not been modified; thus proving that the original porches were indeed open air.
