**KNOXVILLE HISTORIC ZONING COMMISSION
STAFF REPORT - CERTIFICATE OF APPROPRIATENESS APPLICATION**

PROPERTY ADDRESS: 1104 Luttrell St 37917

FILE NO.: 7-O-18-HZ

LEVEL OF WORK: Level II. Painting masonry

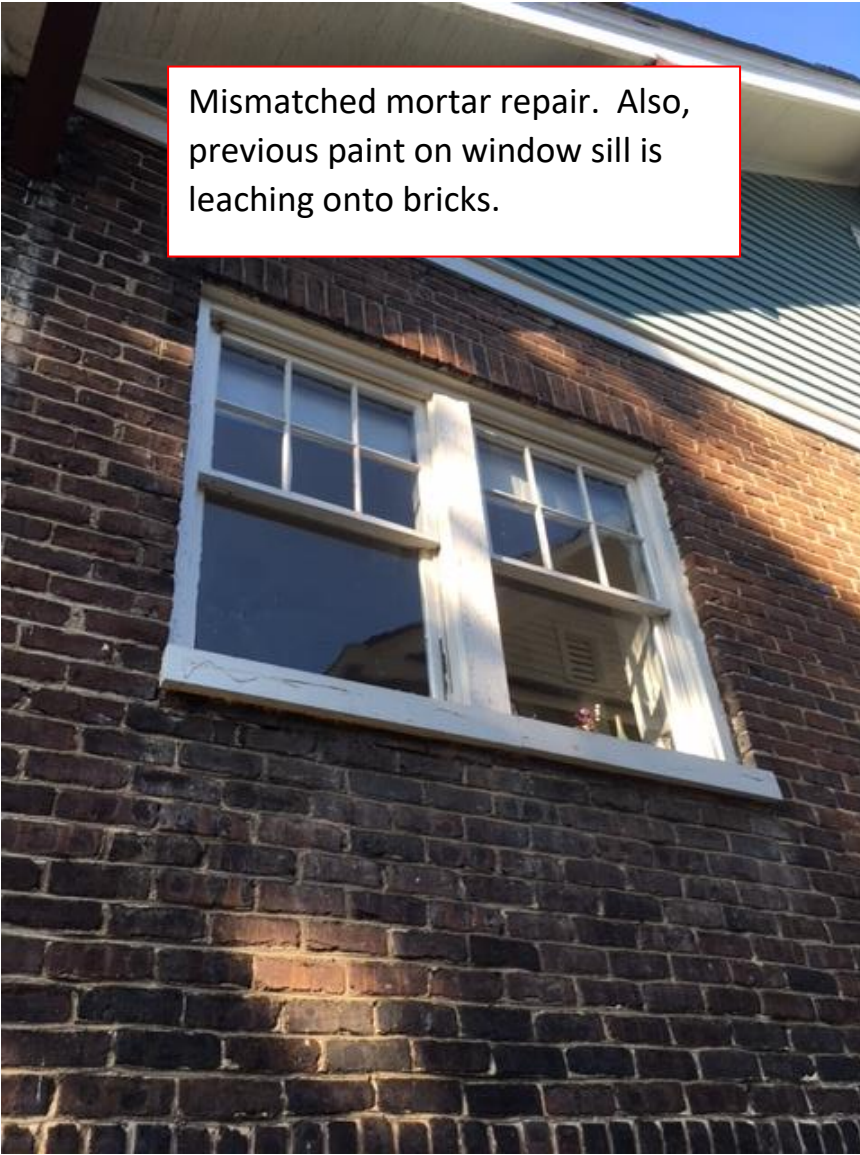
Mismatched mortar repair. Also, previous paint on window sill is leaching onto bricks.

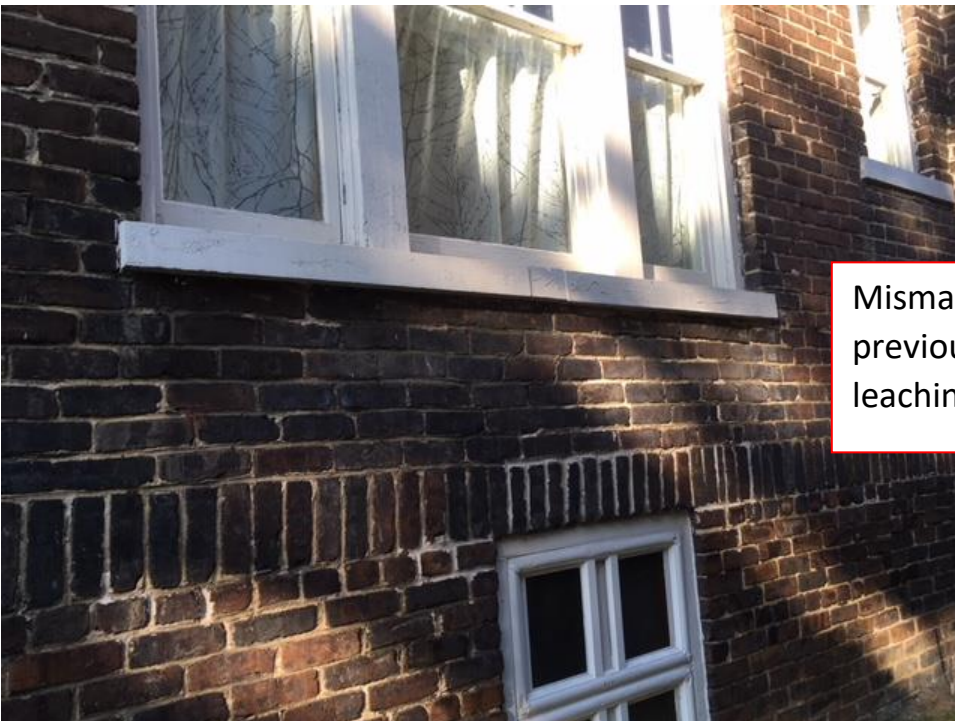
Mismatched mortar repair. Also, previous paint on window sill is leaching onto bricks.

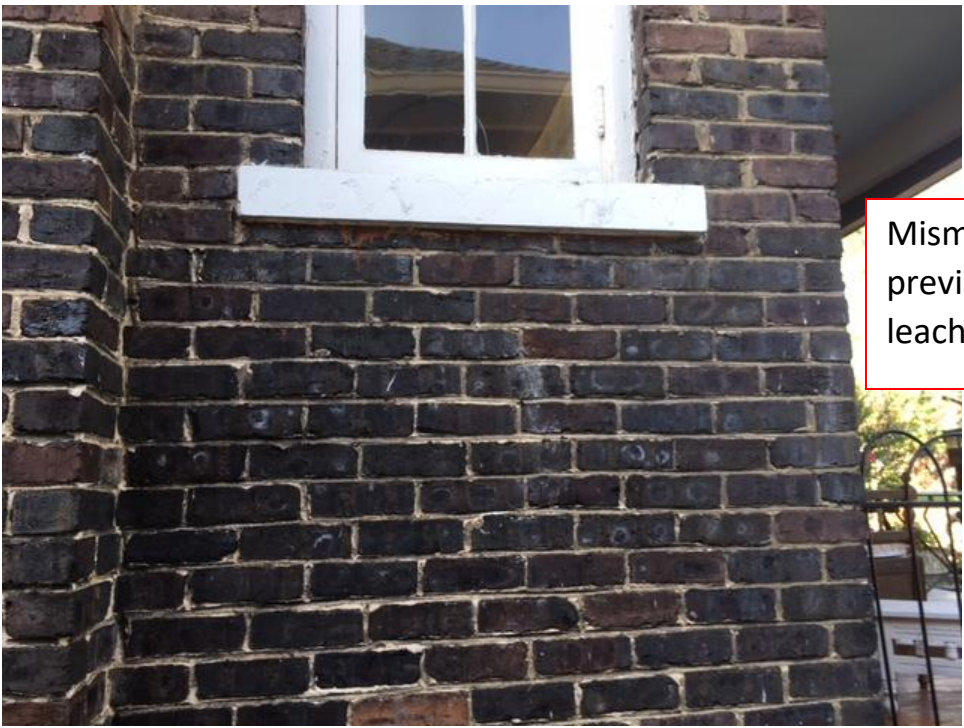
Mismatched mortar repair. Also, previous paint on window sill is leaching onto bricks.

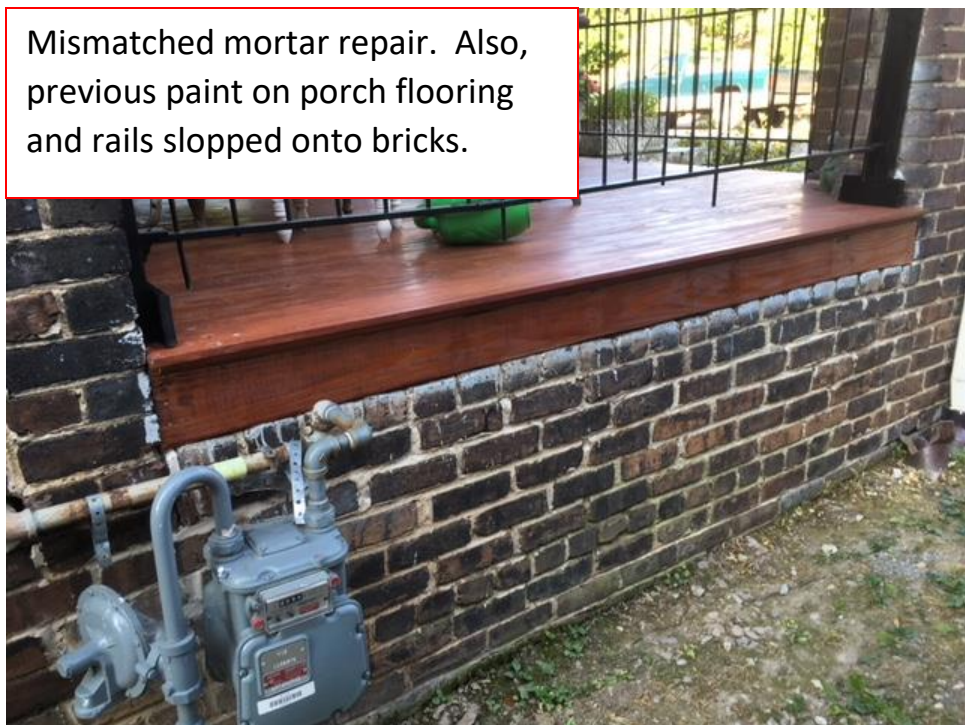
Mismatched mortar repair. Also, previous paint on porch flooring and rails sloped onto bricks.

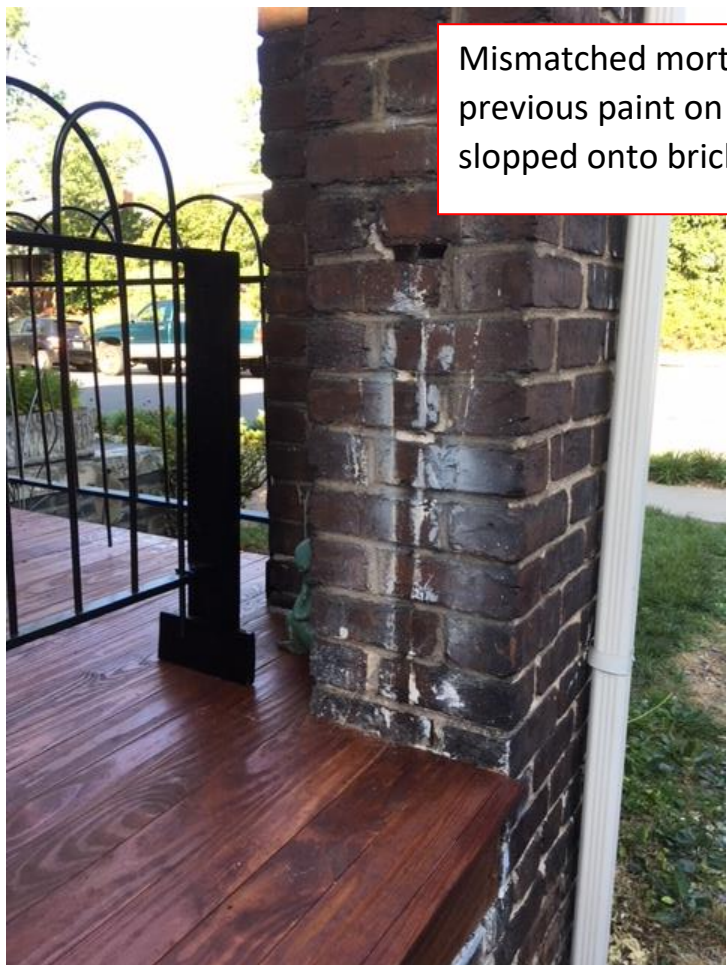
Mismatched mortar repair. Also, previous paint on porch rails sloped onto brick.

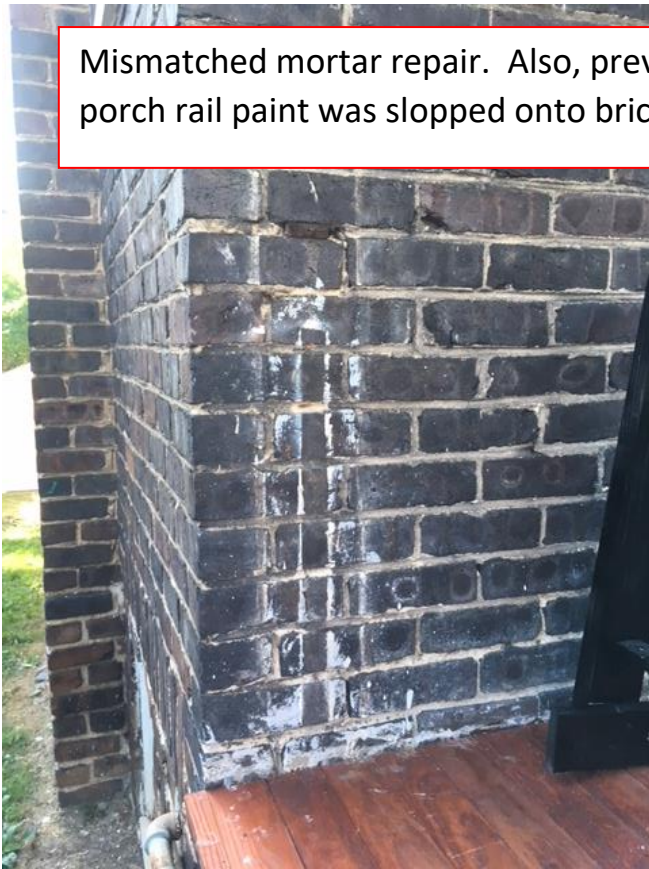
Mismatched mortar repair. Also, previous porch rail paint was sloped onto bricks.

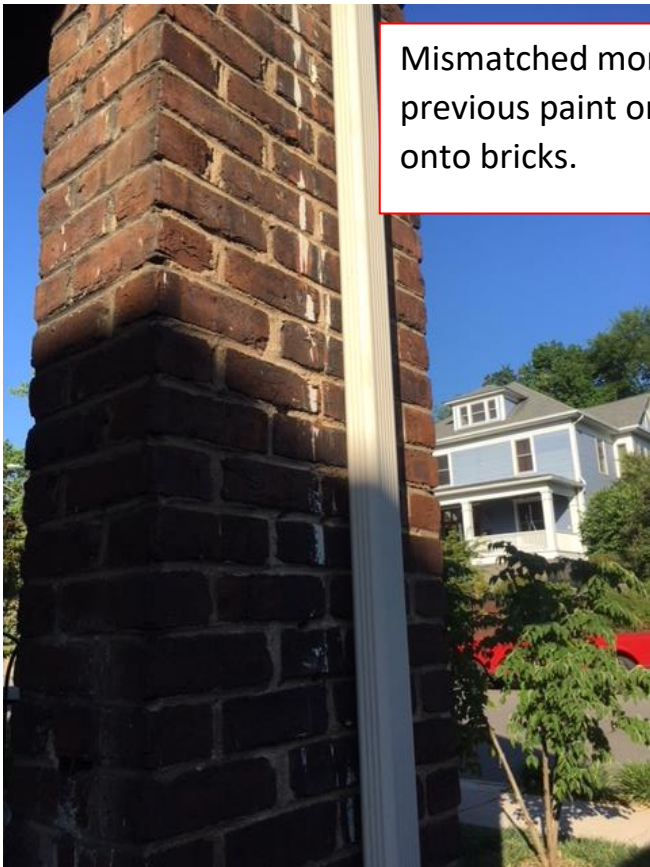
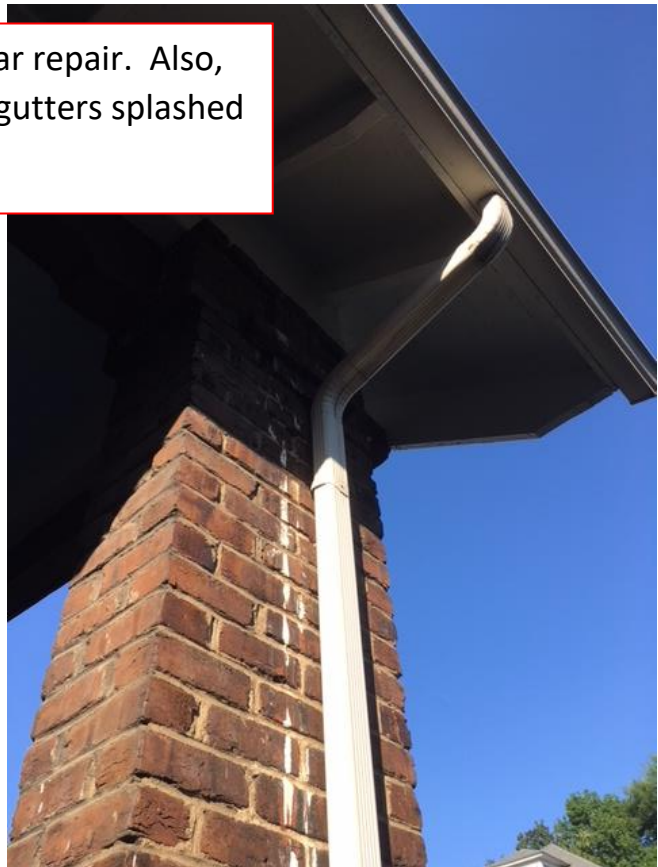
Mismatched mortar repair. Also, previous paint on gutters splashed onto bricks.

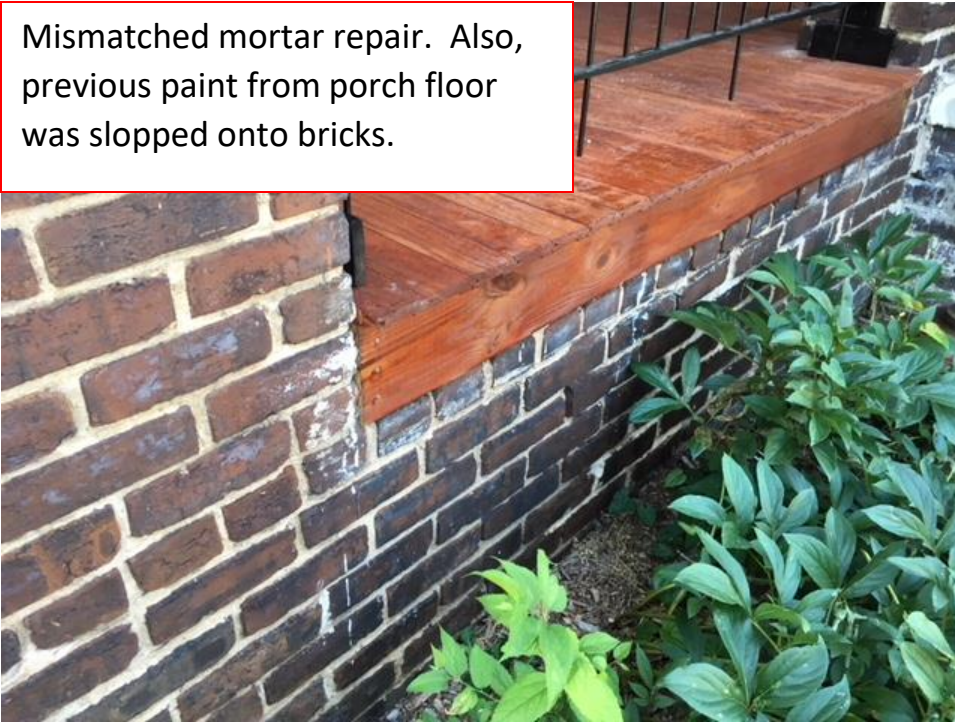
Mismatched mortar repair. Also, previous paint from porch floor was slopped onto bricks.

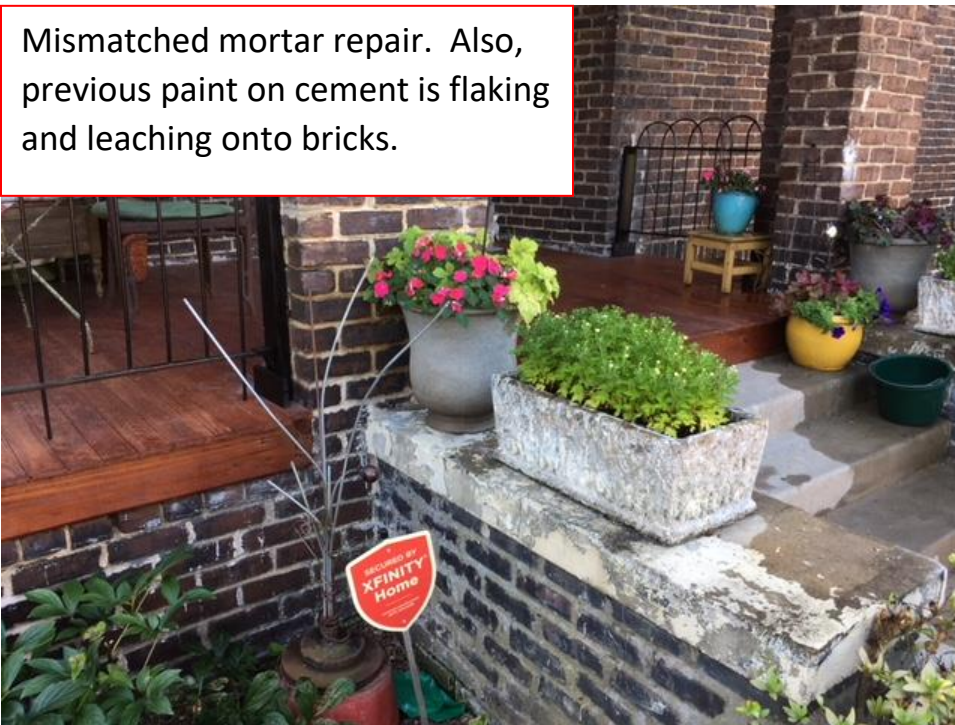
Mismatched mortar repair. Also, previous paint on cement is flaking and leaching onto bricks.

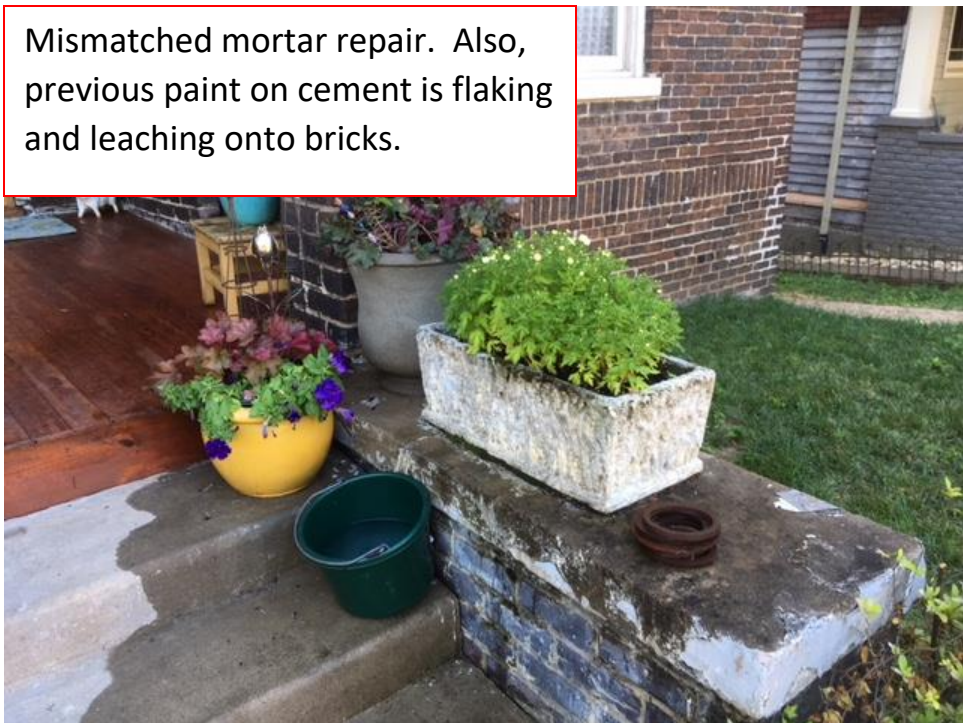
Mismatched mortar repair. Also, previous paint on cement is flaking and leaching onto bricks.

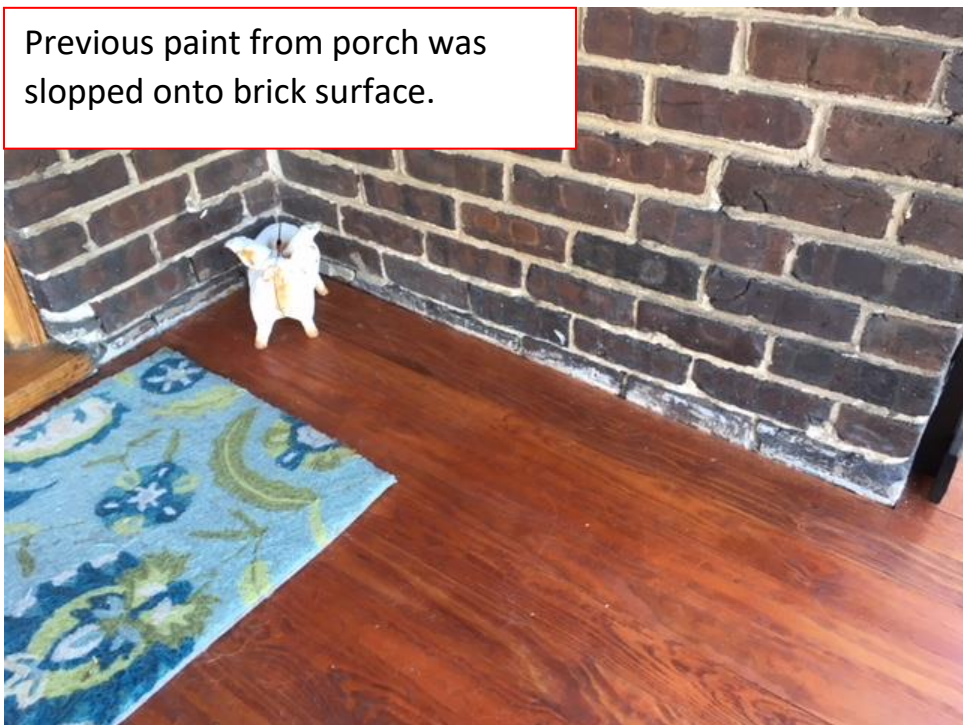
Previous paint from porch was slopped onto brick surface.

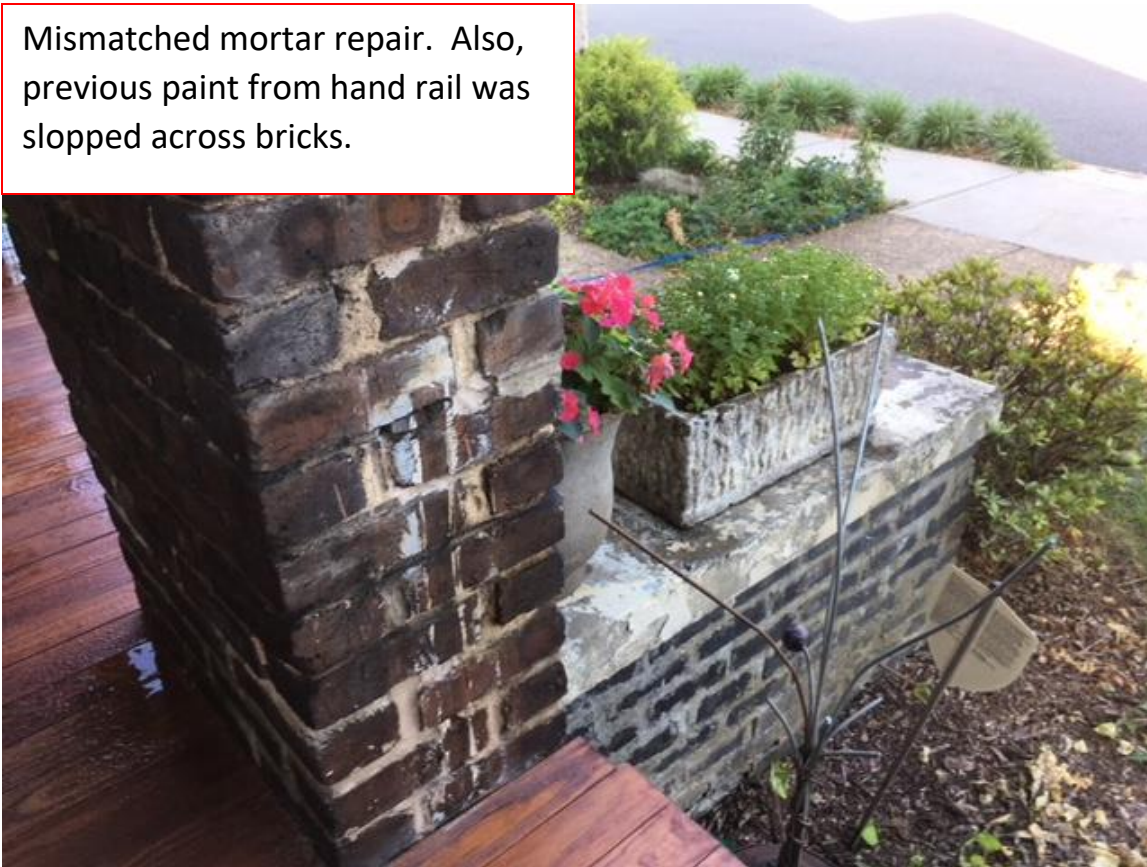
Mismatched mortar repair. Also, previous paint from hand rail was slopped across bricks.

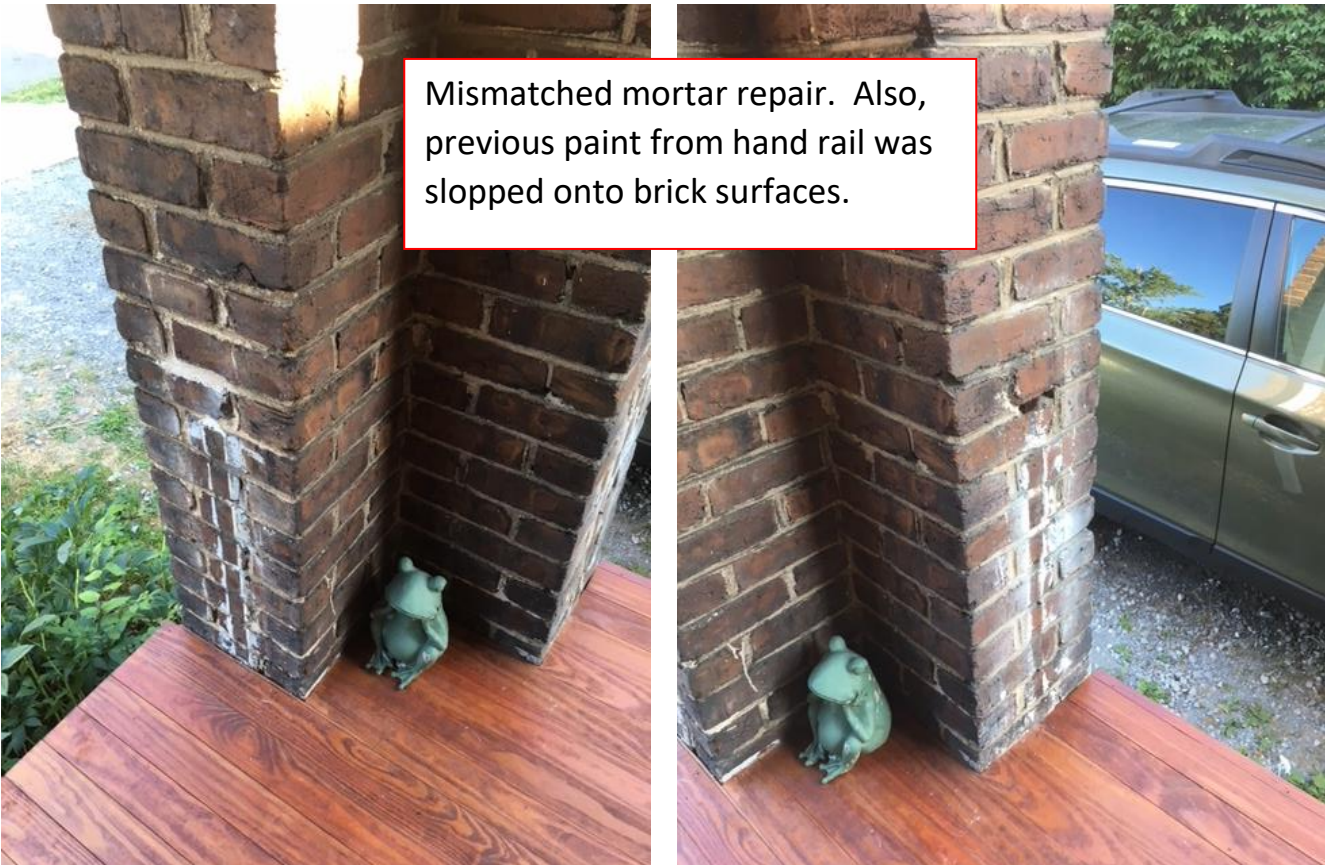
Mismatched mortar repair. Also, previous paint from hand rail was slopped onto brick surfaces.

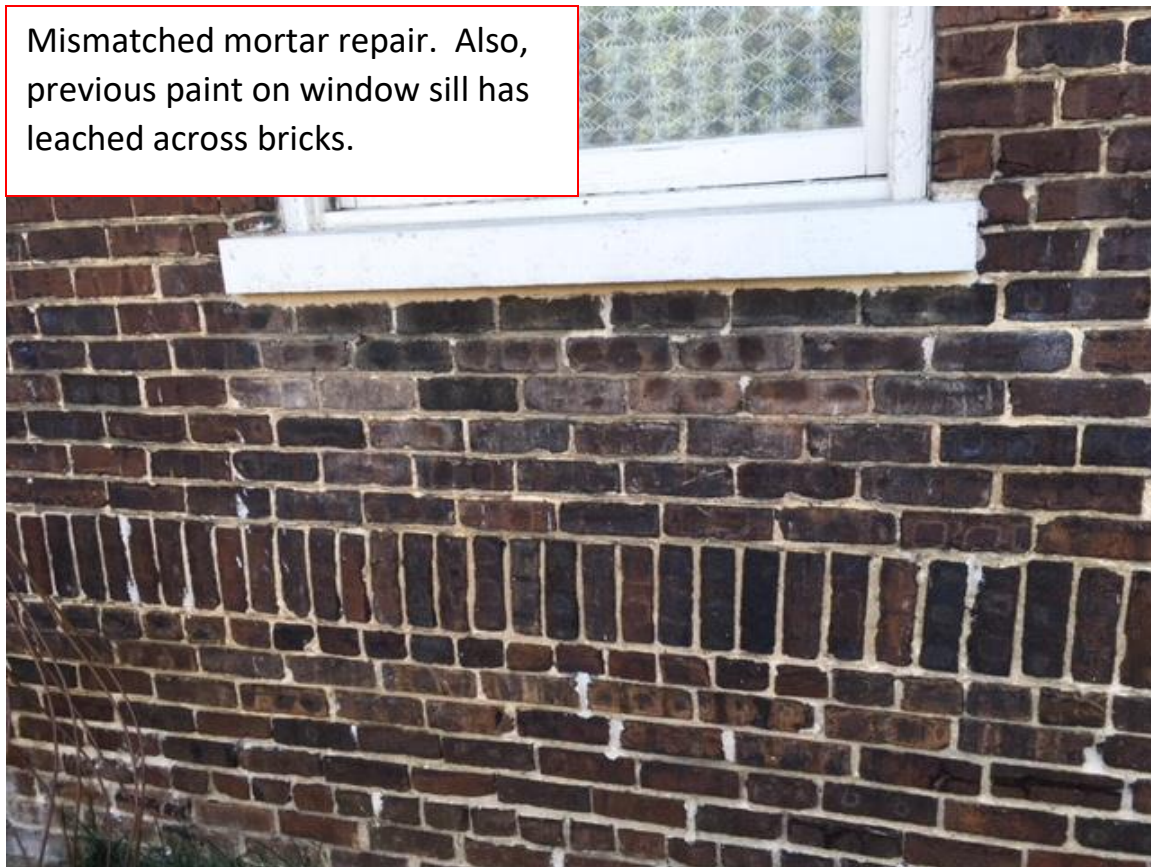
Mismatched mortar repair. Also, previous paint on window sill has leached across bricks.

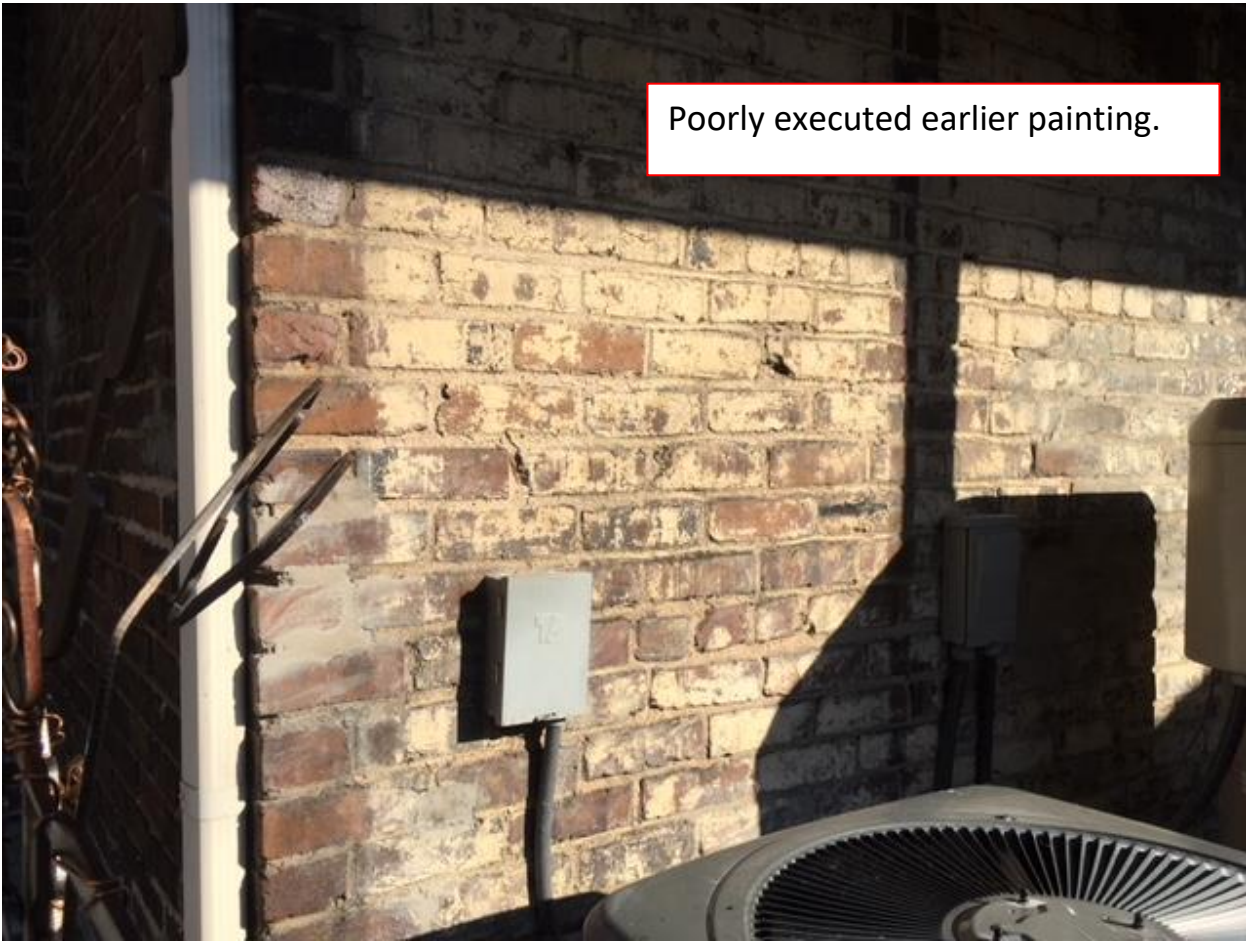
Poorly executed earlier painting.

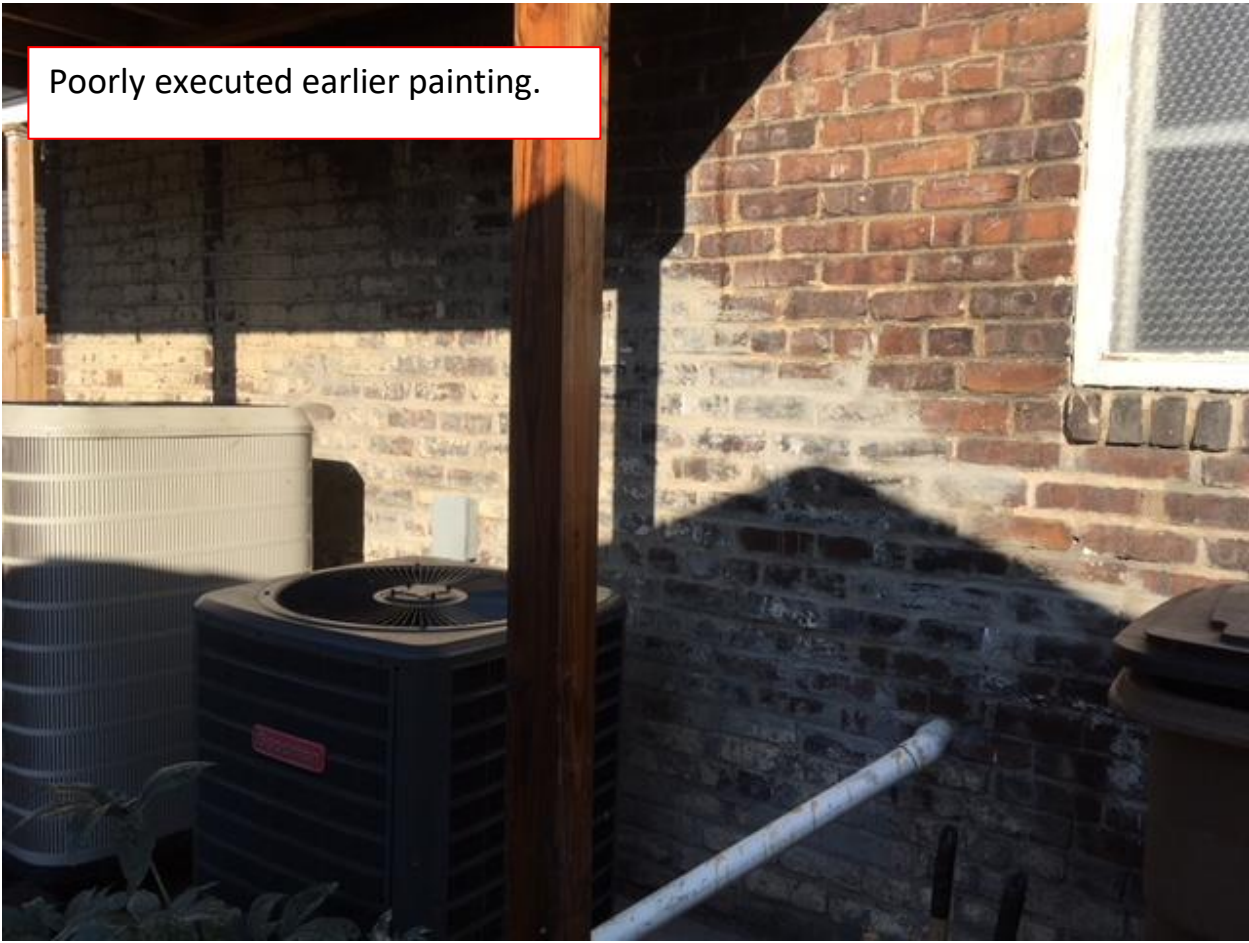
Poorly executed earlier painting.

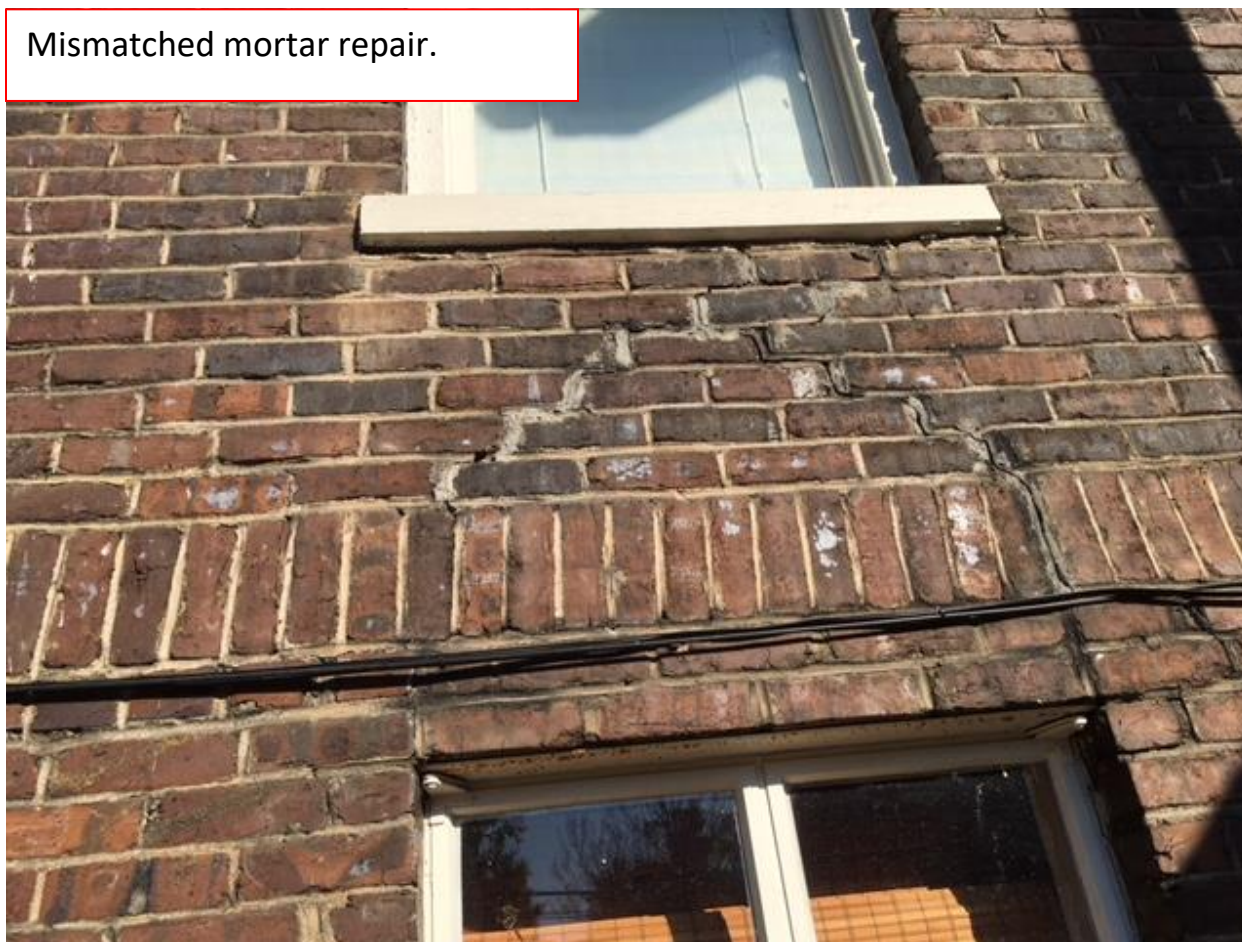
Mismatched mortar repair.

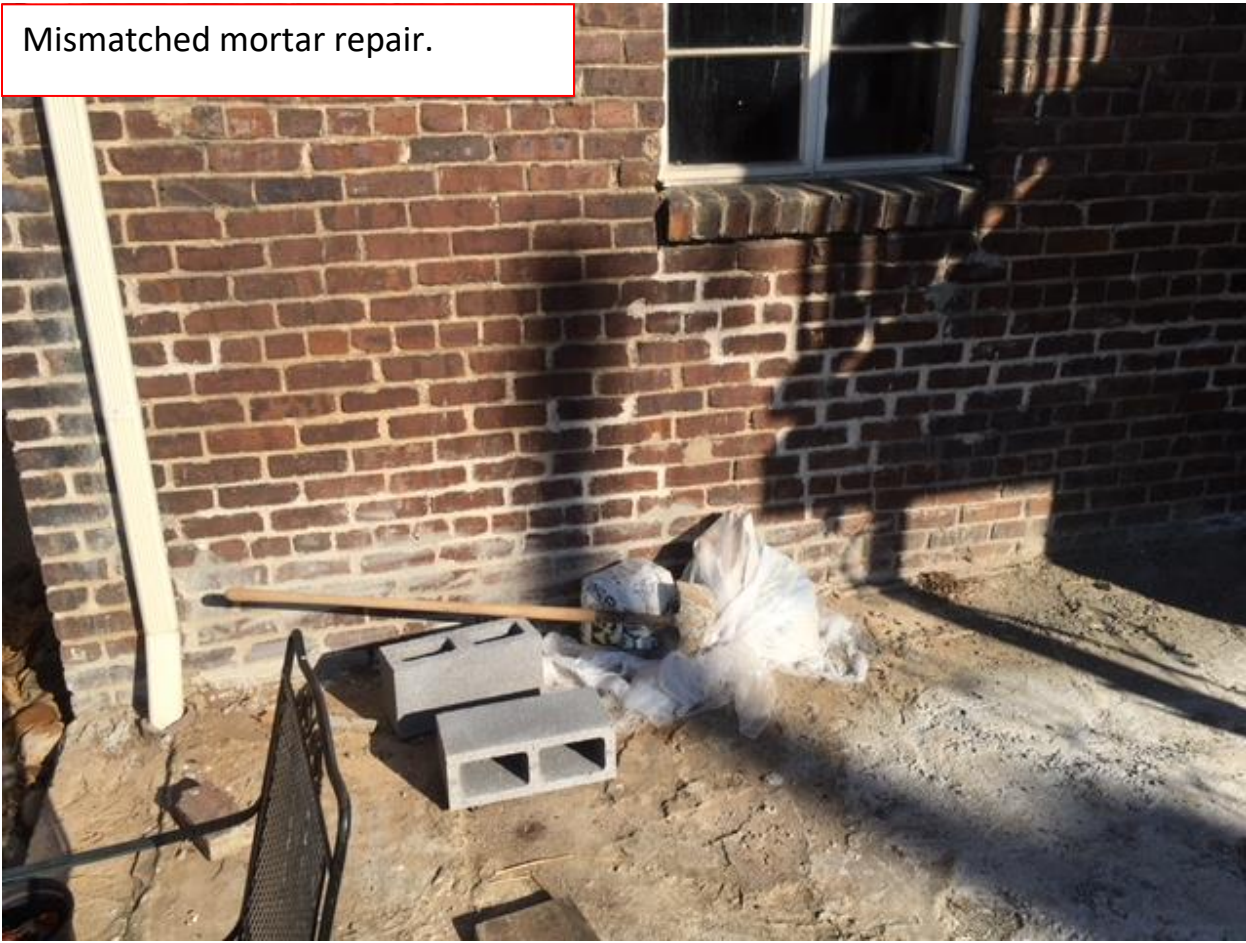
Mismatched mortar repair.

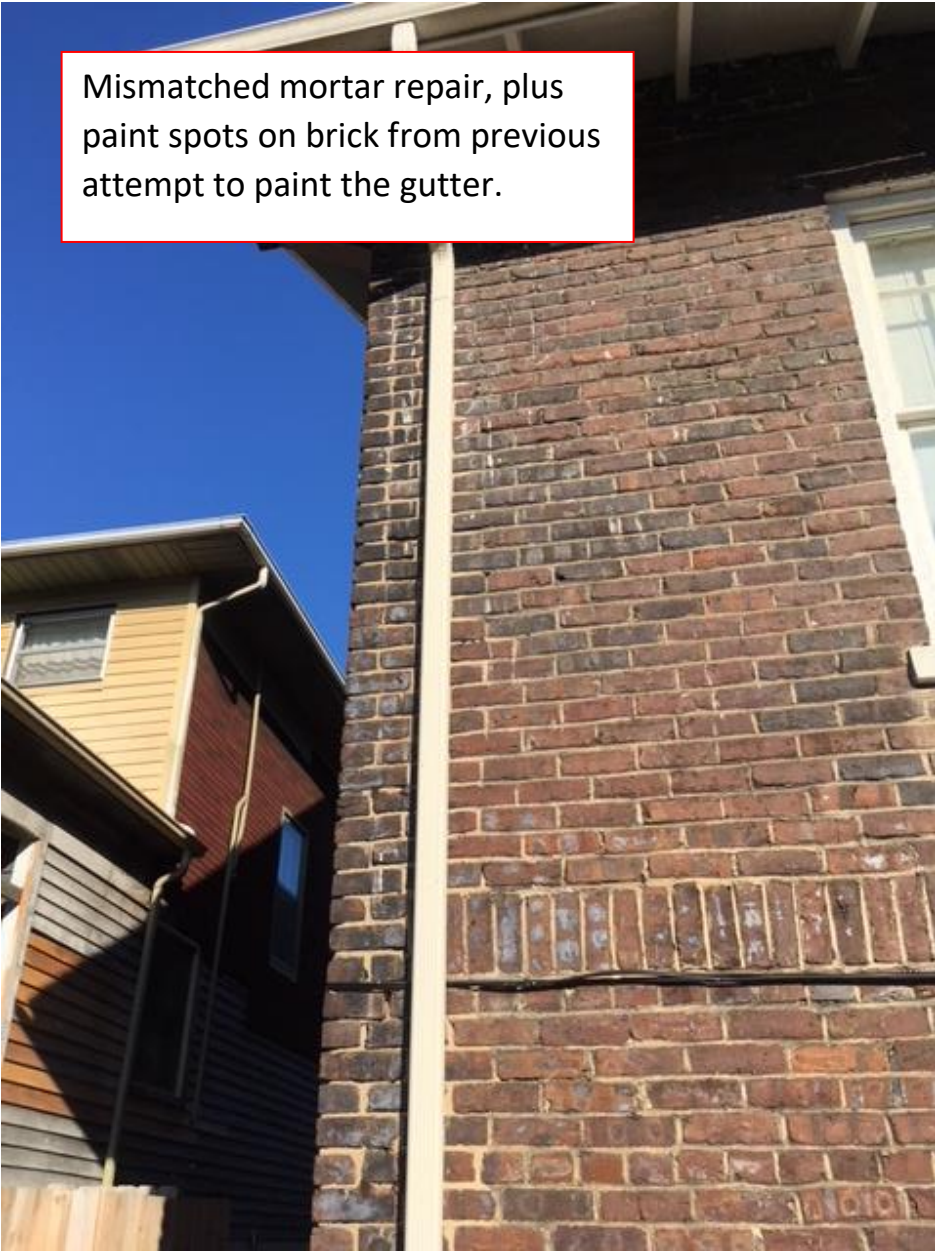
Mismatched mortar repair, plus paint spots on brick from previous attempt to paint the gutter.

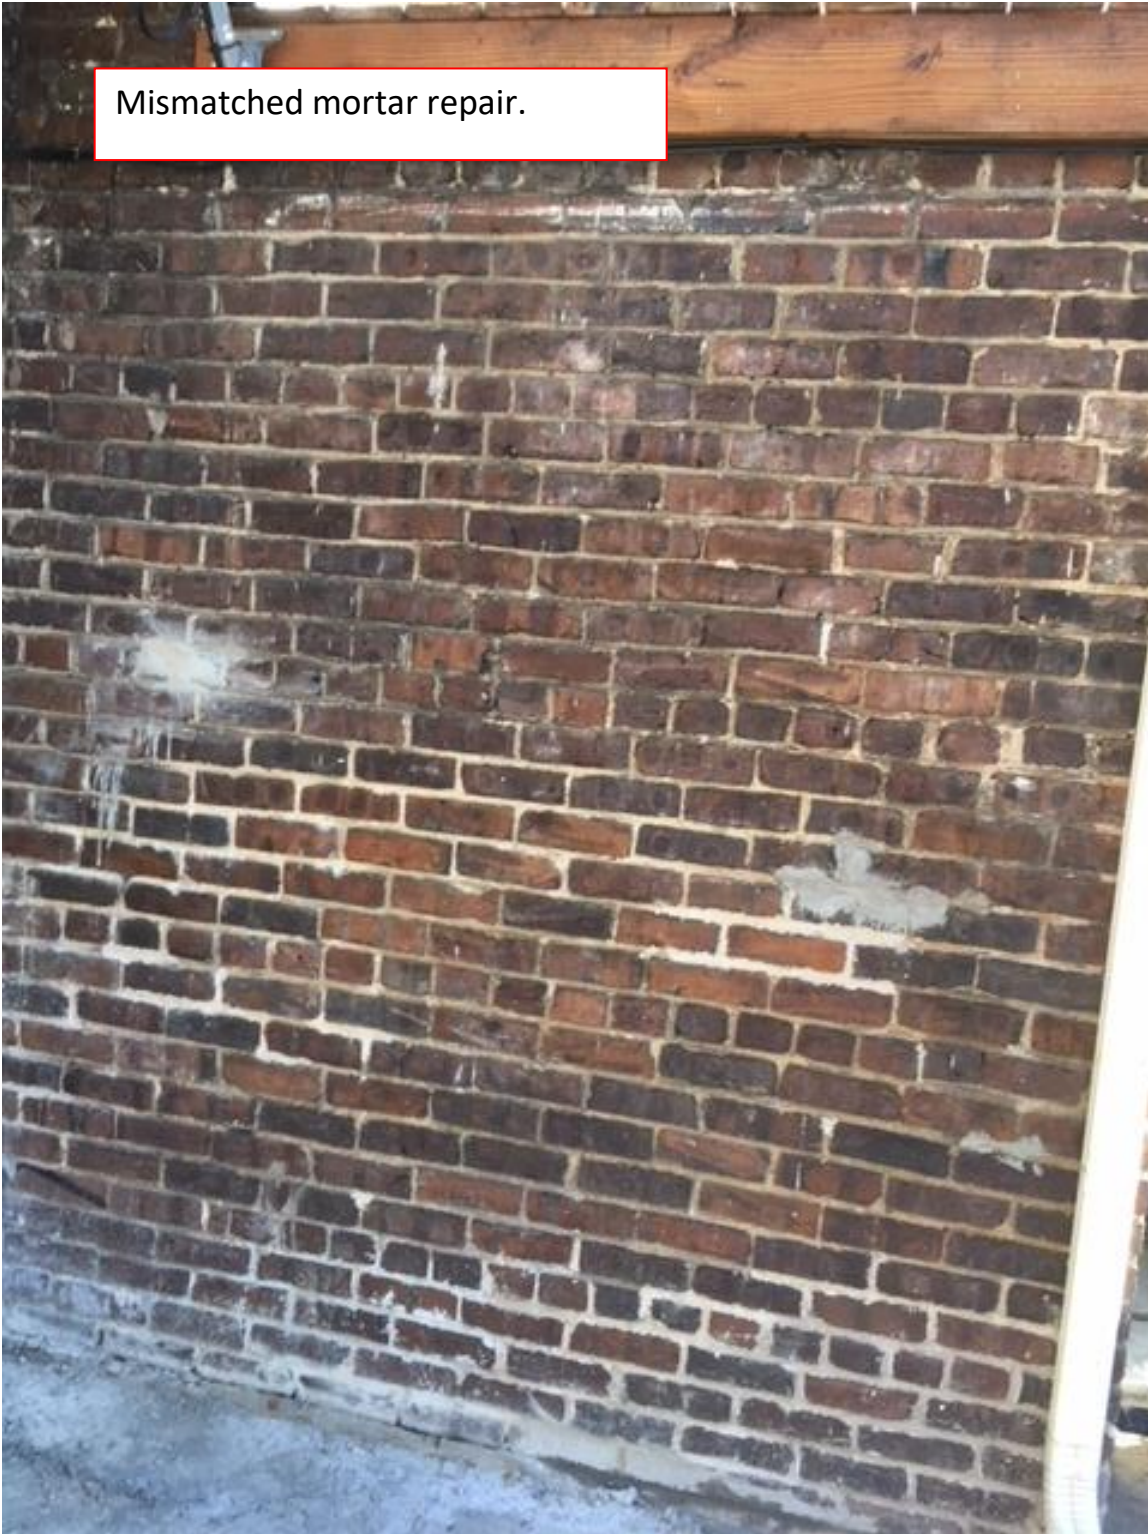
Mismatched mortar repair.

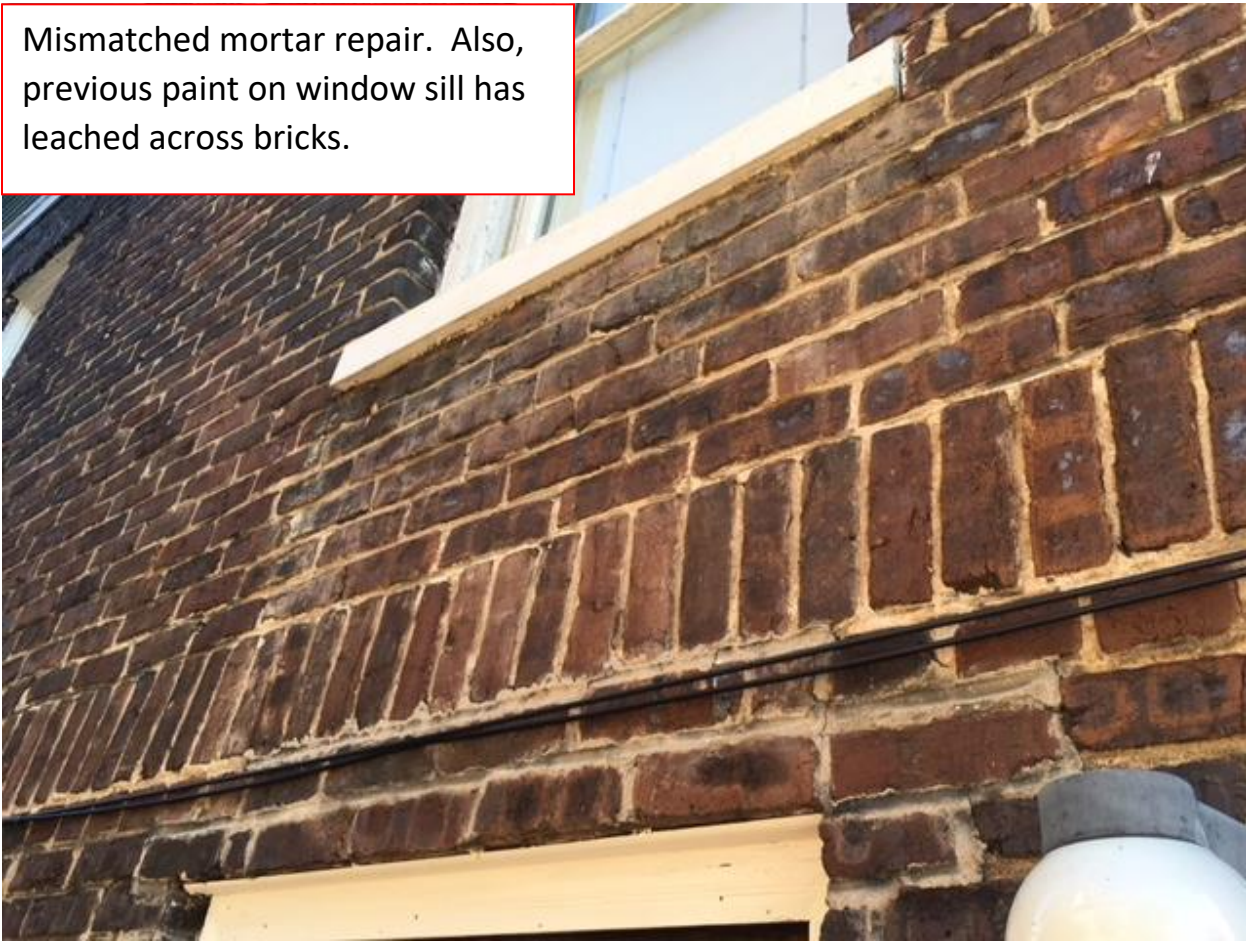
Mismatched mortar repair. Also, previous paint on window sill has leached across bricks.

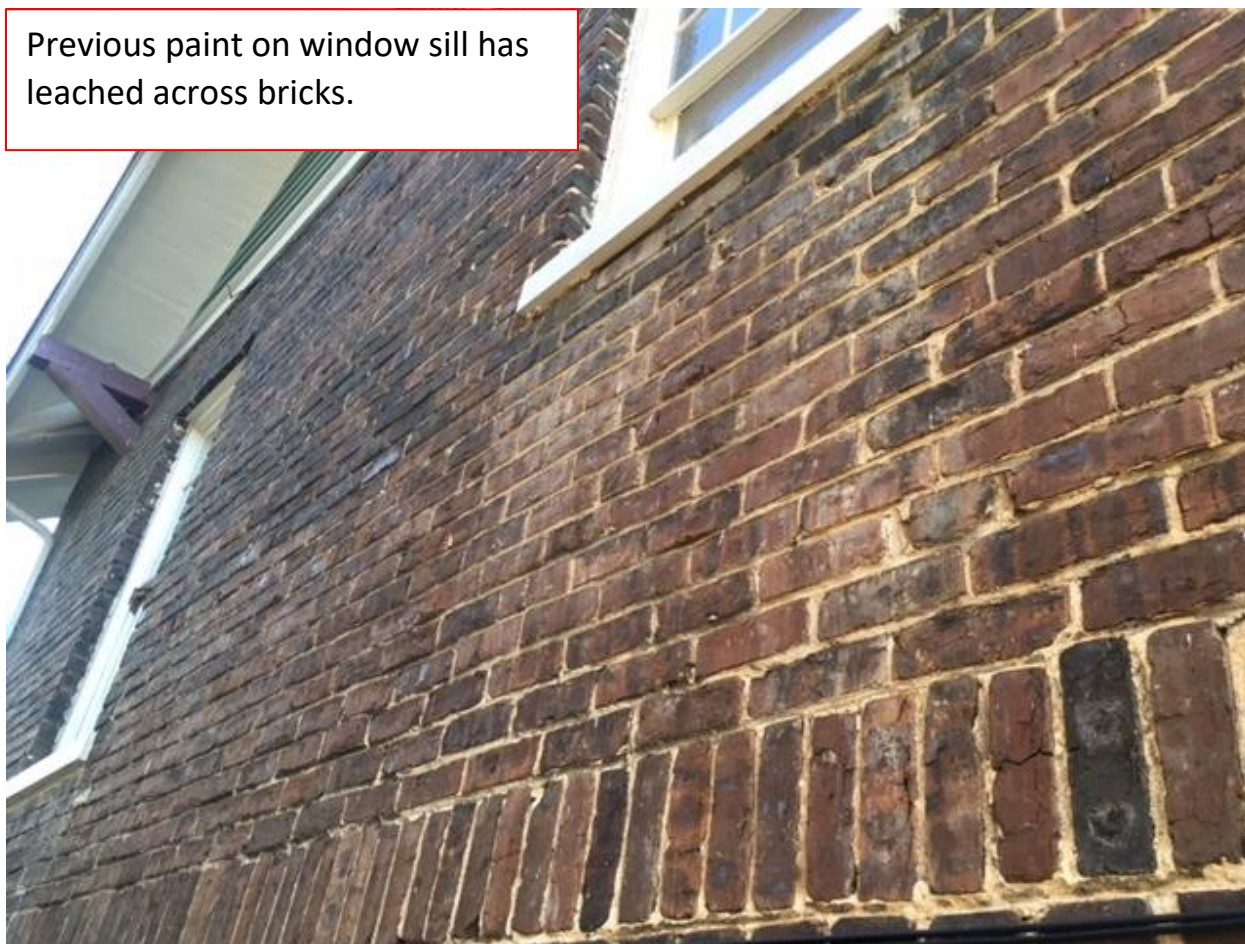
Previous paint on window sill has leached across bricks.
