**KNOXVILLE HISTORIC ZONING COMMISSION
STAFF REPORT - CERTIFICATE OF APPROPRIATENESS APPLICATION**

PROPERTY ADDRESS: 1104 Luttrell St 37917

FILE NO.: 7-O-18-HZ

LEVEL OF WORK: Level II. Painting masonry

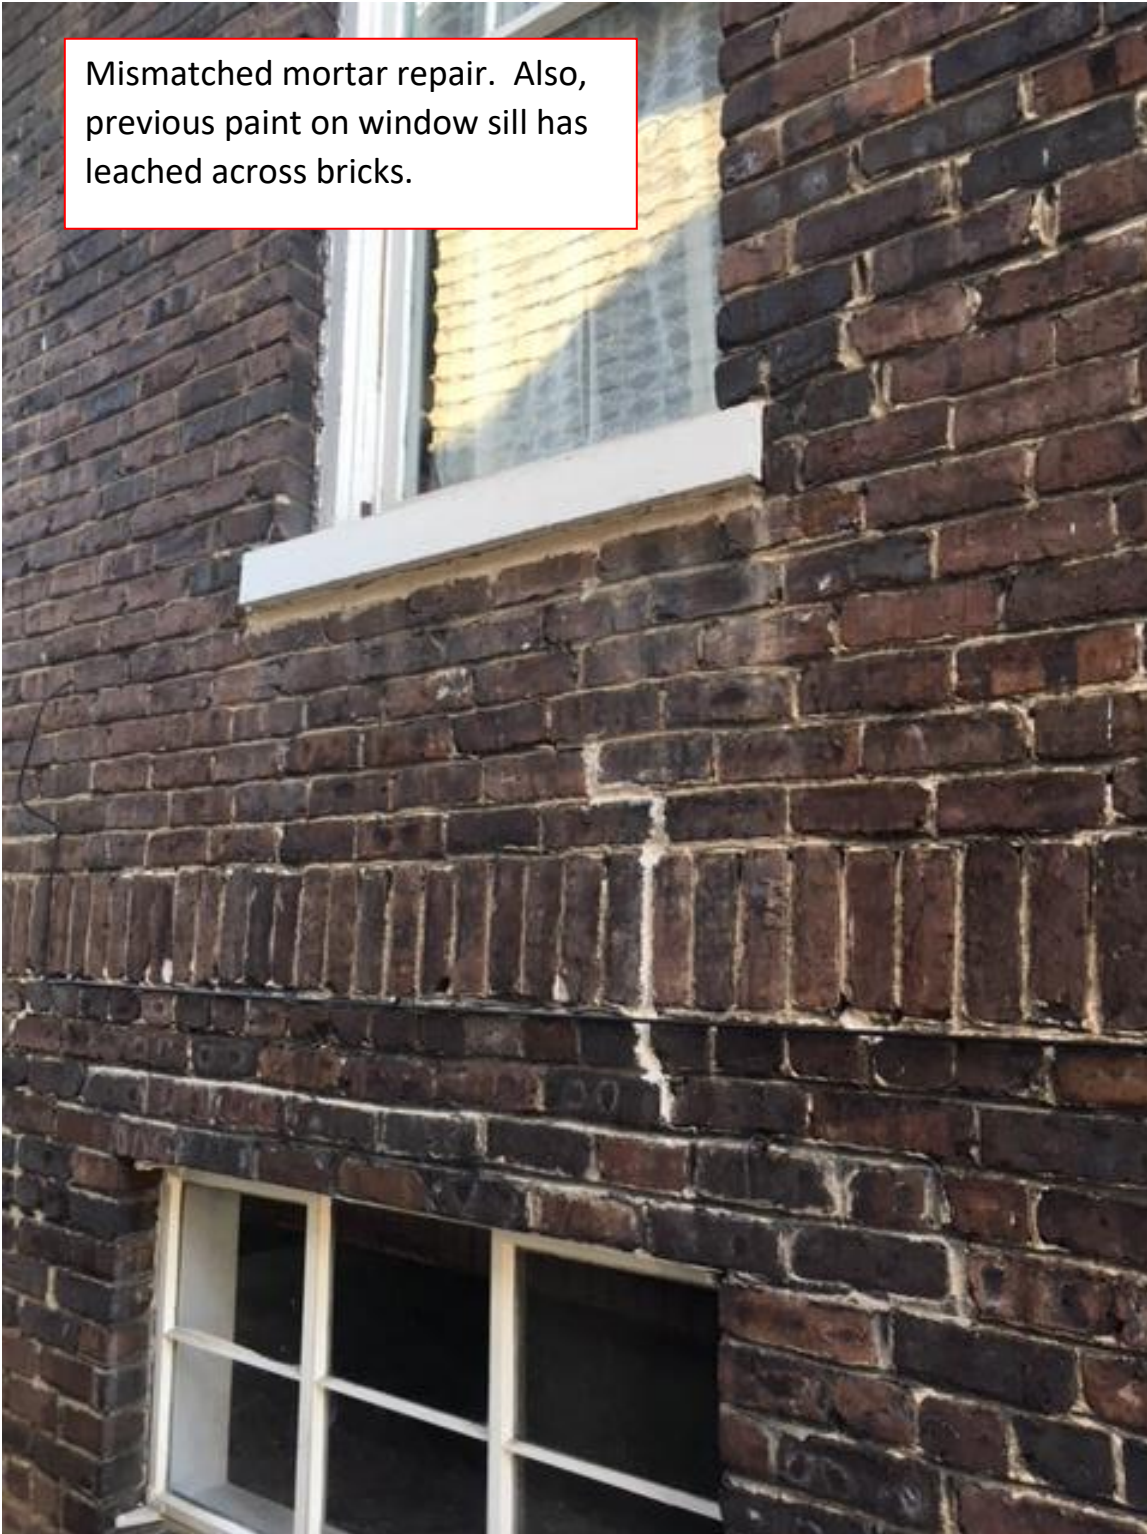
Mismatched mortar repair. Also, previous paint on window sill has leached across bricks.

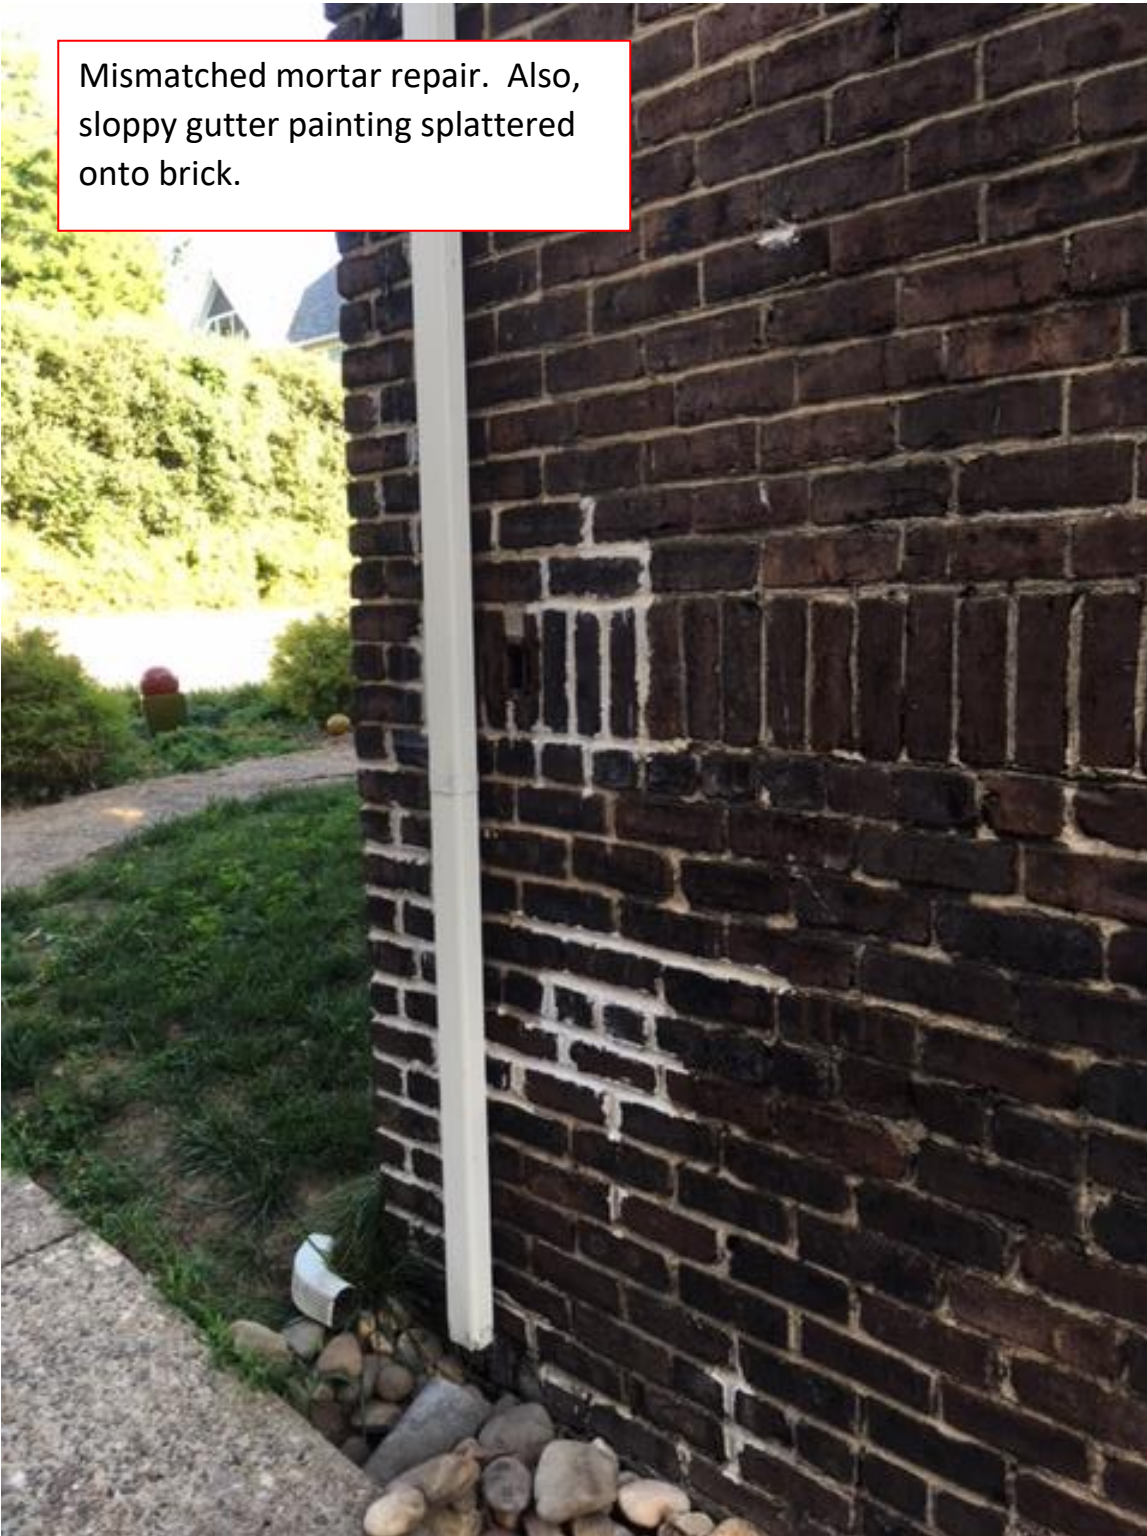
Mismatched mortar repair. Also, sloppy gutter painting splattered onto brick.

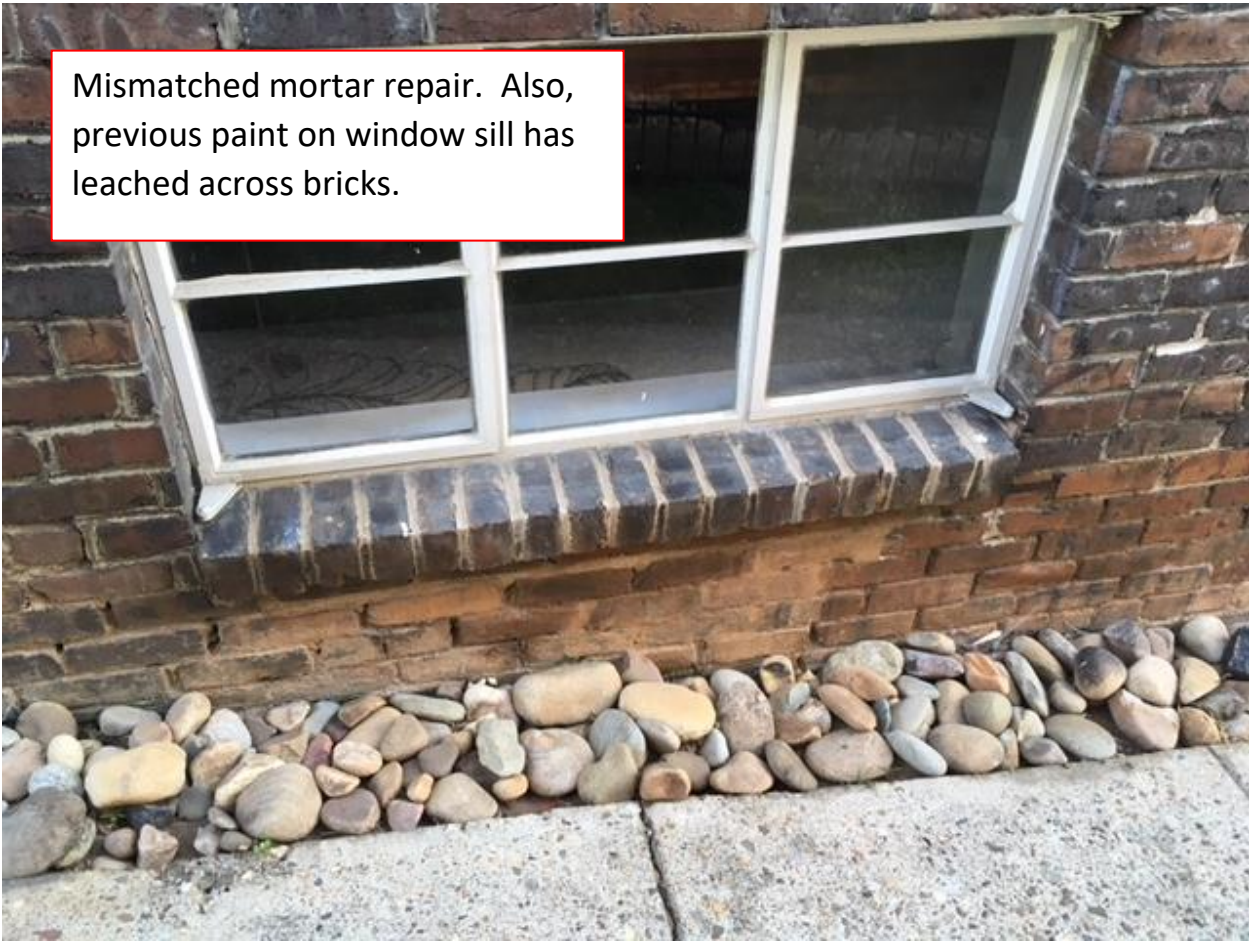
Mismatched mortar repair. Also, previous paint on window sill has leached across bricks.

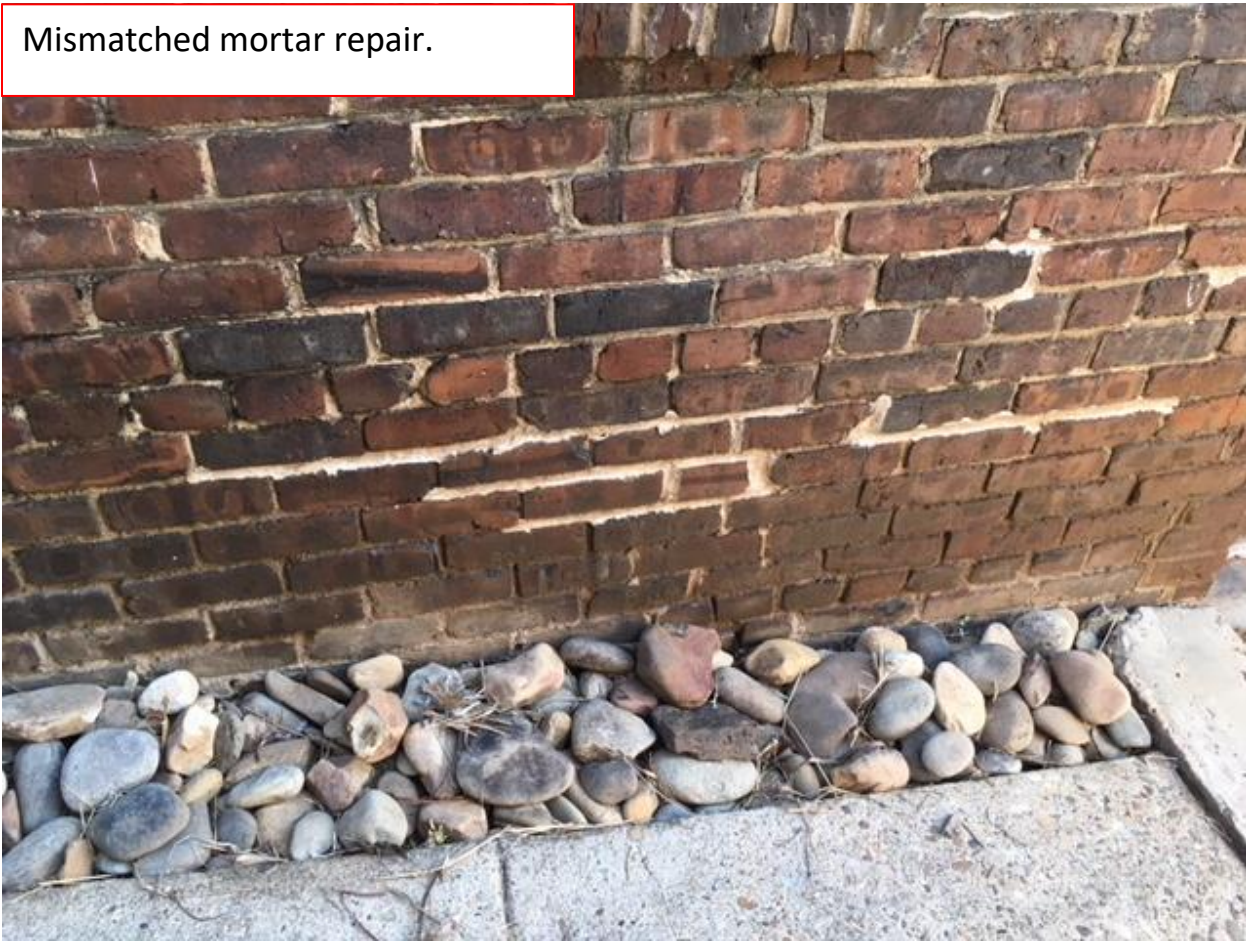
Mismatched mortar repair.

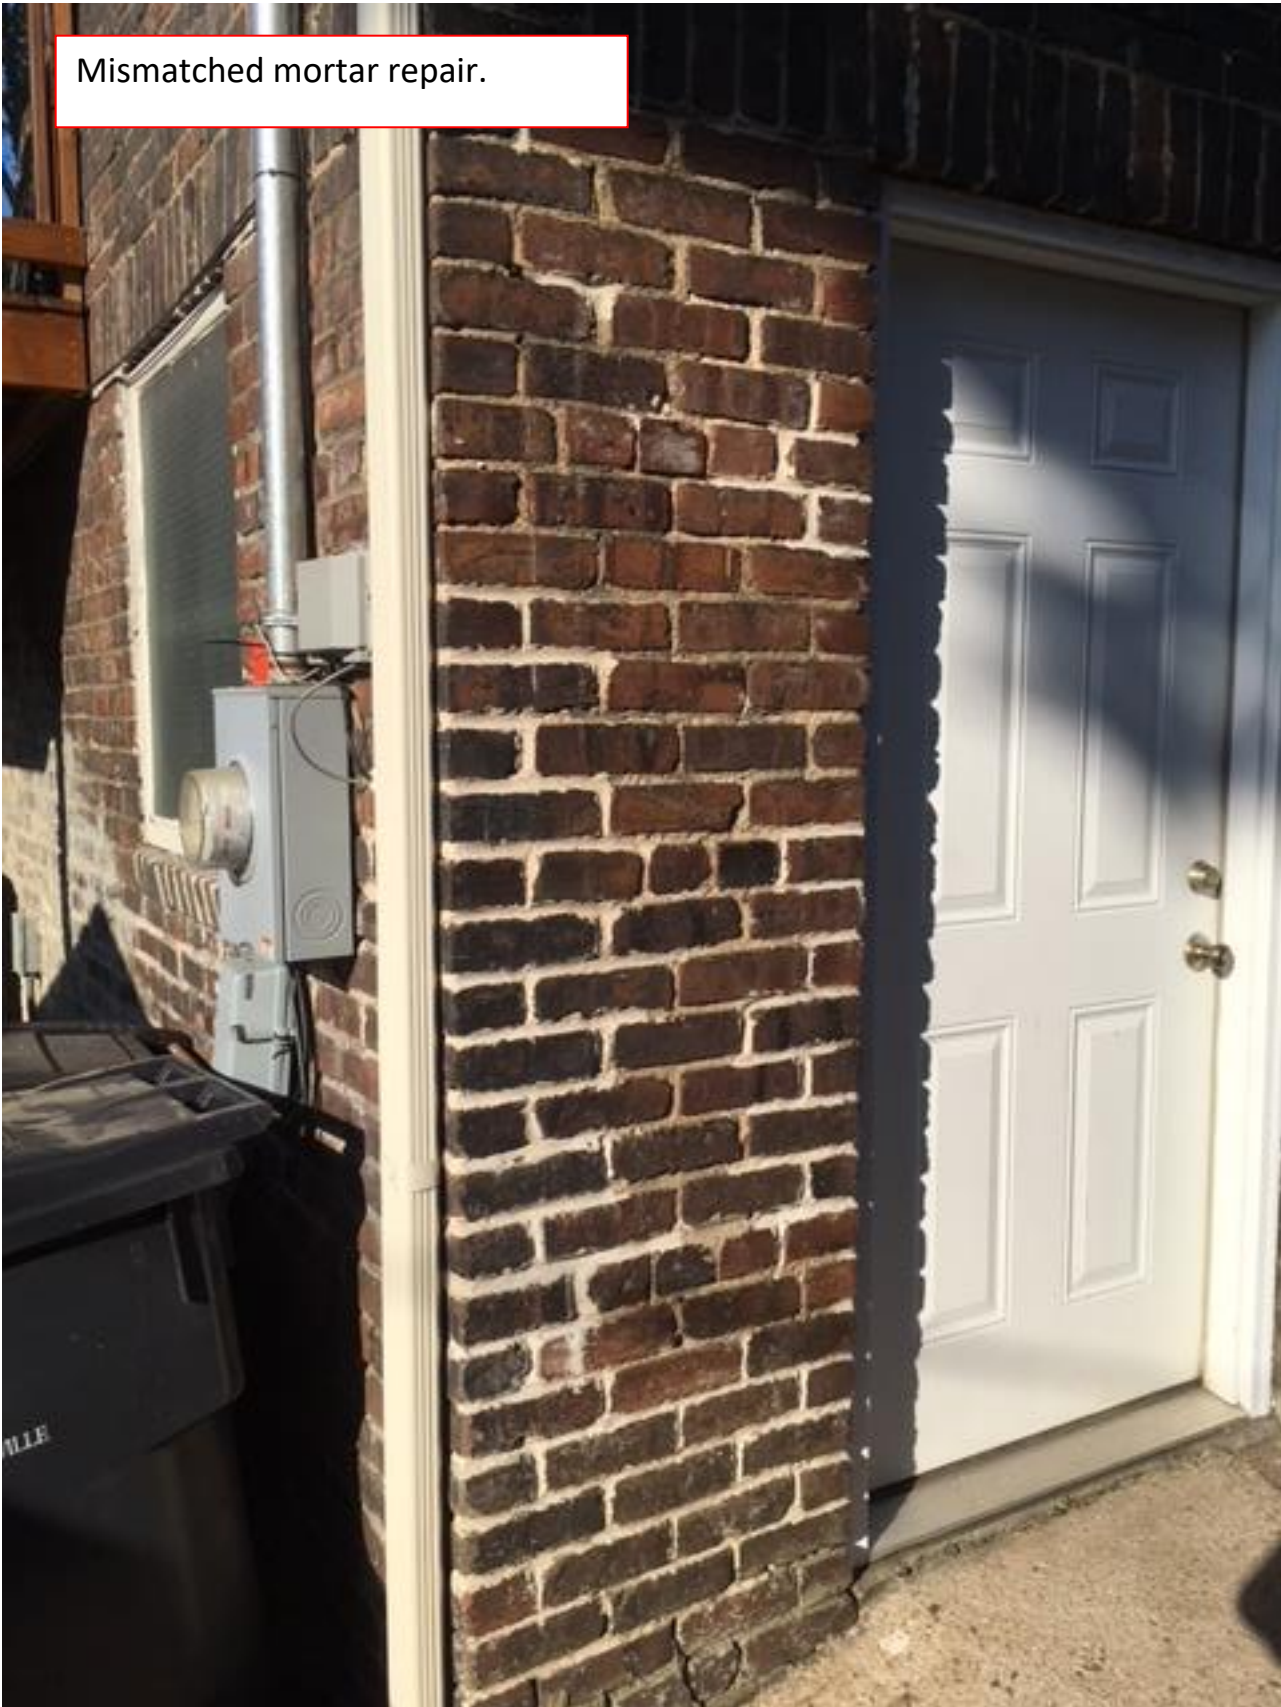
Mismatched mortar repair.

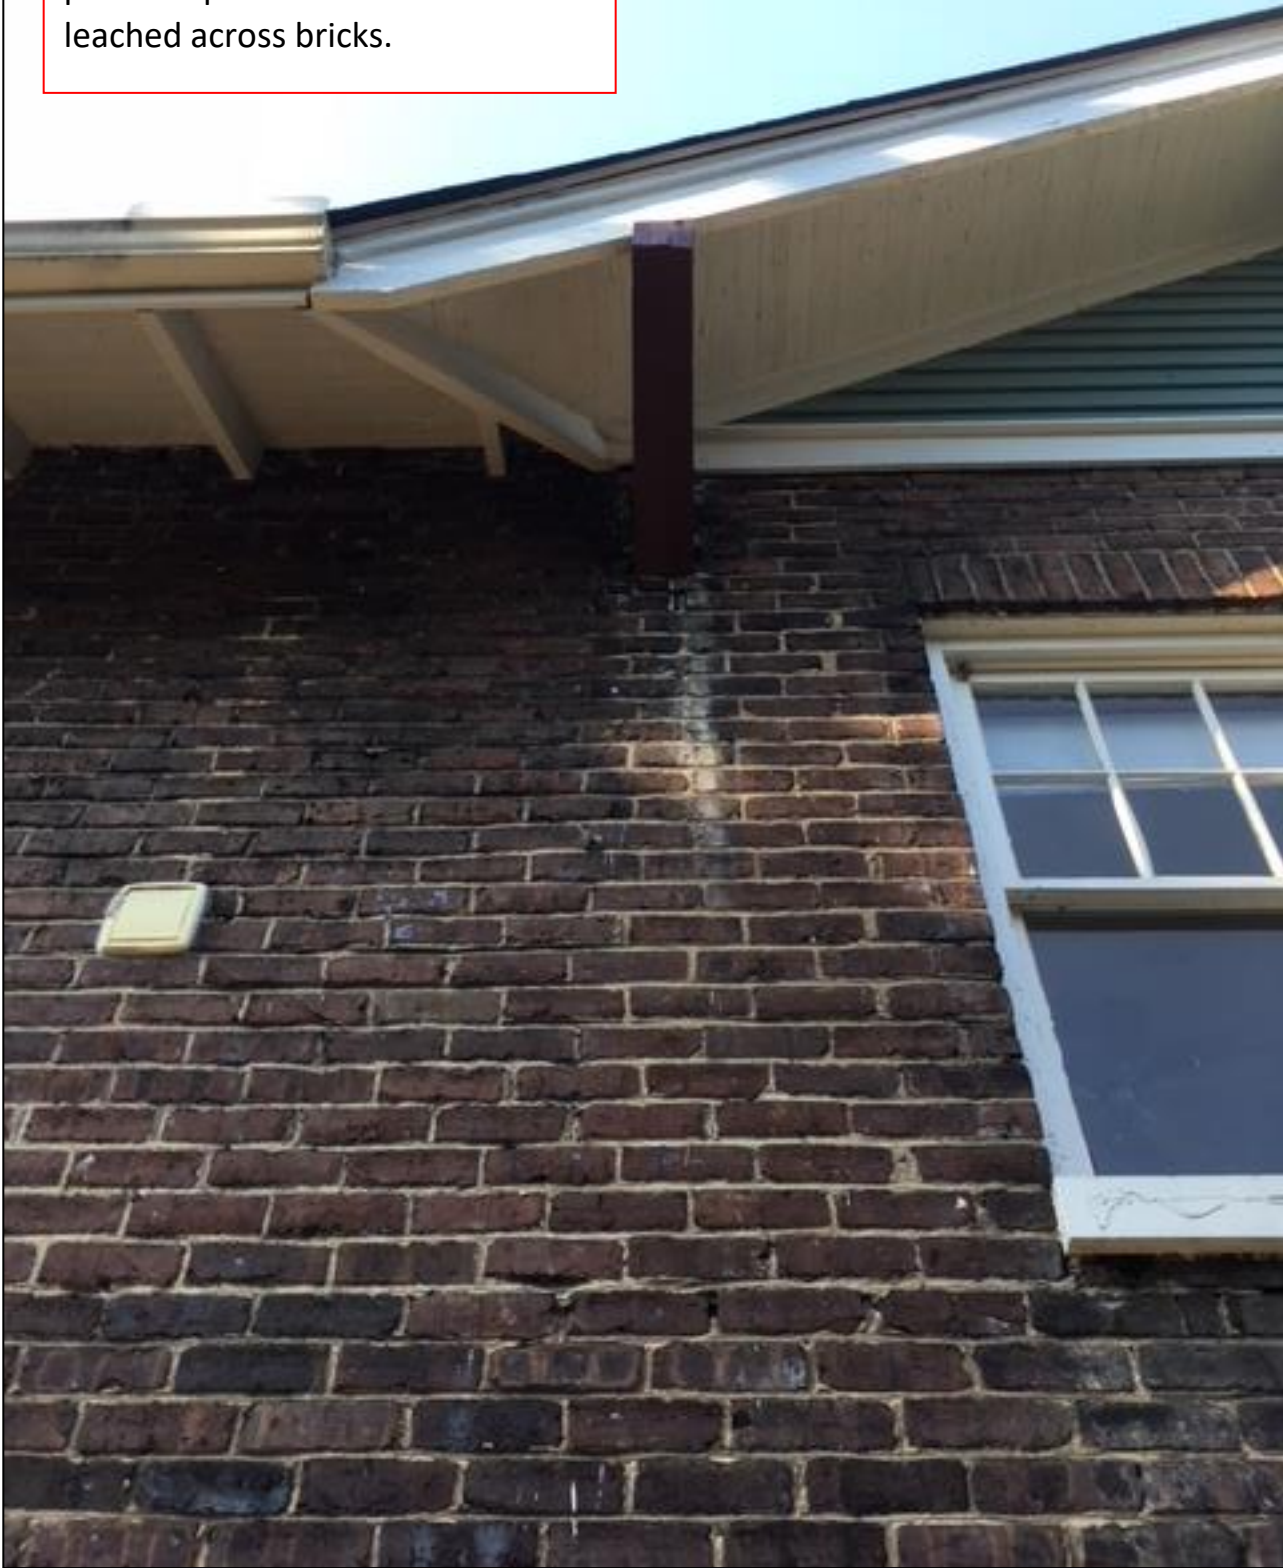
Mismatched mortar repair. Also, previous paint on window sill has leached across bricks.
