**KNOXVILLE HISTORIC ZONING COMMISSION  
STAFF REPORT - CERTIFICATE OF APPROPRIATENESS APPLICATION**

**PROPERTY LOCATION:** 2110 Chapman Hwy /  
Parcel ID 109 A K 014

Reference: **Kern's Bakery**  
**2110 Chapman Hwy, Knoxville, TN 37920**

Subject: **Limited Visual Structural Assessment**

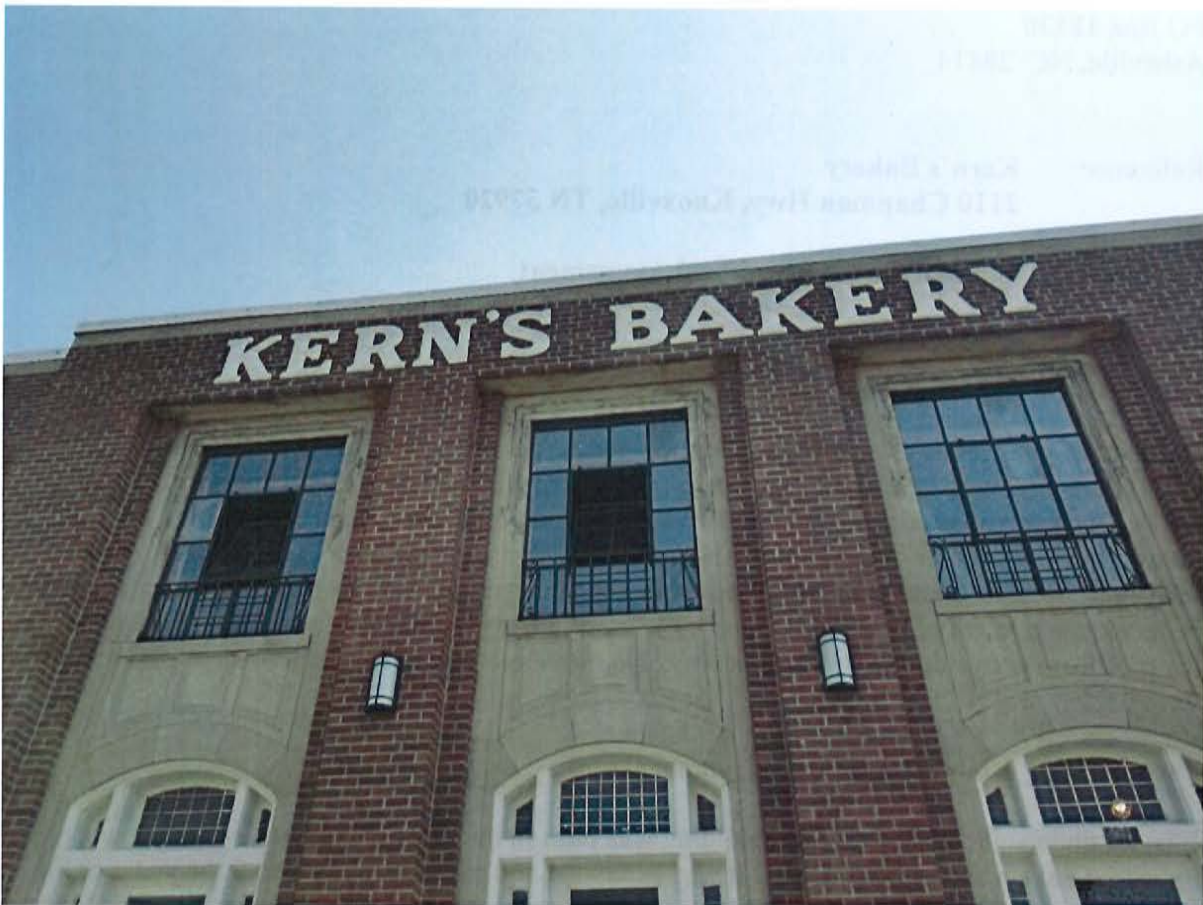
Exterior brick facade facing Chapman Hwy appears to have been recently restored and appears to be in good condition. Brick lintels appear to be rusting and in need of maintenance.

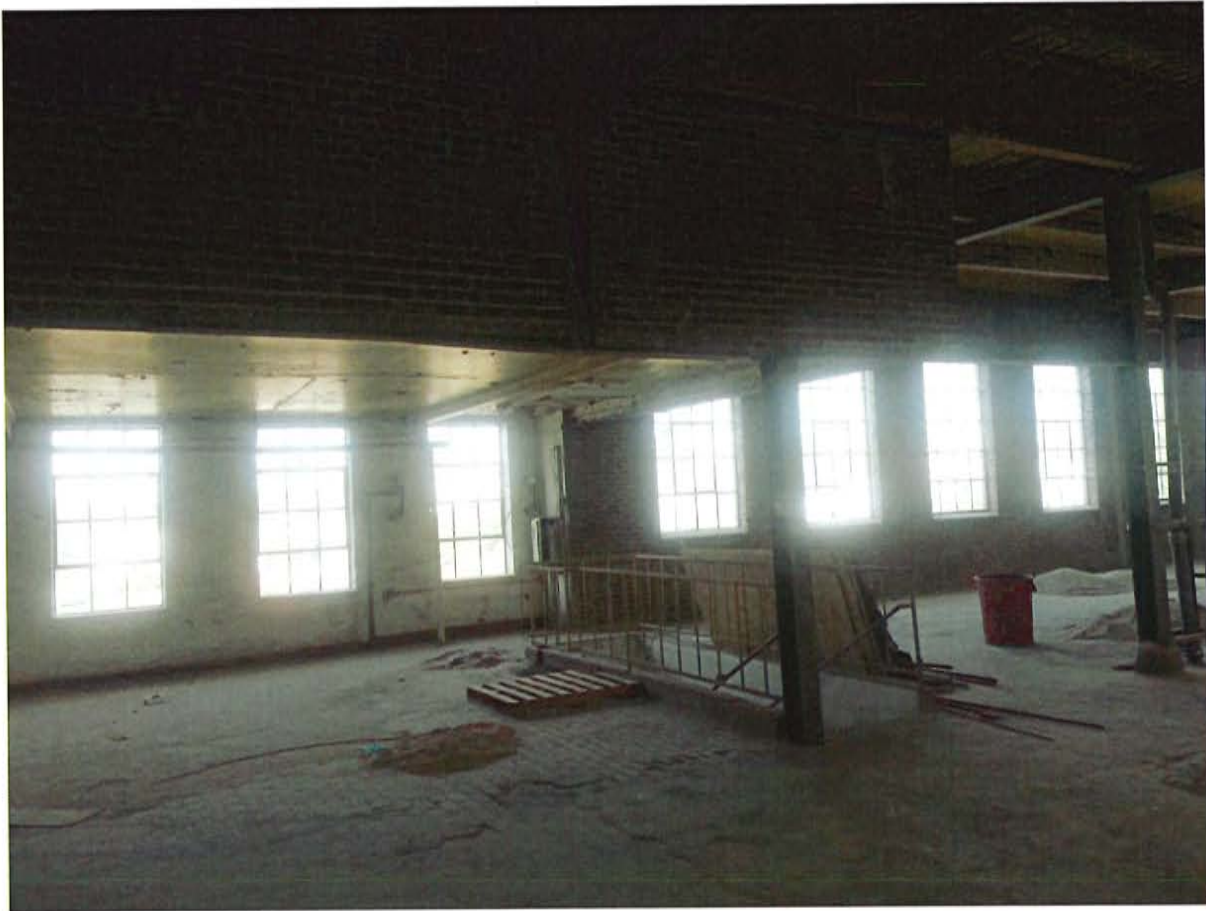
One (1) column supporting the brick bearing wall above appear to have been relocated to the right. While this looks a little odd, there is no signs of structural stress or movement. ADG recommends that this condition be analyzed by a licensed engineer after future loading plans are determined.

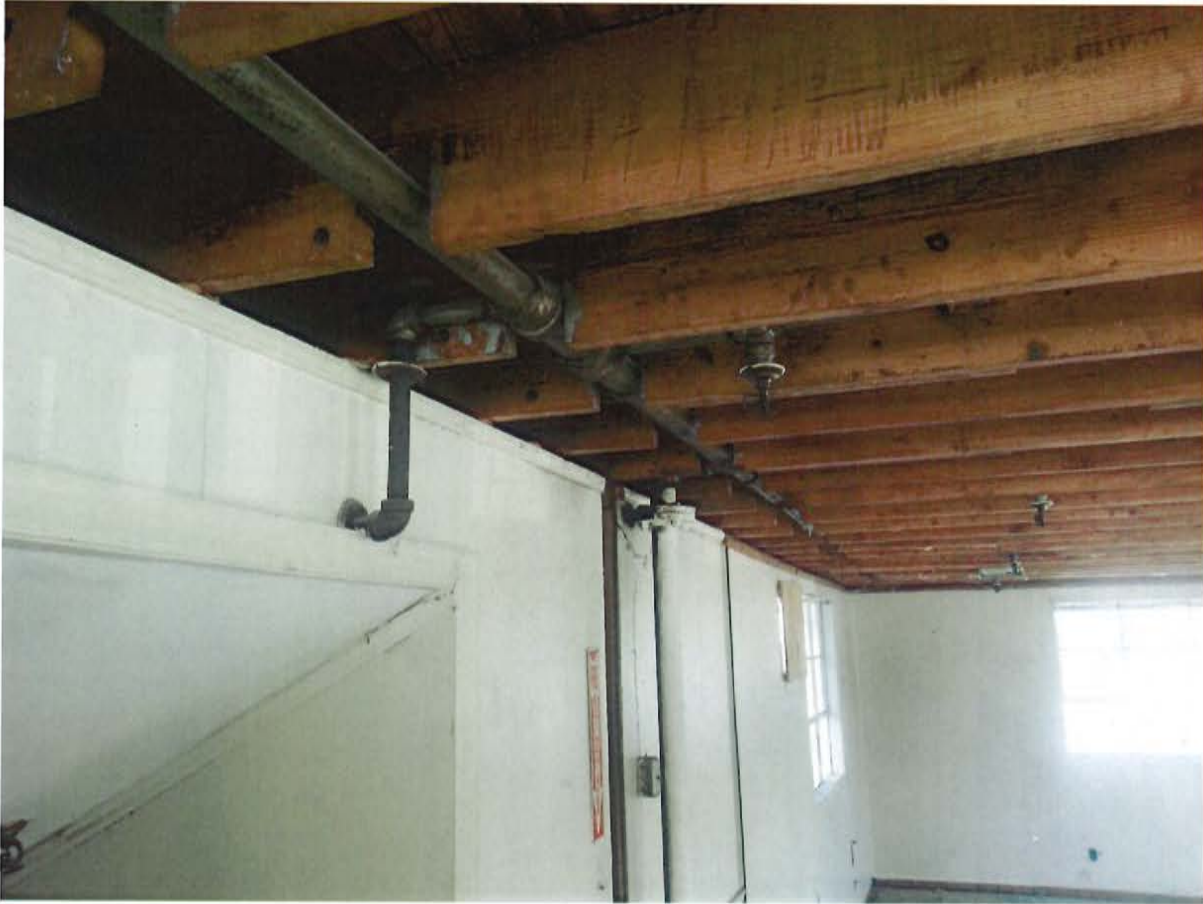
The roof and second floor joists have been significantly notched for the installation of sprinkler piping. Joists seats are shimmed at bearing walls. These joists should be modified and/or replaced to provide correct structural load paths.

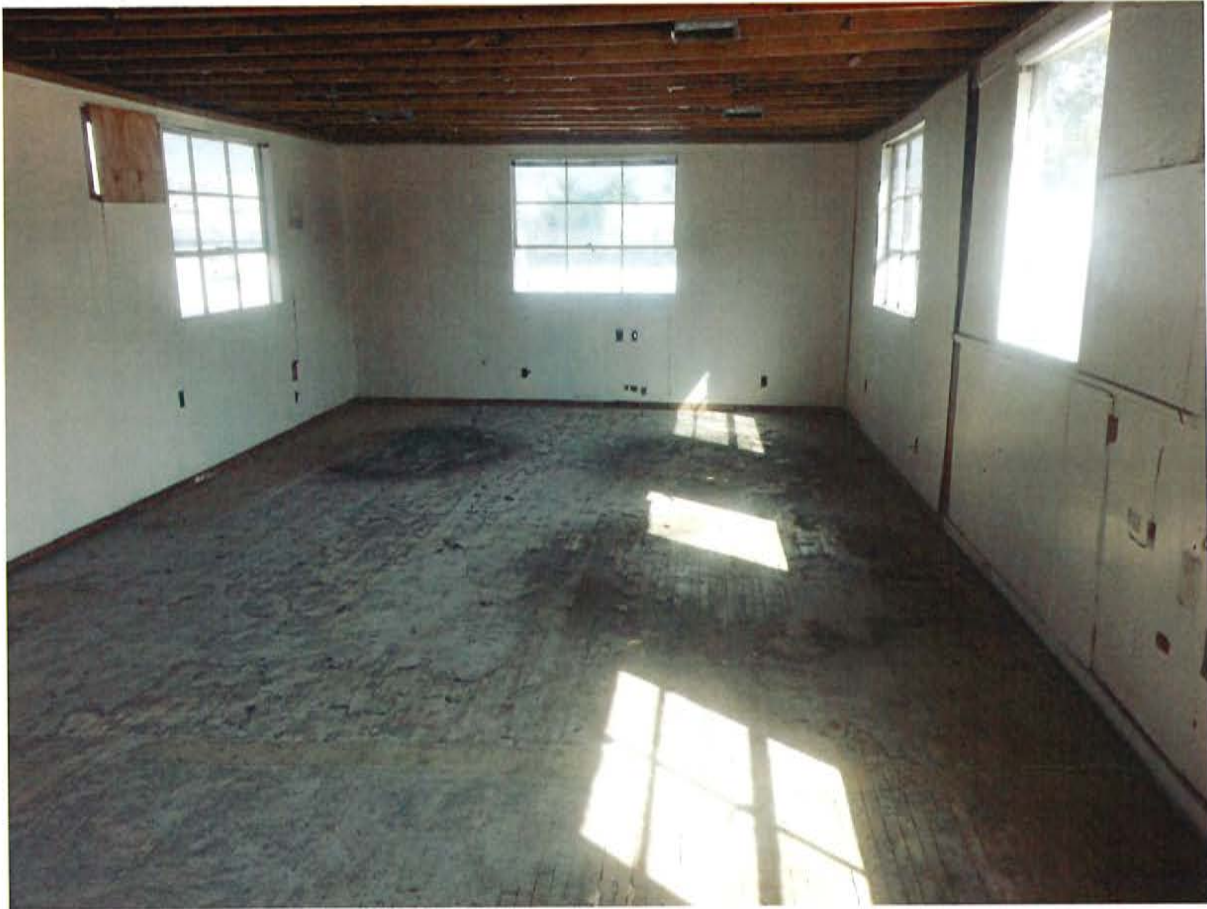
The 3<sup>rd</sup> floor is visibly wet from roof leaks. ADG recommends complete investigation into the condition of the floor joists and roof decking during renovation.

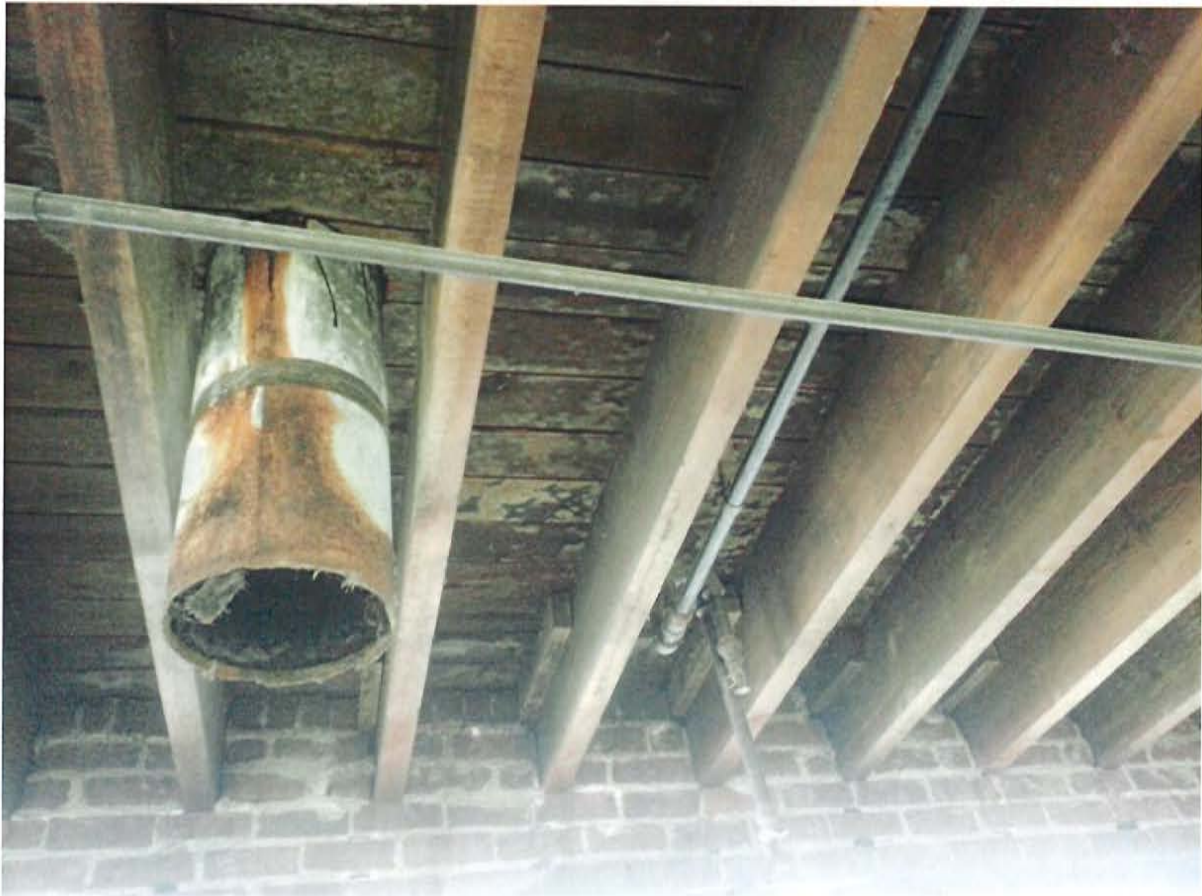
Fungus and decayed wood are visible on underside of the roof deck. ADG recommends mold and fungus firm be engaged to treat the fungus so that deck can be evaluated during renovation for repairs and/or replacement, if required.

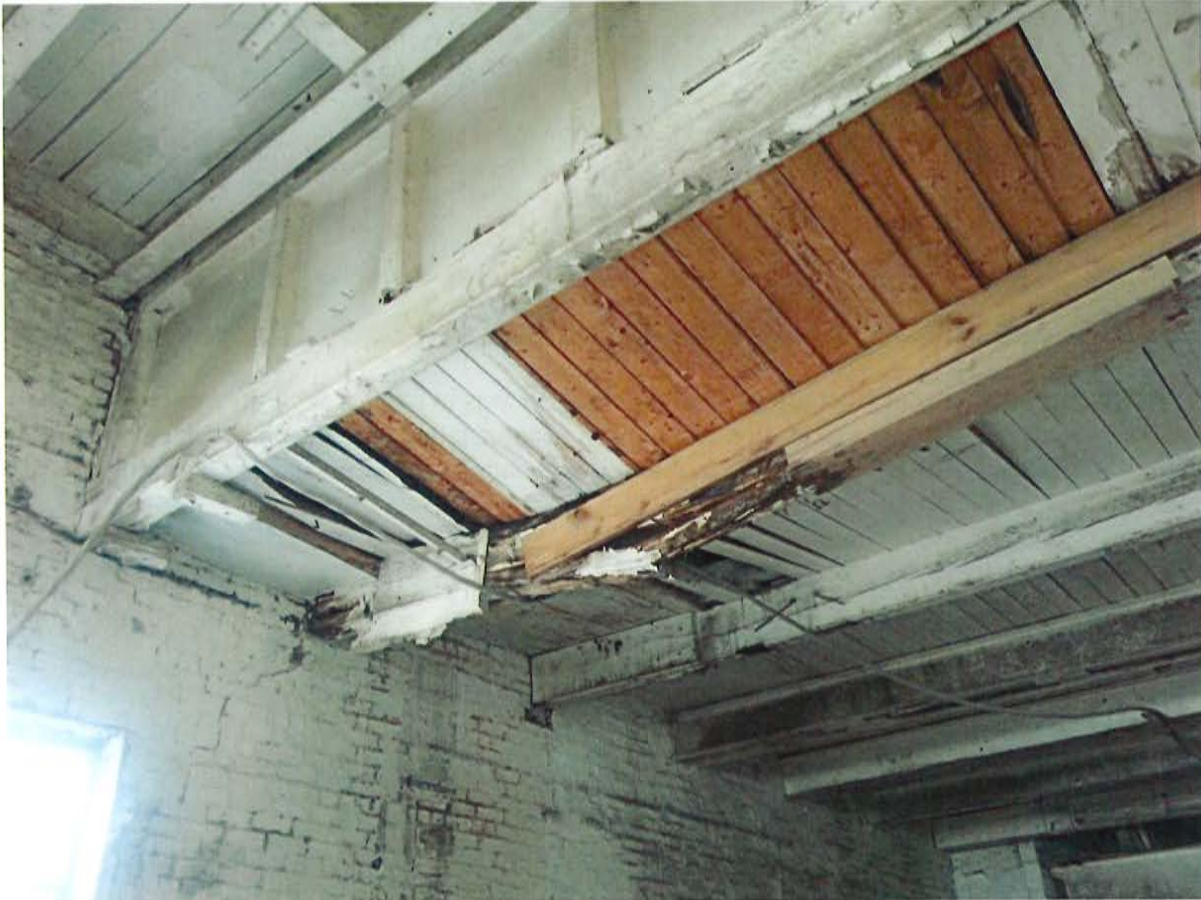
Roof decking and joists have failed in several locations. This is an example of one of the worse conditions found. This area is subject to collapse. Owner should hire a licensed contractor to completely shore this damaged section of roof and repair roof leaks so as to prevent further damage to the wooden members. Areas Like this should be roped off so as to prevent people from getting under the damaged roof areas until repairs are performed.

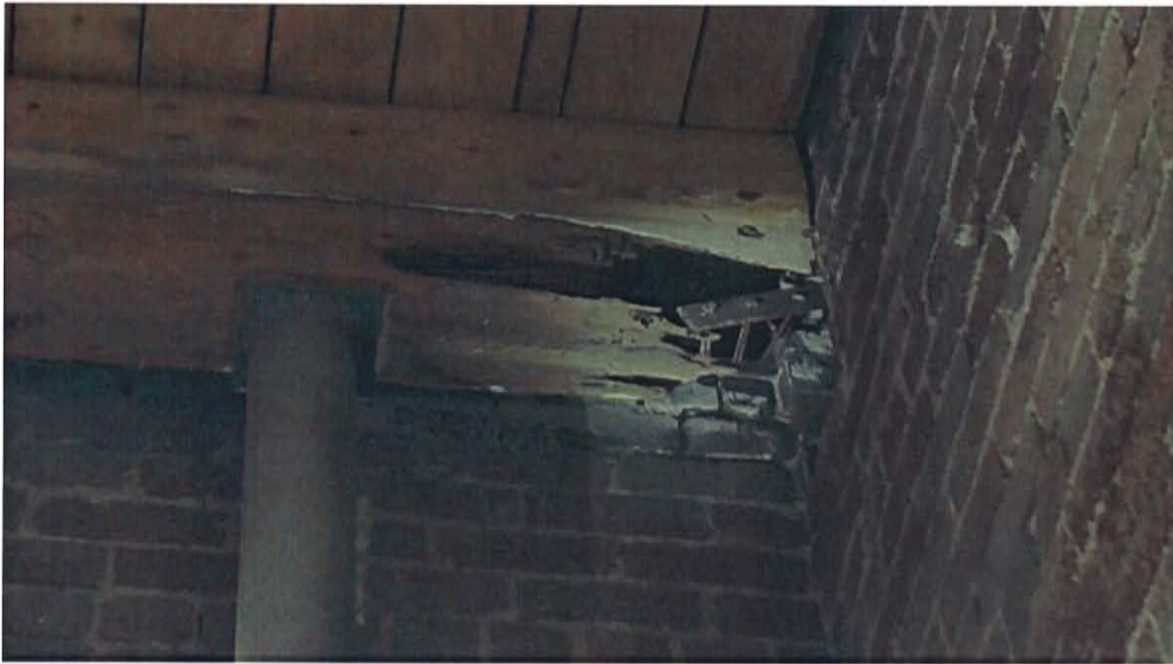
Example of a wood beam where the end of the member was in contact with the masonry and has sustained decay. A temporary steel pipe column has been installed near the end of the member to shore the beam. This should be considered temporary shoring and replaced during building renovations.

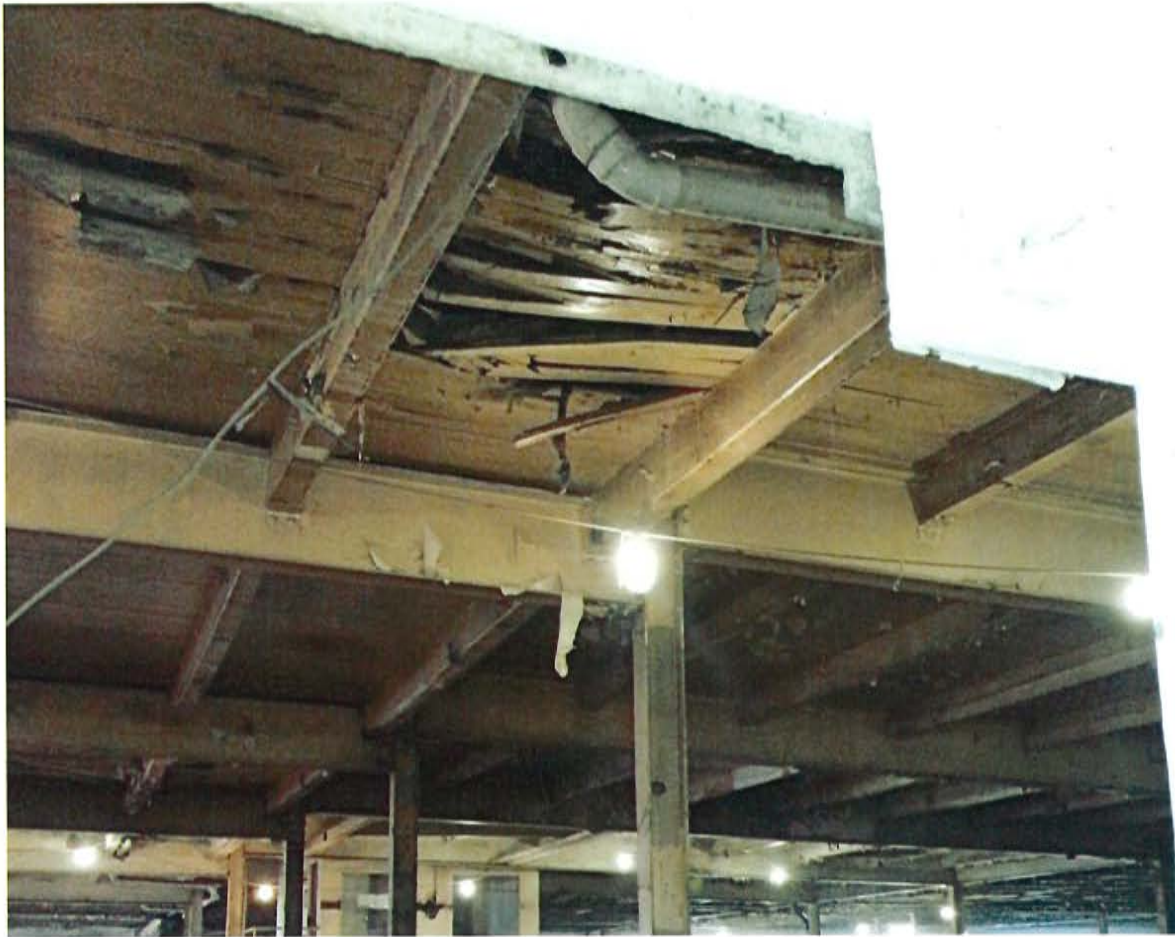
This is an example of the worse heavily damaged wood roof decking and roof joists. ADG recommends when the roof is repaired and/or replaced that all decayed members be replaced at that time. Areas like this with significant damage should be roped off to prevent injury. This is an example of why ADG did not walk on the roof as this condition cannot be observed from on top of the single ply roof membrane.

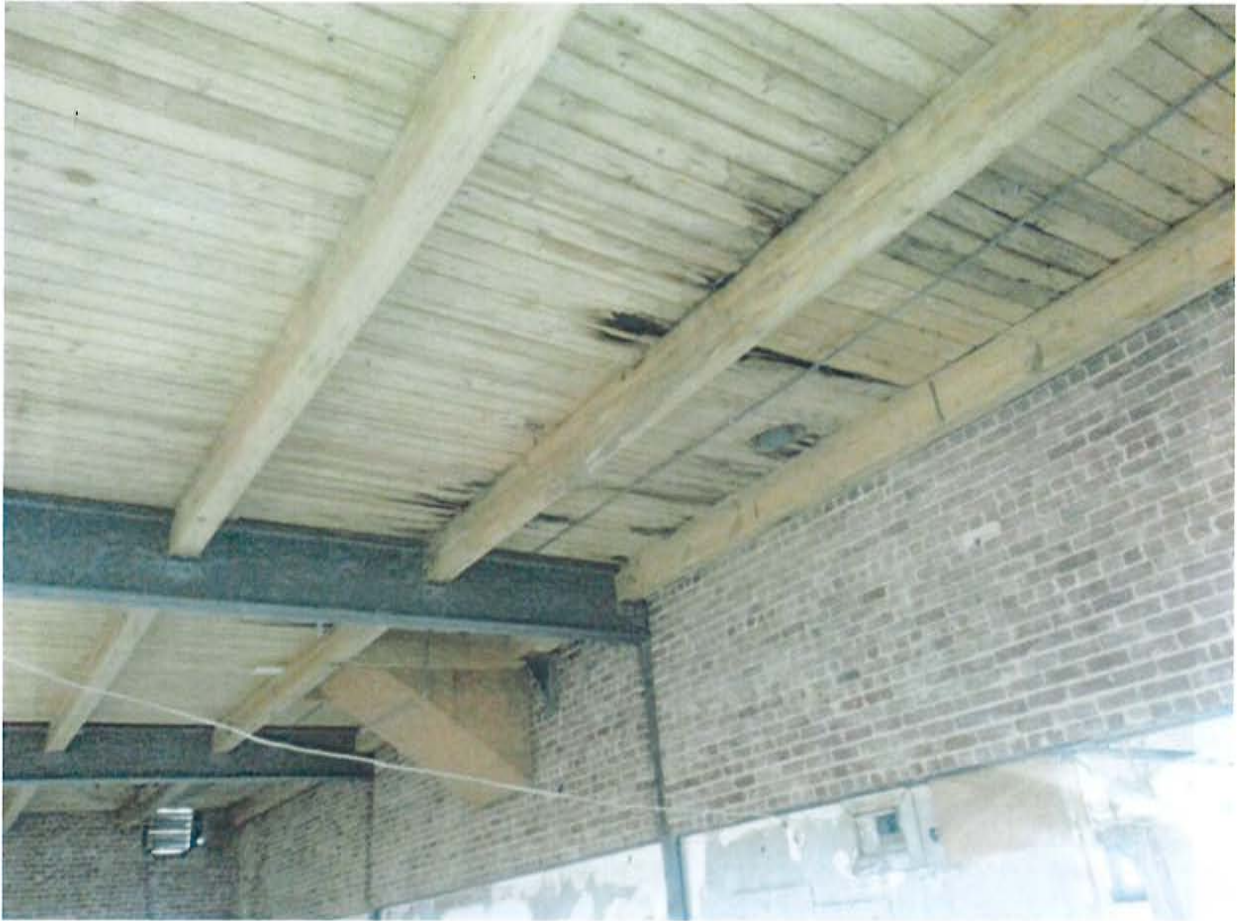
Some areas of the Original Factory have been sandblasted. The removal of old paint and surface materials is very useful in helping to identify decayed roof decking and joists. Some locations like this where the wood has changed to a darker color represents moisture damage has begun. These areas will need to be investigated when the roof is repaired to determine how much of the materials will need replacement.

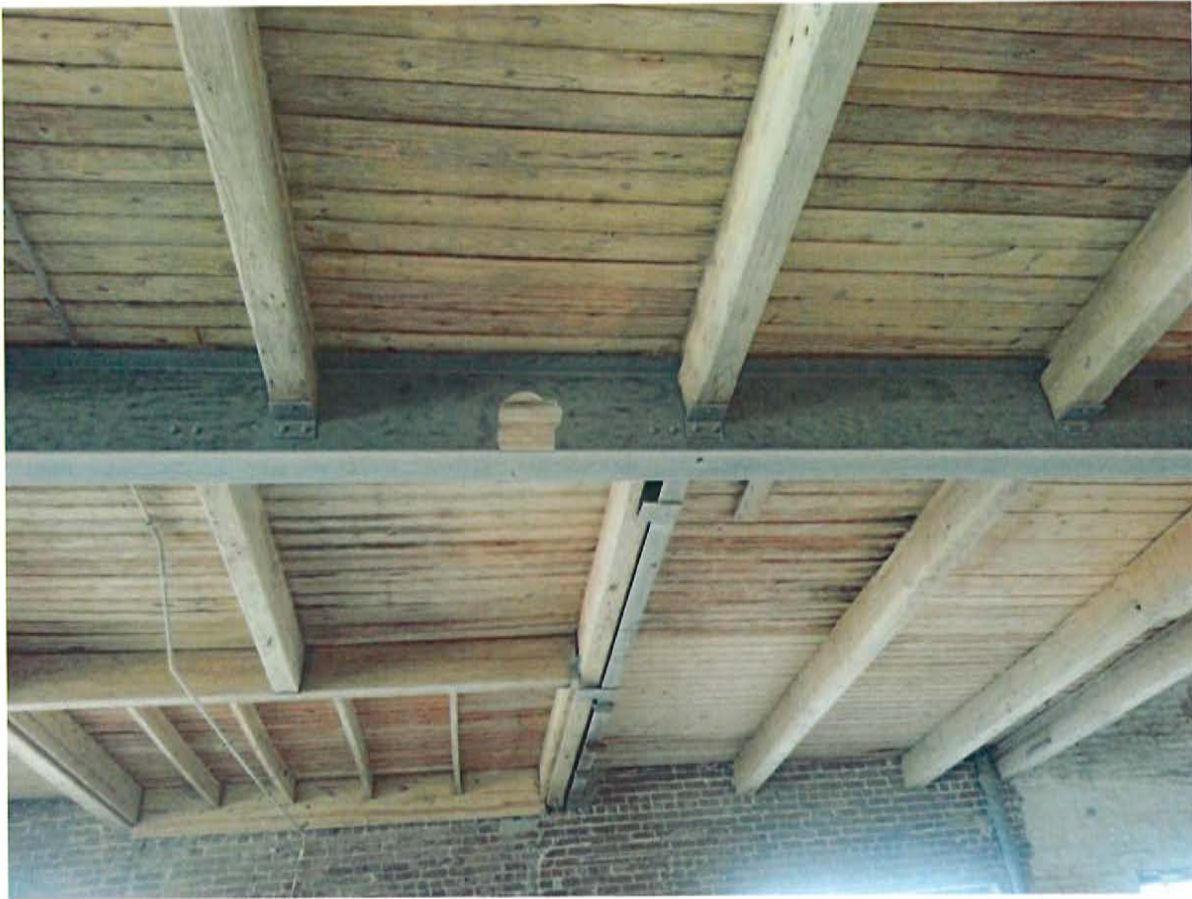
There are some holes cut into steel members that will require patching during renovation. Apparent repair to a wood girder (shown beyond) should be evaluated by a licensed engineer during renovations.

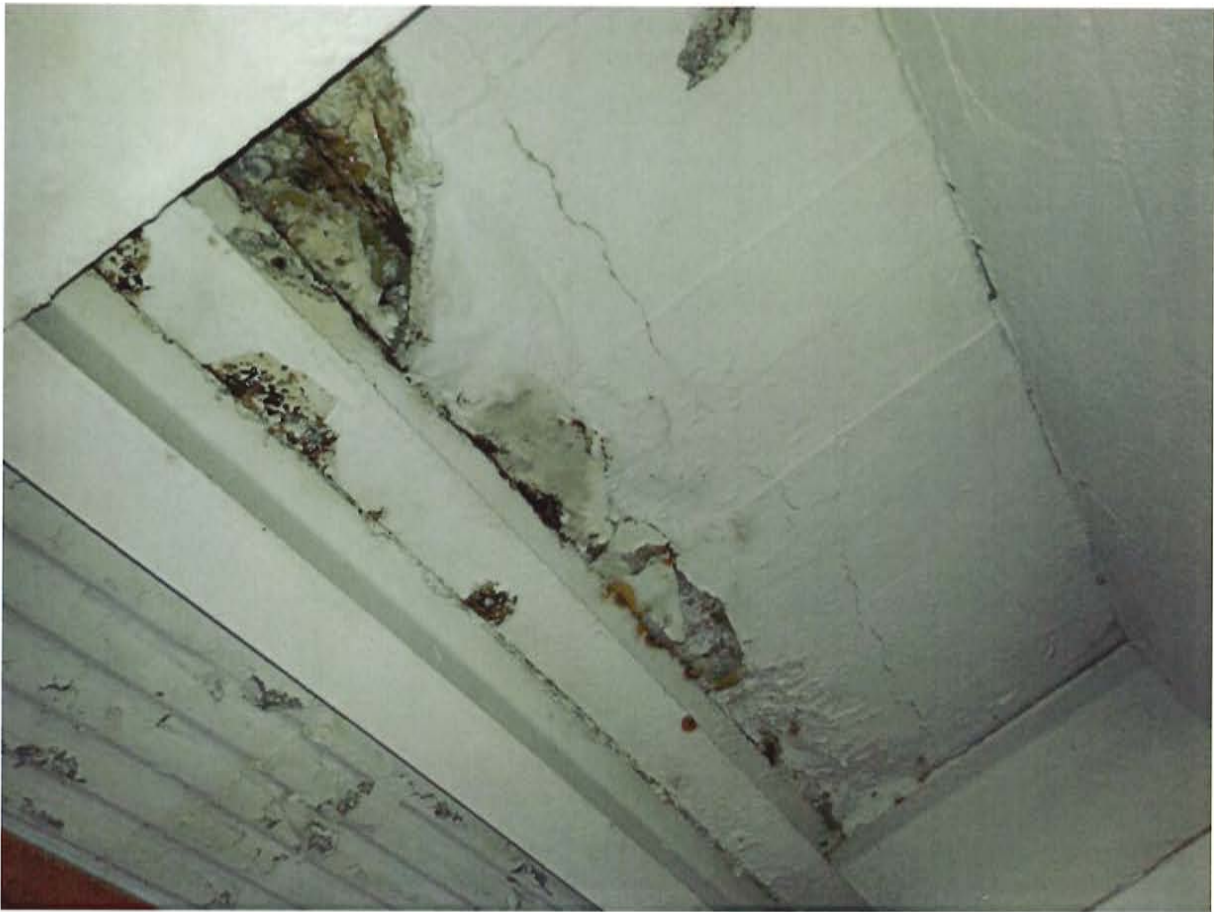
Some reinforced slab locations in the Original Factory area has corrosion to the reinforcement steel. These areas will need to be removed and/or patched as needed for future design loading conditions that may be applied.

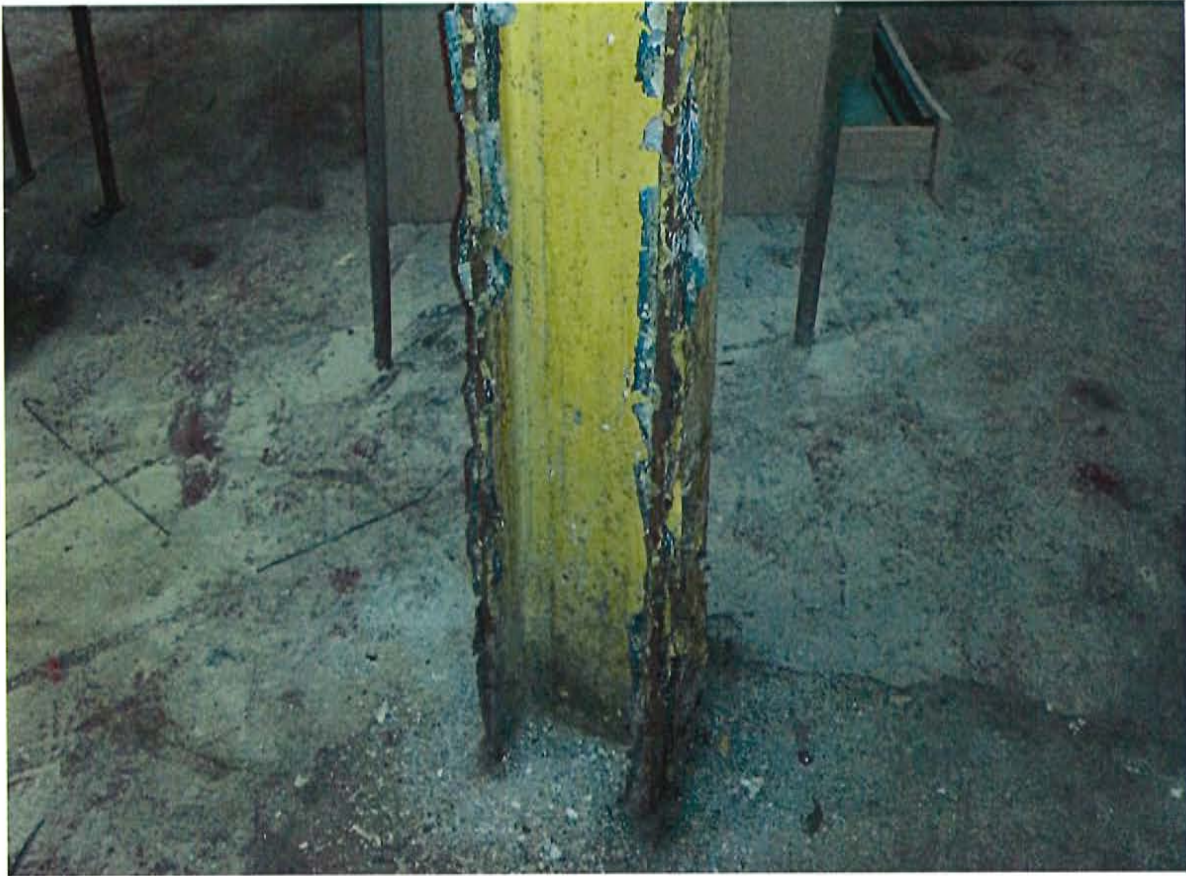
Columns have some rust and abuse over the years. The steel will need to be cleaned, primed and painted during renovation activities. Bent columns will need to be repaired. This type of repair is common in manufacturing industry.

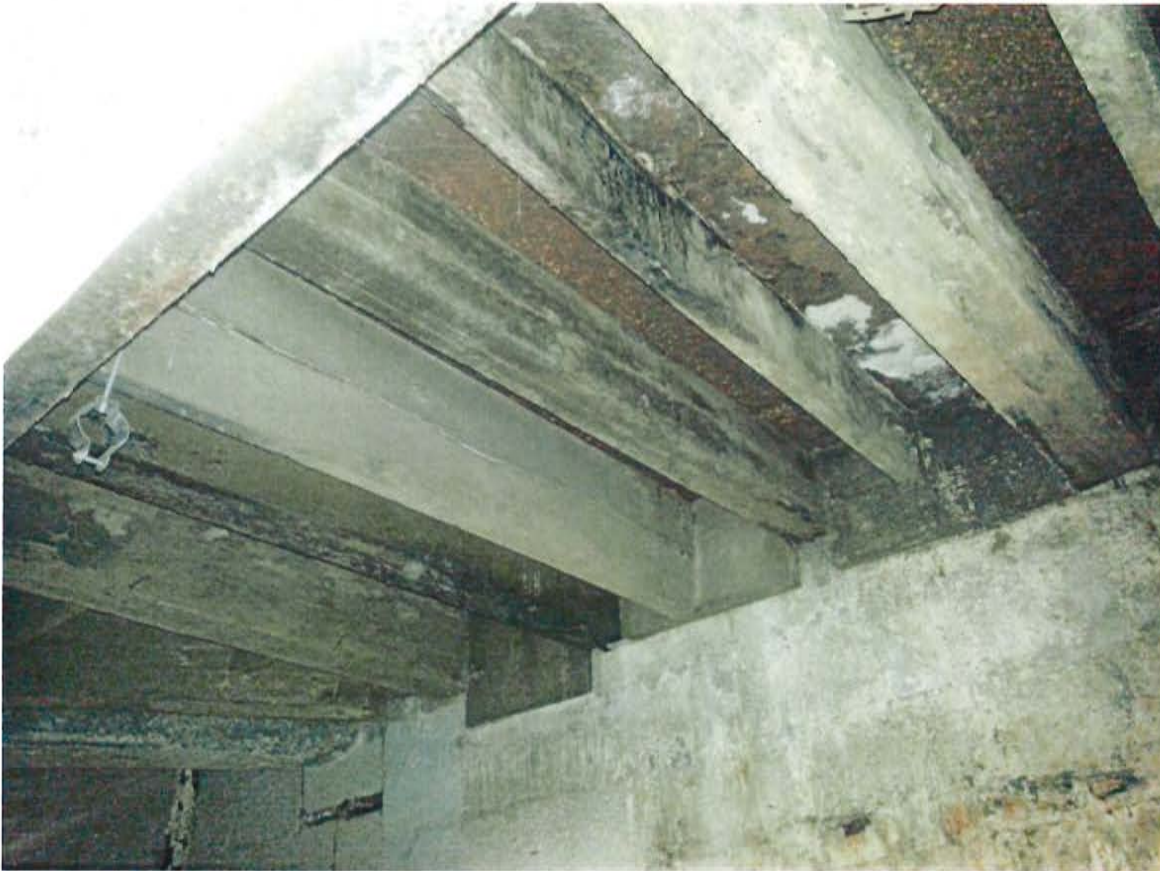
There are pockets of decayed wooden floor joists and rusted steel plates left over from old manufacturing processes that should be removed and/or repaired to meet future building renovation plans.

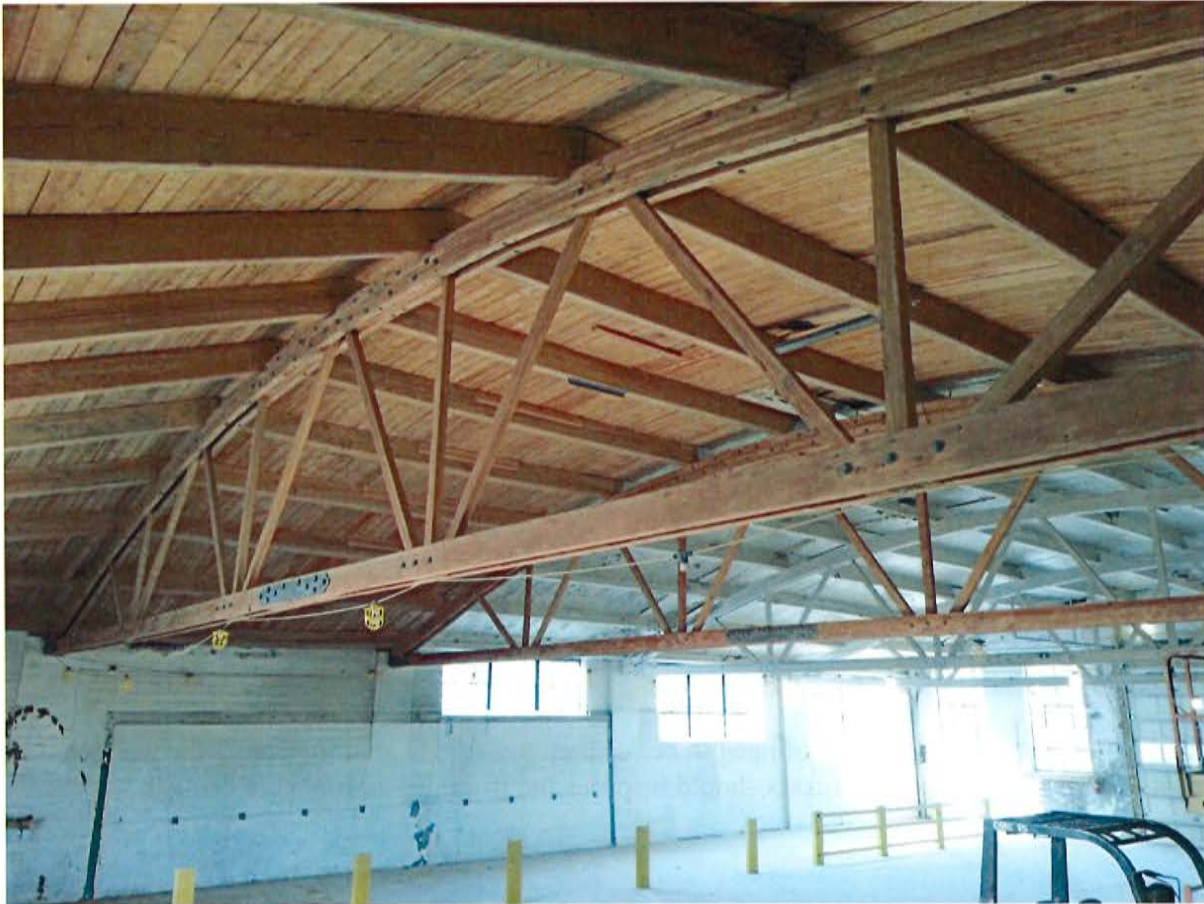
The bottom cord and web members of the trusses appear to be solid sawn timber. The top cords of the trusses appear to be a glued laminated timber. The glulam top cords appear to have some delimitation. This is likely due to the age of the trusses and moisture cycling in an unconditioned environment. ADG recommends all timber purlins and decking inspected during reroofing operations and replaced as needed.

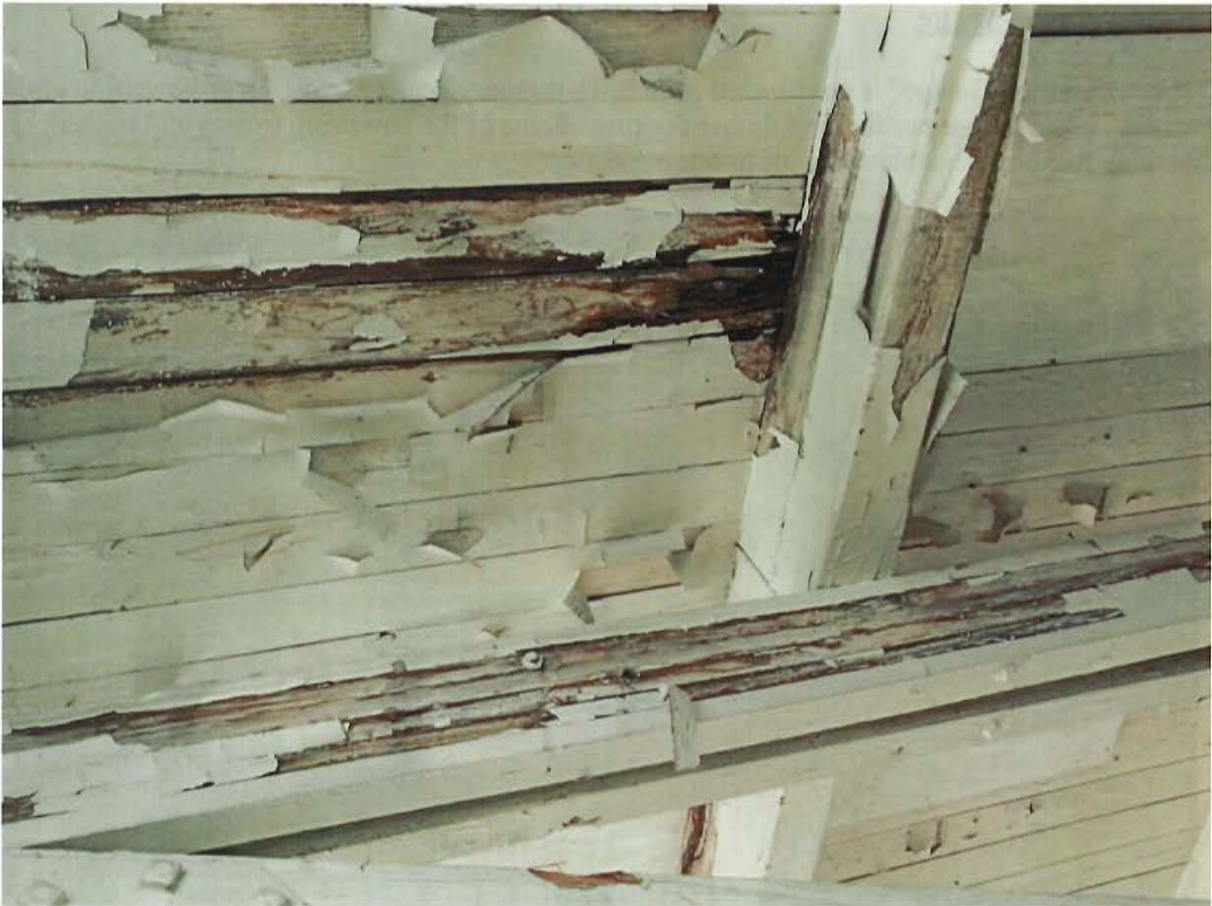
Leaks in Bowstring Garage's roof need to be repaired to avoid further impacting the wooden roof system. The bowstring trusses should be protected from further moisture damage.

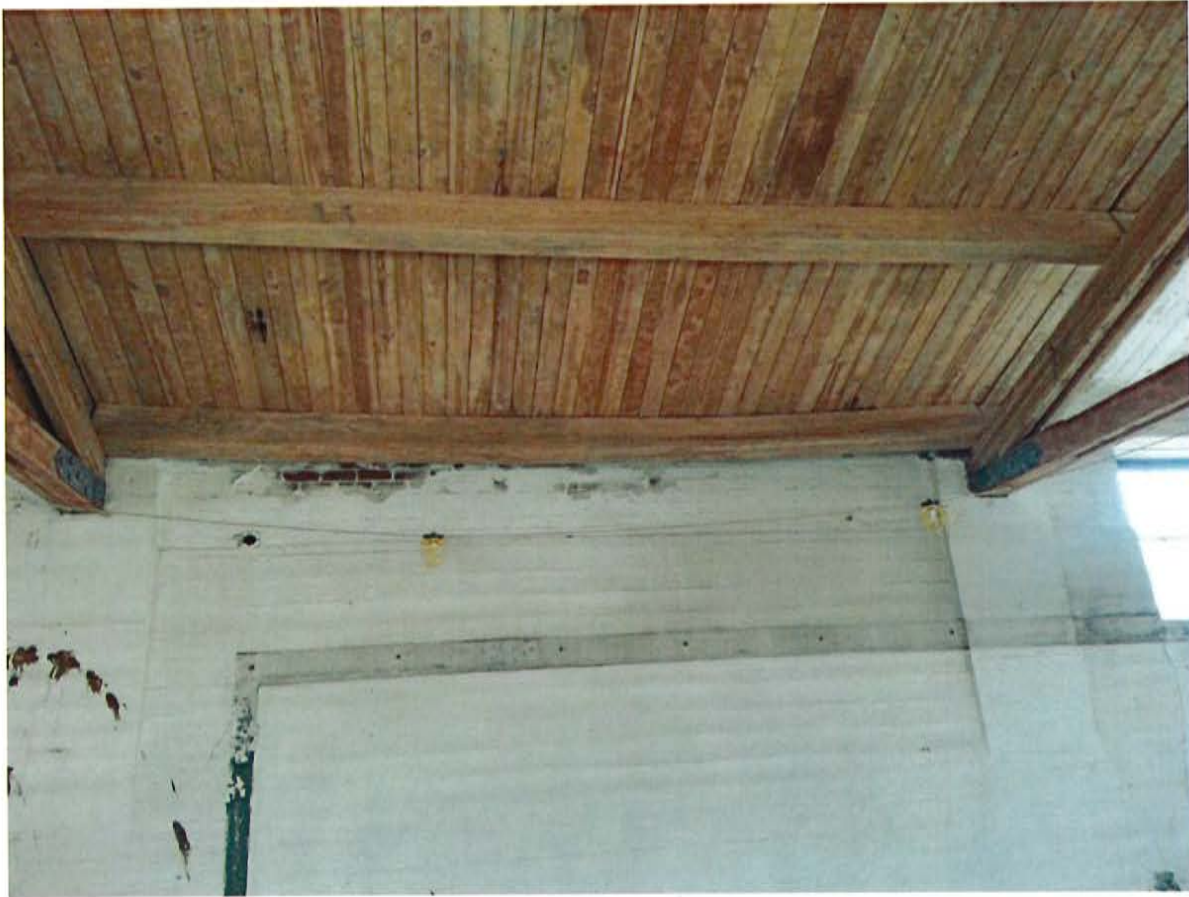
Purlin is visibly bowed and should be replaced. When the roof is repaired the edges of the roof should be inspected for decay.

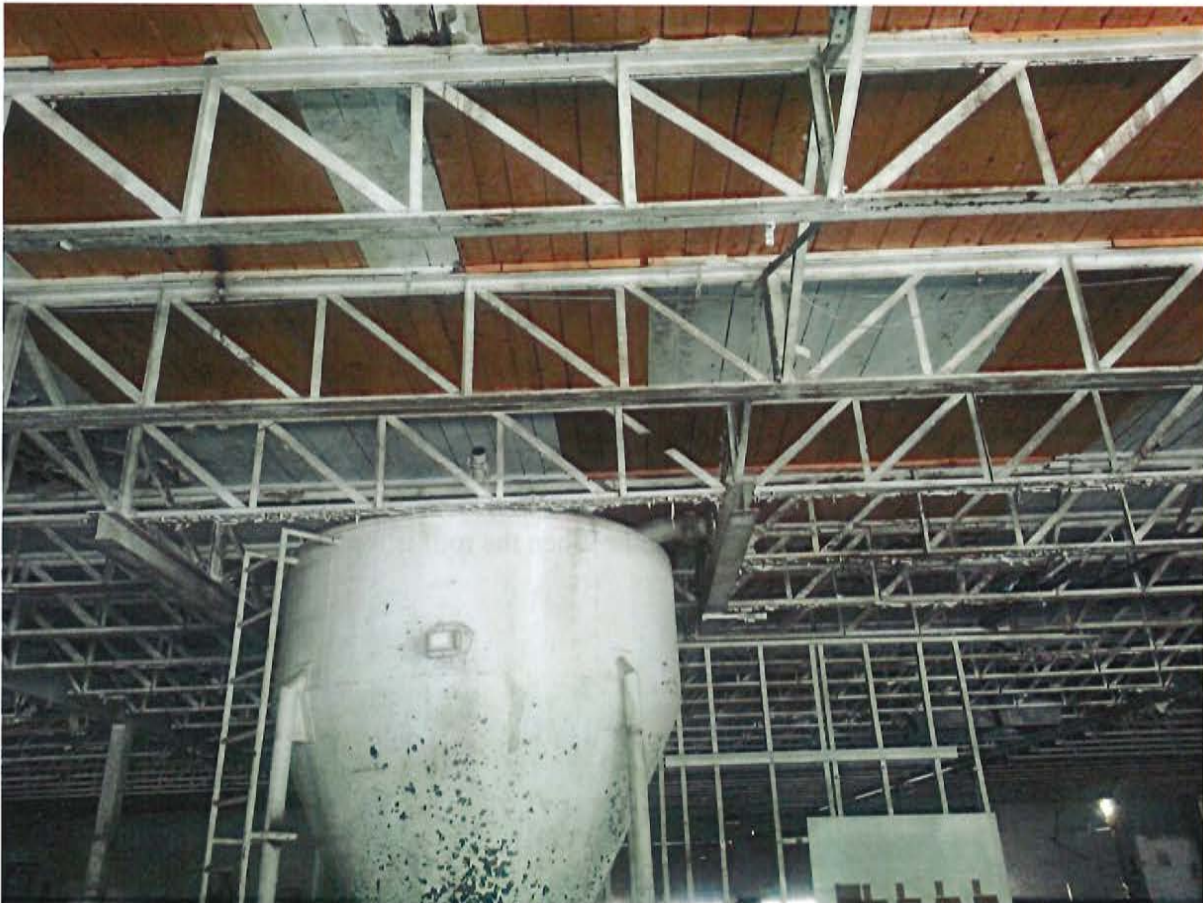
This section of bar joists has been removed and beams added to accommodate the tank installation. The bar joists have been cut and supported by newer girder members. In places some web members have been cut/removed for piping. Bar joists like these will need to be repaired during renovation.

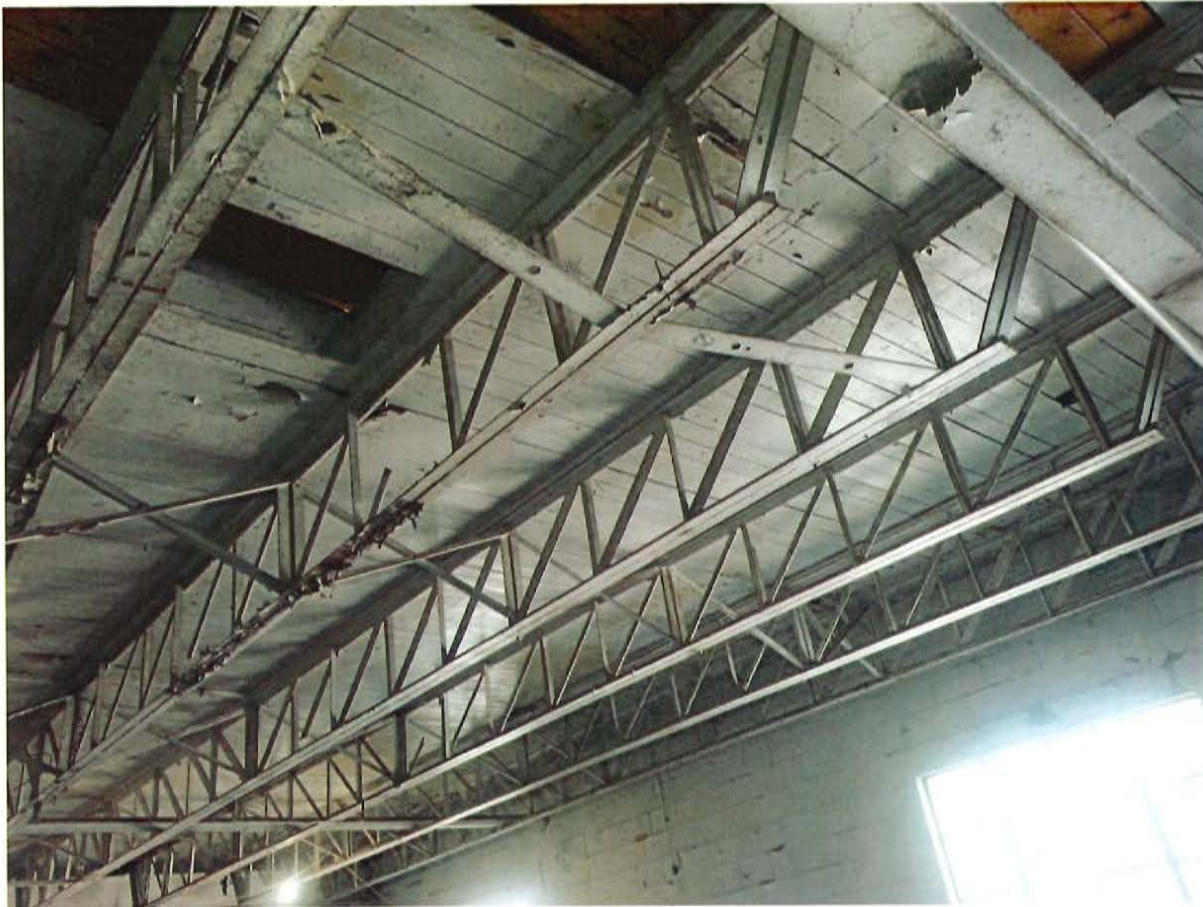
Example of decking that has been replaced and bar joists where web members have been cut. The roof will need to be inspected for moisture decay during re-roofing operations and the cut web members replaced.

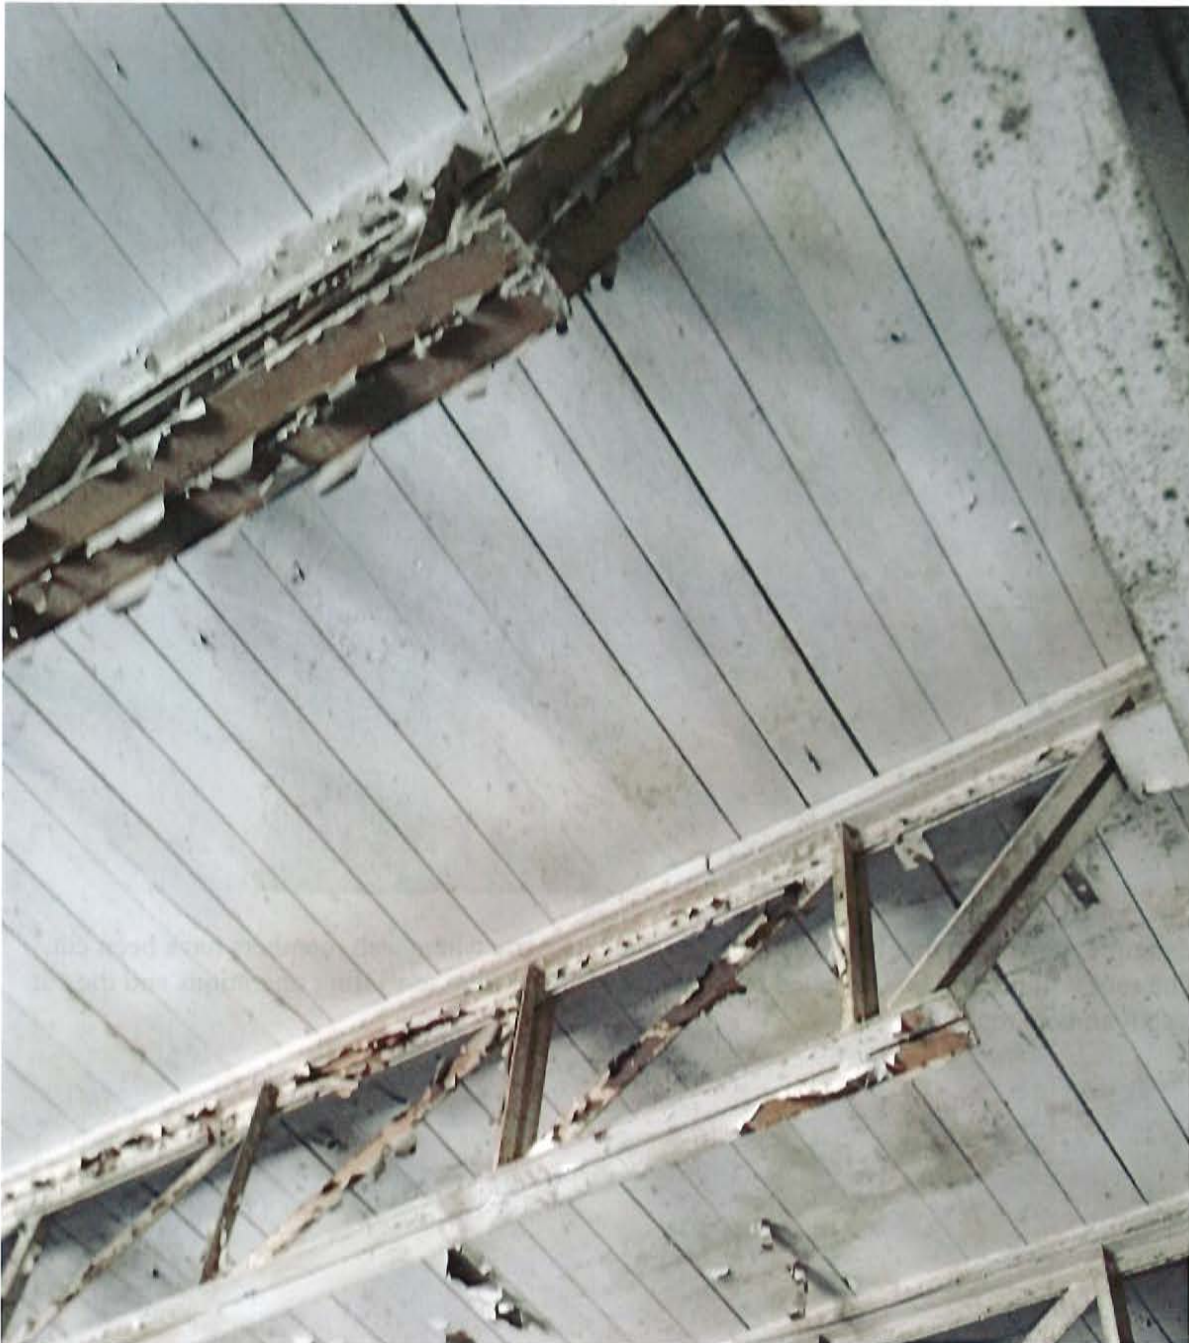
Paint on the bar joists are peeling. The bar joists need to be sand blasted and inspected for the need of repairs, if any. The bar joists should be painted to protect them from further exposure to moisture.
