**KNOXVILLE HISTORIC ZONING COMMISSION  
STAFF REPORT - CERTIFICATE OF APPROPRIATENESS APPLICATION**

**PROPERTY LOCATION:** 2110 Chapman Hwy /  
Parcel ID 109 A K 014

Reference: **Kern's Bakery**  
**2110 Chapman Hwy, Knoxville, TN 37920**

Subject: **Limited Visual Structural Assessment**

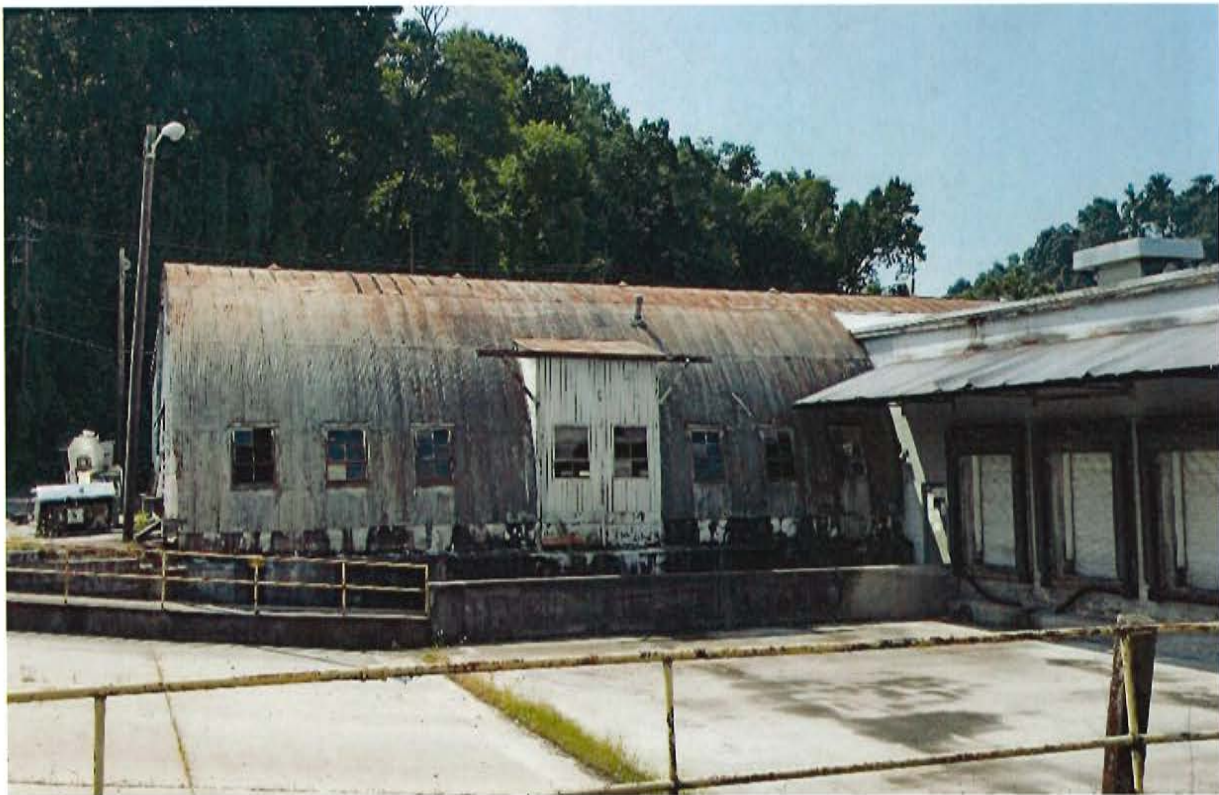
Exterior decking of Quonset Hut is severely rusted. ADG recommends complete demolition and removal of the Quonset Hut.

It is our engineering opinion the Quonset Hut is past its useable life and should be demolished. The exterior decking is rusted and the ends of a large number of structural ribs are rusted severely and in our opinion cannot be repaired.

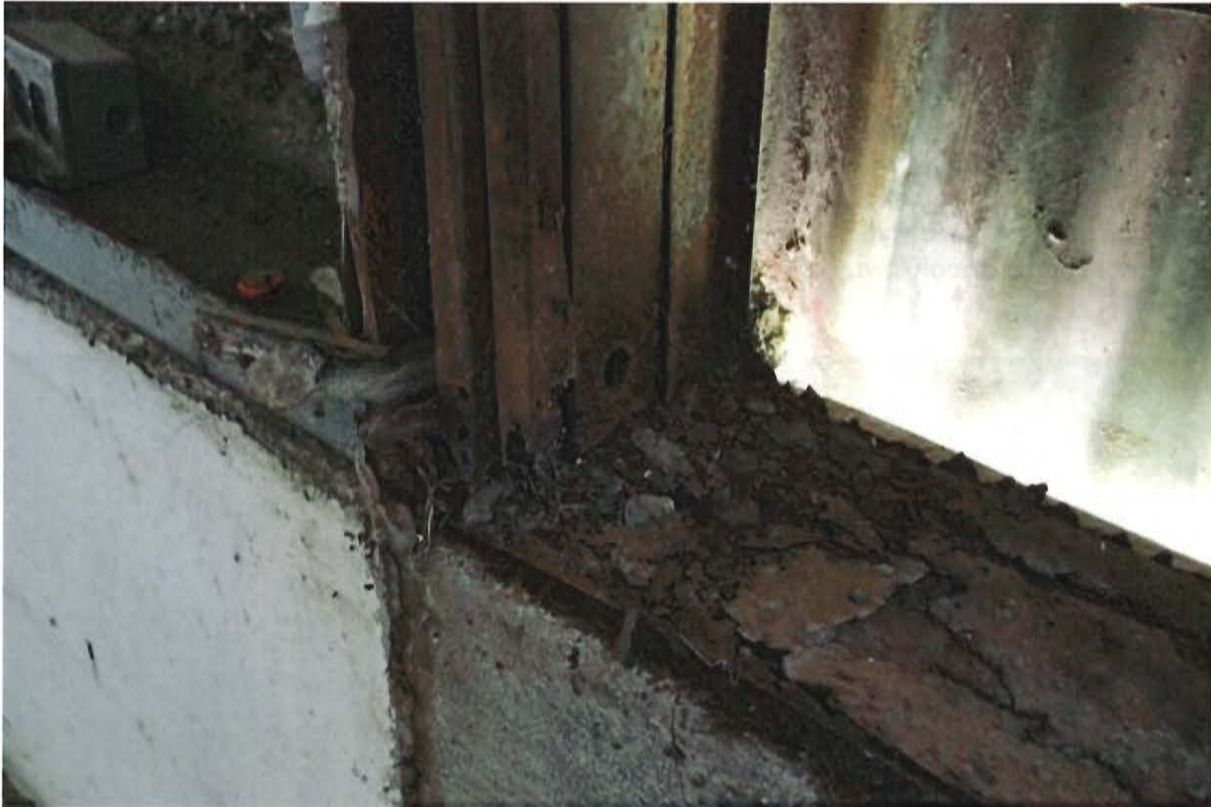
Base channel is completely rusted through and disintegrating. End of structural rib is severely rusted.
