**7-G-20-HZ**  
**APPLICATION FOR CERTIFICATE OF APPROPRIATENESS**

1111 Eleanor St. 37917  
 \_\_\_\_\_  
 Fourth and Gill H-1

# Staff Report - Certificate of Appropriateness Application

# National Property Inspections

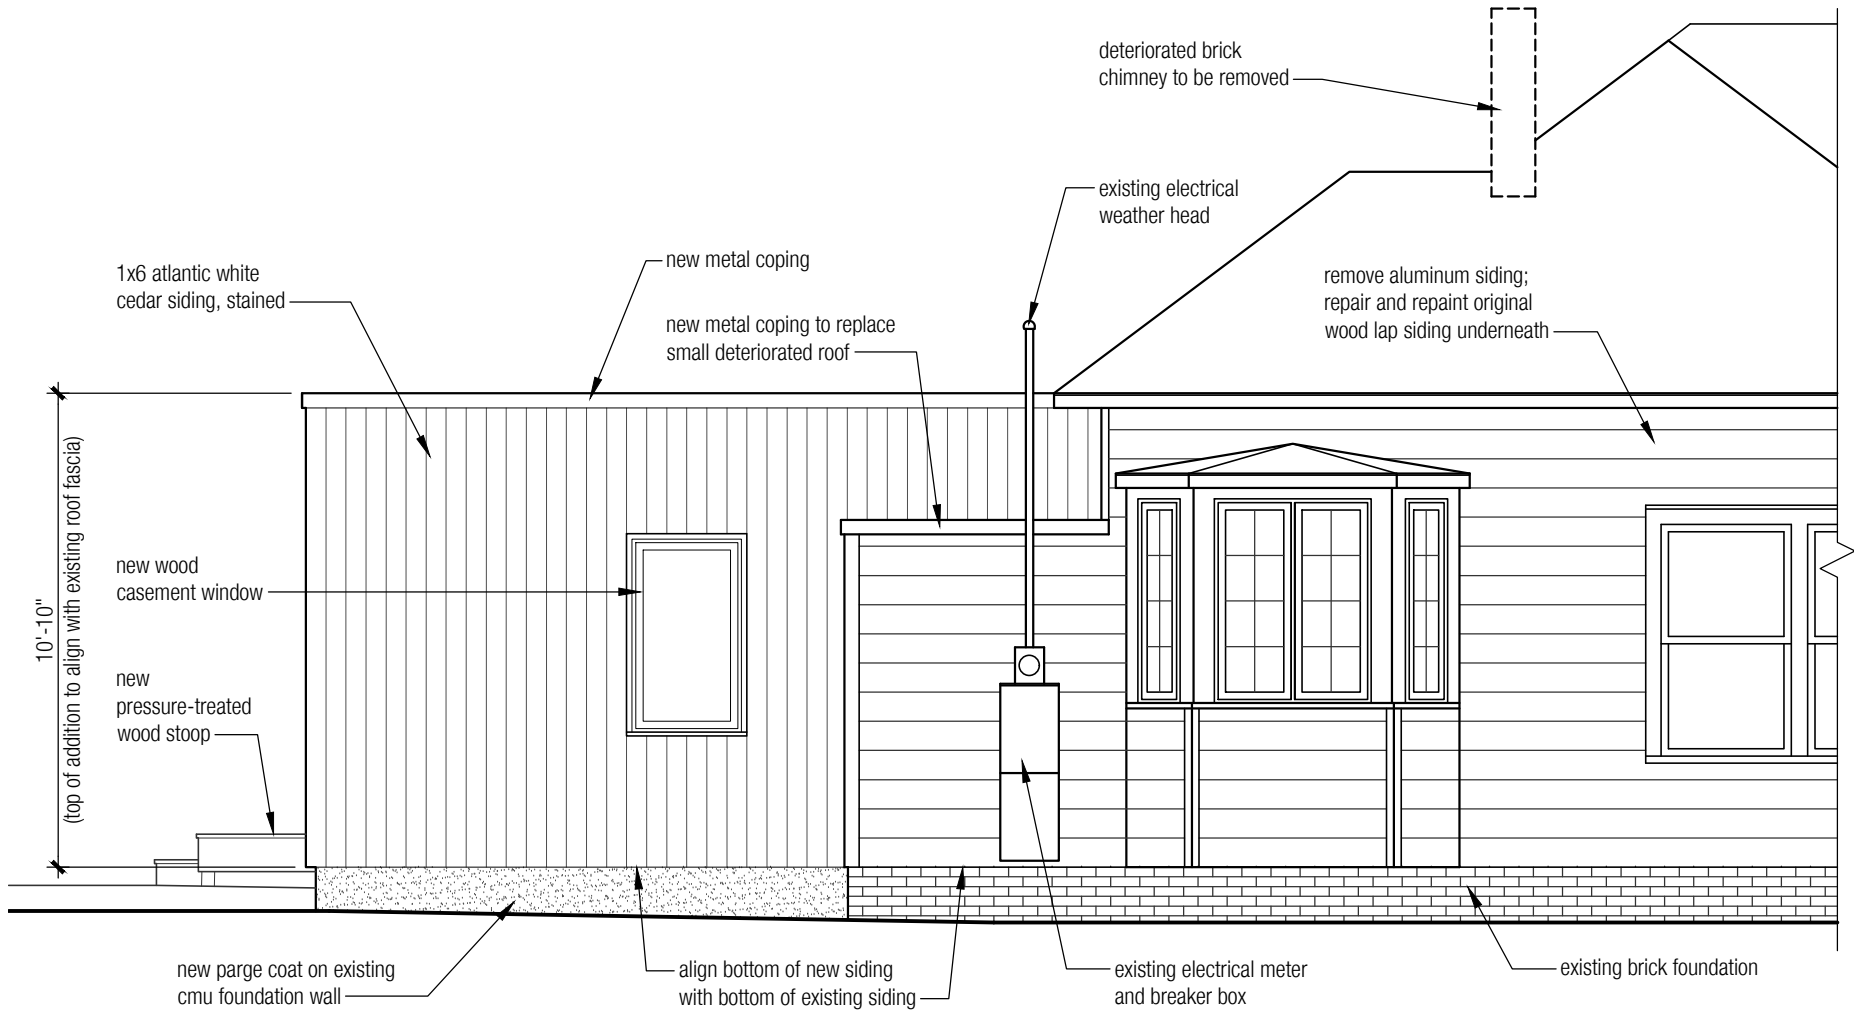
**SIDE ELEVATION (SOUTH)**

Foundation will receive new parge coat. Addition is proposed to have a flat roof with new metal coping along the roofline, and new metal coping along an existing roof on the south elevation. South (side) elevation to feature a single-light wood casement window. North (side) elevation to receive two adjoining wood casement windows. Rear (west) elevation to feature aluminum-clad sliding patio doors with cedar carriage doors on each side (hinged to swing closed over patio door), one rectangular wood awning window, and a pressure-treated wood stoop.

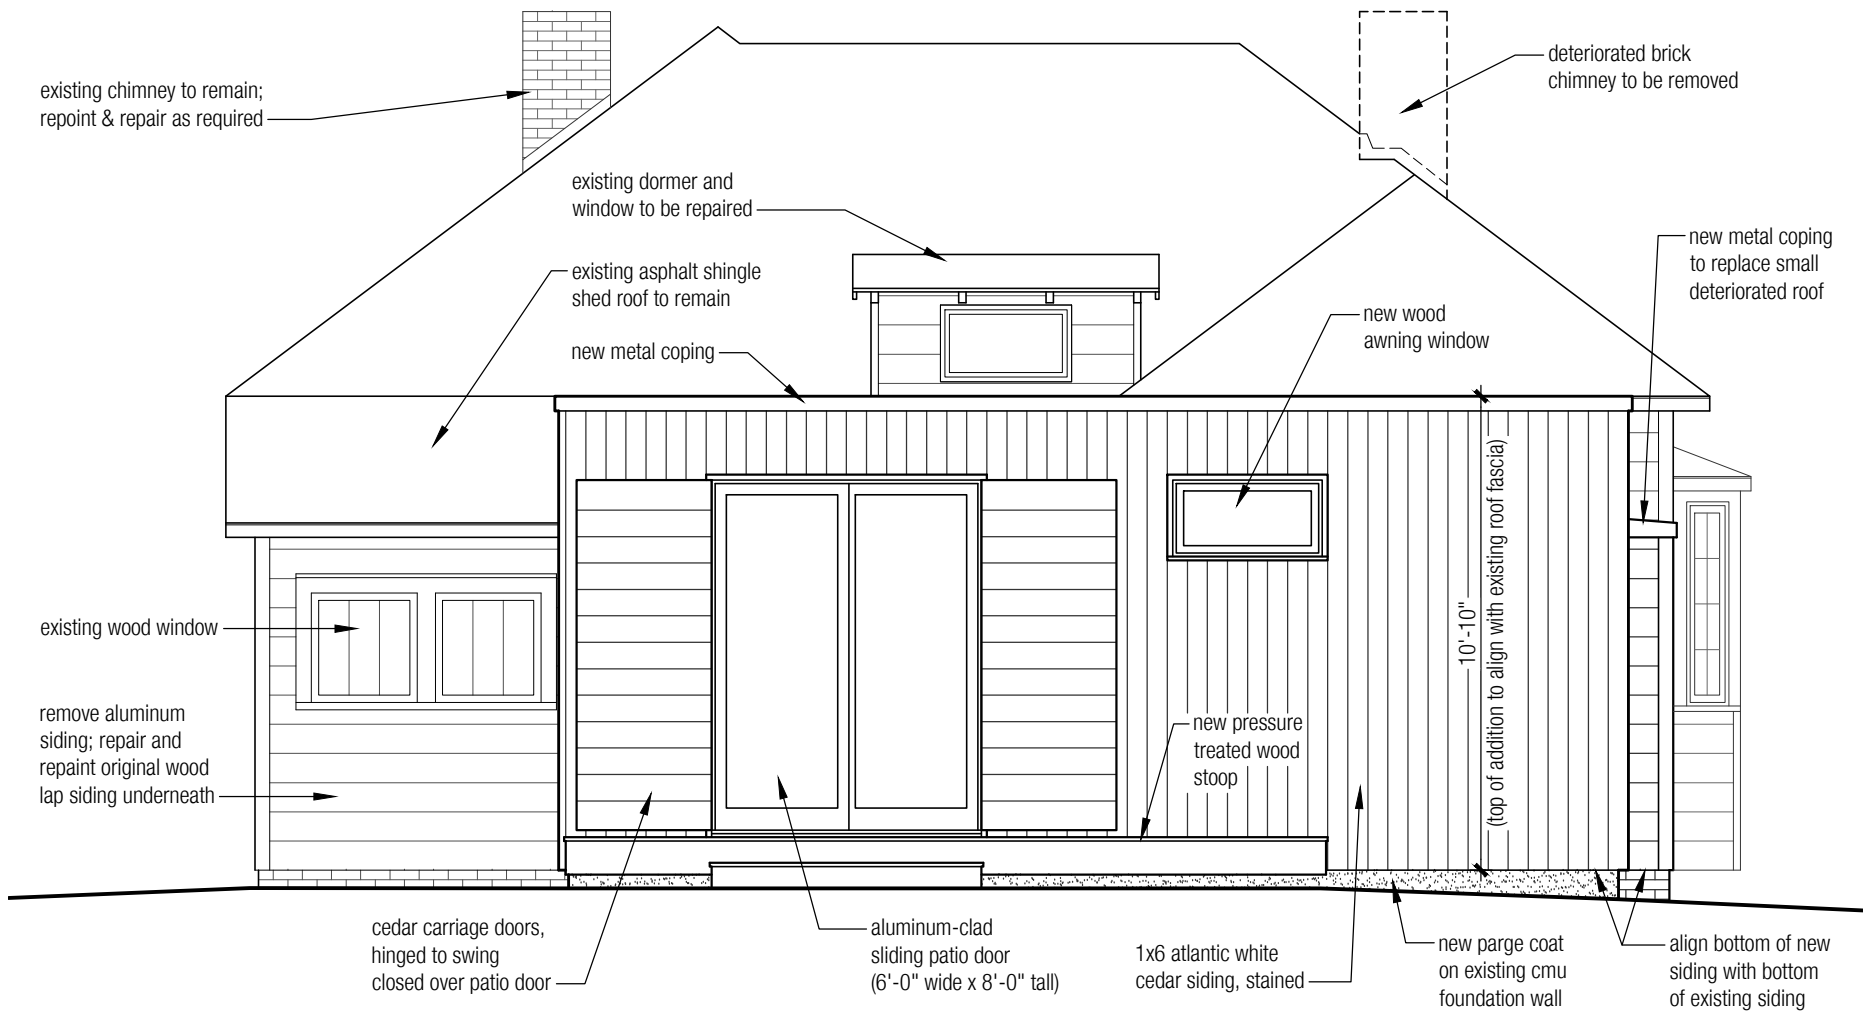
**REAR ELEVATION (WEST)**

Rear addition: removal of non-historic, rear, shed-roof screened-in porch. Rear addition to be constructed on existing CMU foundation and will not expand the footprint of the existing porch. Addition will measure 24'-1" long by 12'-2" deep and be clad in 1x6 atlantic white cedar wood vertical siding, which will be stained. The addition will be 10'-10" tall, with the top of the roof aligning with the existing roof fascia.

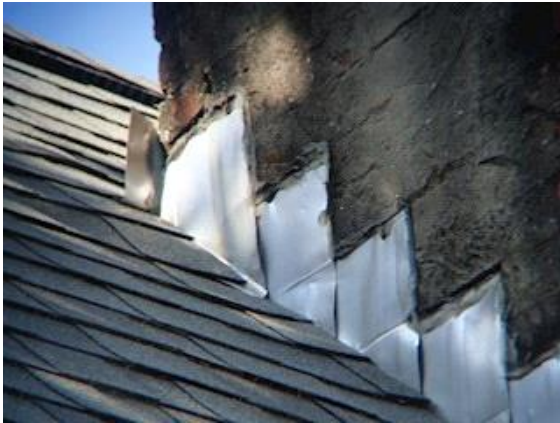
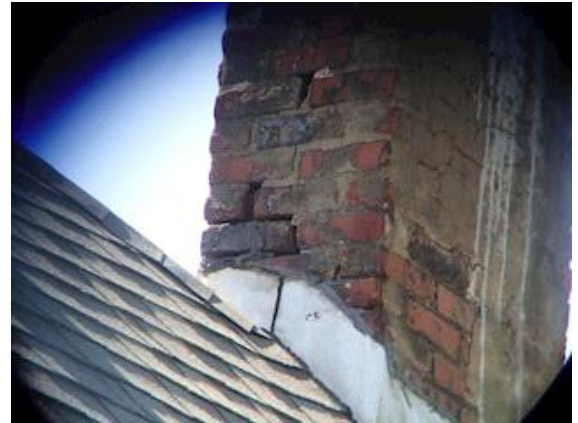
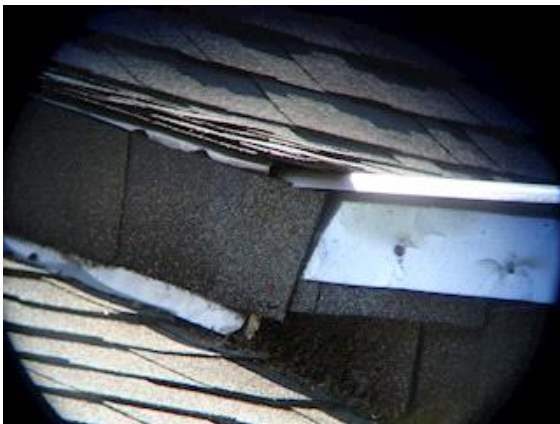
Numerous sections of flashing around the house were improperly installed, have been previously repaired, and/or show signs of damage/deterioration. Recommend a qualified roofing contractor further evaluate all flashing and repair/replace prior to the end of the contingency period. Hidden damage may exist.

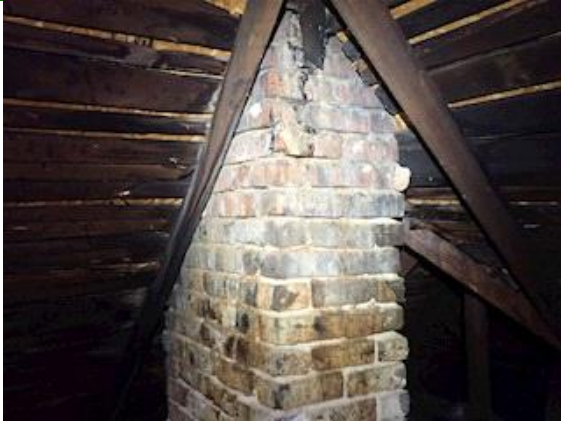
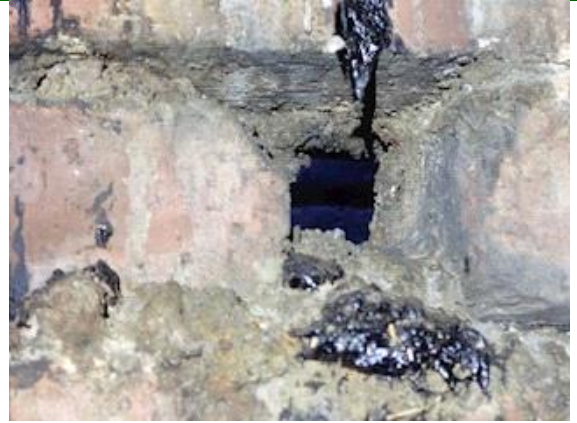
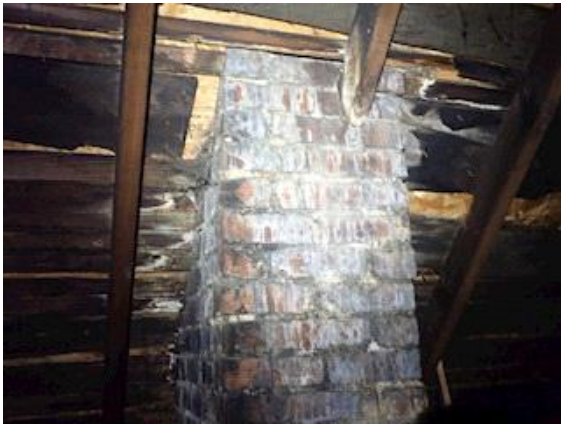
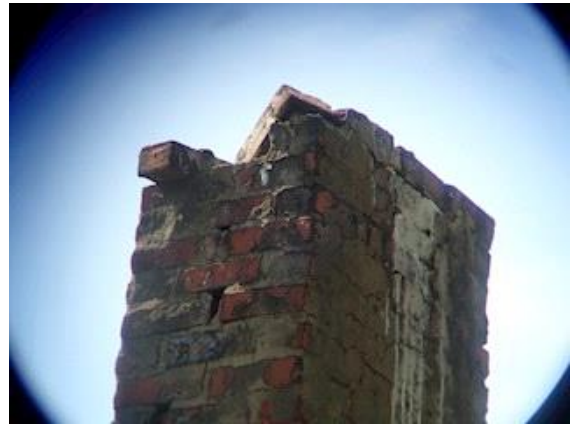
Chimney removal: applicant proposes removal of the left (south) side chimney due to deterioration of flashing, mortar, and bricks.

Staff recommends approval of the work as proposed, with the condition that the chimney be retained and repaired to meet the design guidelines.

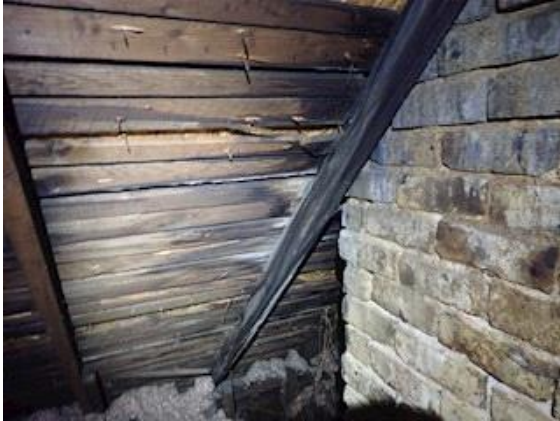
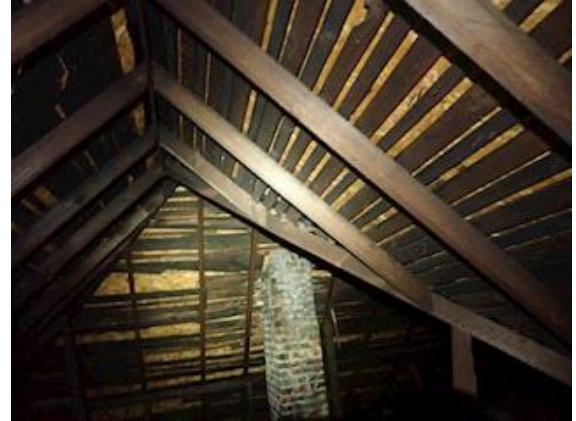
- Many framing members throughout the attic were bowed and/or damaged. Many of the rafters were split. Recommend further evaluation of the framing members in the attic by a qualified contractor and repair/replace as necessary.
- Water stains noted in attic but did not test wet during inspection. Monitor condition for future leaks and have a qualified contractor further evaluate and repair if necessary.

Leaks not always detectable.
