**8-D-21-HZ**  
**APPLICATION FOR CERTIFICATE OF APPROPRIATENESS**

1361 Armstrong Ave. 37917  
Old North Knoxville H

**Location:** 1361 Armstrong Ave. **Parcel ID** 81 L E 034  
**District:** Old North Knoxville H  
**Zoning:** RN-4 (General Residential Neighborhood)  
**Description:** Neoclassical, c.1925

Proposed replacement of the existing cement tile roof with a new GAF dimensional asphalt shingle roof.  
Replacement of low-slope porch roof (currently asphalt roll) with new TPO rubber roofing material.

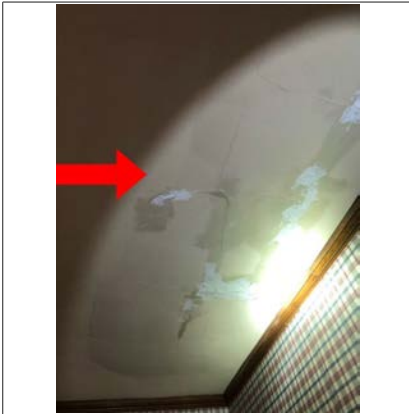
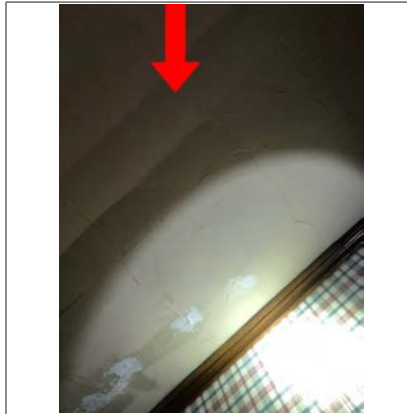
Ceilings at kitchen and gathering room show moisture damage. Recommend further evaluation and repair as.

\*\*\*\* Damage appears to be due to previous leaks from above.

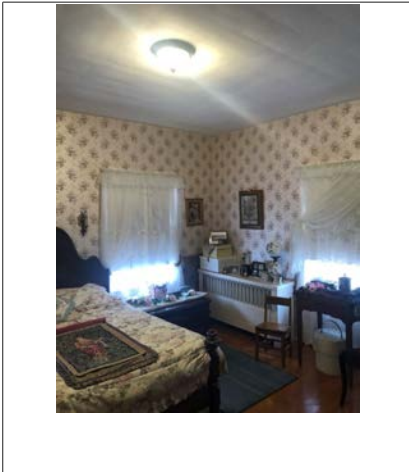
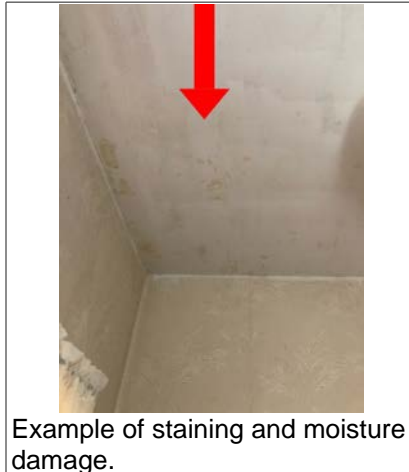
Example of staining and moisture damage.

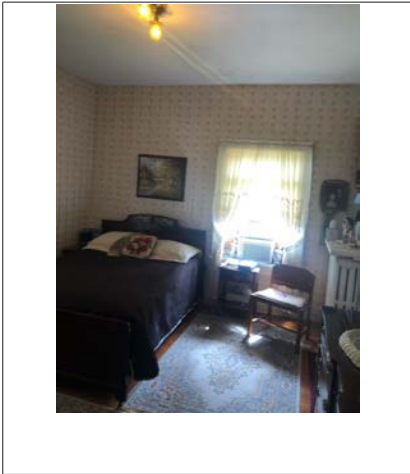
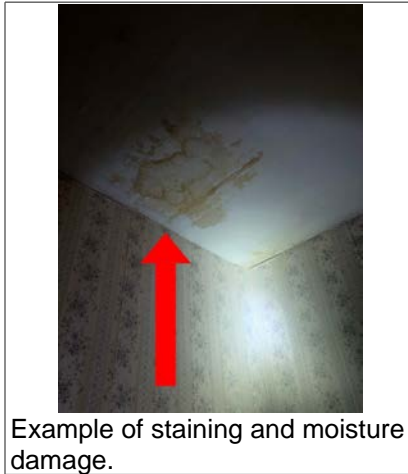
Example of staining and moisture damage.

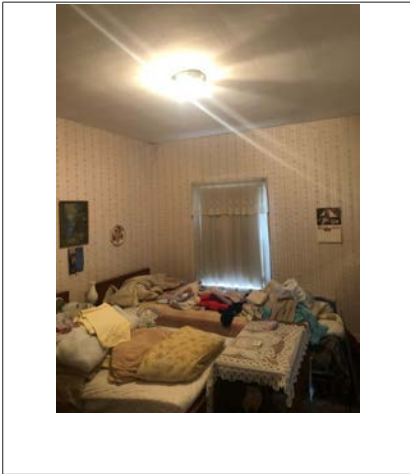
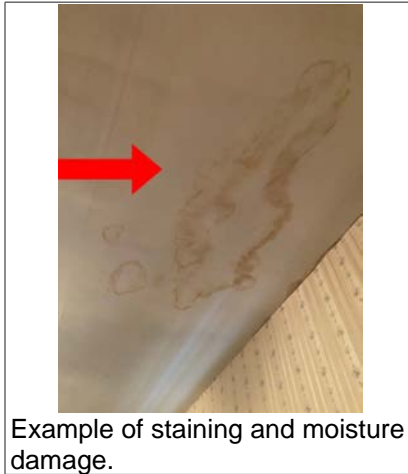
Example of staining and moisture damage.

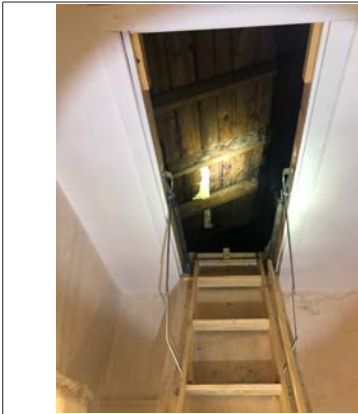
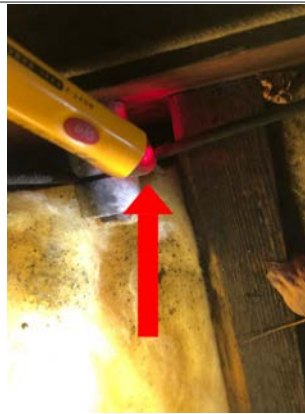
Example of energized knob and tube in contact with insulation. Recommend repair as needed.

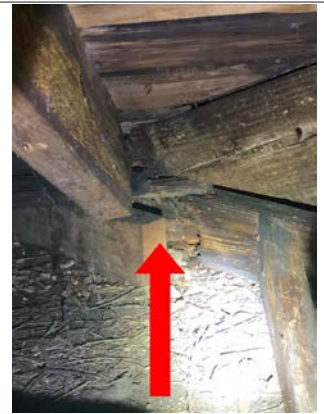
Example of moisture damage at eaves.

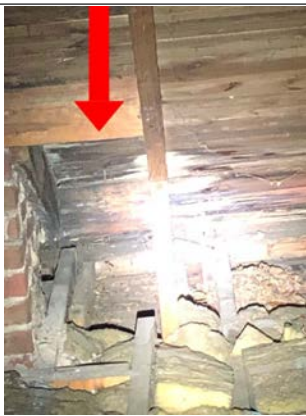
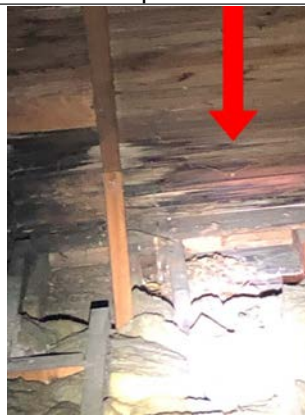
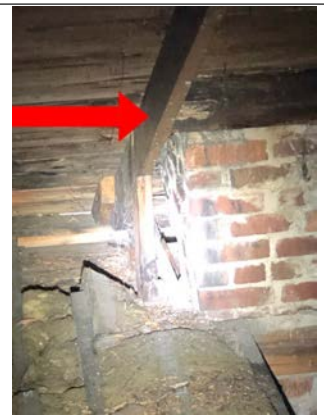
\*\*\*\* Damaged sheathing / planking should be part of roofer evaluation to properly prepare an estimate of repairs.

Example pics of sheathing / planking damaged noted in roofing section of report.

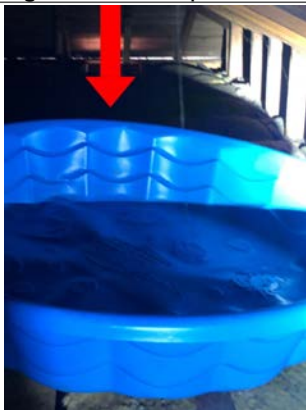
Plastic swimming pool appeared to be containment during leaking.
