# Staff Report

Knoxville Historic Zoning Commission

File Number: 12-A-25-HZ

**Location:** 1618 Clinch Ave. **Parcel ID** 94 N H 013  
**District:** Ft. Sanders NC  
**Zoning:** O (Office)  
**Description:** Queen Anne with Neoclassical influence, c.1907

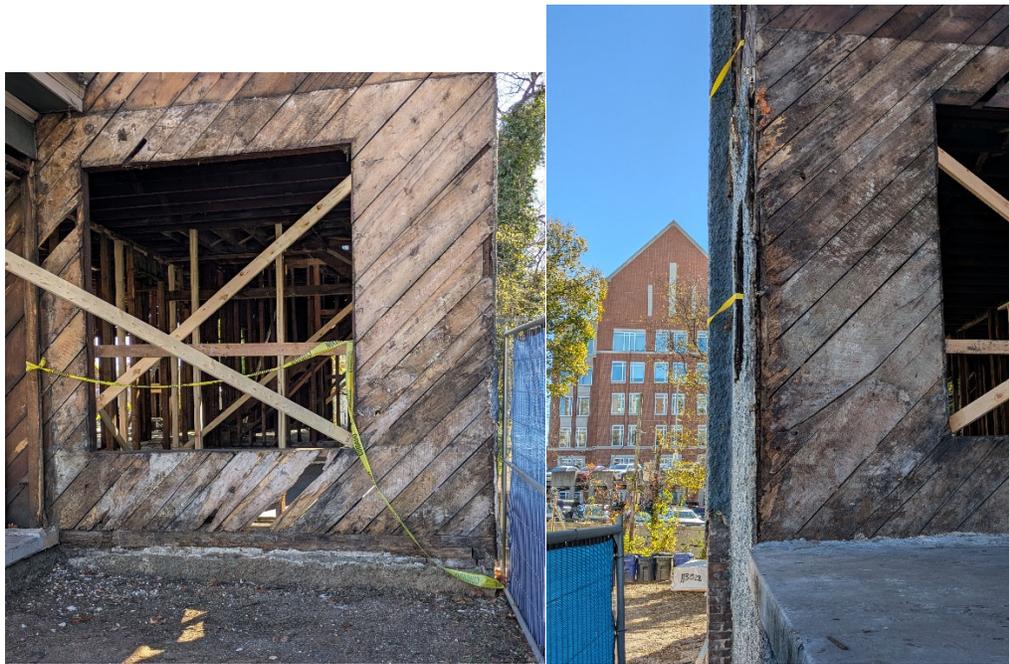
Rot at wood/sill in contact with stucco

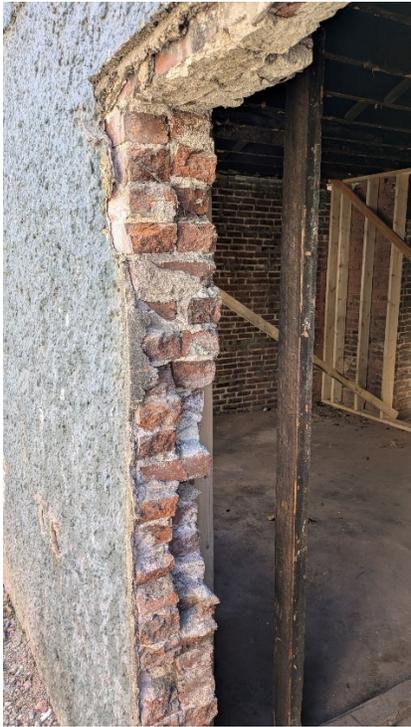
Depiction of two wythe foundation

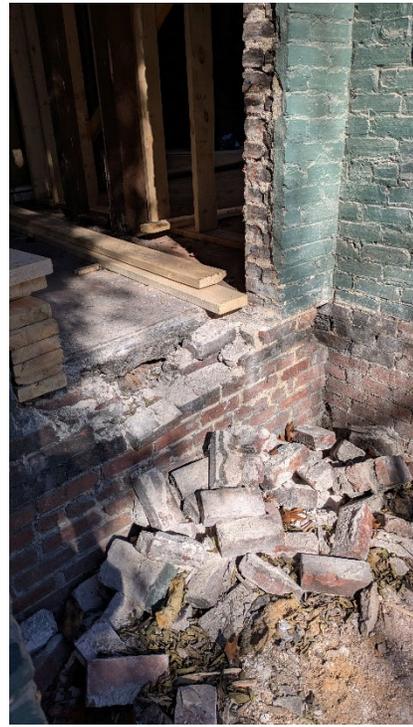
area of foundation falling apart

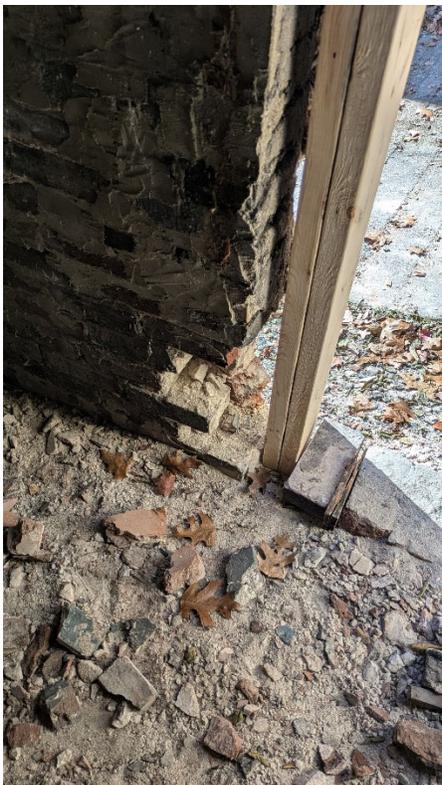
Evidence of mortar integrity loss

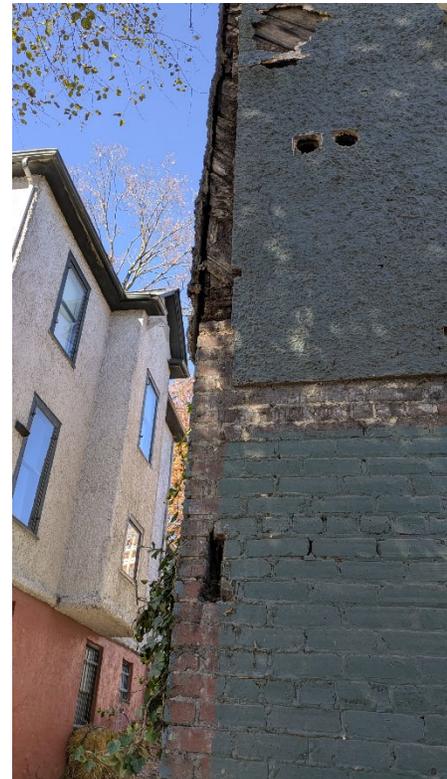
sill plate rot and foundation issues

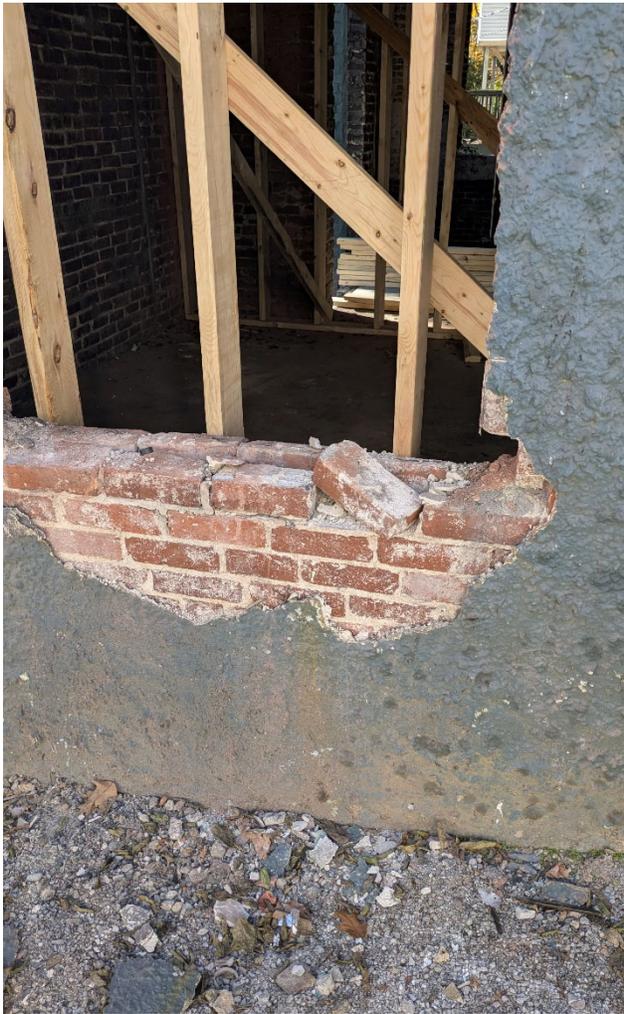
Brick easily removed due to fretting

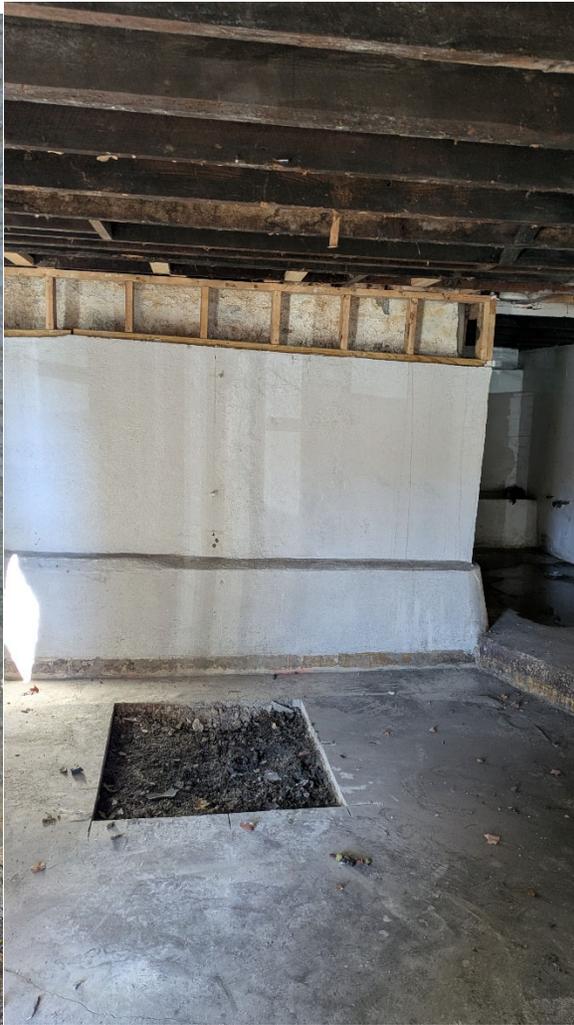
prior foundation repair at front of house

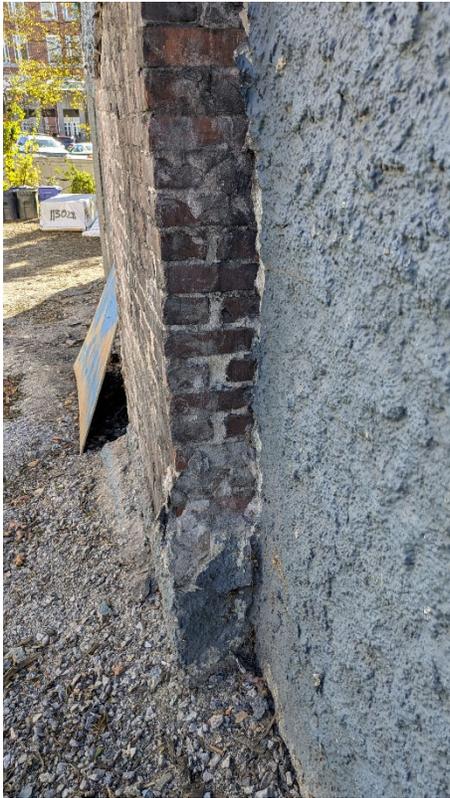
Fretting at chimney base

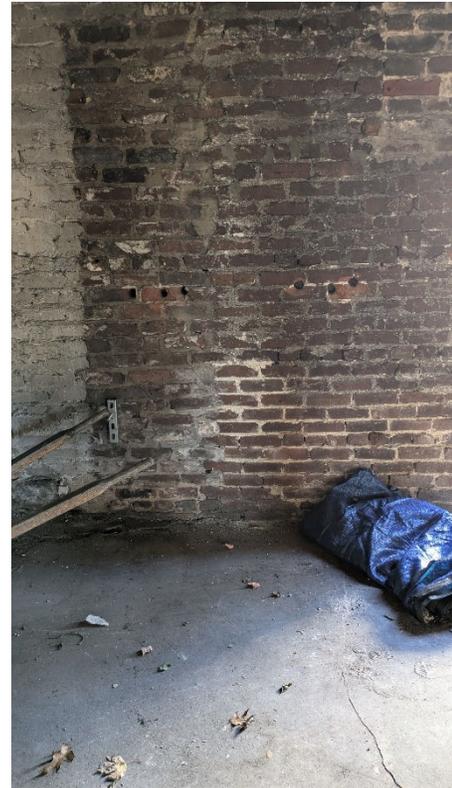
fretting at interior of building
