Downtown Knoxville Design Overlay District Certificate of Appropriateness

RE: Application for MPC Downtown Knoxville Design Overlay District – Certificate of Appropriateness

Address: 119 S. Central Avenue, Knoxville, TN 37902

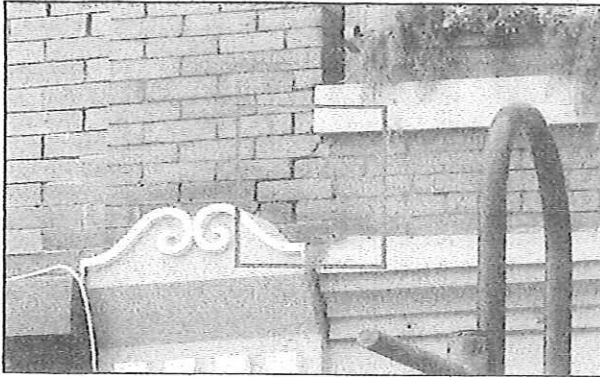
4.2 Item 7(Picture)

window. One brick is loose next to exterior white key stone at window top and could fall. A licensed Structural Engineer should evaluate.

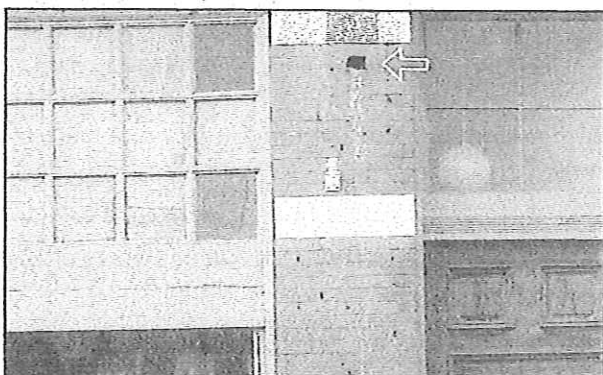
2.0 Item 10(Picture) Front side brick missing

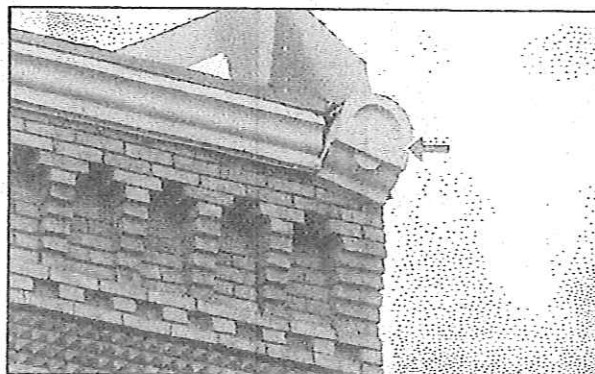
2.1 Item 1(Picture)

- 3) The right corner semi-circle trim is loose and tilting. This needs to be stabilized and returned to its original position and condition, so it doesn't fall or become un-savable.

🔧 Semi-circle trim at front right corner is loose and could fall. Repair needed soon.

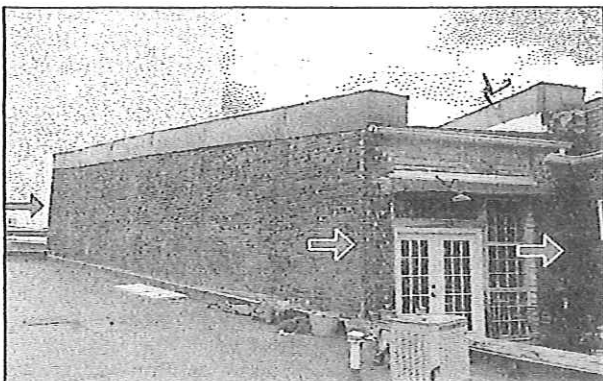
2.0 Item 5(Picture) Gaps at comers

⚠ (2) Mortar missing at many areas on brick walls. Occasional loose bricks. Number of wall cracks low, considering age. Larger cracks & gaps noted at front near windows. Repairs needed to prevent further damage and to waterproof.

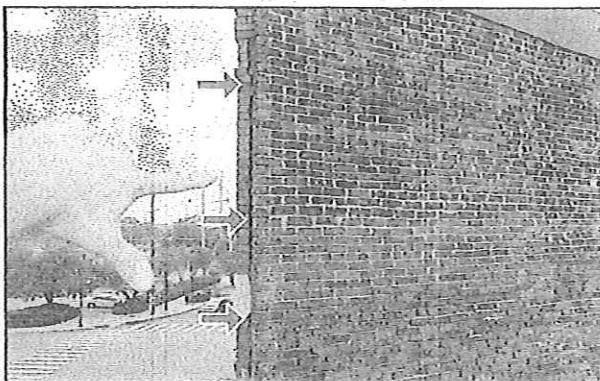
2.0 Item 6(Picture) Gaps at comer. Also gapped at interior walls here.

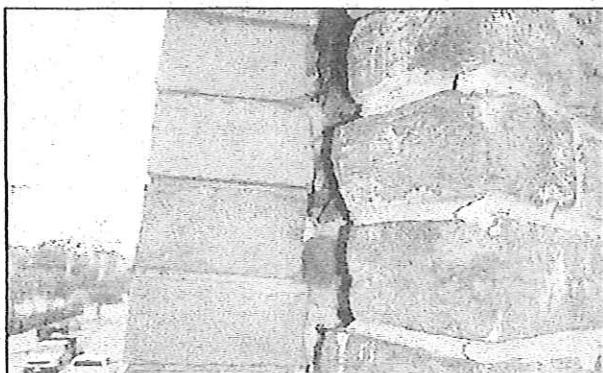
2.0 Item 7(Picture) Close up of previous picture

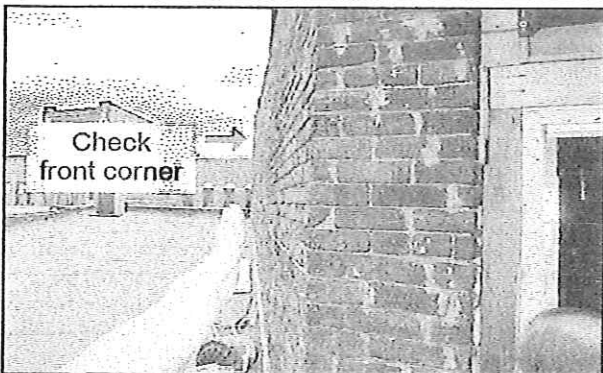
4.2 Item 3(Picture) Outward bulge in wall visible from deck

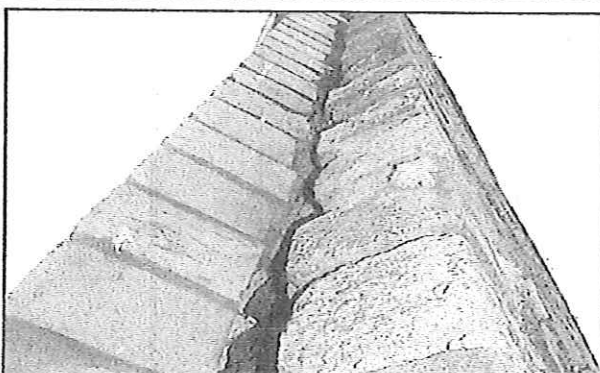
4.2 Item 4(Picture) Wall separation at front right exterior corner (above stairway).
