**KNOXVILLE HISTORIC ZONING COMMISSION
STAFF REPORT - CERTIFICATE OF APPROPRIATENESS APPLICATION**

PROPERTY ADDRESS: 1237 Armstrong Ave 37917
DISTRICT: Old North Knoxville H-1

FILE NO.: 11-G-13-HZ

PROPERTY DESCRIPTION: 1237 Armstrong Avenue. Craftsman (c. 1910)

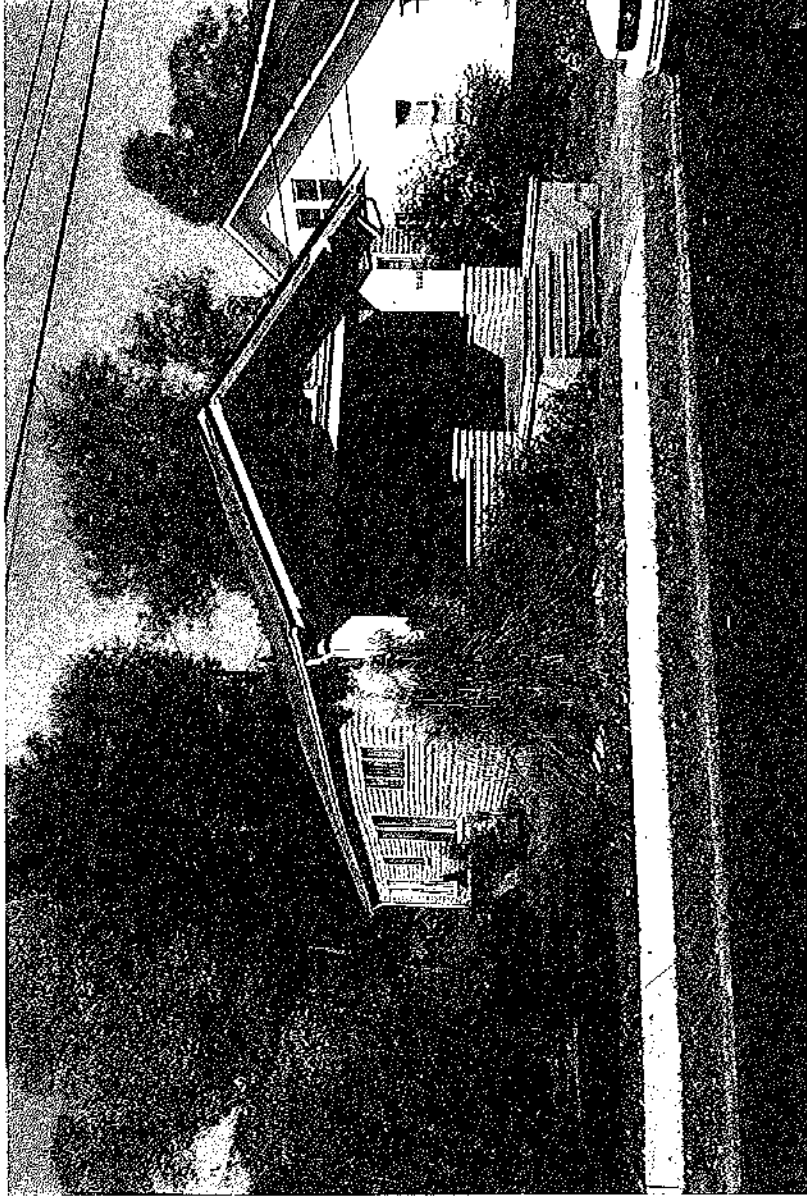
1237 Armstrong

Window #1

Window #2

West Side

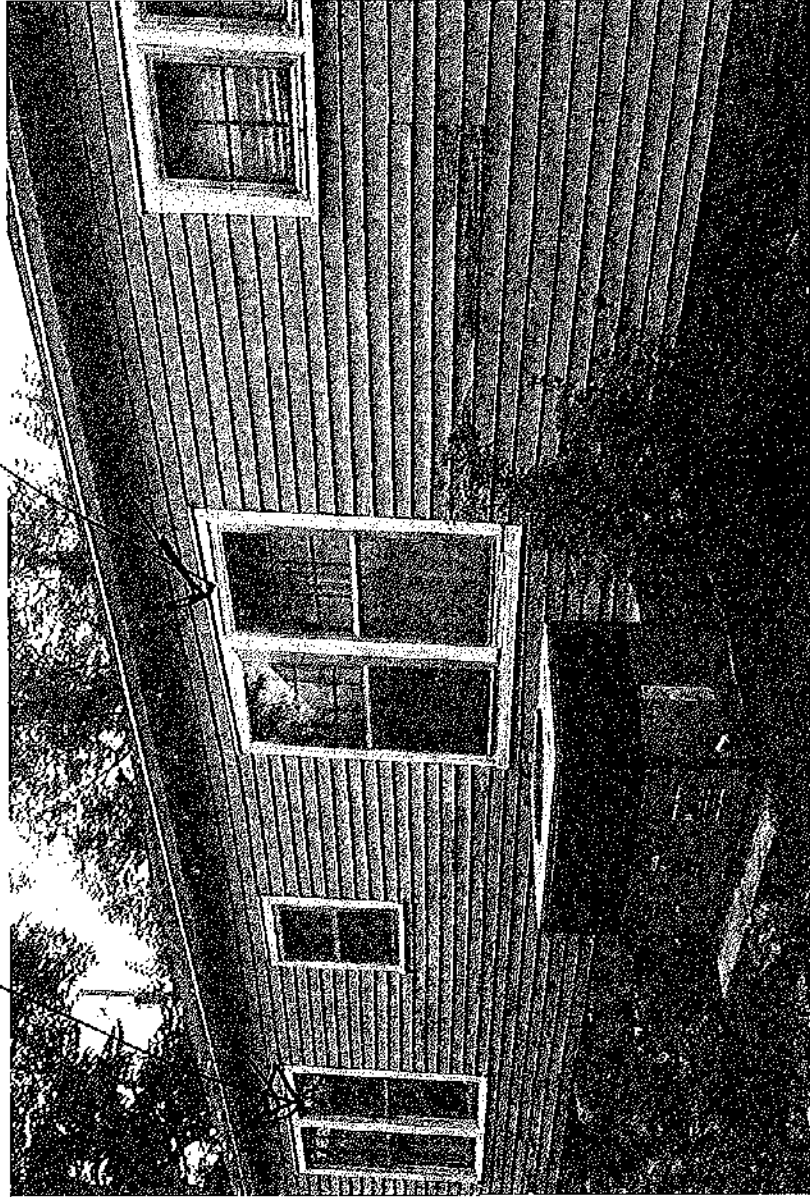
Window # 2

Replaced sill
with piece of

wood

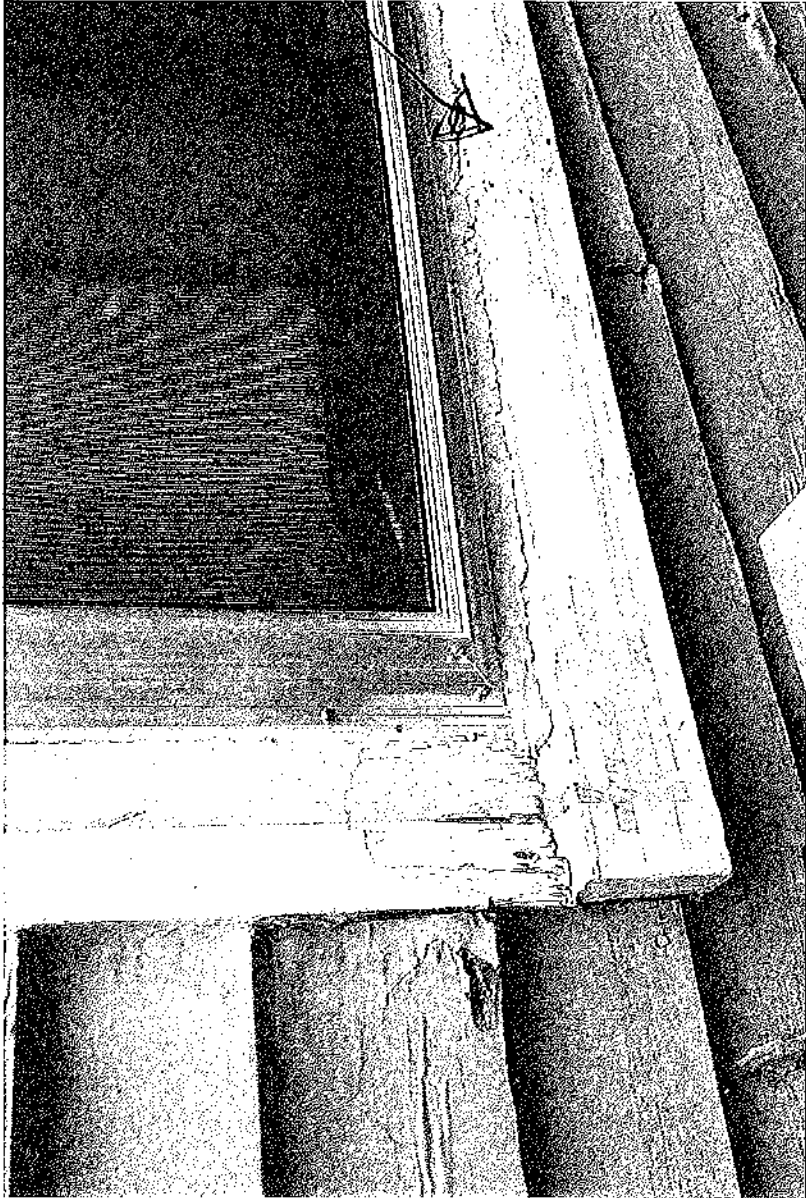
Window # 2

- 6) Window pair #2 on the west side is out of square and will not operate properly, partially due to the sagging foundation.
- 7) The steps are not original and the tread/rise dimensions do not meet building code.

- ① Window out of square
- ② won't operate
- ③ Bottom sill is gone with
A piece of wood stuck
on it

3. Two of the four windows on the west side are beyond repair (pictures don't do justice on how rotten they are) so we propose to replace the two windows with a 9/over 1 STL wood window to match existing as close as possible with identical width in trim and sill. These are the two double windows. The two remaining single windows we will repair and repaint.

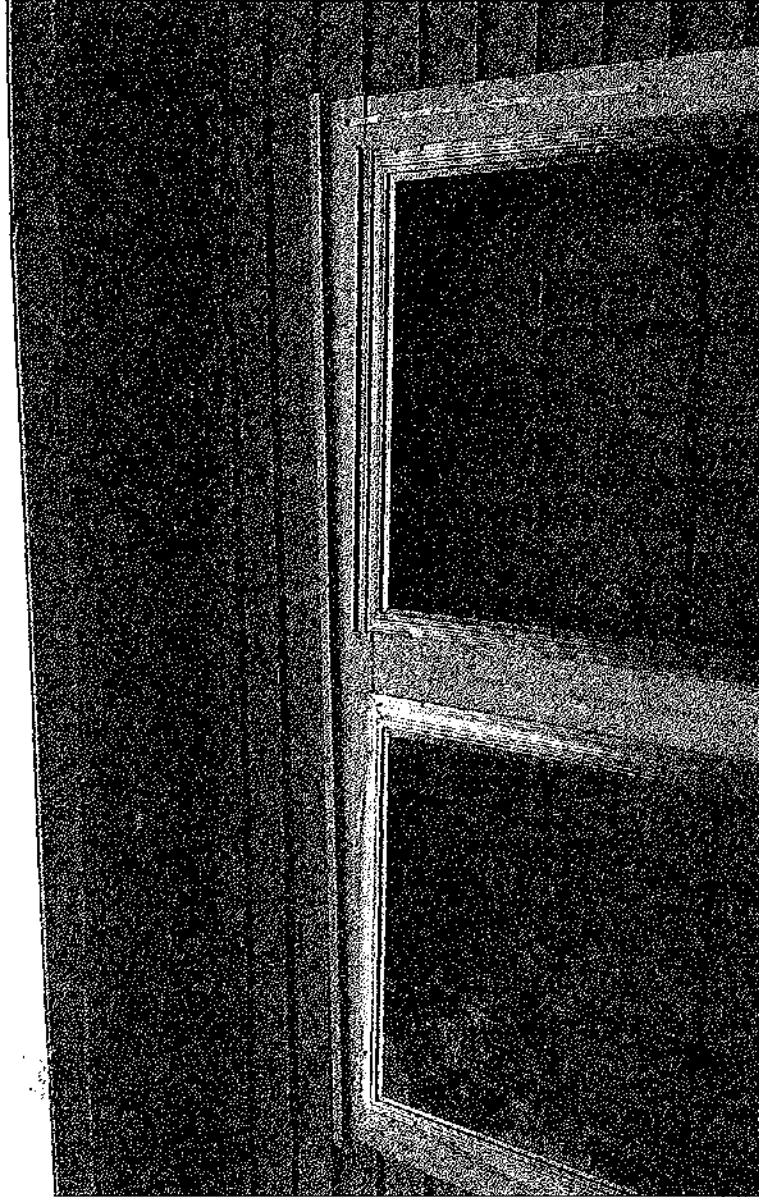
WEST SIDE

Will save these windows

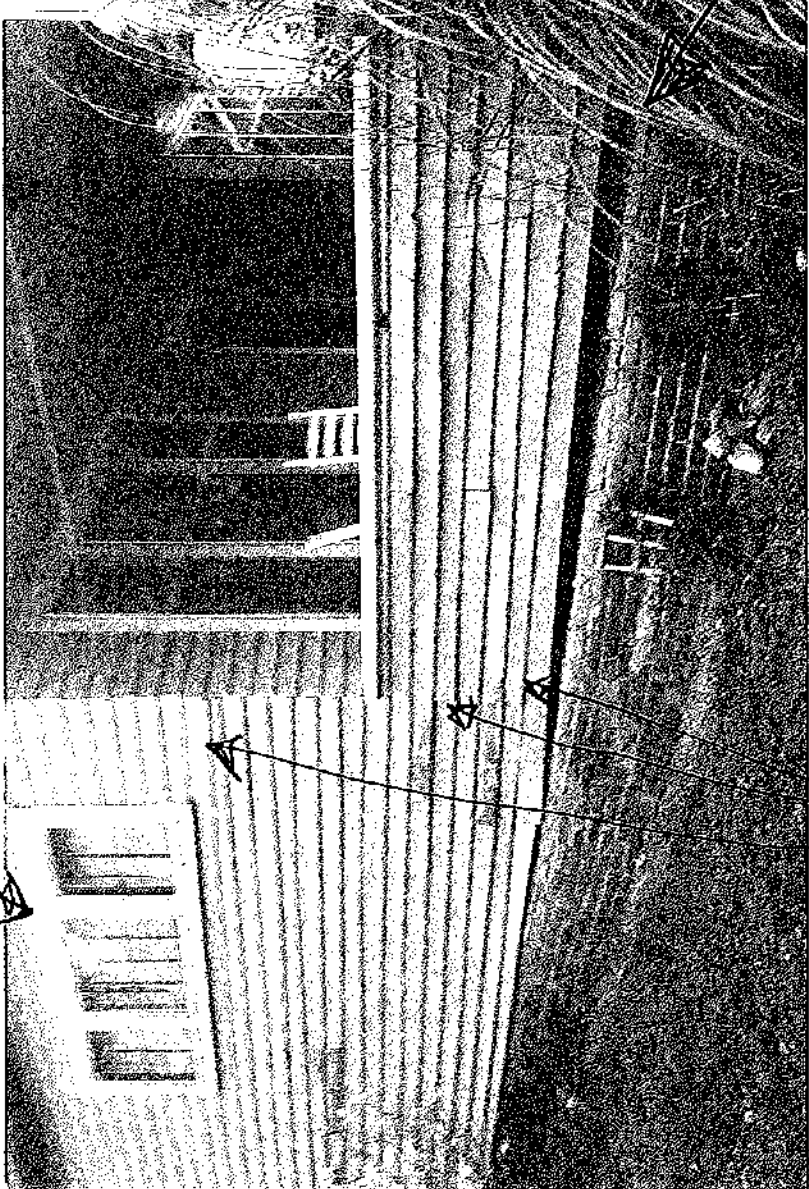
① WINDOW # 1

- 3) The windows exhibit moisture damage which has caused the wood to deteriorate.
- 4) Some of the lower sashes have plexi-glass installed.
- 5) The foundation has settled and is sagging on the west side. This has occurred partially due to earlier improper foundation repairs.

Setled Foundation

Popping Siding

REAR Windows on West
SIDE, Rotten window,

4. Remove all siding on west side. Siding is badly deteriorated and is popping off house where the house was leveled(Front corner of house was raised 3-4"). Replace with a popular side to match dimensions and appearance as closely as possible.
5. Paint west side of house to match existing color scheme.
6. Add some dirt to front corner of house to eliminate sink hole allowing water to drain towards front of house .
