**KNOXVILLE HISTORIC ZONING COMMISSION
STAFF REPORT - CERTIFICATE OF APPROPRIATENESS APPLICATION**

PROPERTY ADDRESS: 726 Deery St 37917
DISTRICT: Fourth and Gill H-1

FILE NO.: 11-J-13-HZ

Replace one original window on the 1st-level front of the house and two originals on the north side to match the existing 2/2 double-hung configuration, but with wooden simulated divided light windows.

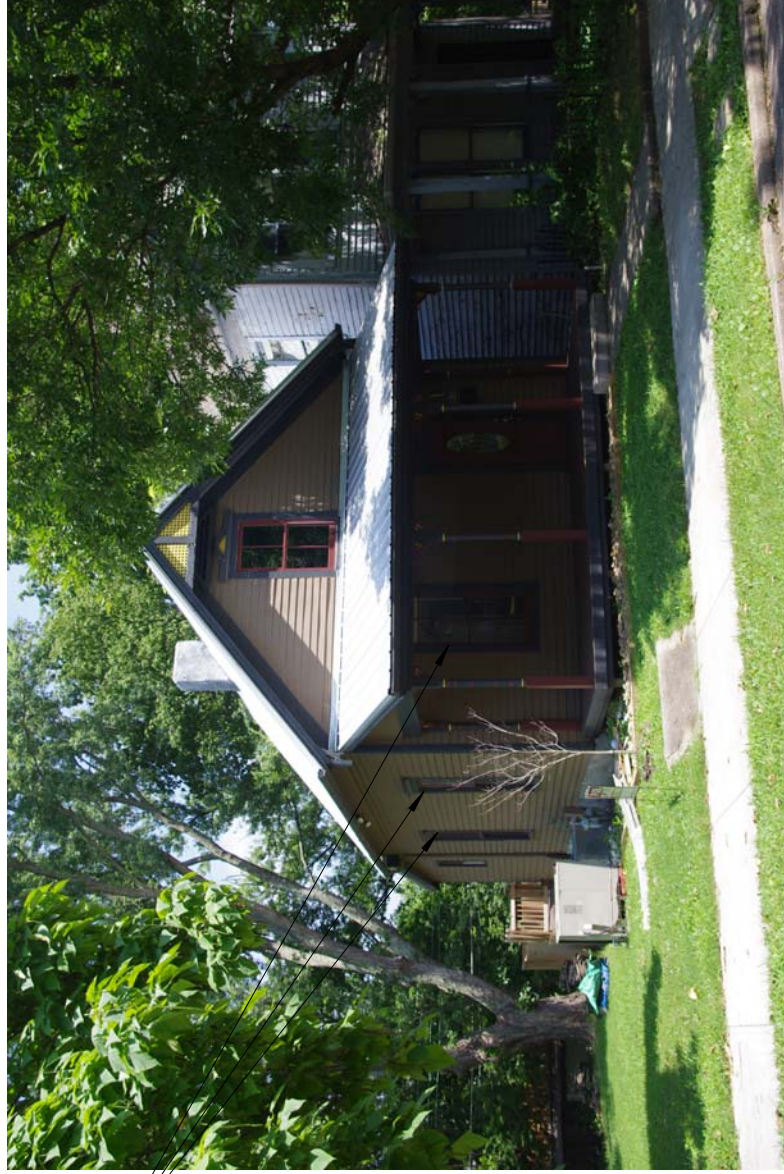
REPLACE THESE WINDOWS

THESE ORIGINAL WINDOW SASHES HAVE DETERIORATED AND HAVE BEEN SEALED TO THE FRAME WITH CAULK AND PAINT. NEW, WOOD-SIMULATED DIVIDED LITE WITH SPACEBAR, WINDOWS WITH MATCHING SASH AND MUNTINS WILL REPLACE THE EXISTING TO ENSURE INTEGRITY OF THE BUILDING'S ENVELOPE AND TO INCREASE ENERGY EFFICIENCY.

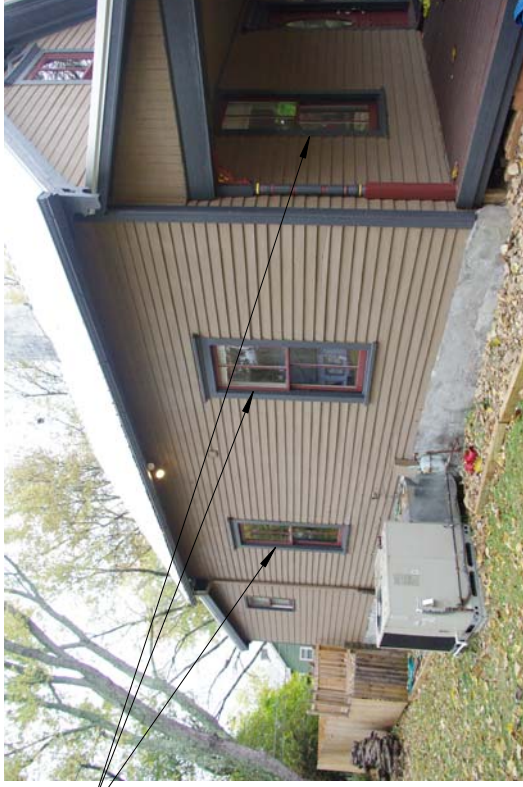
REPLACE THESE
WINDOWS

THESE ORIGINAL
WINDOW FRAMES AND
SASHES HAVE
DETERIORATED AND
HAVE BEEN SEALED
WITH CAULK AND
PAINT. NEW, WOOD,
SIMULATED DIVIDED
LITE WITH SPACEBAR,
WINDOWS WITH
MATCHING SASH AND
MUNTINS WILL
REPLACE THE EXISTING
TO ENSURE INTEGRITY
OF THE BUILDING'S
ENVELOPE.

THIS WINDOW HAS
BEEN REPLACED.
NEW WINDOWS TO
MATCH.

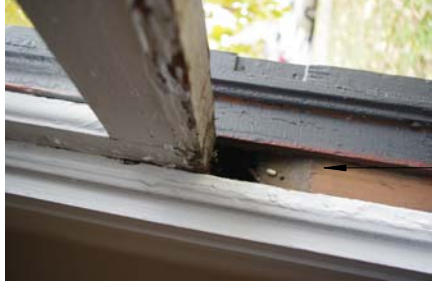
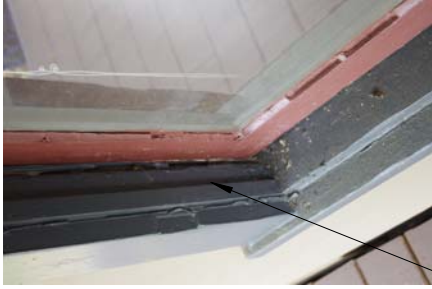
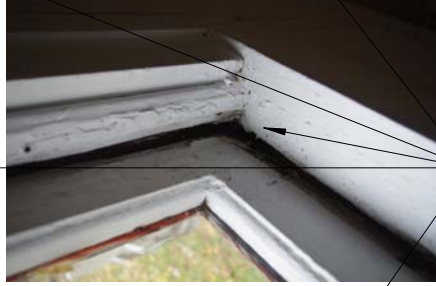
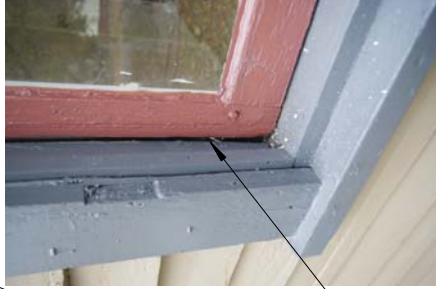
THE SASHES AND FRAMES HAVE DETERIORATED
ALLOWING LARGE GAPS AT ALL WINDOWS. THE
SASHES DO NOT FIT IN THE FRAME WHICH WERE
PREVIOUSLY MODIFIED

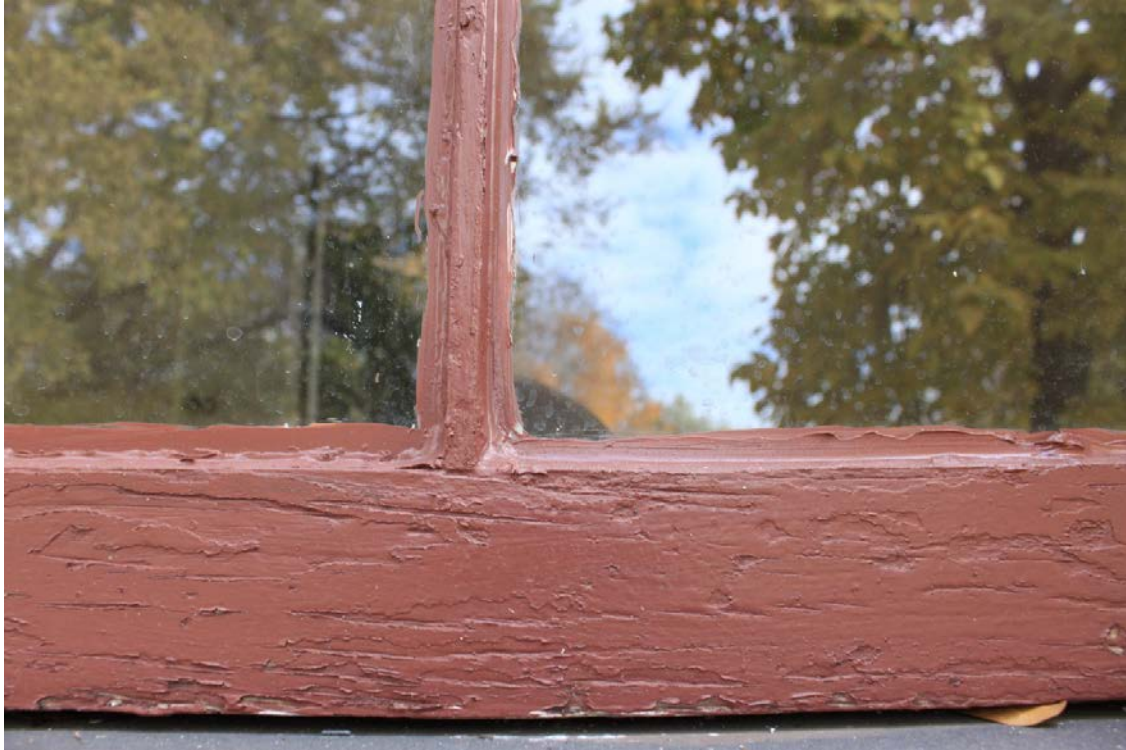
726 Deery – North side muntin close - up

-
2. The two windows on the north side of the house exhibit multiple layers of paint and caulking. There are some small gaps between the sashes and frames that may cause some degree of difficulty in operation.
 3. The windows do not exhibit signs of rot that are readily visible.
 4. The window in the front gable of the house is a replacement window.
 5. Staff finds the following facts from The "Windows" issue of the National Alliance for Preservation Commissions' Alliance Review, Jan-Feb. 2012:

Staff recommends utilizing storm windows over [properly repaired windows in order to gain more energy savings.
