CITY HISTORIC ZONING COMMISSION
STAFF REPORT - CERTIFICATE OF APPROPRIATENESS APPLICATION

MEETING DATE: 10/17/2013 ▶ FILE NO.: 10-H-13-HZ

ADDRESS OF PROPERTY: 609 Caswell St 37917

TYPE OF WORK: Level II. Replacement/repair

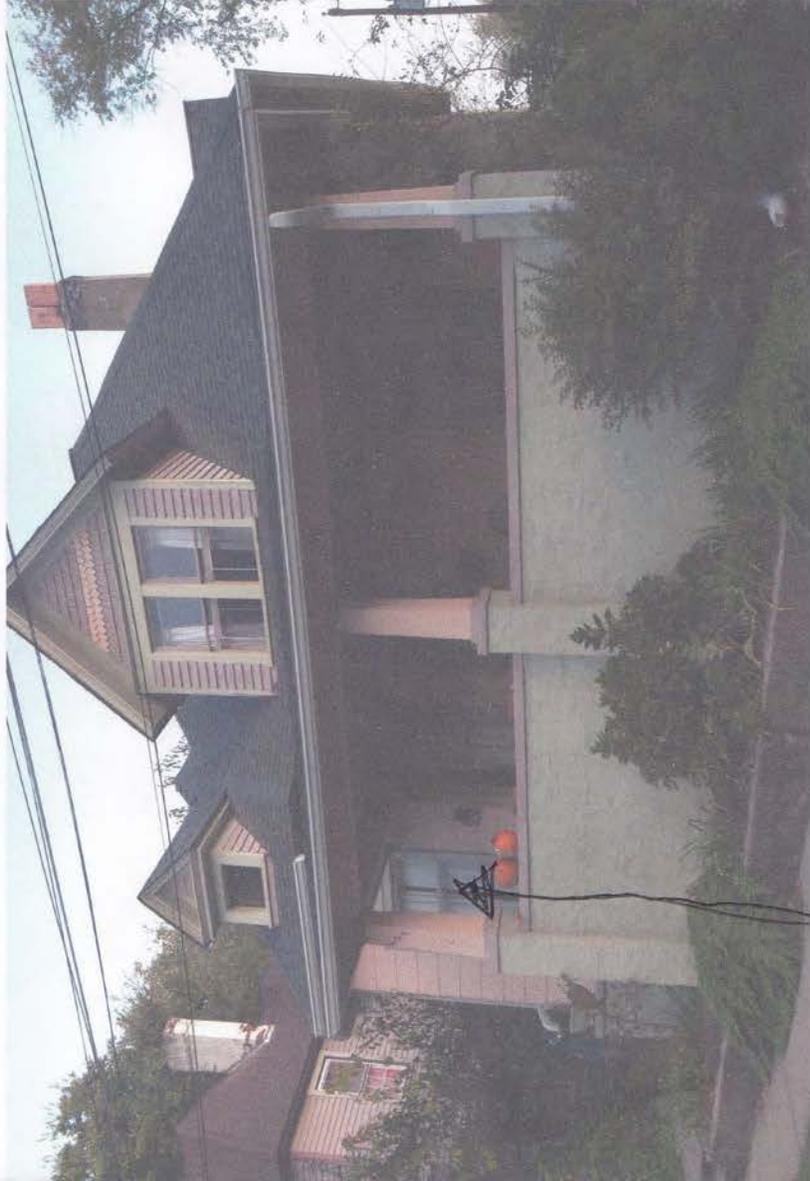
The bay enclosure on the front of the house has three windows that are in bad need of repair.

Bay where
windows are

The proposal is to do a sash replacement in all three. There is some deterioration to the sills but to preserve the integrity of the original size, thickness of the sill and original sill we submit to repair the frames and trim. The sash replace will be with the same glass configuration (except thermal pane) and similar routing style. We believe this will be the last intrusive repairs to the original windows.

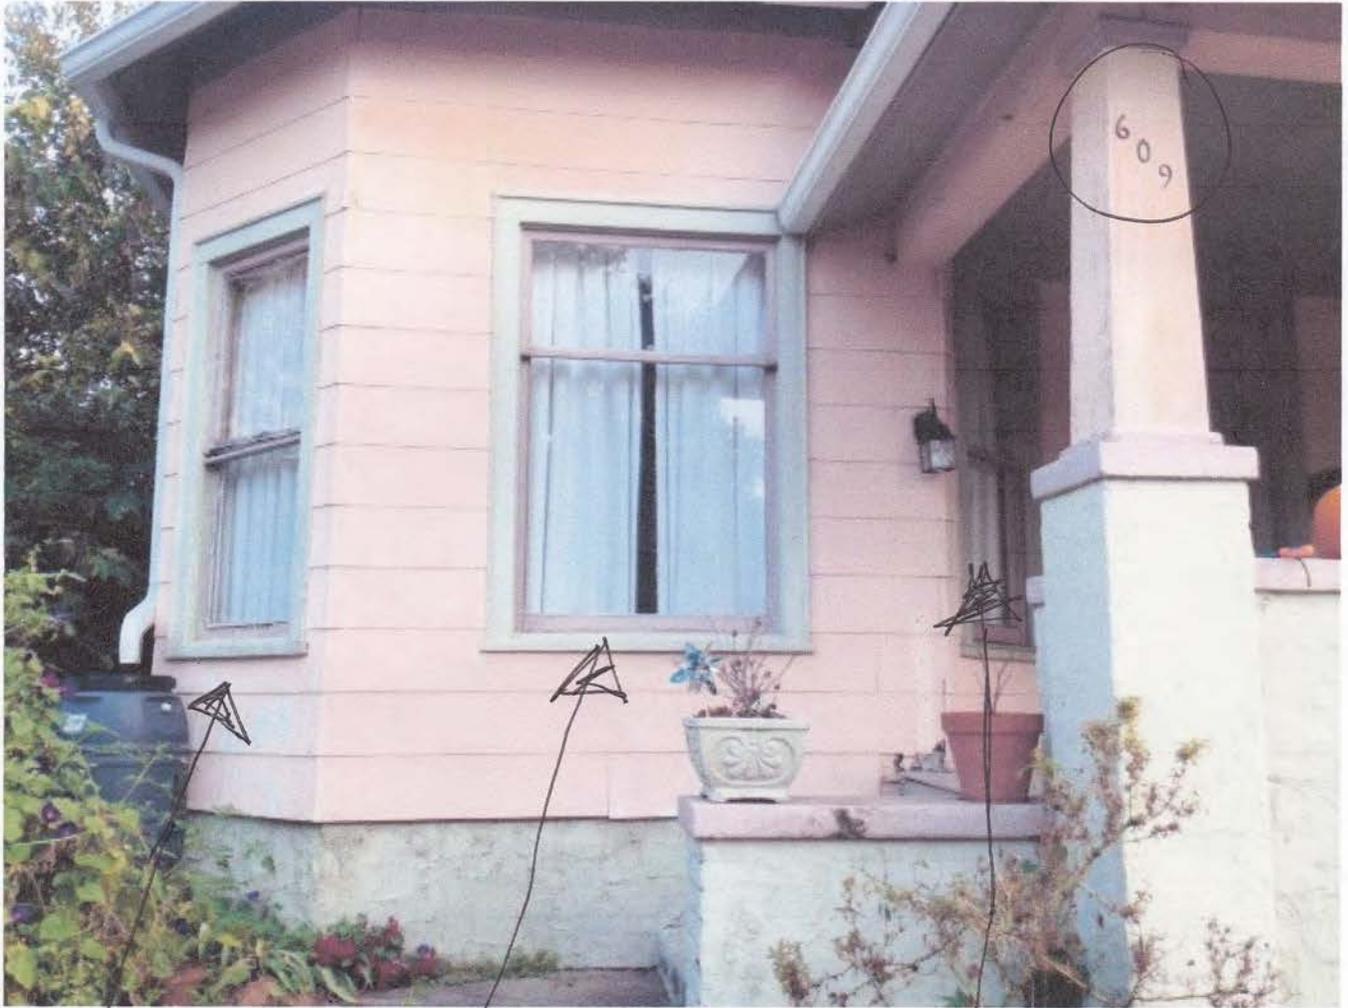
Front left View

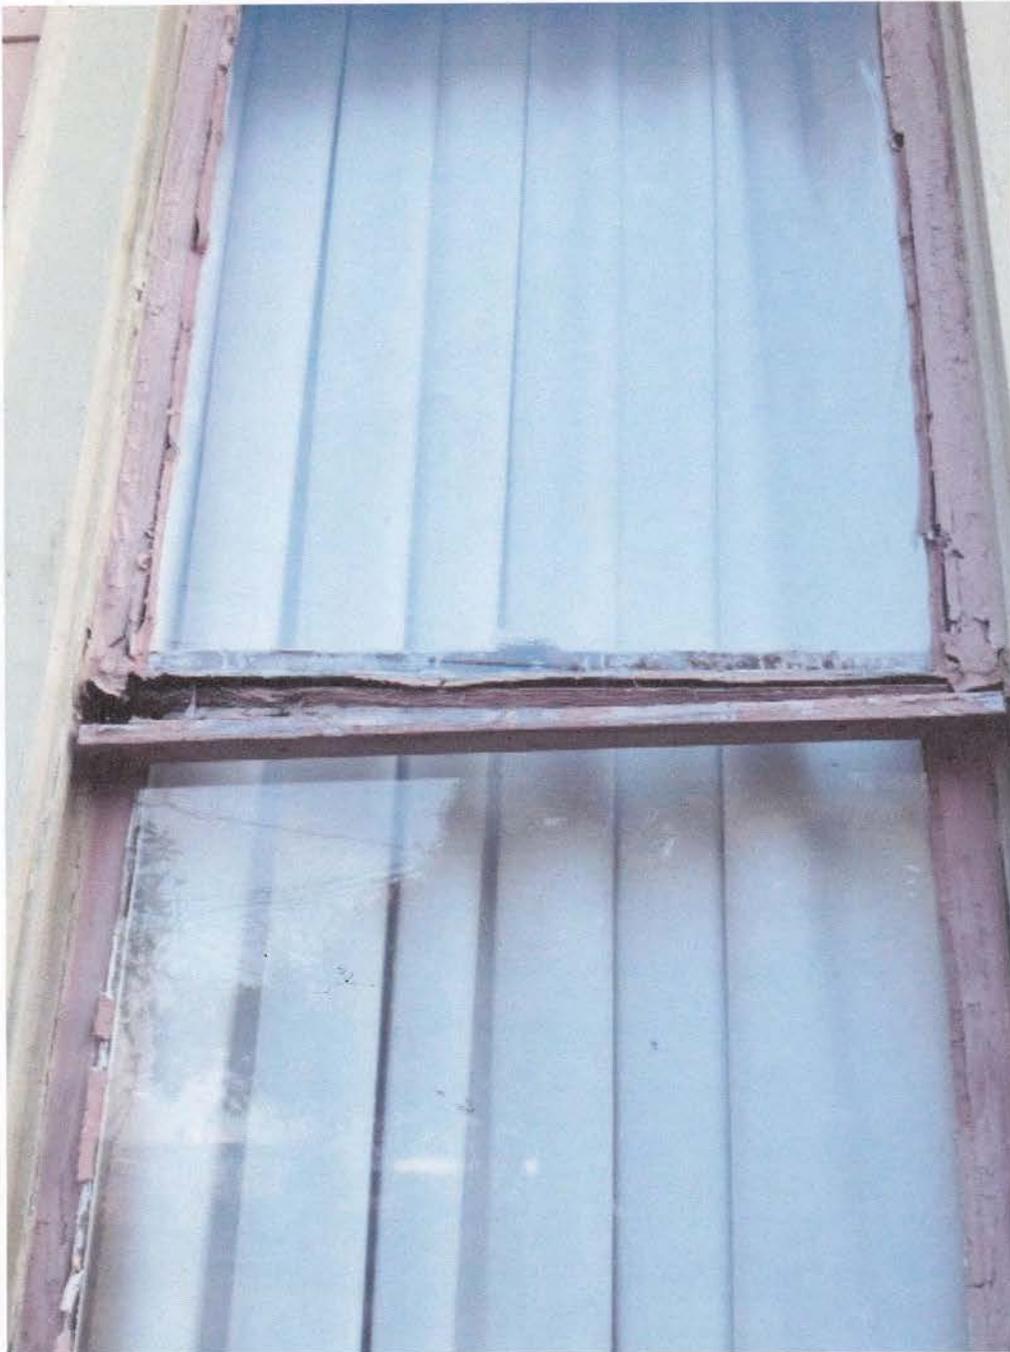
- 2) Some of the window sash members have disintegrated and are misshapen to the point that it is not feasible to repair them as shown in photo of window #1.

WINDOW # 1 Beyond Repair!

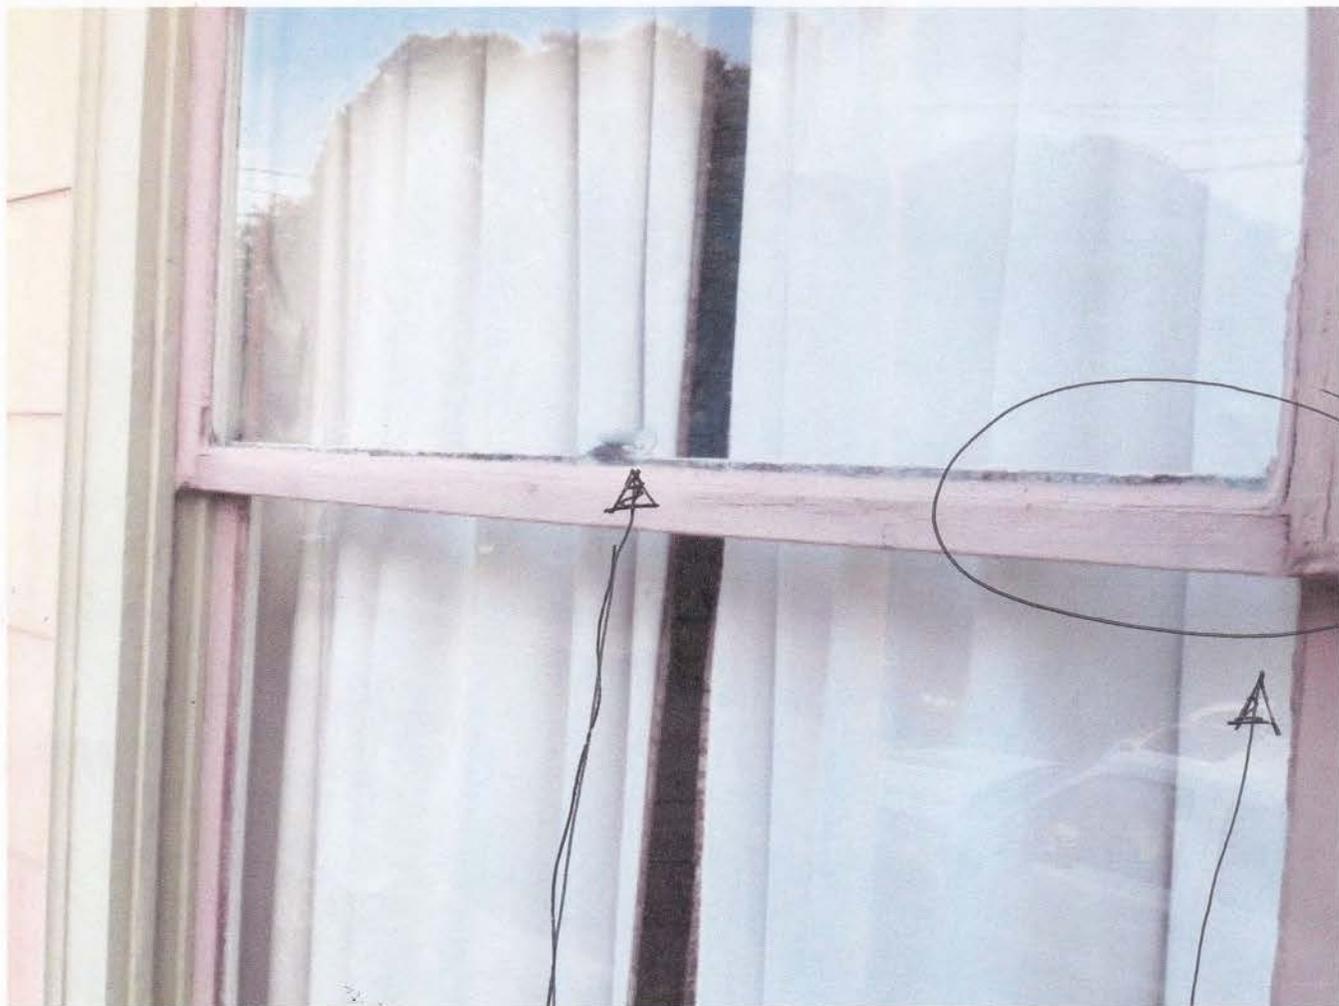
2

- 3) On window #2, the top rail of the bottom sash is not original and doesn't align with bottom of the top sash, as shown in photo
- 4) The middlewindow on the bay has a non-original board attached to the bottom of the top sash which doesn't allow it to line up with the bottom sash, close or lock correctly.

Damage

Sent from my iPhone Also; Top Rail of Bottom
SASH is NOT ORIGINAL & Doesn't
Align with Bottom of Top SASH.

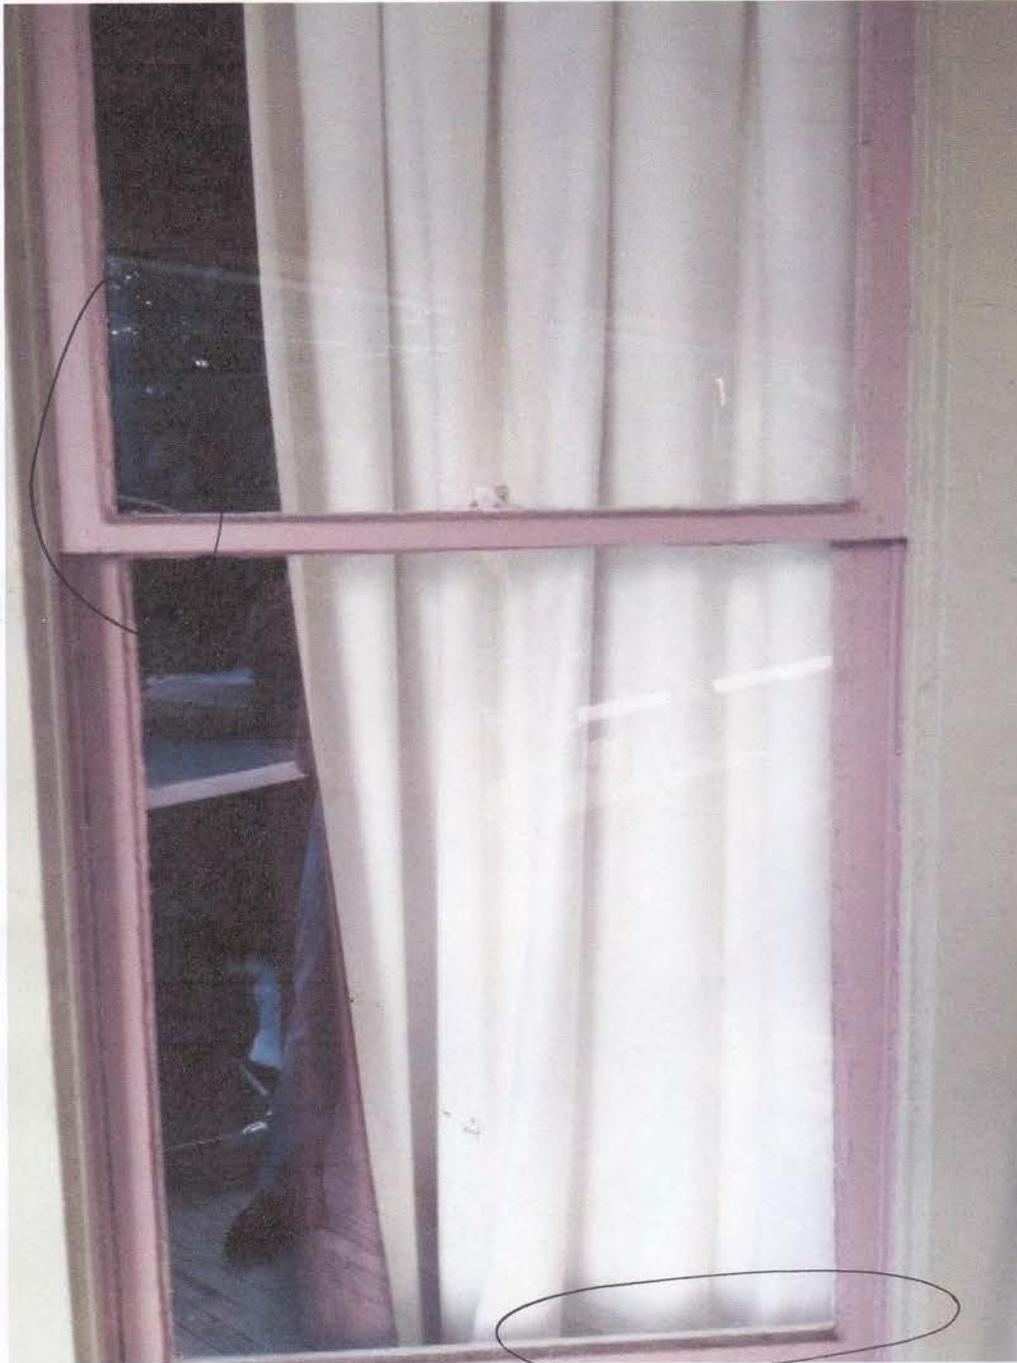
- 1) The three windows in front bay located on the front the left appear are deteriorated, but components can be repaired; however, they have been heavily puttied as shown in the photo of window #3 (the worst of the three). There is an effective process to remove putty from window frames which would allow re-use of the windows.

- 5) The right-hand window (#3) on the bay is not as deteriorated as the other two and the putty could be removed. However, the applicant states that although this window could be repaired, it would not match the other two which need to be replaced..

#3 Best of 3 window But Thiers of
Bay set. Some bad putty.
