**KNOXVILLE HISTORIC ZONING COMMISSION  
STAFF REPORT - CERTIFICATE OF APPROPRIATENESS APPLICATION**

**PROPERTY ADDRESS:** 1206 Washington Ave 37917  
**DISTRICT:** Old North Knoxville H-1

**FILE NO.:** 4-E-14-HZ

**MEETING DATE:** 4/17/2014  
**APPLICANT:** Helen and Andrew Bryenton (owners)  
**LEVEL OF WORK:** Level II. Major repair or replacement of materials or architectural elements

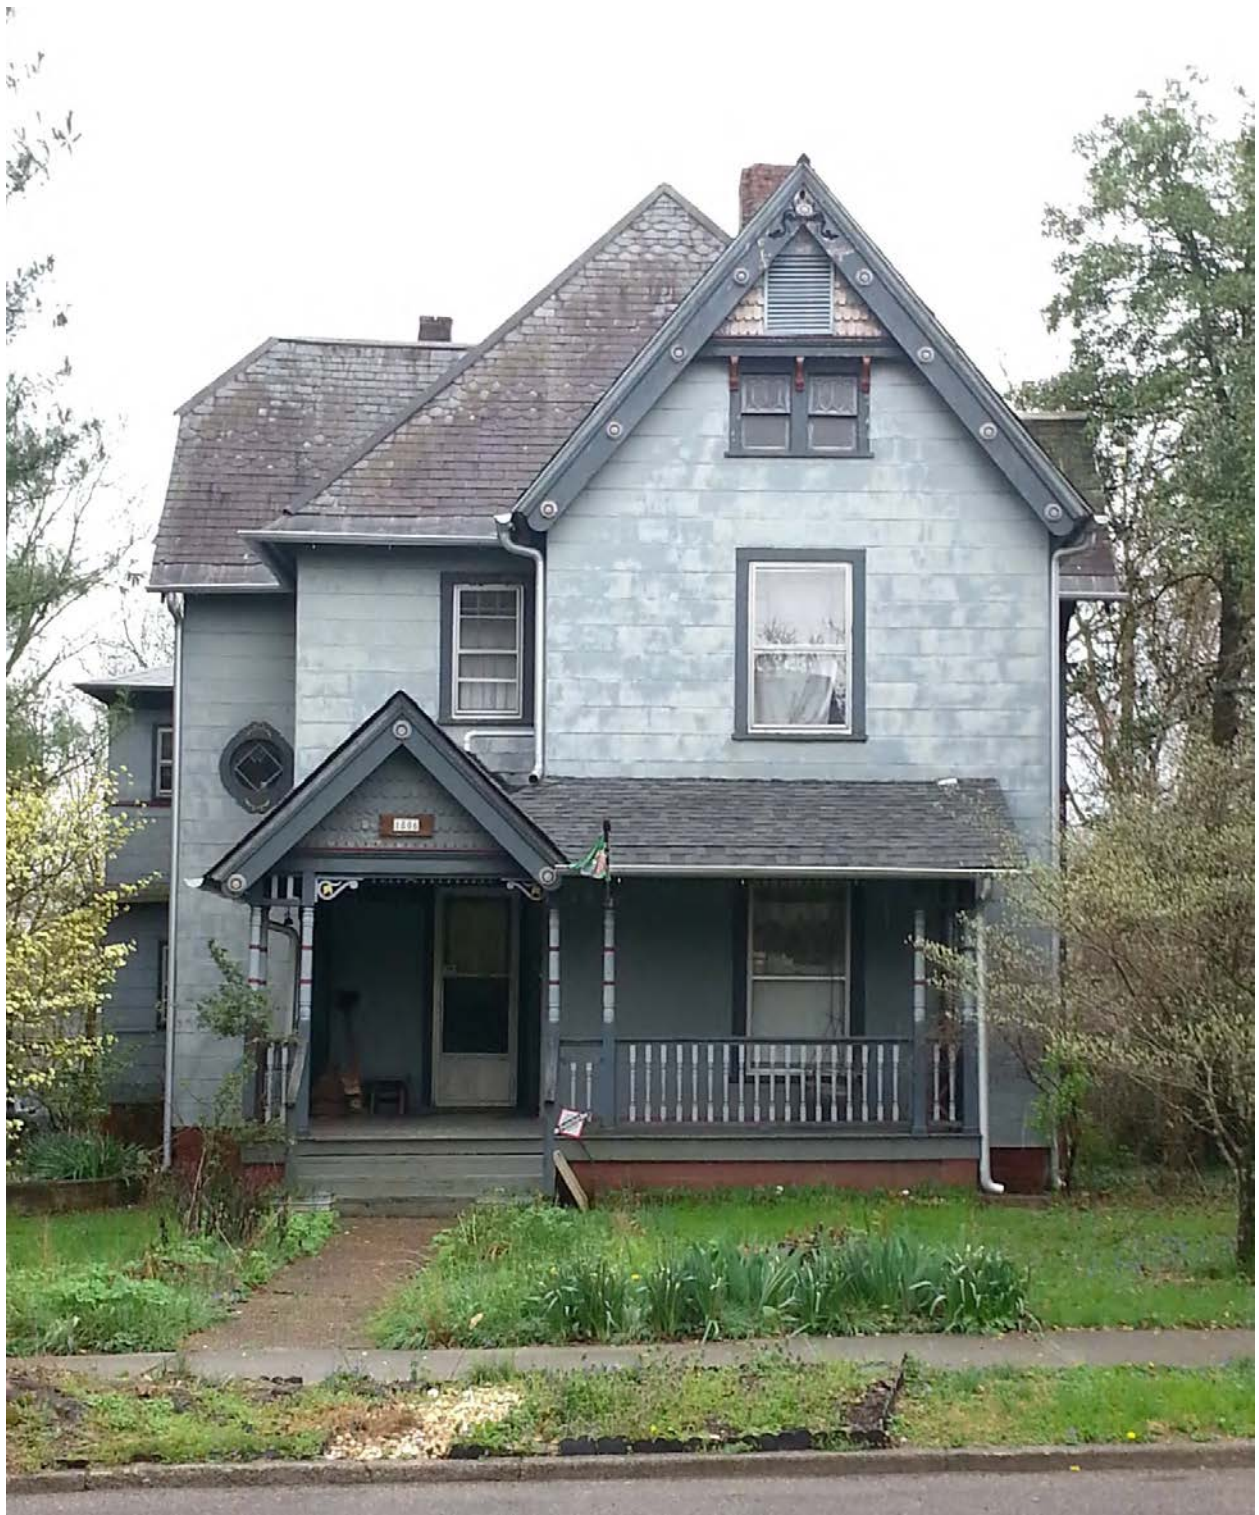
1806 Washington - Street view

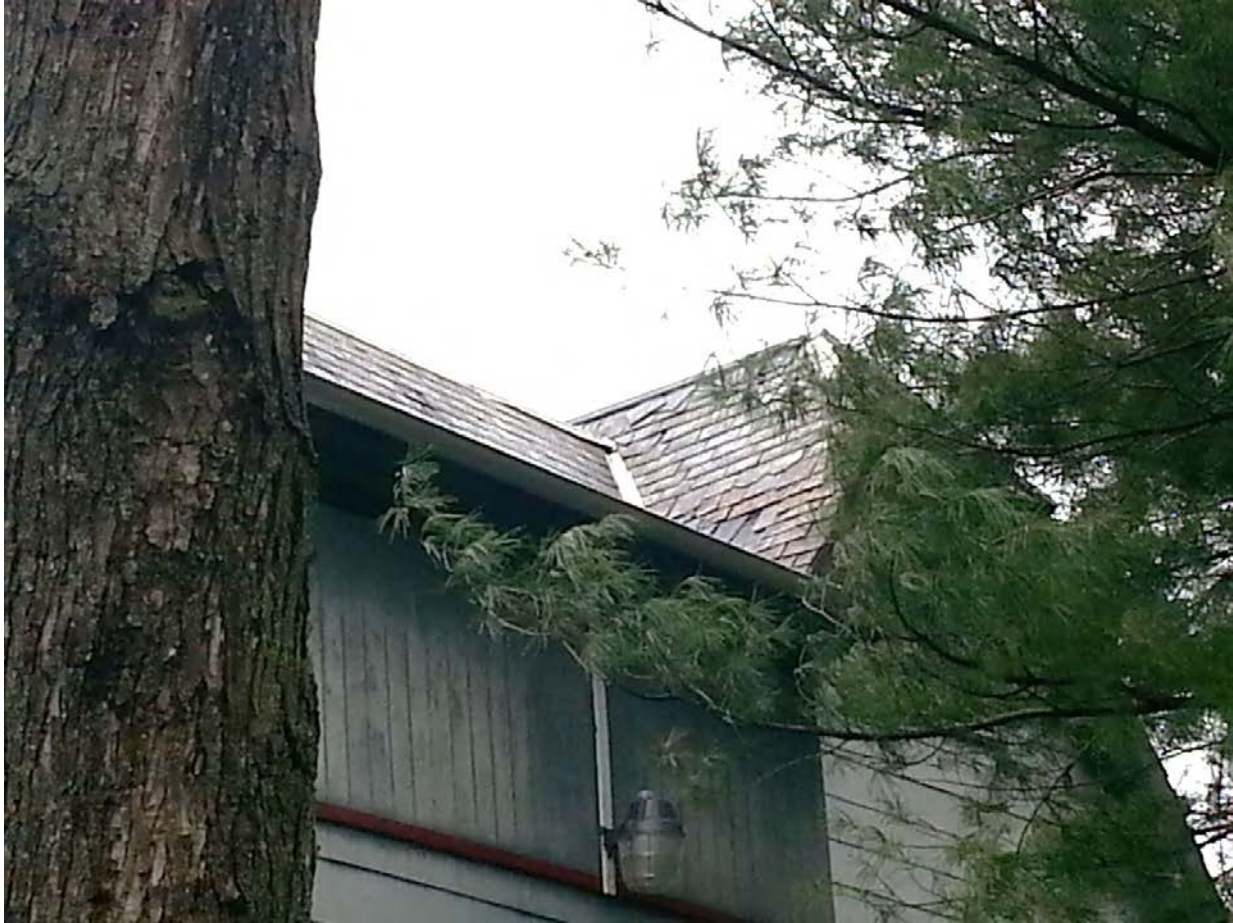
1806 Washington - East gable from alley

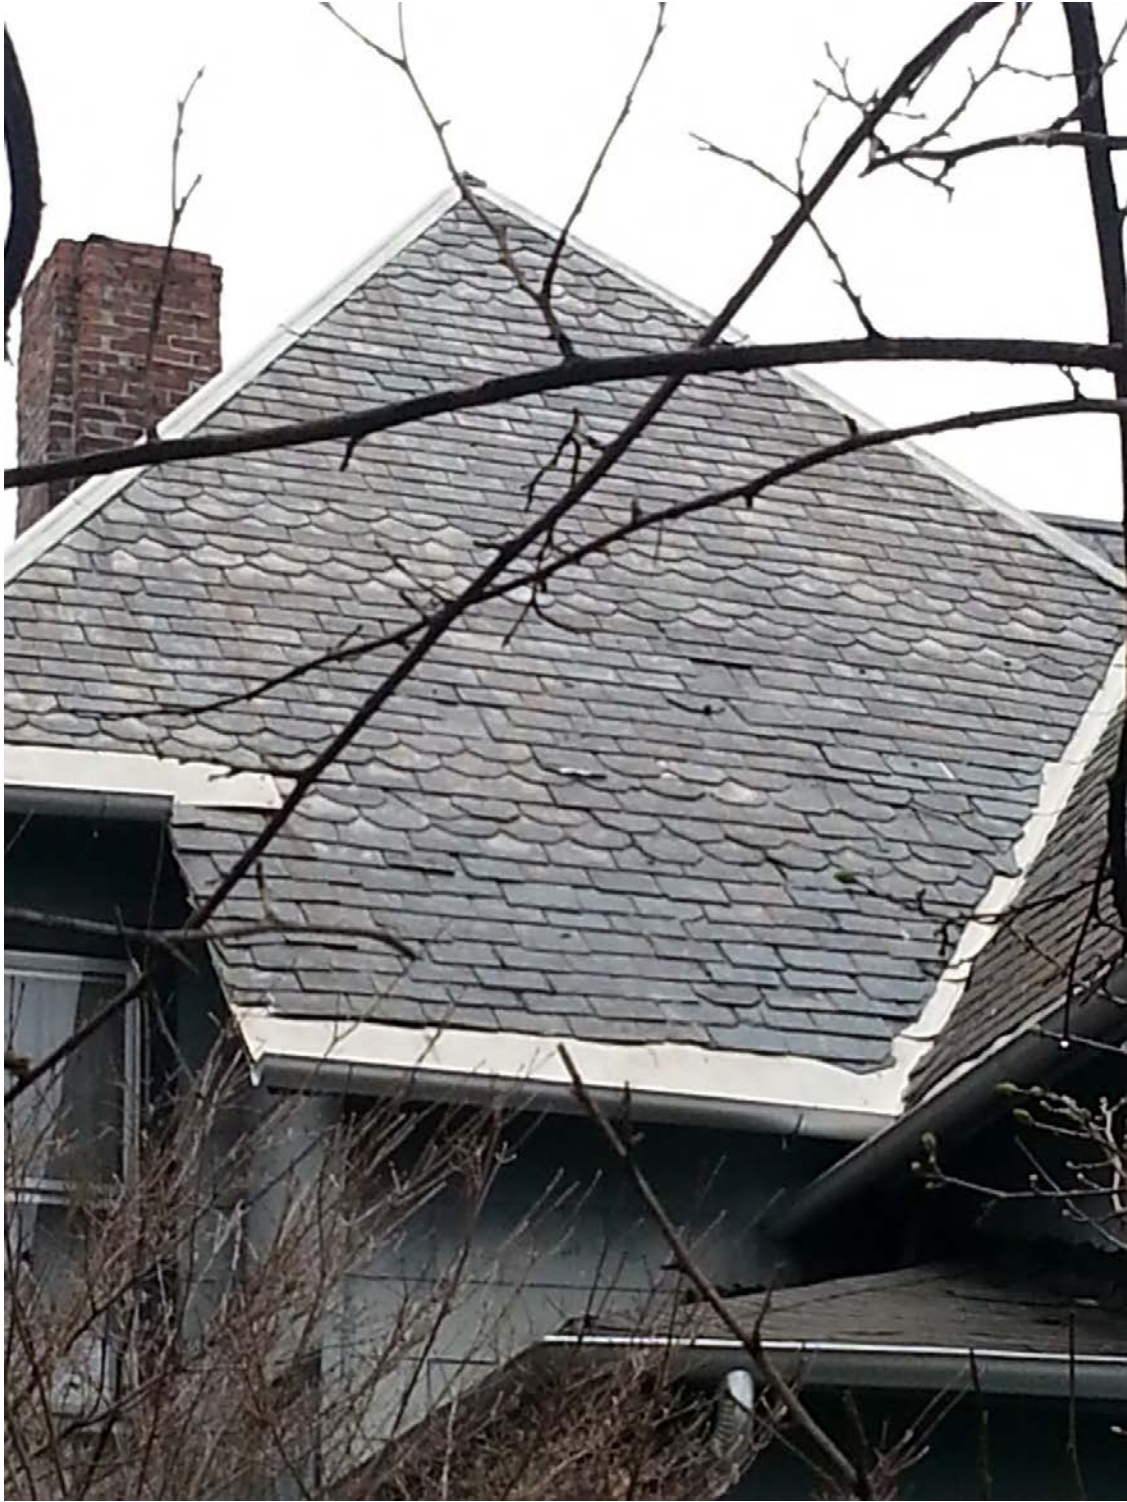
- 2.) The roof is original, and thus 115 or 122 years old and at the end of its functional life.
- 3.) According to the applicant's insurance claims adjuster, the roof damage is too old to be due to the hailstorms of 2011 or 2012; therefore, the deterioration is due to weathering with age.

1806 Washington - Rear, from alley, showing missing slates

Approval to replace deteriorated original slate roof shingles on main roof of house with Owings Corning TruDefinition Duration asphalt shingles with color of "Estate Gray."

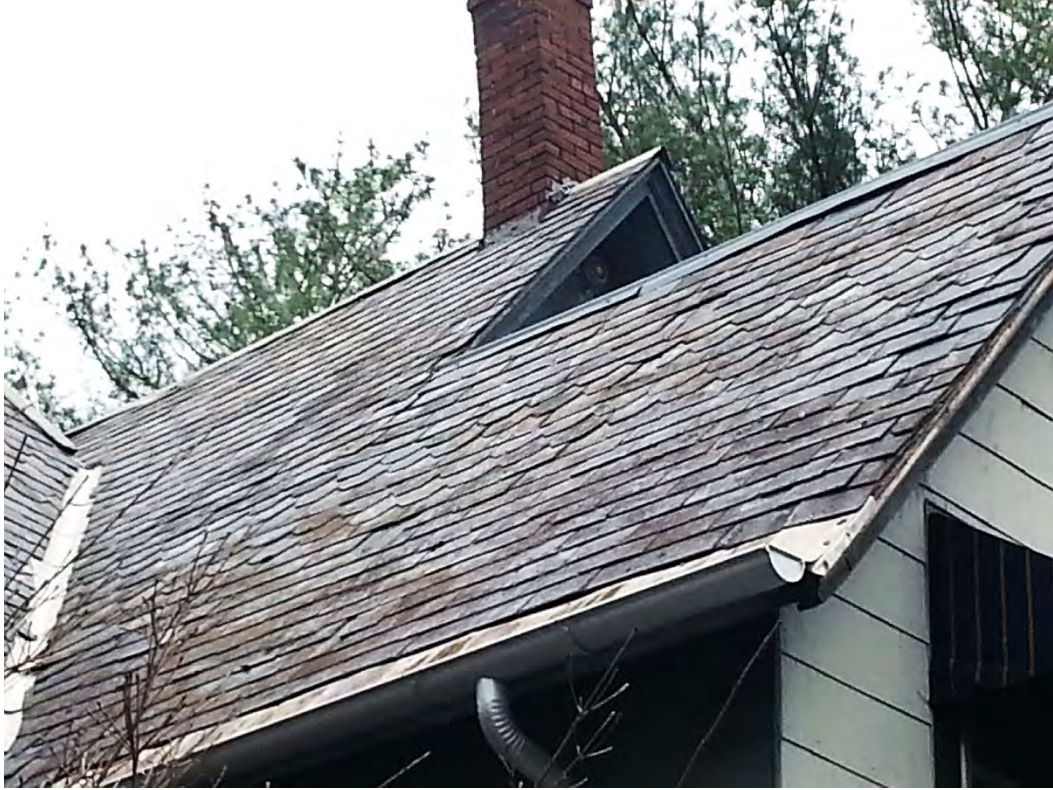
1806 Washington - Rear-close-up

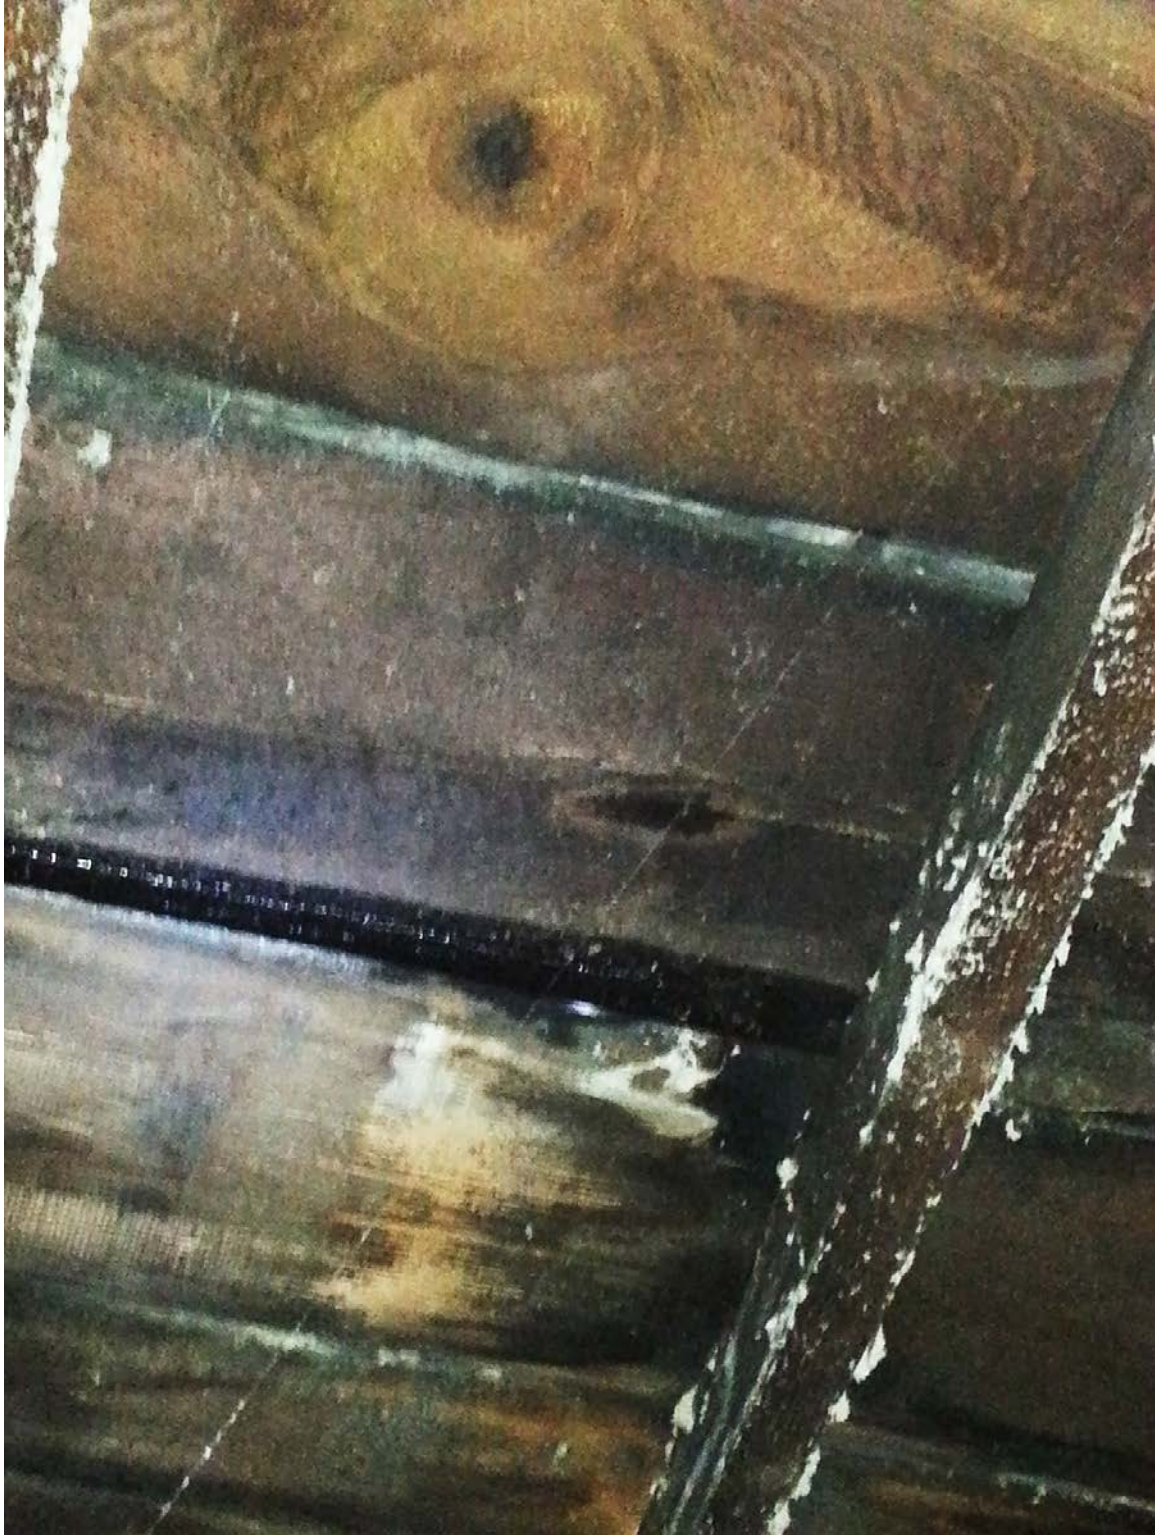
- 4.) Based on the water damage shown in the submitted photos, the roof is leaking.
- 5.) According to staff's as well as the applicant's survey, there is evidence within the district of an evolution over the years of shingled roofs from to slate, as the slate has deteriorated due to lack of periodic repair or simply itage, and has become very expensive to replace.

1806 Washington - Rain dripping through wood underlayment
