**KNOXVILLE HISTORIC ZONING COMMISSION  
STAFF REPORT - CERTIFICATE OF APPROPRIATENESS APPLICATION**

**PROPERTY ADDRESS:** 609 Caswell St 37917

**FILE NO.:** 6-C-14-HZ

**DISTRICT:** Fourth and Gill H-1

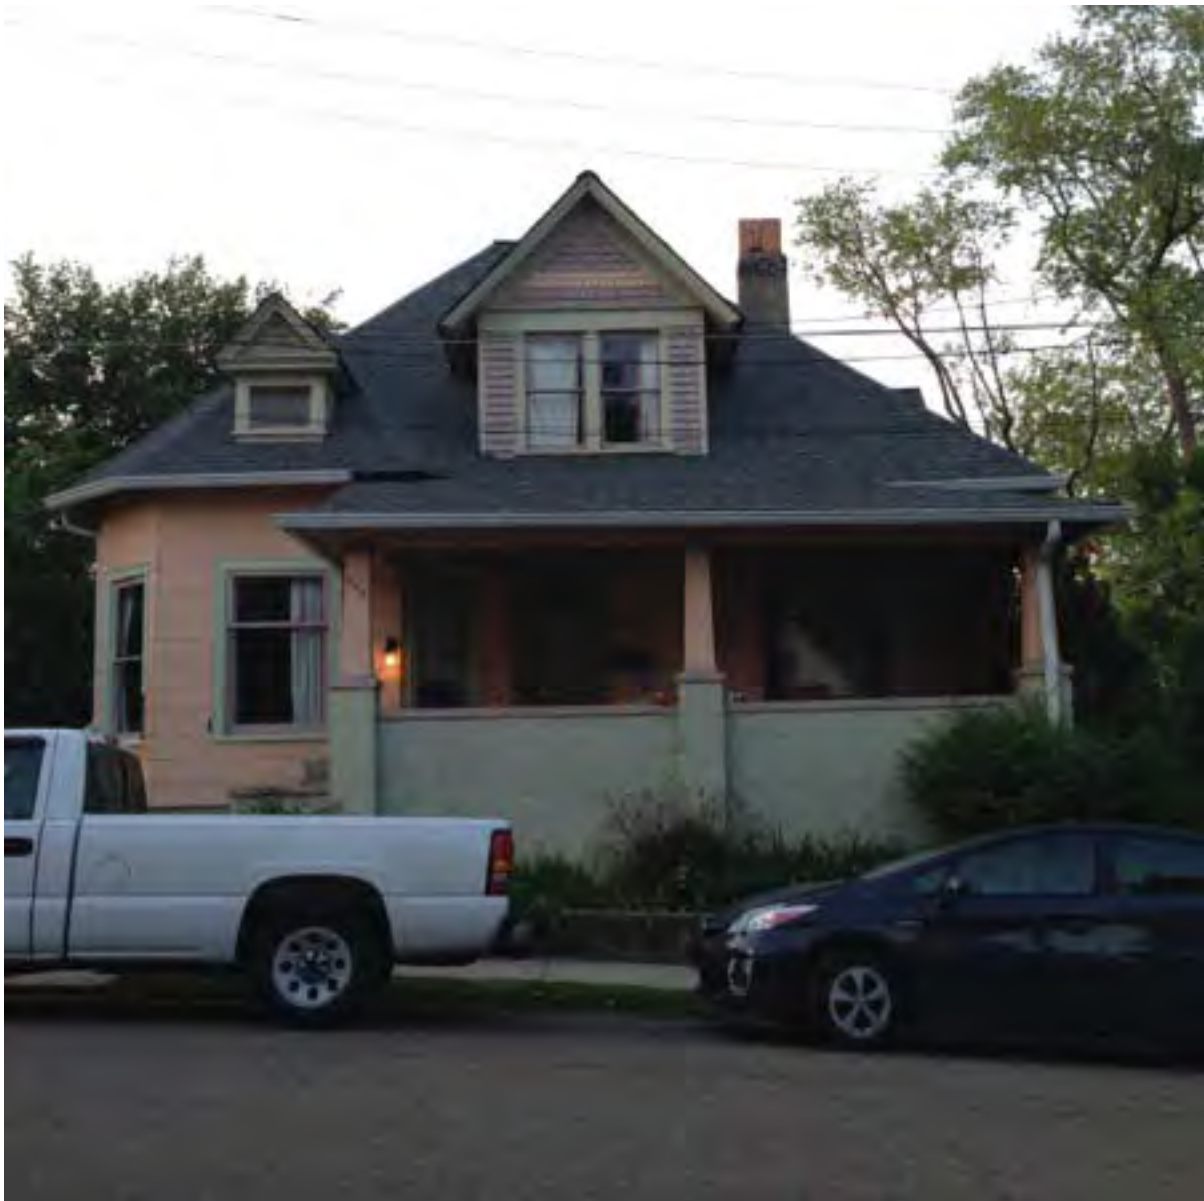
*609 Caswell Ave, current front view.*

- 6) The proposed removal of the solid masonry balustrade will break up a tall expanse of stucco foundation, which currently causes the house to stand out as an anomaly among streetscapes where the porches are more at street-level and pedestrian-scaled.

**Front Porch\*:** Lower foundation wall of porch to floor level and add wood columns, balusters and rails as seen in attached photos. 609 Caswell Ave was built in approximately 1895 and the existing porch was added in 1920. We would like to open up the front facade and break up the large expanse of stucco foundation, giving the house a more traditionally Victorian look.

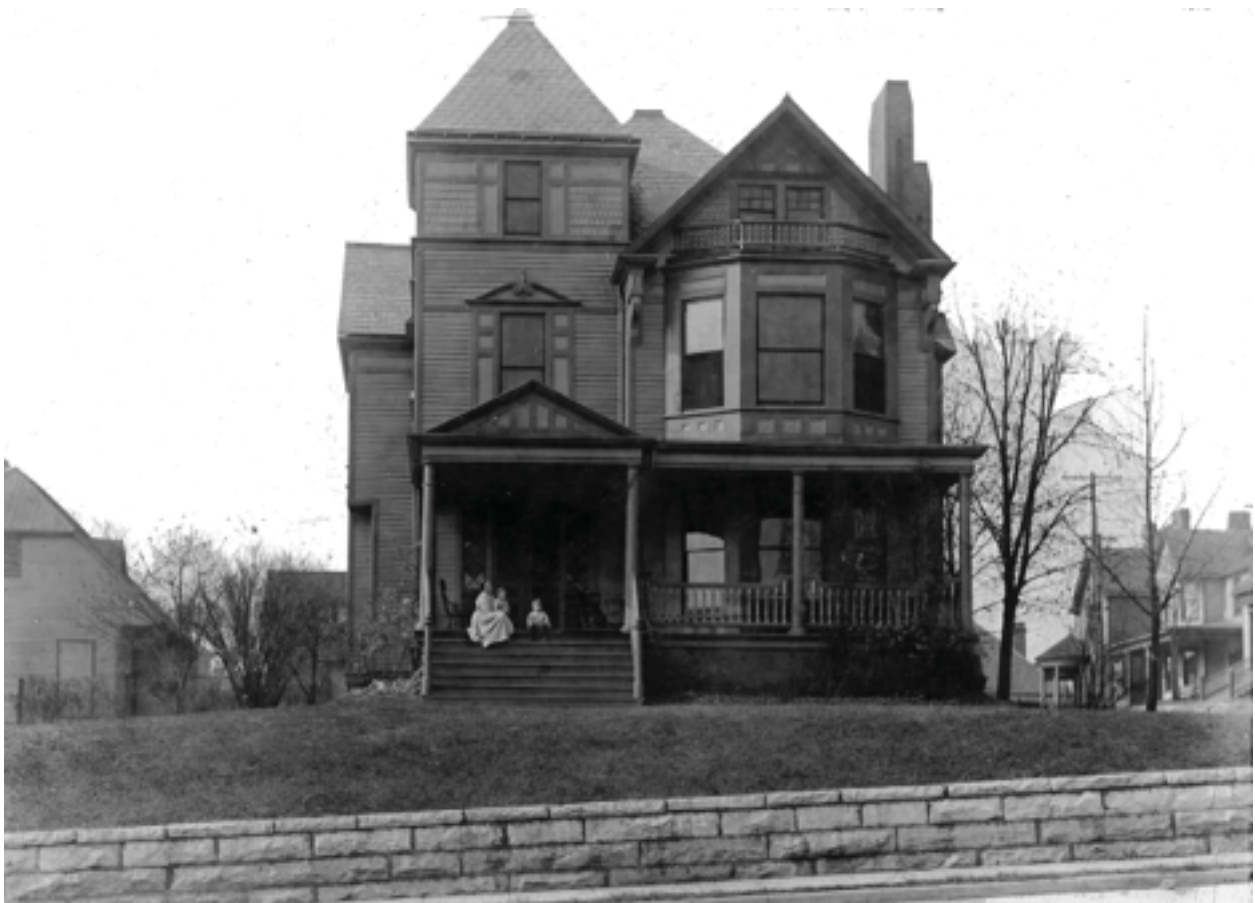
- 4) Some photo-documentation exists to indicate that the stairs leading up to the original porch, had a turned or square-picket balustrade.
- 5) The brick pier porch column supports shown in Option 2 would continue to convey the stylistic evolution of the porch from the Victorian to the Craftsman style. Simple square 2x2 balusters would be less conjectural than the turned balusters shown on the submitted drawings and would be compatible with the Craftsman-style square brick piers.

In this photo of 1041 Luttrell, we believe we can see the original porch stairs and rails of 609 Caswell- they can be seen on the far right side of the photo.

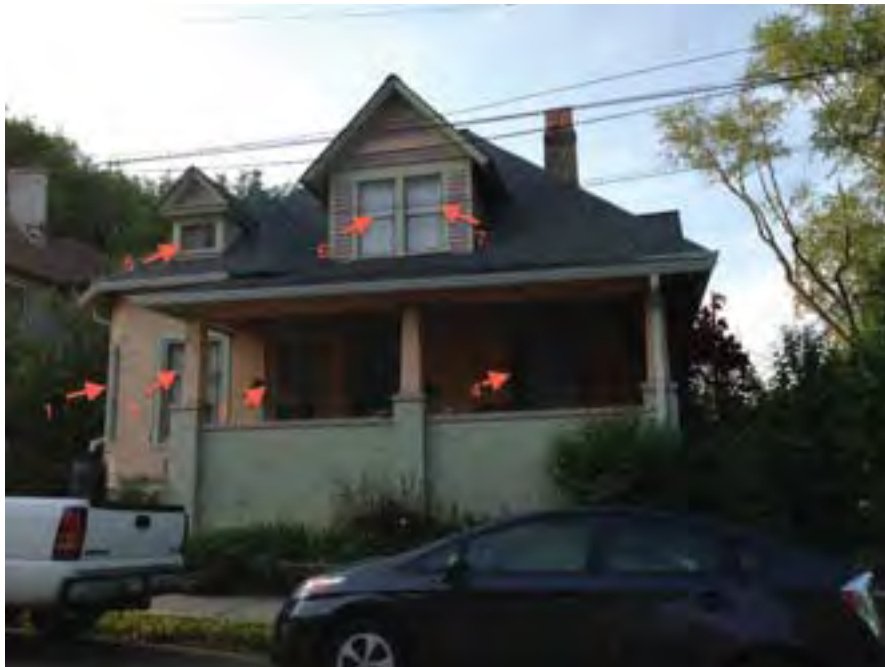
Front Cottage Window, replaced in November 2013. JeldWen brand, Auralast pine frames, LowE 366 glass. (COA File No. 10-H-13-HZC). The same style and brand will be used for any sashes replaced in this renovation.

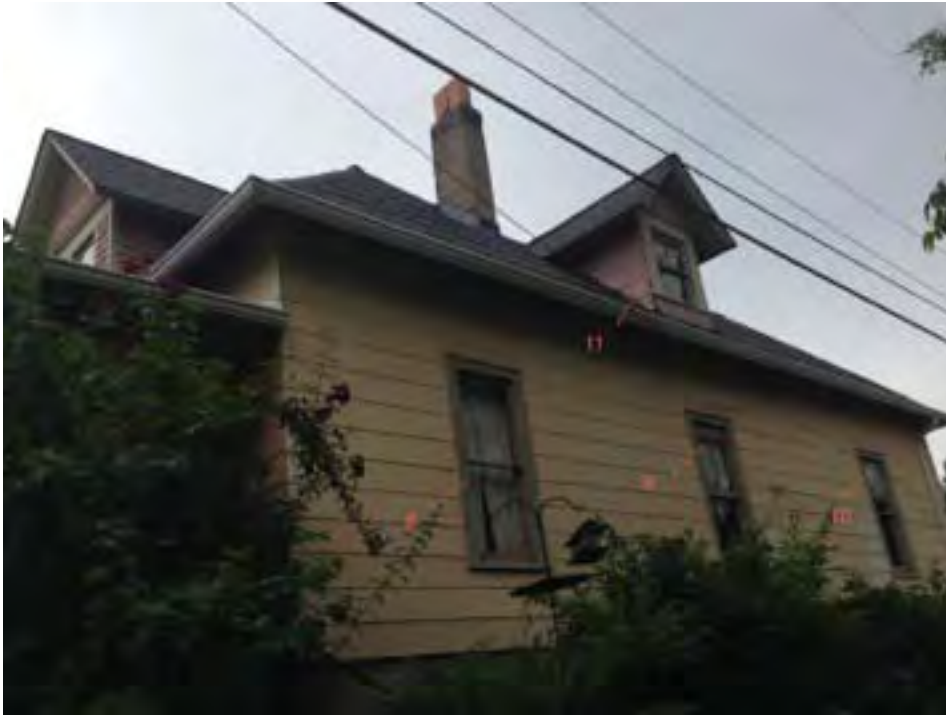
Windows 1-3: replaced fall 2013.

Window 4: Replace sash to match windows 1-3; bad putty and glass damage

Window 5: Leave existing- unique shape

Window 6 & 7: Replace sashes, non functioning, rot, not well fit, match to lower level windows on side of house (1-over-1 evenly spaced)

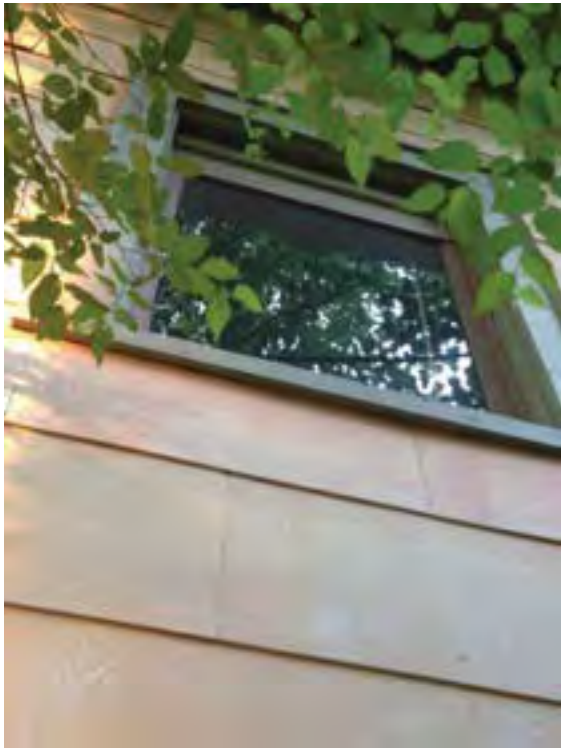
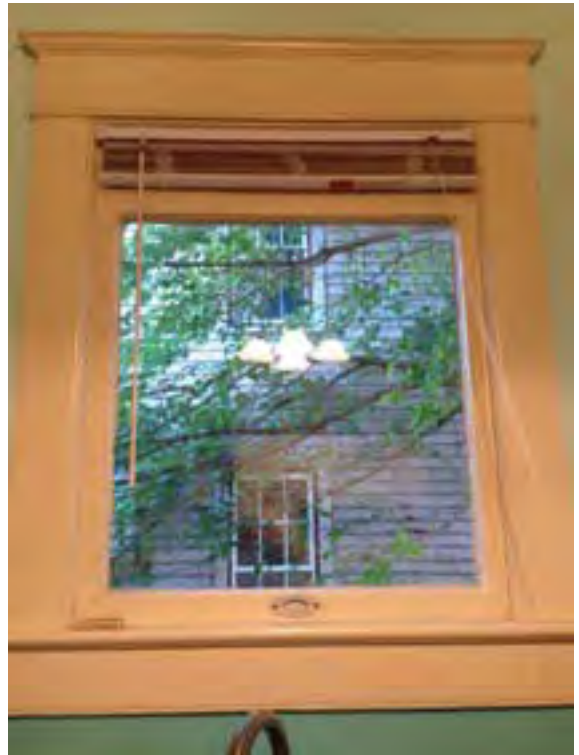
North side (rear)

Window 12-13: rot, non functioning

Window 14 & 15: See level I application
