**KNOXVILLE HISTORIC ZONING COMMISSION  
STAFF REPORT - CERTIFICATE OF APPROPRIATENESS APPLICATION**

**PROPERTY ADDRESS:** 708 Morgan Ave 37917

**FILE NO.:** 5-E-15-HZ

**DISTRICT:** Fourth and Gill H-1

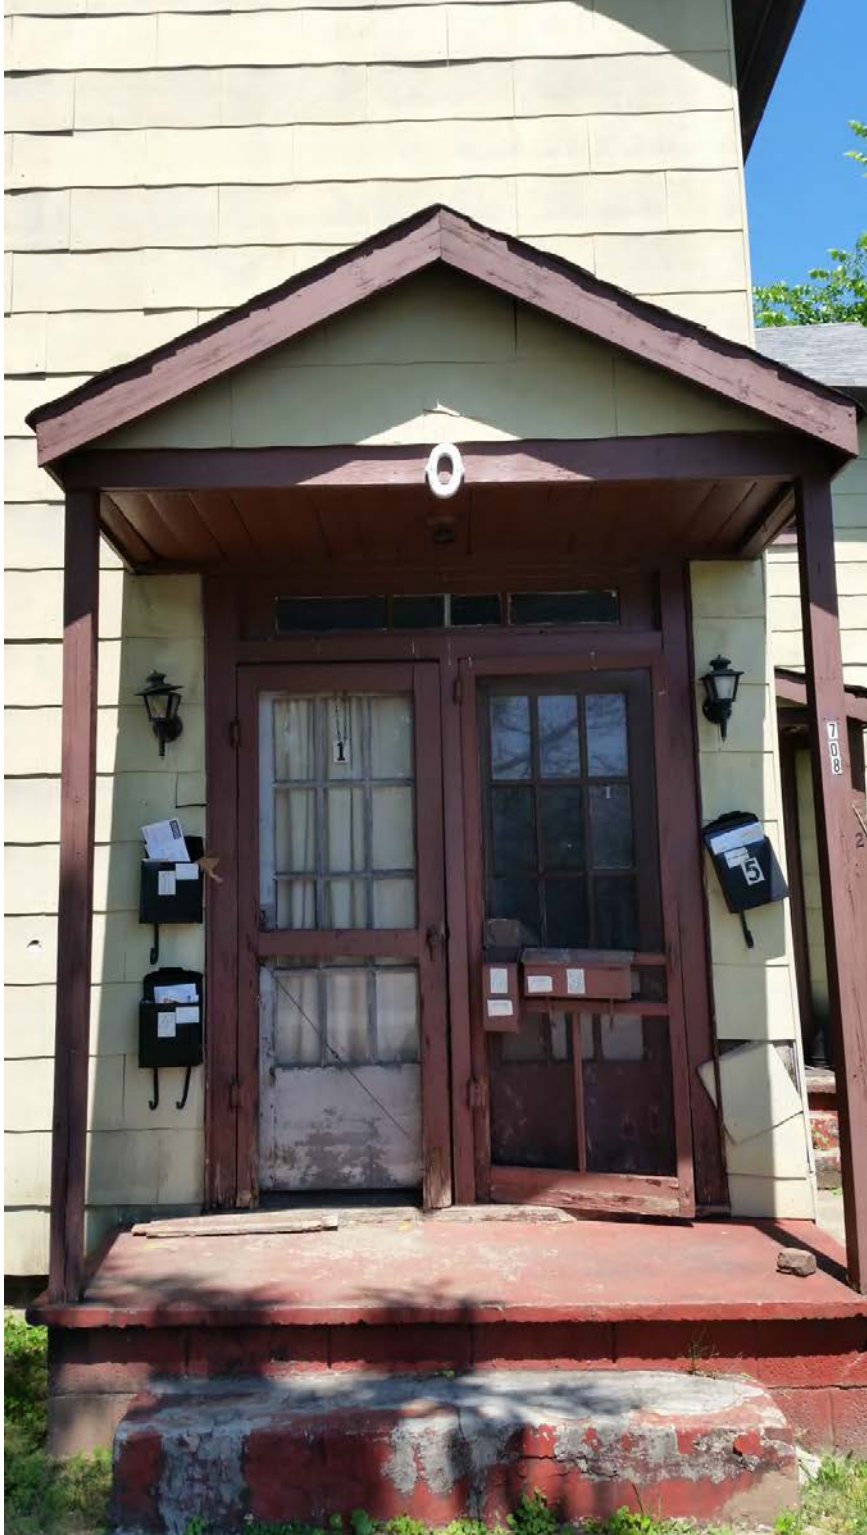
2) The double-entry door is likely not original since other houses of this type did not have them, but the double french doors are early and other styles of doors would not be appropriate as a double-leafed front door.

708 Morgan - Non-original French door front entry with pedimented stoop

Replace/rebuild existing fire-escape steps on west side with balusters that butt into top and bottom rail. Handrail grip to be molded to meet building code. Repair the early screen and entry door on the rear rather than replace them. Repair double front entry doors rather than replace them or replace with salvaged similar french doors. If window opening to be uncovered requires a replacement window, it is to be a double-hung wood window with pane configuration and size to match existing window on second level.

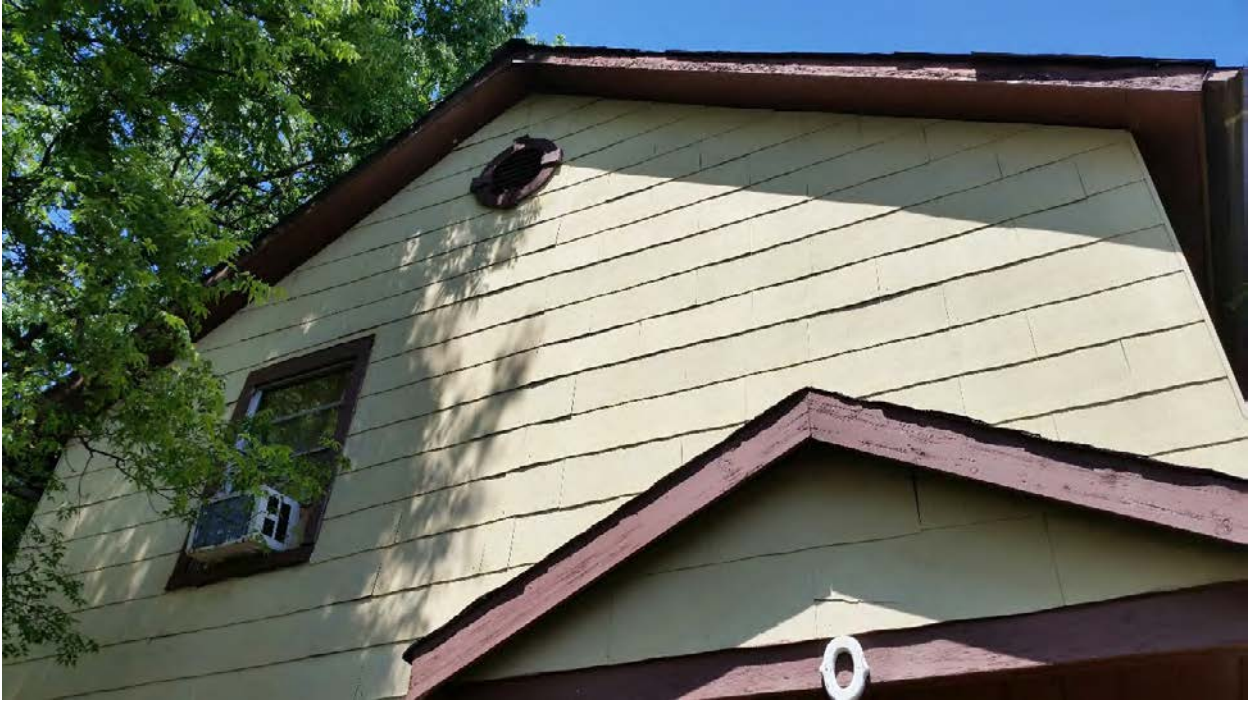
1) It is likely that a window opening existed above the entry door since other houses of this type do not have windowless walls above the entry door.

708 Morgan - Front second level showing covered window

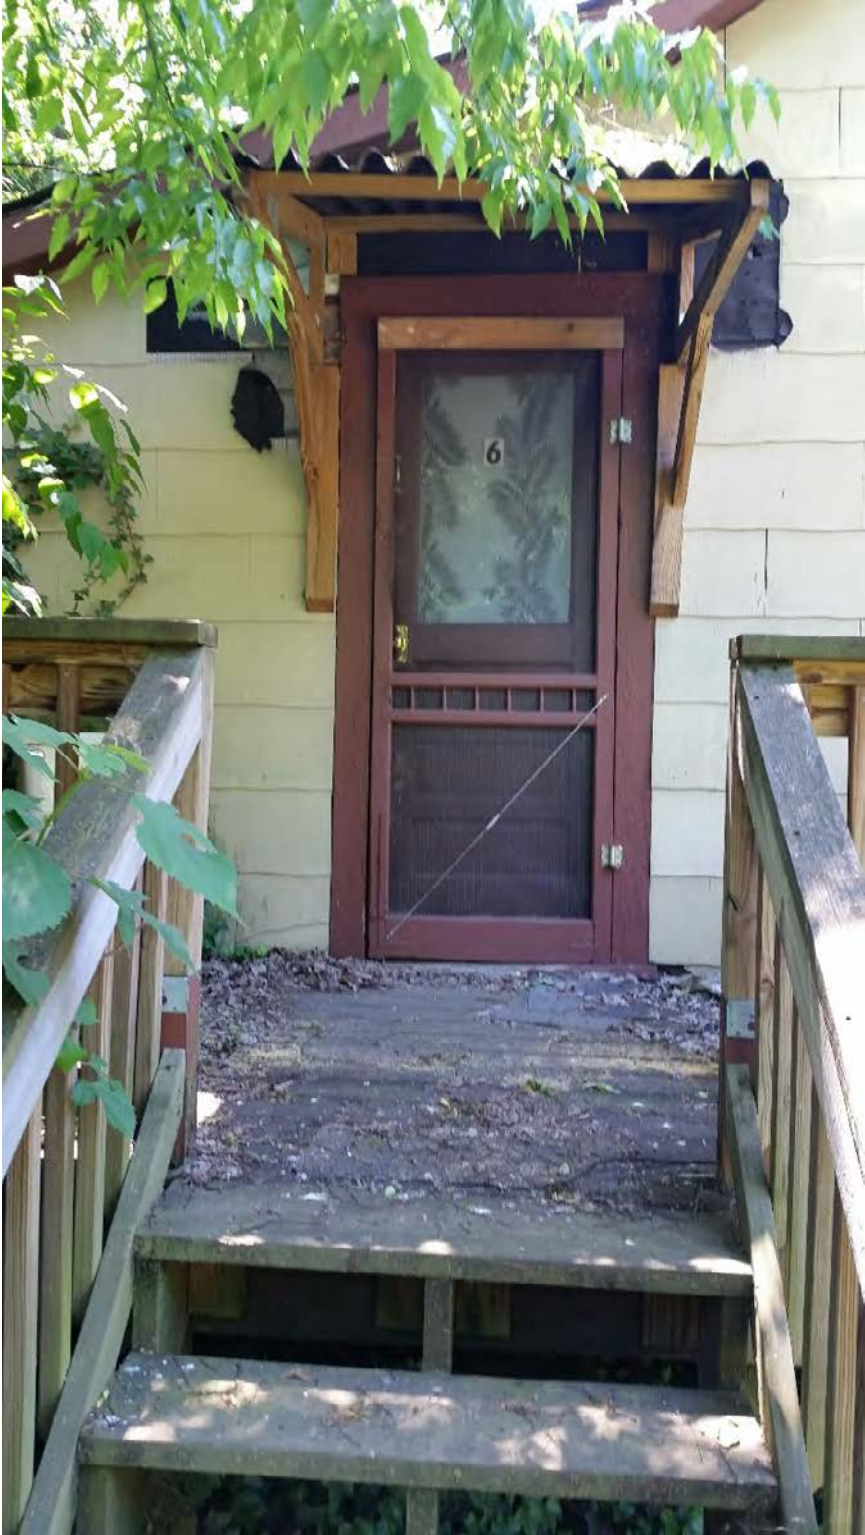
3) The back door and screen are early or original.

708 Morgan - Back door and stoop

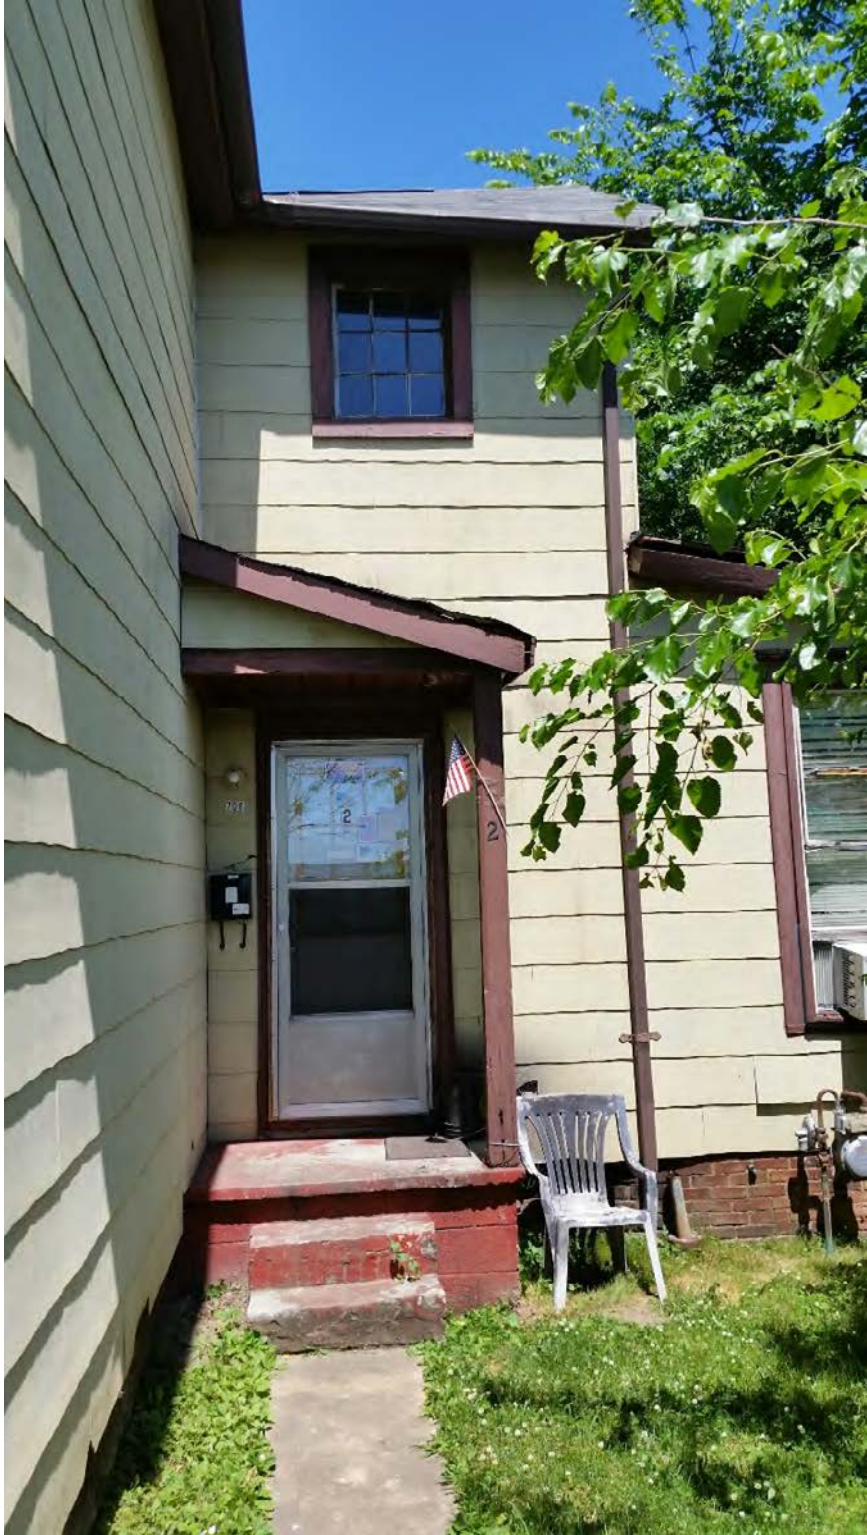
4) The door to the side apartment addition is late added. A half-light wood door would be more appropriate for this style and era of house.

708 Morgan - Apartment entry

Fiberglass or wood replacement door proposed for door to side apartment, to be painted.

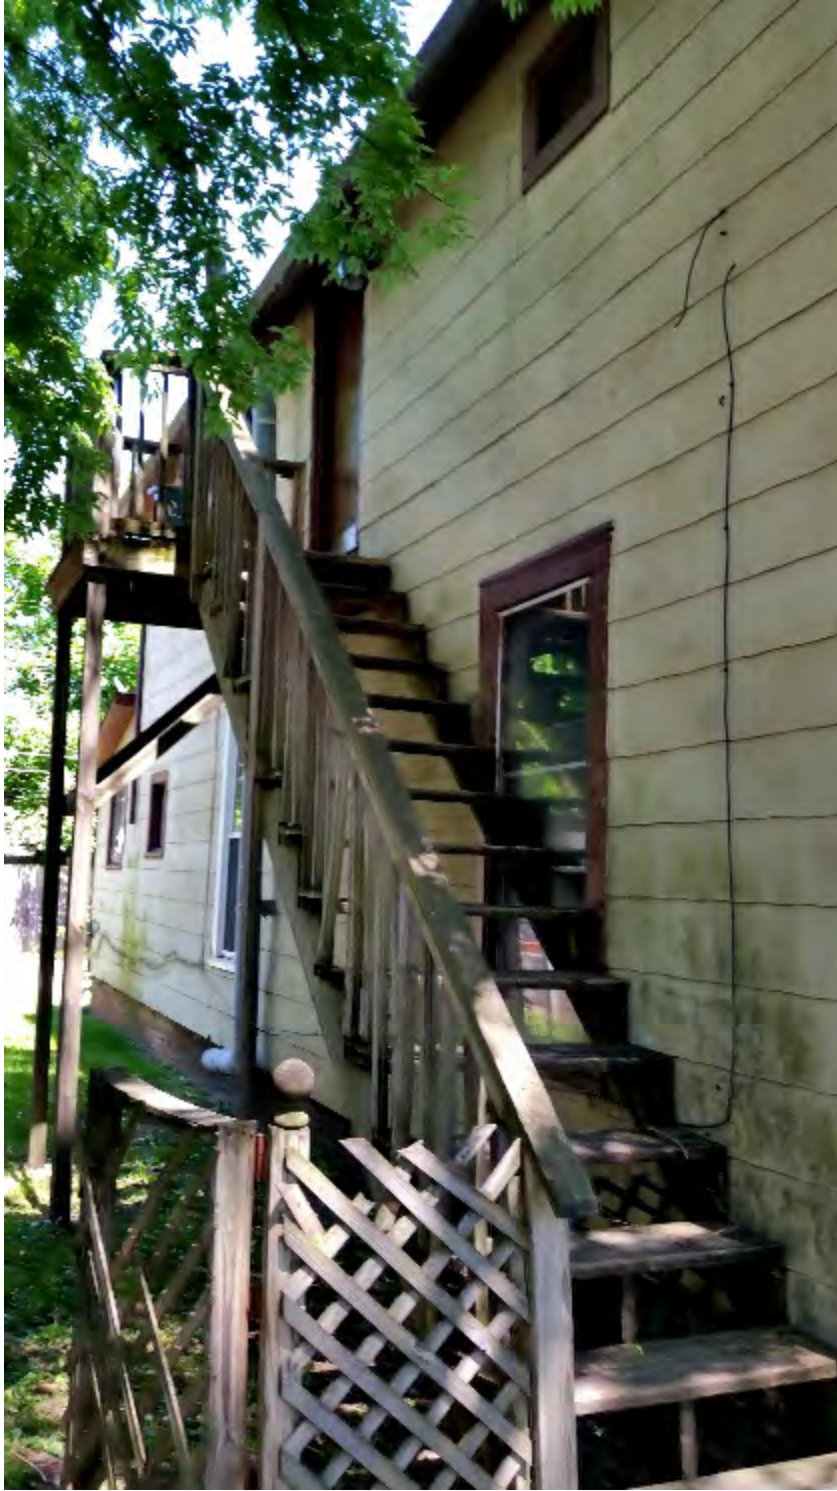
5) The existing fire-escape stairs are obtrusive leading up from the front of the house. The existing stairs do not meet building code and will need to be reconstructed. Re-orienting the stairs to lead up from the back of the house would less their obtrusiveness.

708 Morgan – Fire steps on NW side to be rebuilt

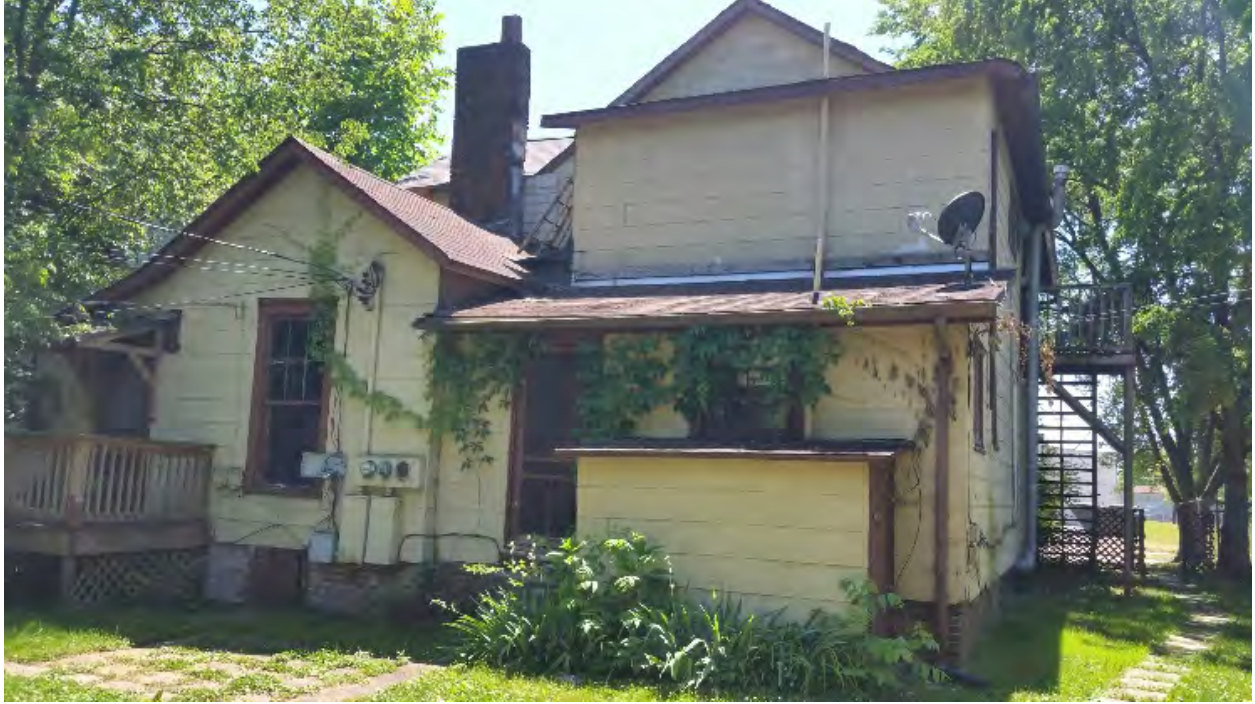
708n Morgan - Rear of house showing room for relocating fire stairs

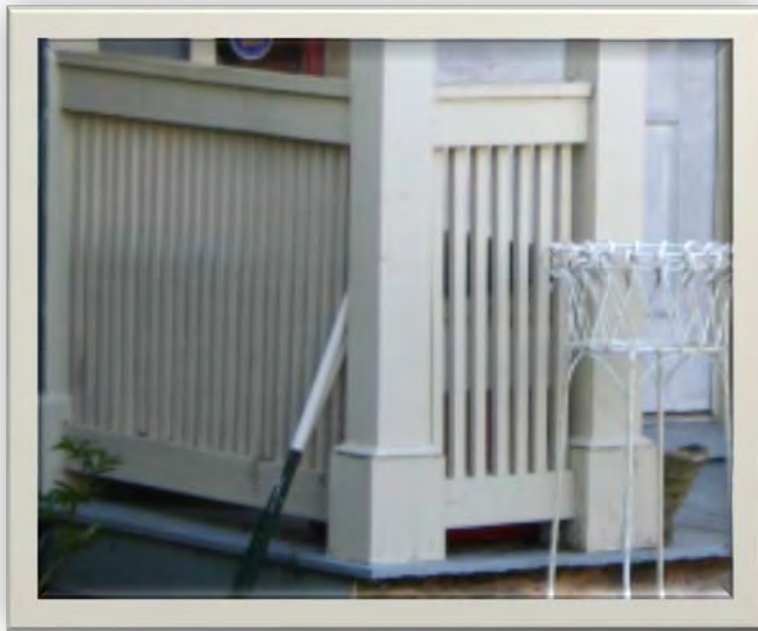
6) The front porch is not original and the posts are not proportionate. The 5-inch square posts with base would be more appropriate for the current style of porch.

Type of porch post base proposed for 708 Morgan – 5 inches with canted top
