**KNOXVILLE HISTORIC ZONING COMMISSION
STAFF REPORT - CERTIFICATE OF APPROPRIATENESS APPLICATION**

PROPERTY ADDRESS: 300 E Oklahoma Ave 37917

FILE NO.: 5-J-15-HZ

DISTRICT: Old North Knoxville H-1

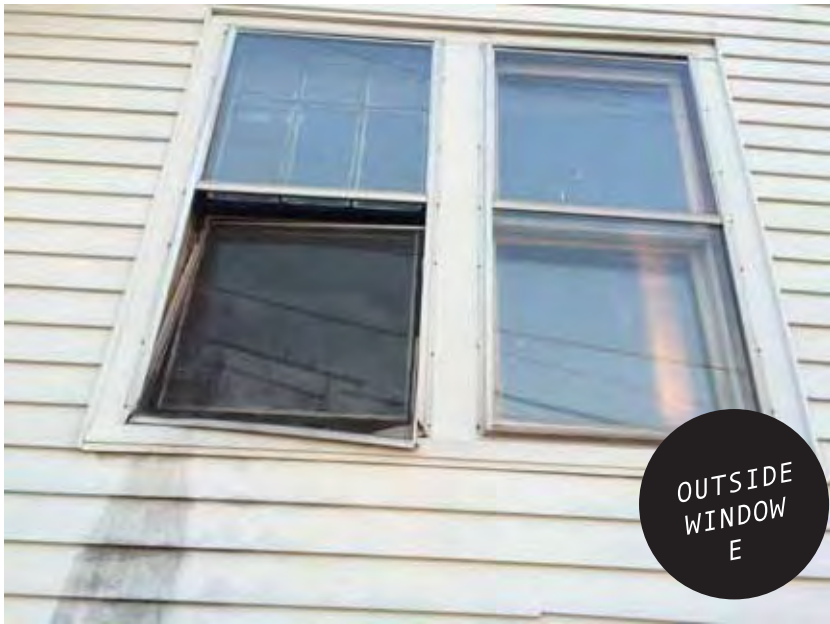
OUTSIDE WINDOW E

- 1) The rear and southwest sides of the house have had several inappropriate modifications to windows and doors in pre-H-1 years.
- 2) Window E on the southwest side is not original as indicated by hardware and window surround. The window C proposed to be relocated from the rear to replace it is the appropriate type.

- Install backdoor in location where **Window A** was removed. Backdoor will be made of wood and will match front door with same window pattern
 - Move **Window C** from South wall to rehab/replace **Window E** facing West towards Cornelia Ave. **Window E** is not original but will be after this is completed

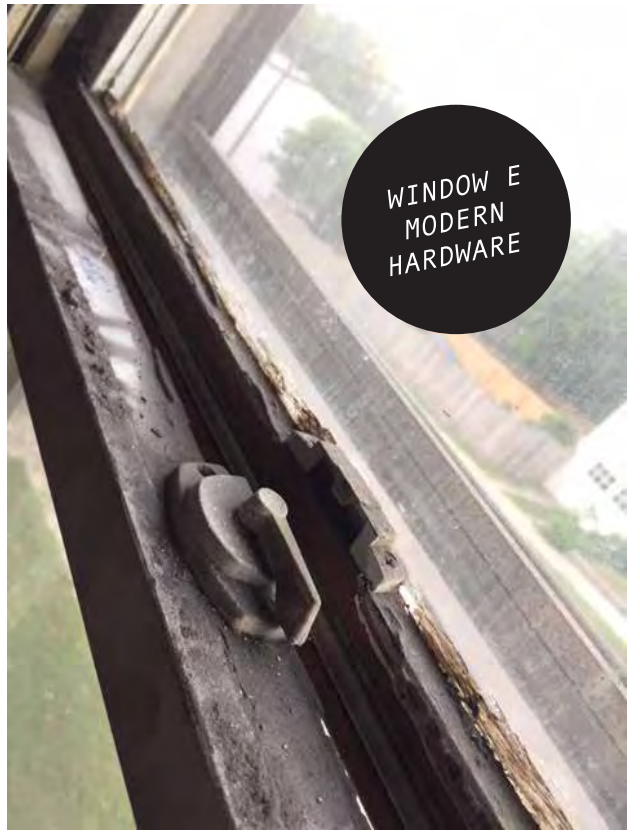
WINDOW E MODERN HARDWARE

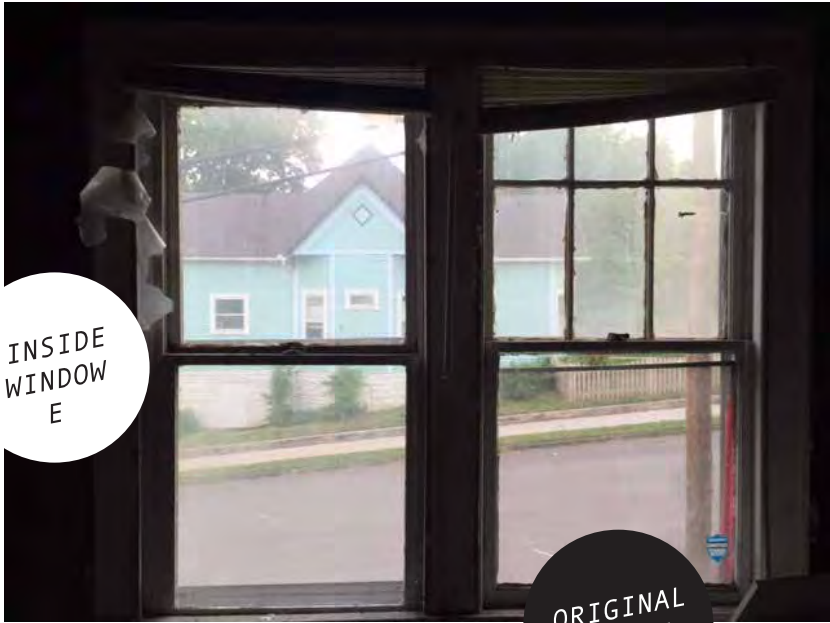
INSIDE WINDOW E

WINDOW E
NON-ORIGINAL
NON-HISTORIC

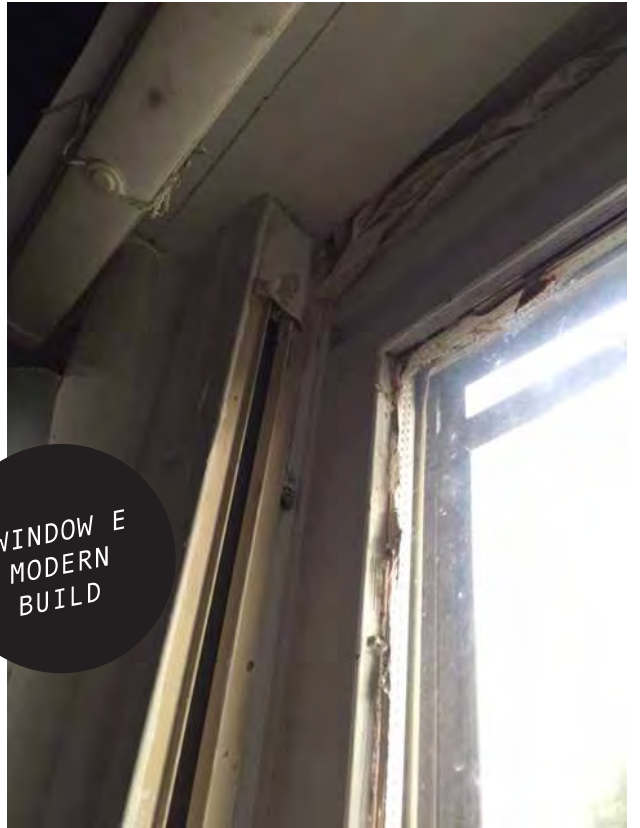
WINDOW E MODERN BUILD

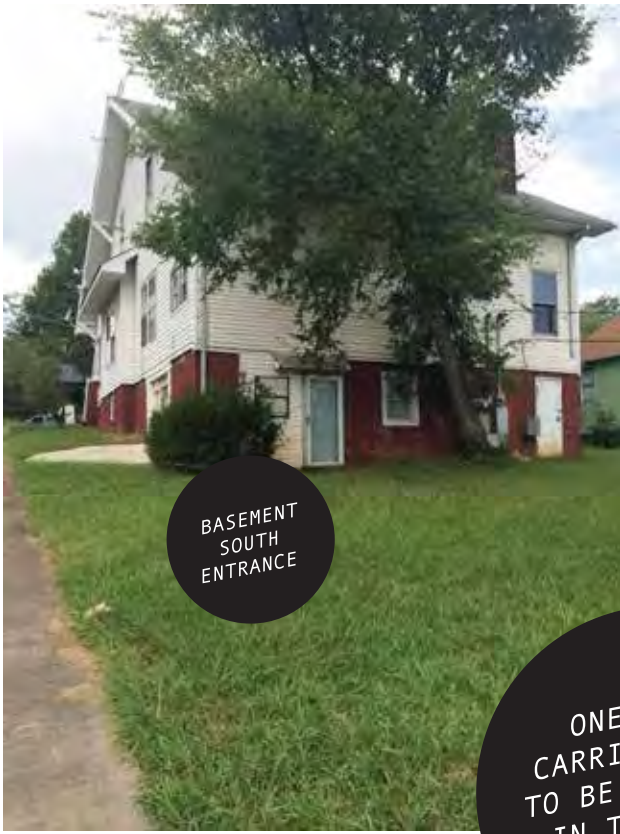
BASEMENT
SOUTH
ENTRANCE

South and west basement entrances have been removed due to heavy deterioration from termites and prolonged water exposure to adjacent floor joists and structural beams. New beams and posts have been installed to renew structural integrity to the back of the house.

ONE OF THE
CARRIAGE DOORS
TO BE INSTALLED
IN THE SOUTH
BASEMENT
ENTRANCE

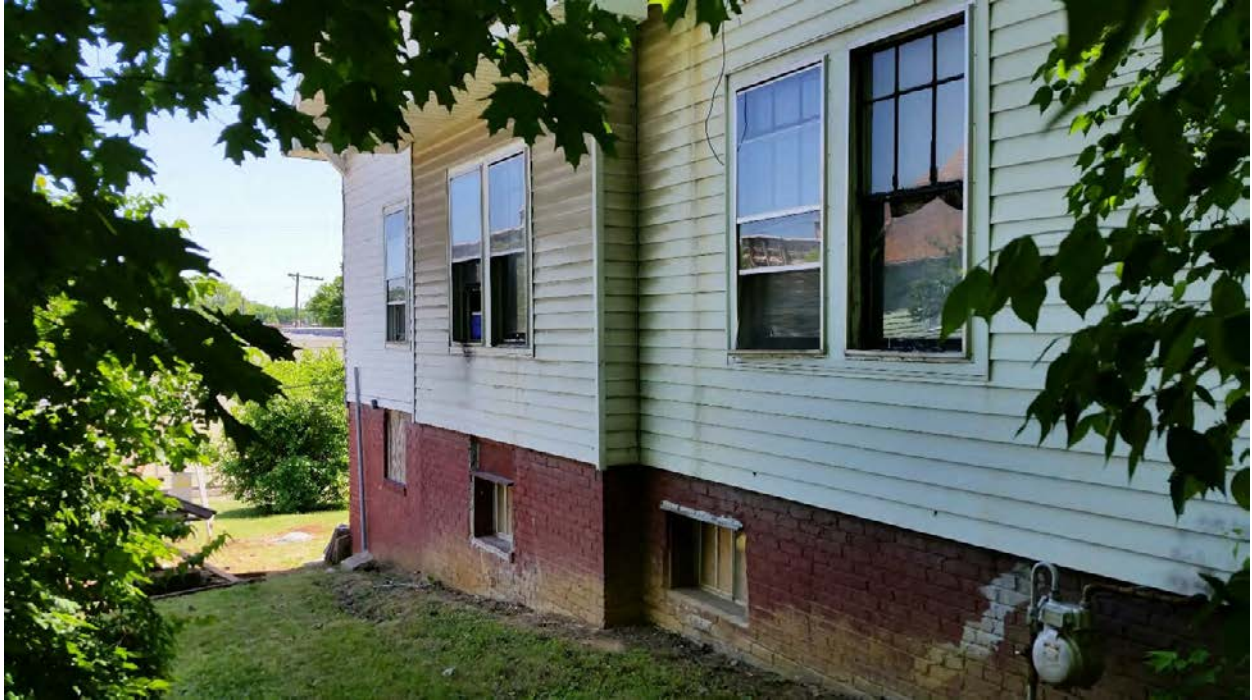
- 4) Window D on the northeast side to be removed and replaced with a shorter window of the same pane configuration is not visible from the right-of-way. Although foliage currently obscures the view, the window would be difficult to see without the foliage because it is beyond the projecting bay on that side and the depth of the house. The window parts will be used to restore and retain original windows that are viewable from the right-of-way.

300 E. Oklahoma - Window D on northeast to be replaced

- o Replace Window D with new window that is 47 inches tall and 35 inches wide. The existing Window D is 68 inches tall and 35 inches wide. New window will match in materials (wood) and 6/1 muntin configuration of windows original to the house.

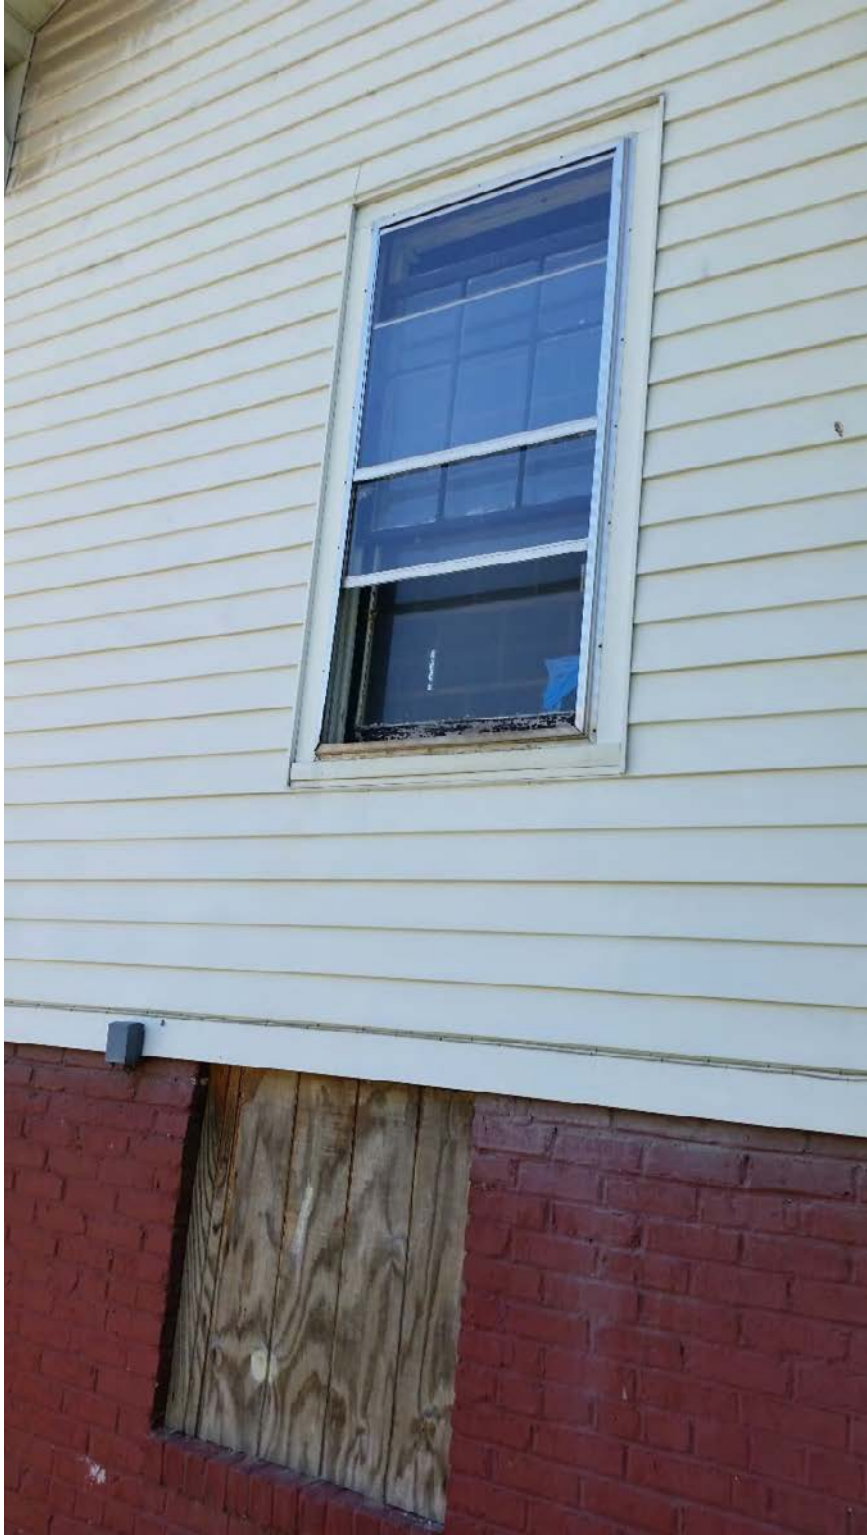
300 E. Oklahoma - Close-up of Window D on northeast

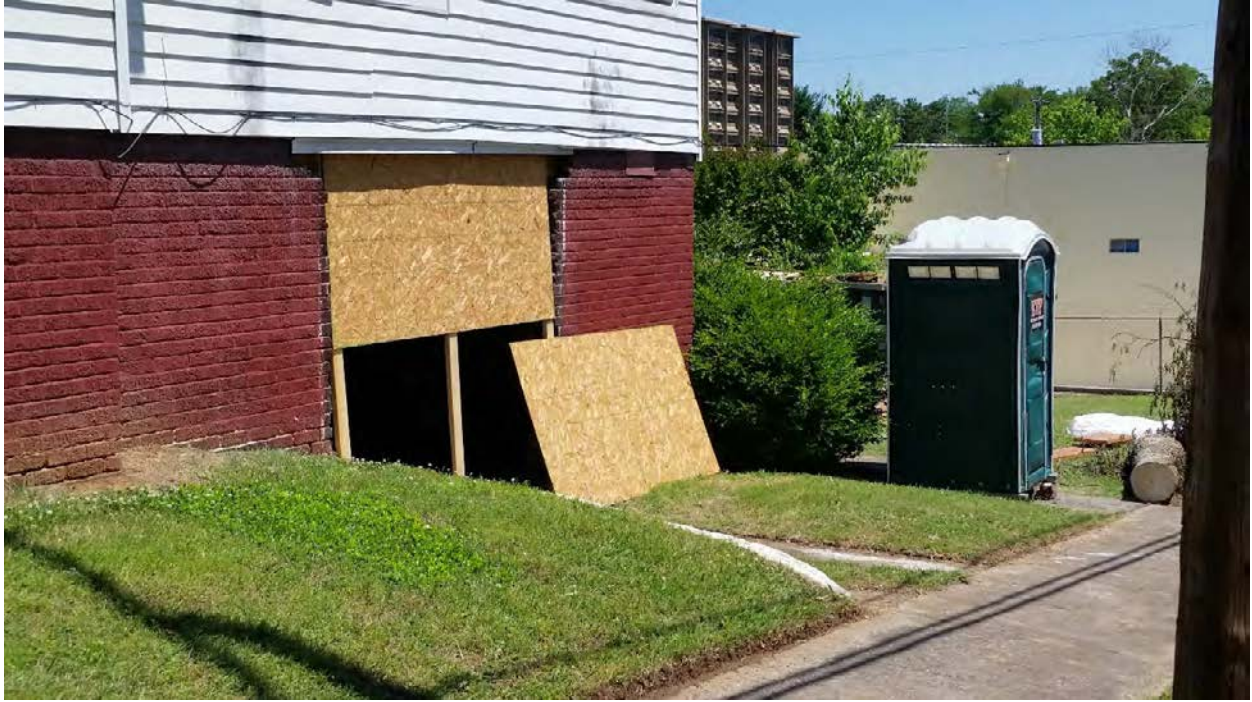
- 5) The proposed carriage house doors are appropriate for the style of the house, and the door and infill to be removed to accommodate them are inappropriate materials. Wood or painted composite or fiberglass garage doors have been deemed appropriate on other garages in the district.

300 E. Oklahoma - Southwest opening for carriage doors

o Replace south entrance to basement with salvaged wooden side-opening carriage doors or new doors in Craftsman style . Each door will be 4 feet wide by 7 feet tall.
