KNOXVILLE HISTORIC ZONING COMMISSION STAFF REPORT - CERTIFICATE OF APPROPRIATENESS APPLICATION

PROPERTY ADDRESS: 412 E Scott Ave 37917

FILE NO.: 2-B-18-HZ

DISTRICT: Old North Knoxville H-1

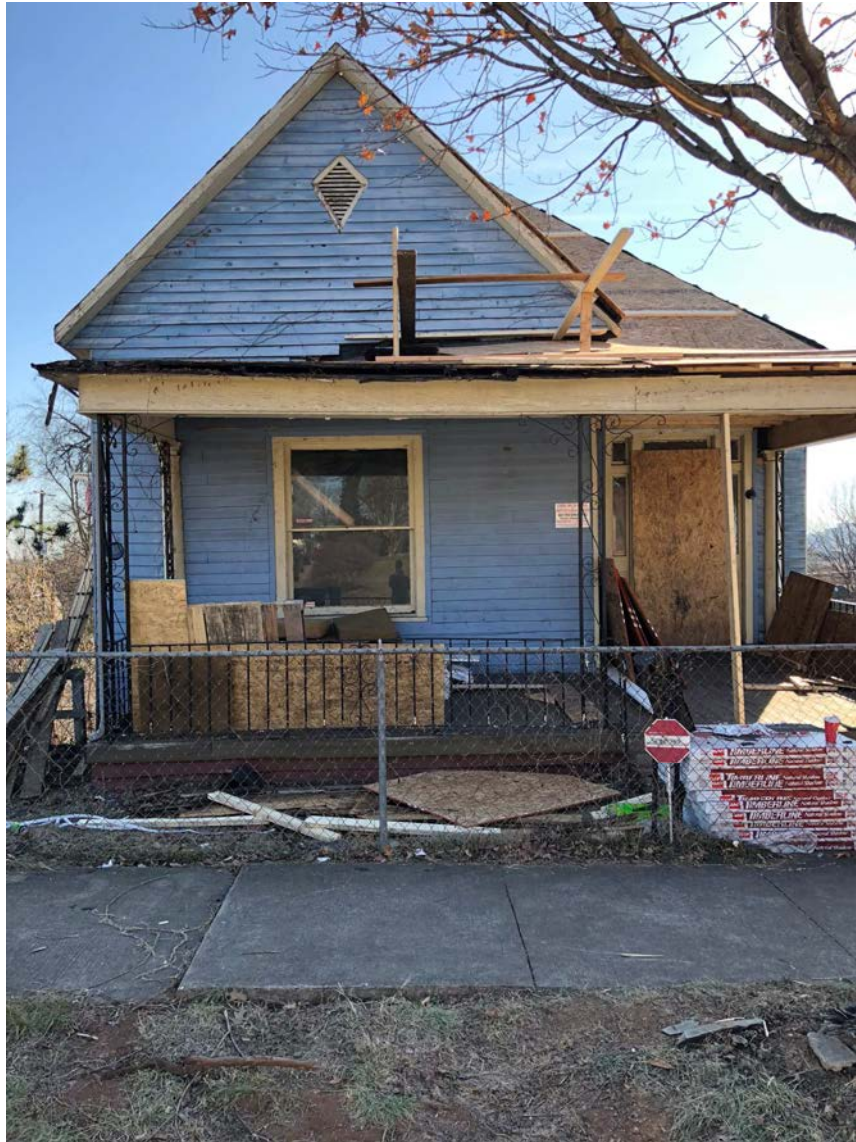
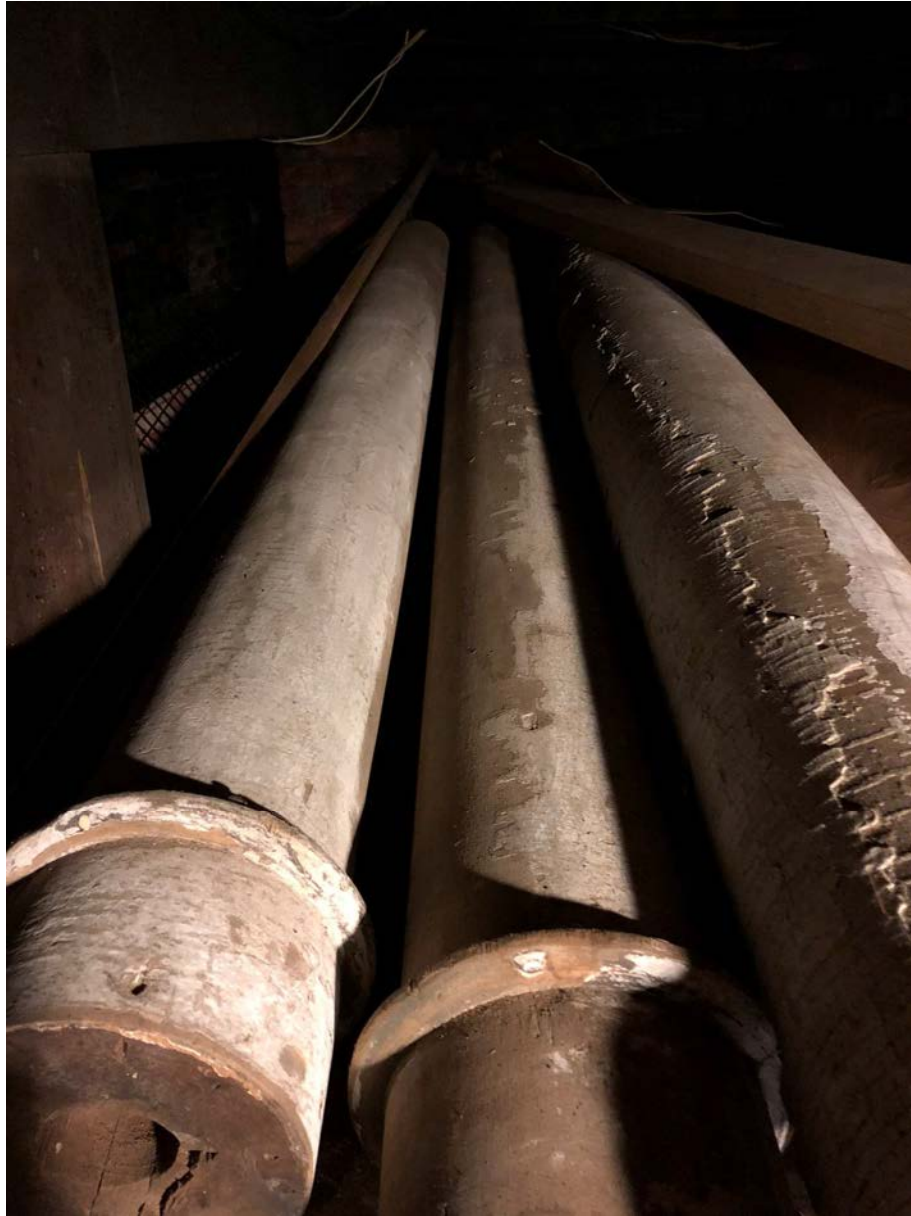
Columns on front porch – Remove metal posts and railings and replace with wooden columns and balustrade. Picture of proposed columns included, antique approximately 8" width similar to the 2 existing half columns on front of house.

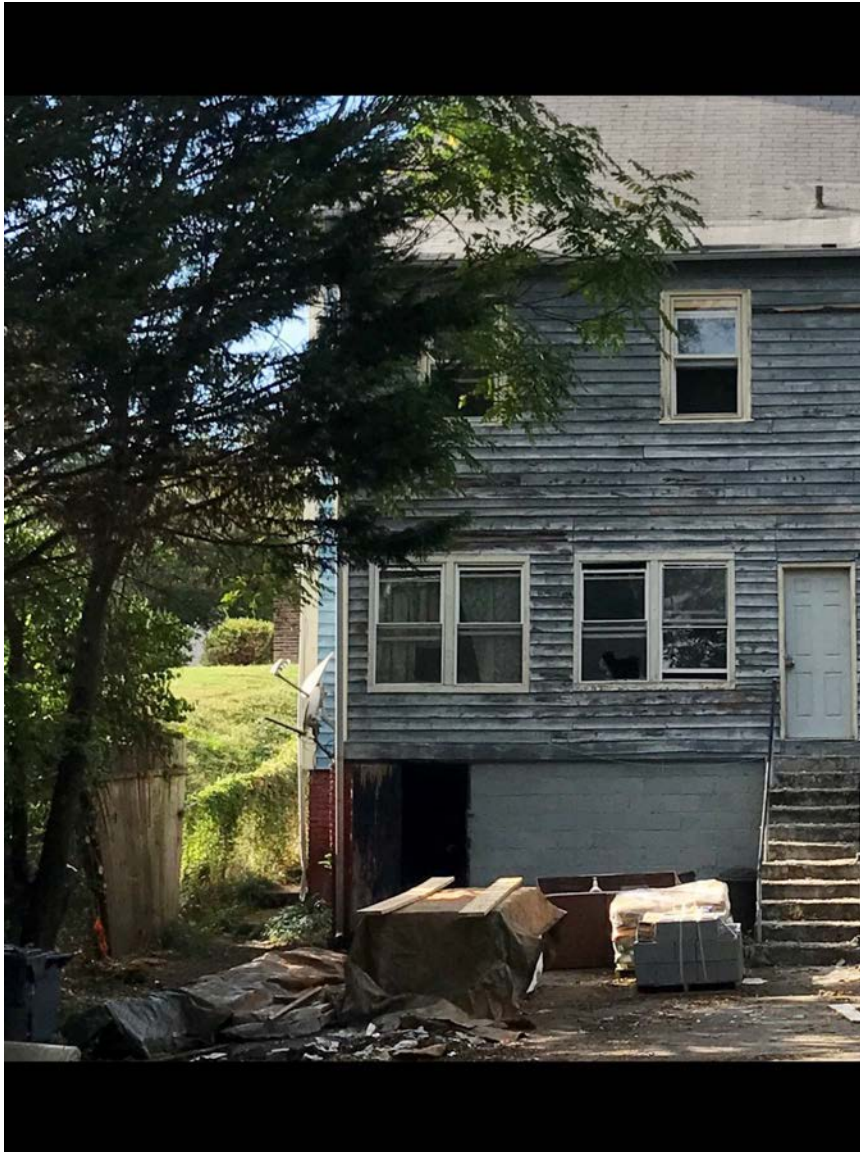
Door – Replace non-original metal back door with a wooden half glass door

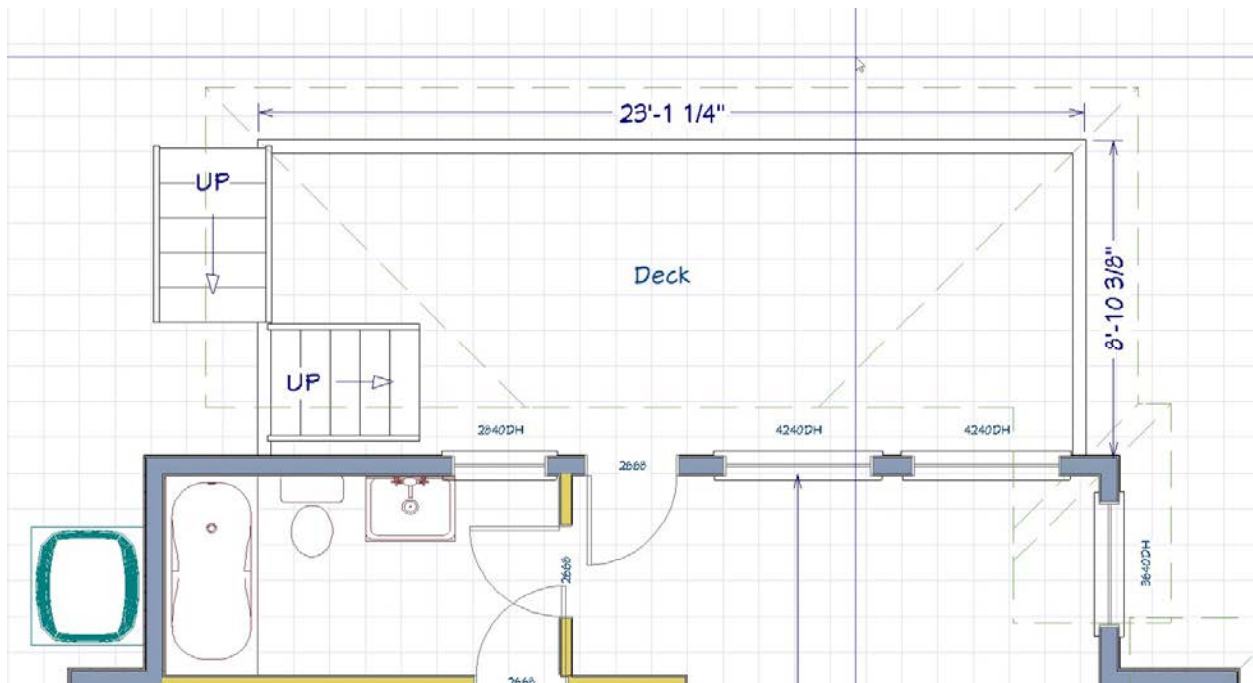
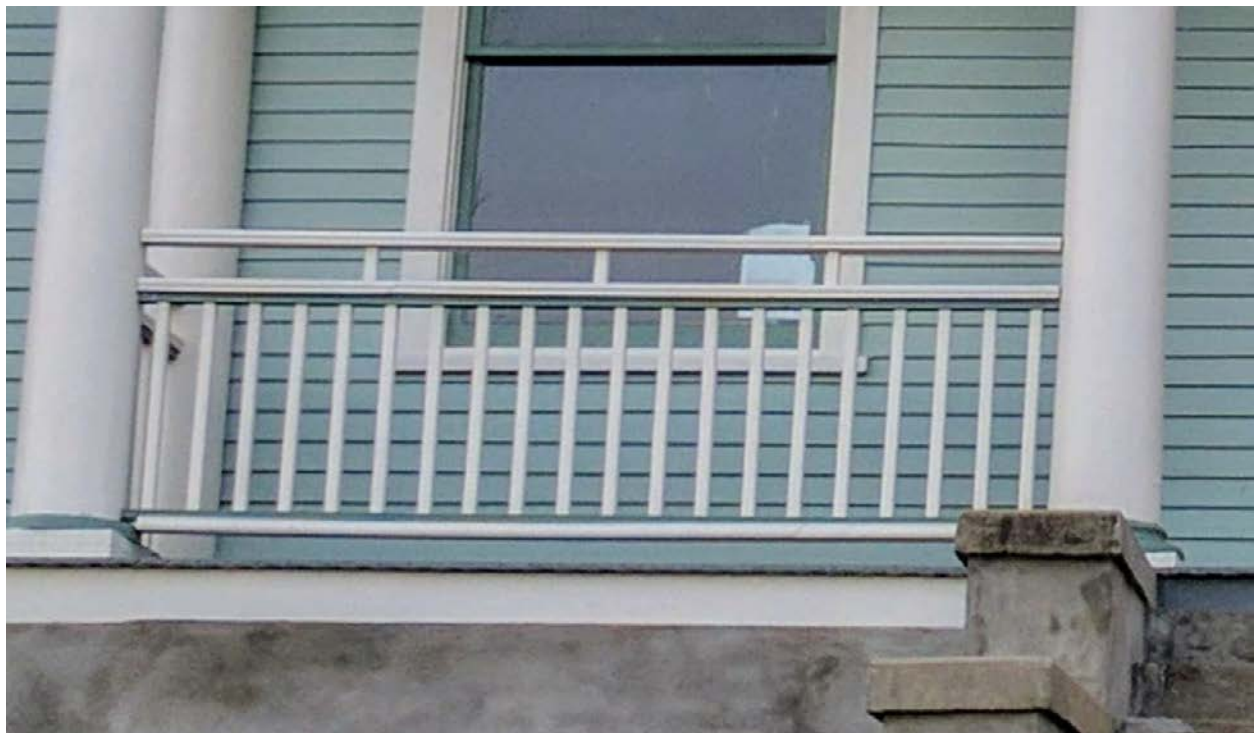
Deck – Request to add wooden deck on back of the house, approximately 23' x 9' deep. Railings to be 2"x2" as show below.

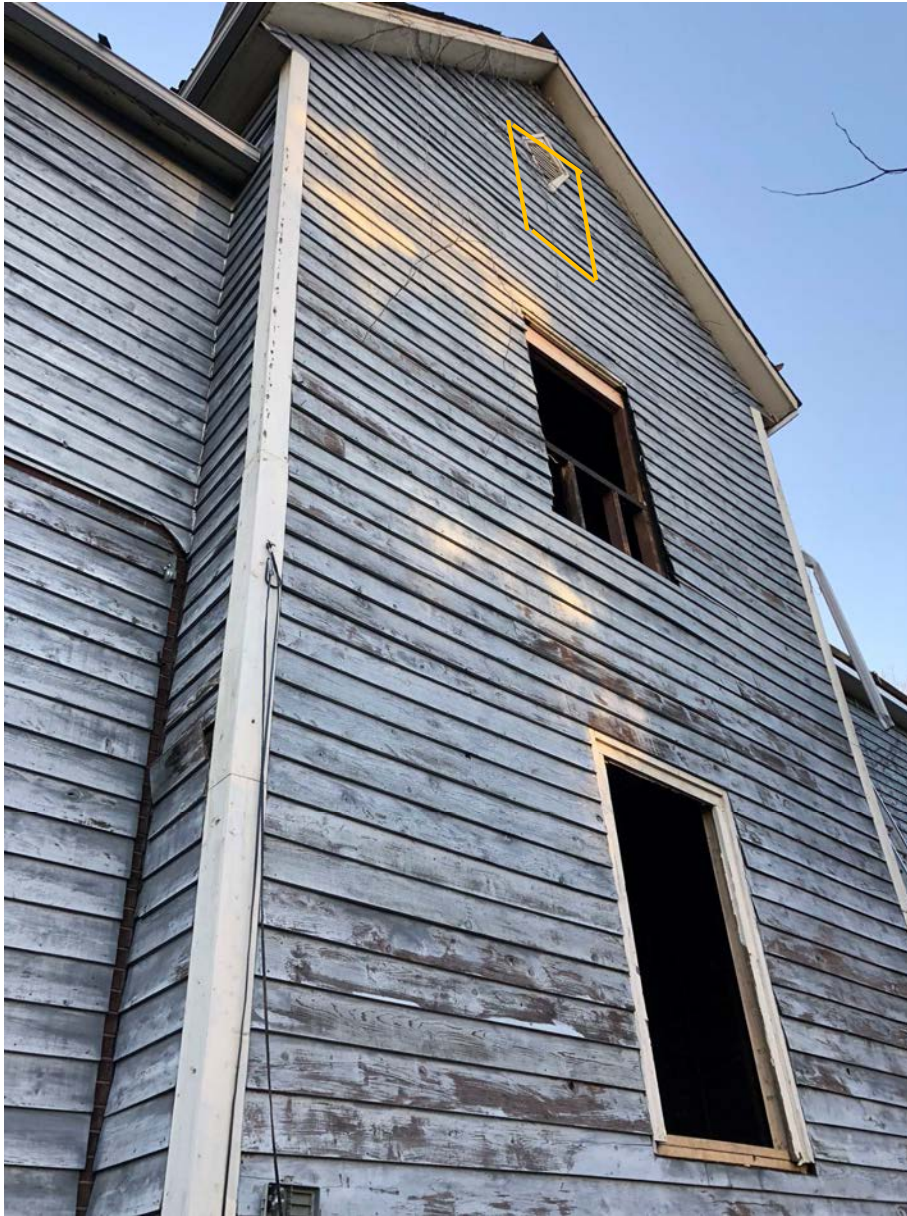
Egress Window – Building codes require an egress window for the upper level of the house. Install the minimum acceptable size of 3'x5' in the upper East side gable at the back of the house.

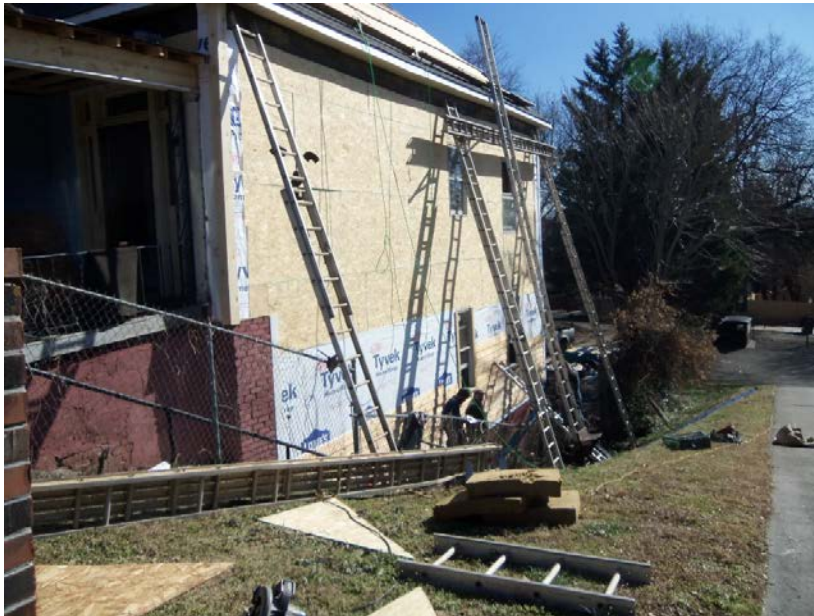
5) The 6"-siding on the south and rear was found to be more deteriorated than originally thought; therefore, instead of repairing and replacing as needed, the entire south and rear walls of sheathing and siding were replaced to match previously existing. The 6-inch replacement siding does not abut the 4-1/2 " siding on the front corner.

412 E. Scott - Re-siding in progress on south side during Inspection on 1-25-18

- Approve new porch balustrade on condition that a design drawing be submitted.
- Approve porch columns on condition that design be submitted for capitals.
- Approve new siding based on the original having already been replaced, and the new siding matching the existing siding to be retained on the north side.
- Approve rear deck.
- Approve replacement wood half-light rear door as existing door is not original and not appropriate.

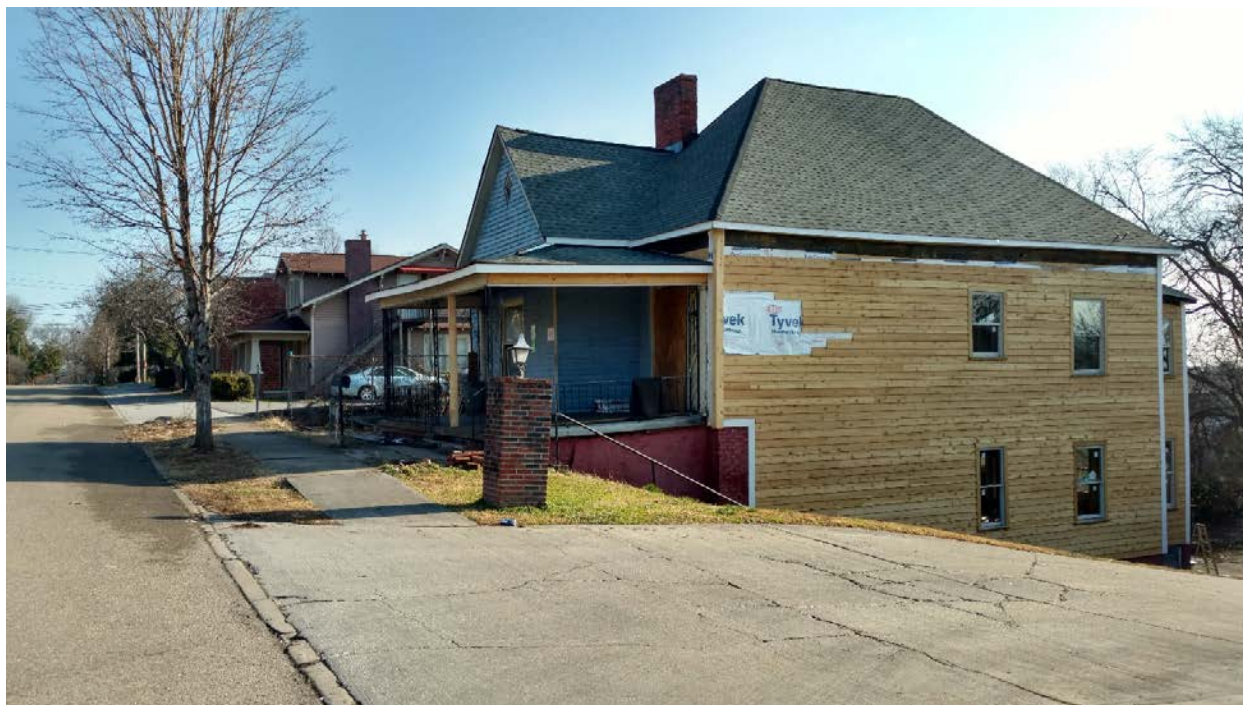
- 8) Two of the existing windows on the south side toward the front of the house were blocked in when the wall was re-sheathed and sided. One was a horizontally-oriented decorative window and the other a 1/1 double-hung.

412 E. Scott - Current status of south facade as viewed from sidewalk

- 1) Re-construct the two windows on the south side that were blocked in, based on earlier Google earth photo. Muntin pattern to be confirmed as appropriate.
- 2) Re-construct the south side upper level window closest to front of house (westernmost) to be the same size as, and align with, the window to the east.
- 3) Install 1/1 wood windows to fit the original openings as indicated by the existing framing on all of the street-level windows on the north side.
- 4) Replace the small square double-hung window on the rear of the house toward the north side with square wood casement or stationary window as it is out of historic proportion. Consider aligning it with the window above.
- 5) Deny installation of 1/1 egress window in attic gable on north side.

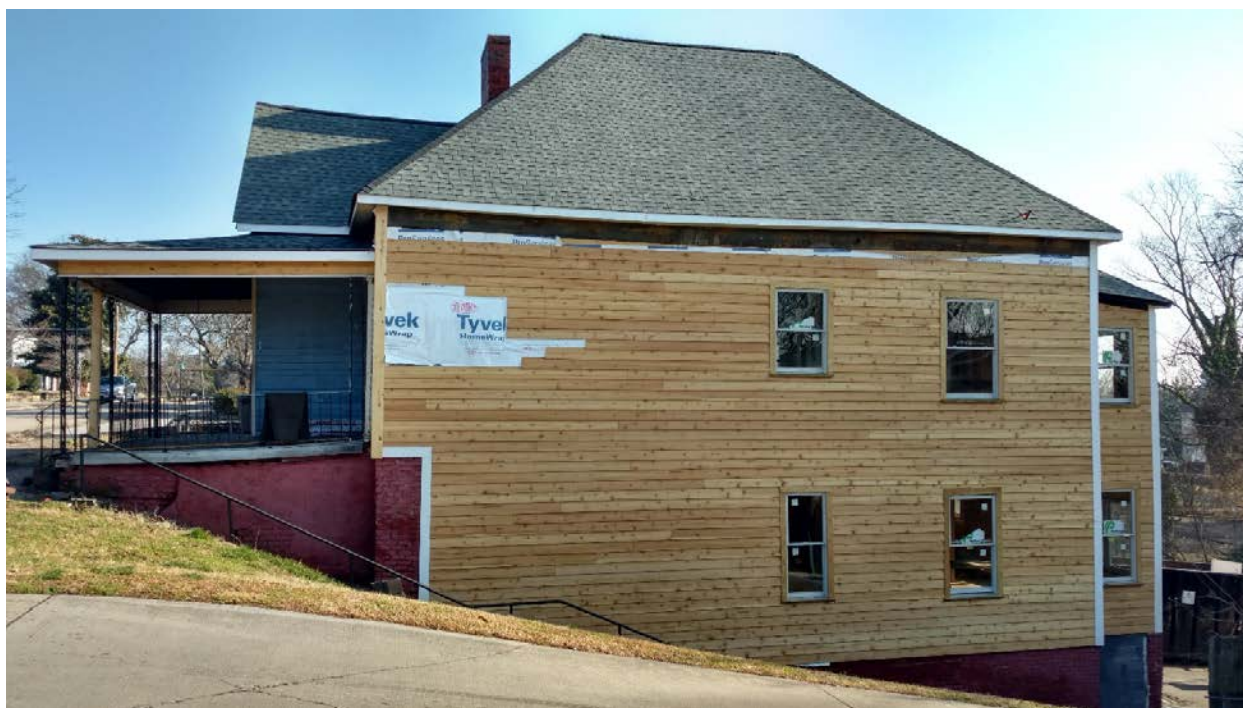
412 E. Scott - Current status of south facade as viewed from south

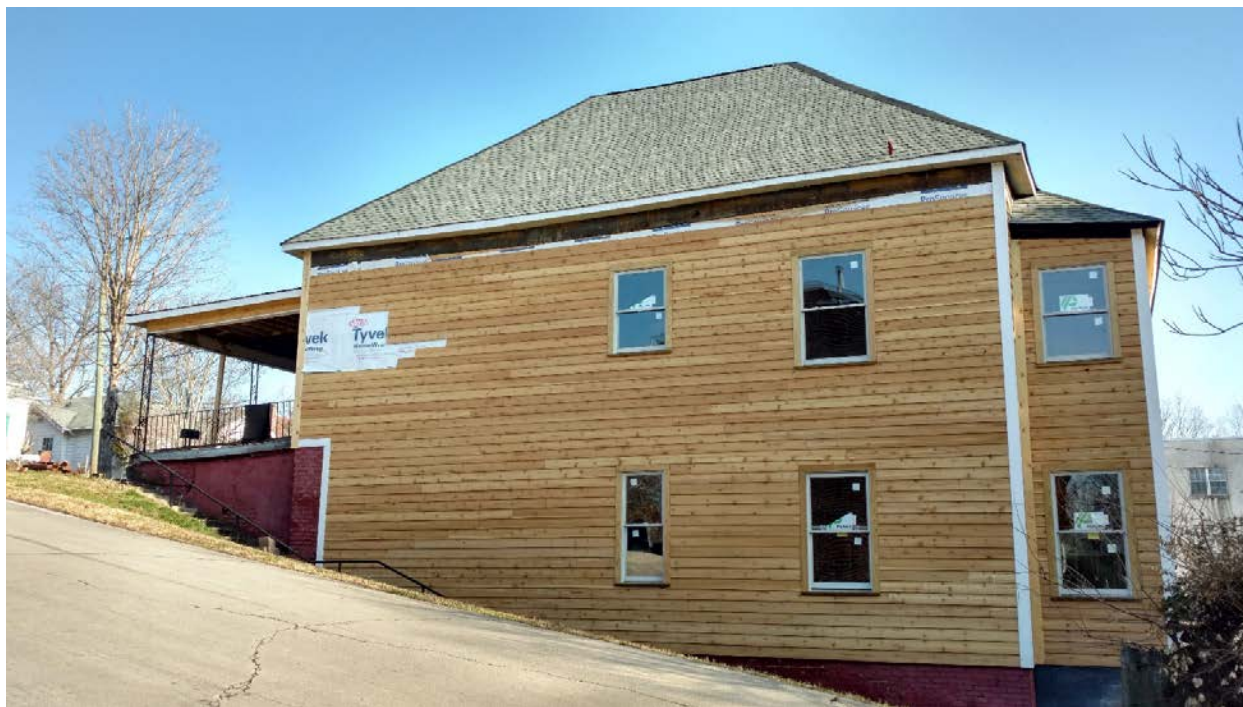
412 E. Scott - Current status of south facade as viewed from SE

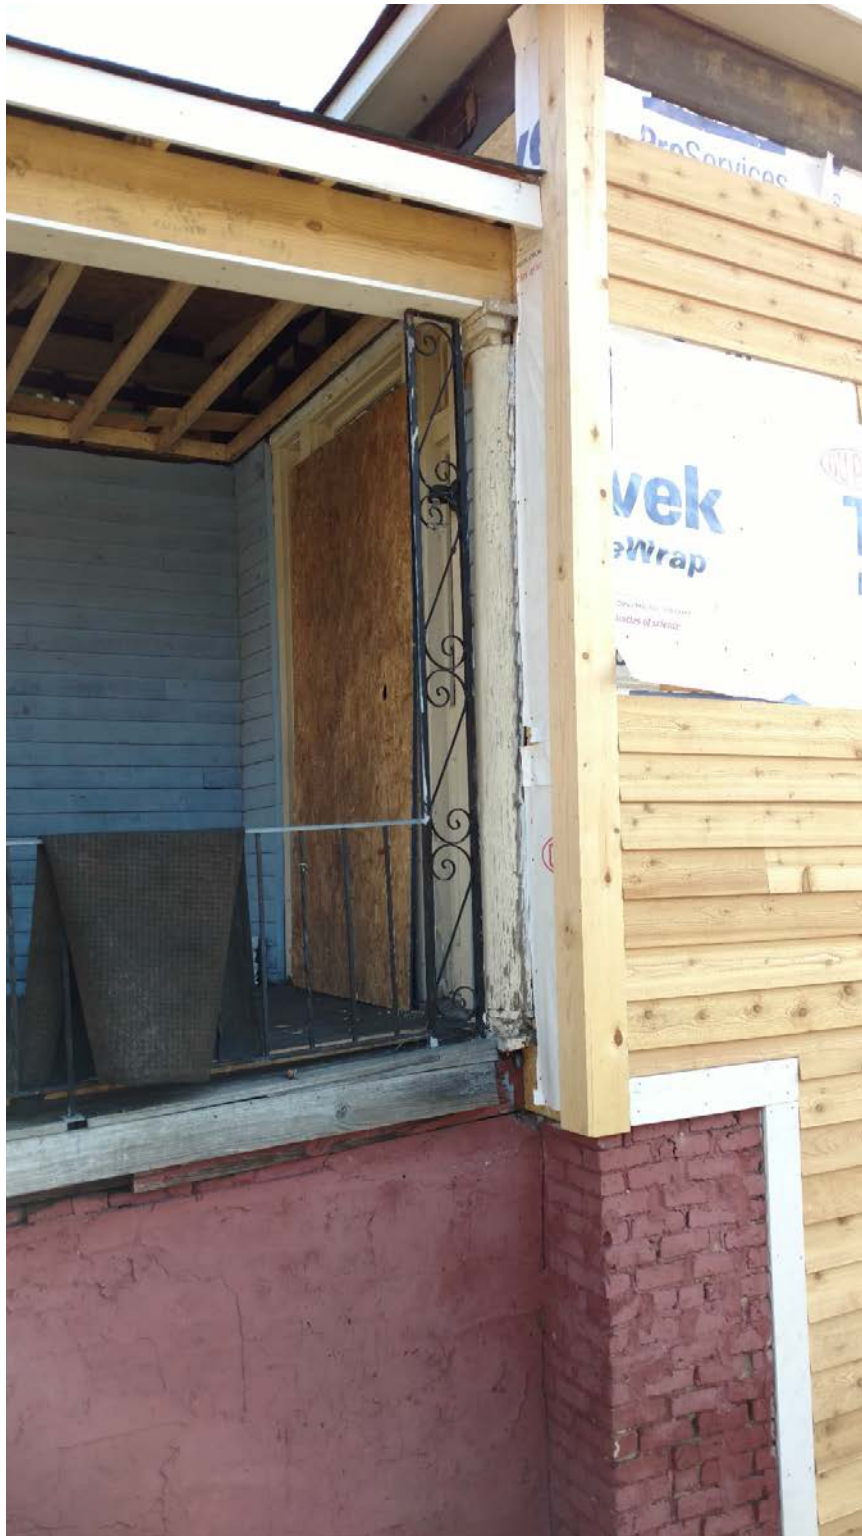
412 E. Scott - SW (Front) corner of house showing south siding does not meet up with siding on front

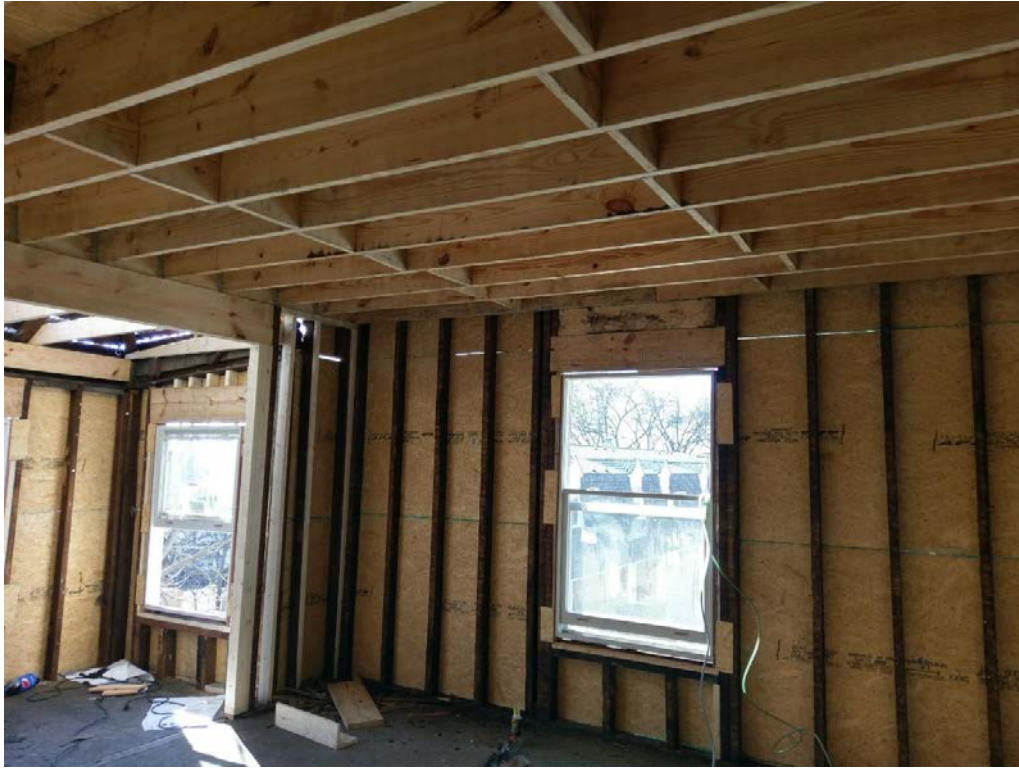
- 7) The framing for the non-original openings on the south side was adjusted by the applicant/owner to add in the required window headers, so the non-historic sizes of the openings lost their grandfathered status.

412 E. Scott - Windows on 2nd-level south from interior showing new headers

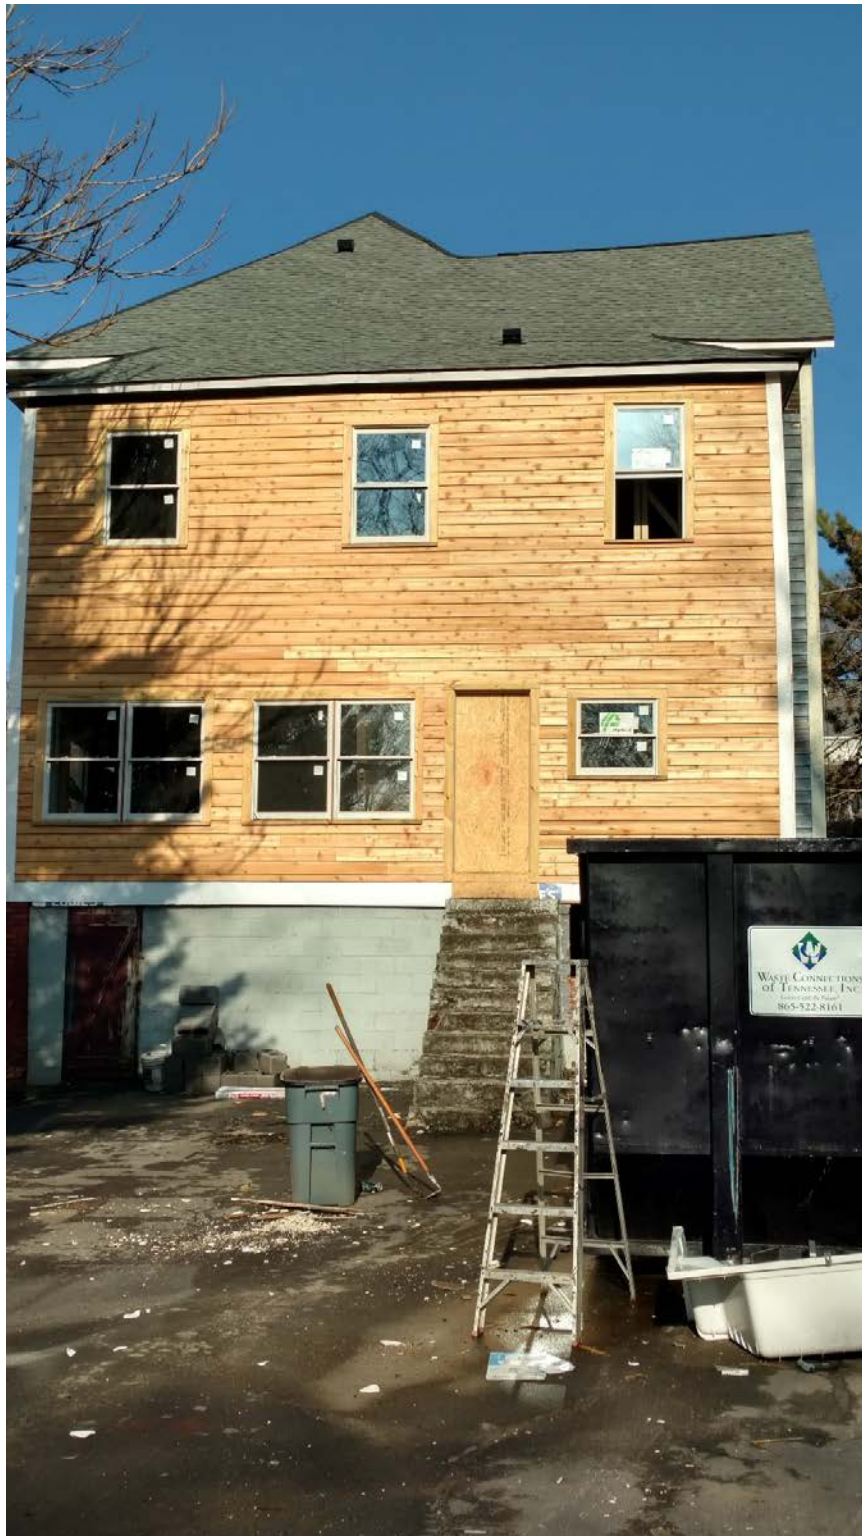
- 9) None of the windows on the rear were original, but the replacements to match the previously existing are fairly appropriate given that they are vertically-oriented 1/1s, except for one square double-hung. The framing for the openings of these windows was adjusted as well.

412 E. Scott - Current status of rear facade showing completed siding

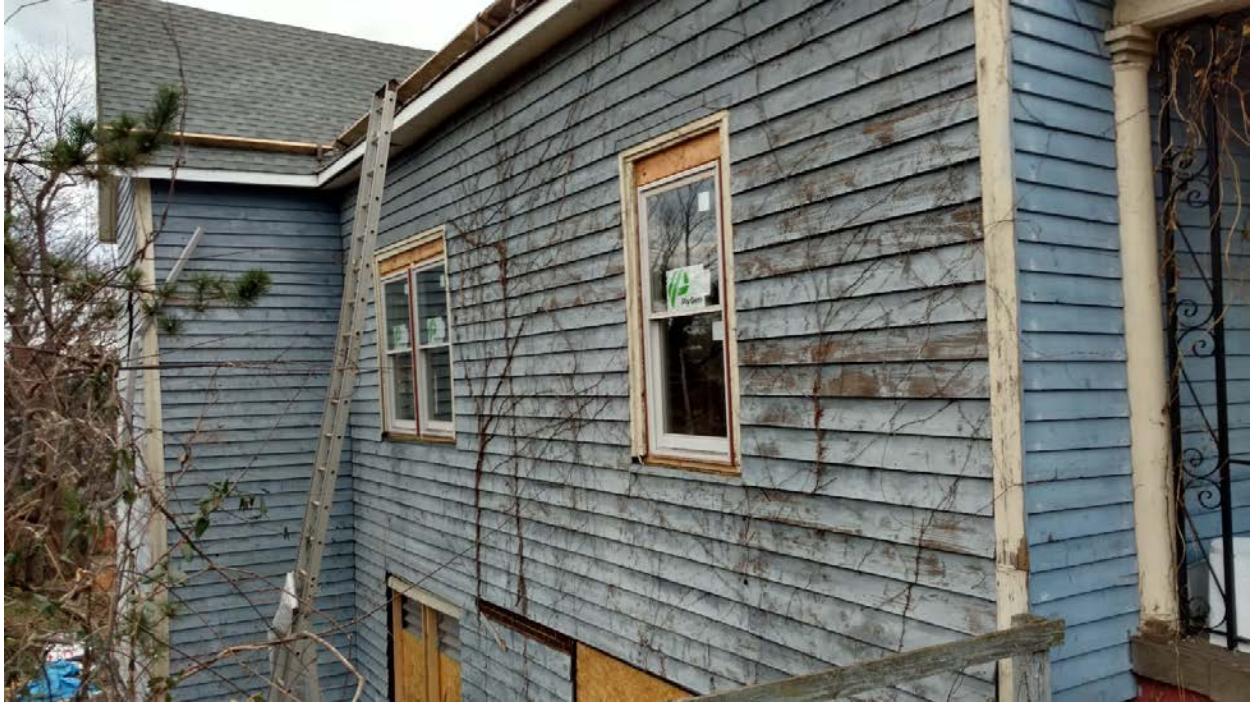
- 6) After work was begun, the original window openings on the north side were found to have been filled in to make them smaller in earlier years. The infill was removed and then re-installed by the applicant, causing the infill to lose its grandfathered status. The applicant has agreed to install 1/1 wood windows to match the historic opening size at the street-level on that side, since the original framing exists. The windows below grade will not be noticeable from the street, and are proposed to be installed as the existing size. It isn't known if these openings are original.

412 E. Scott - Replacement windows on north side showing infill

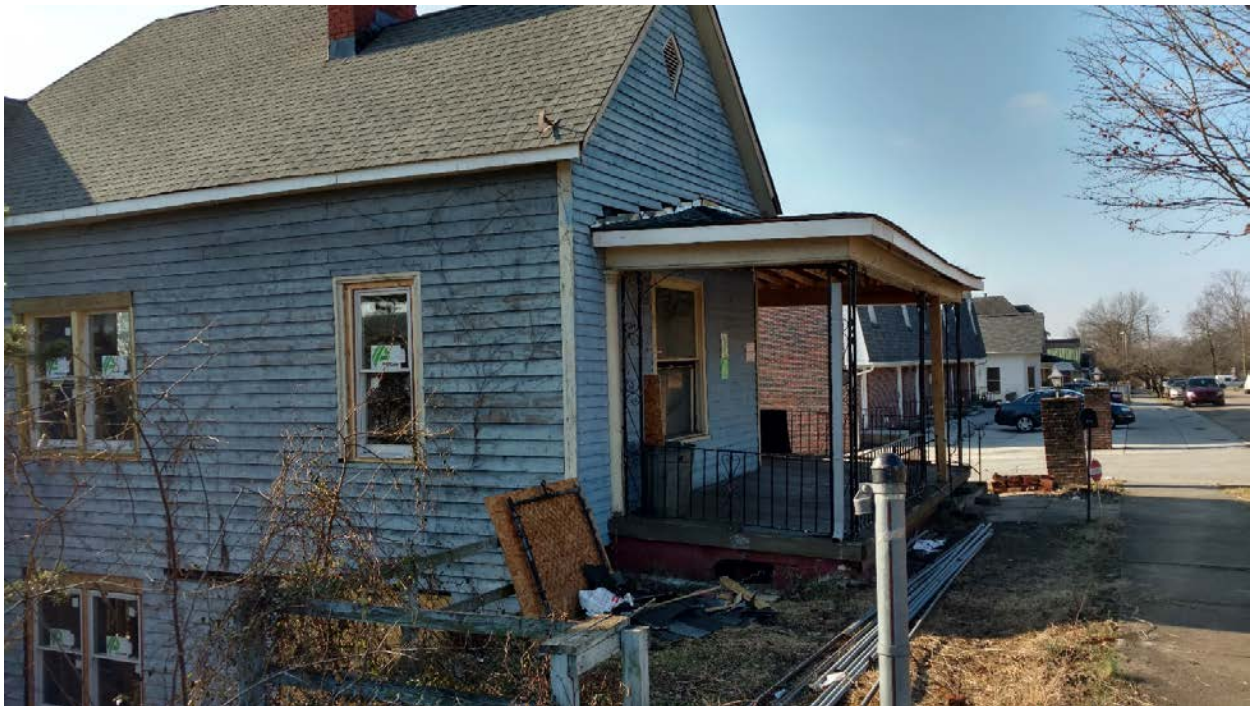
412 E. Scott - North side from front yard showing infilled windows on both levels

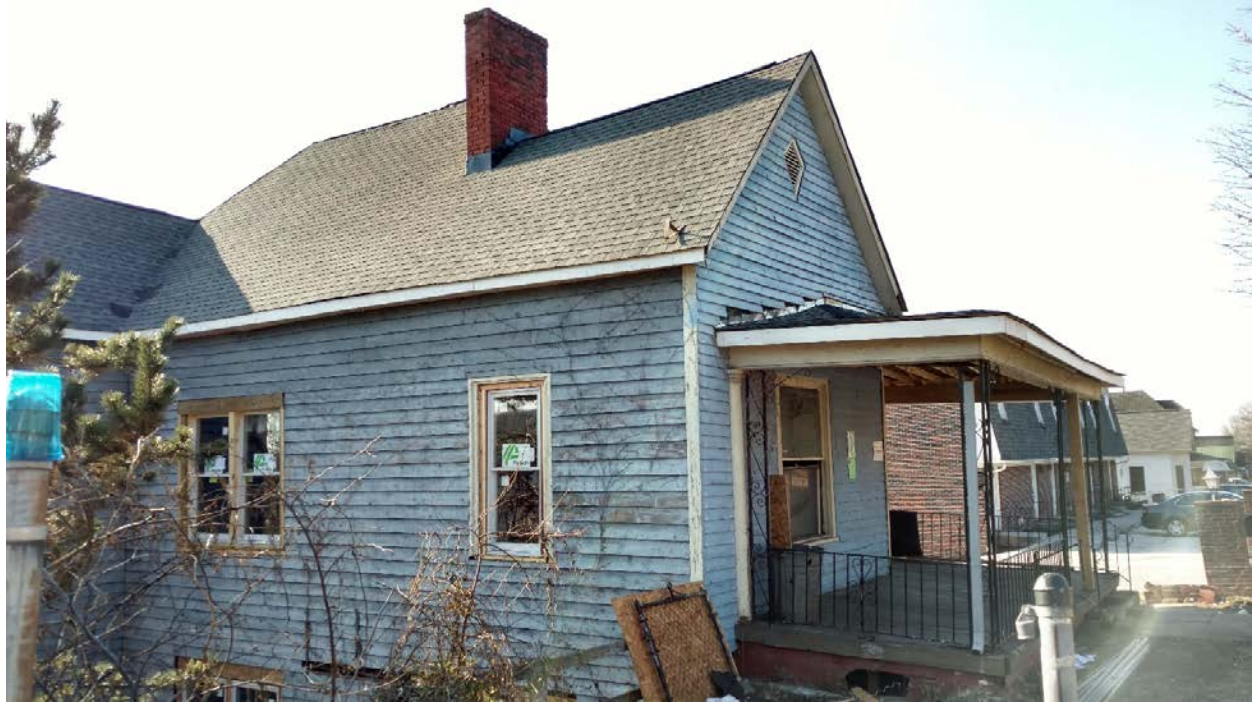
412 E. Scott - North side from front sidewalk showing infilled windows on top level

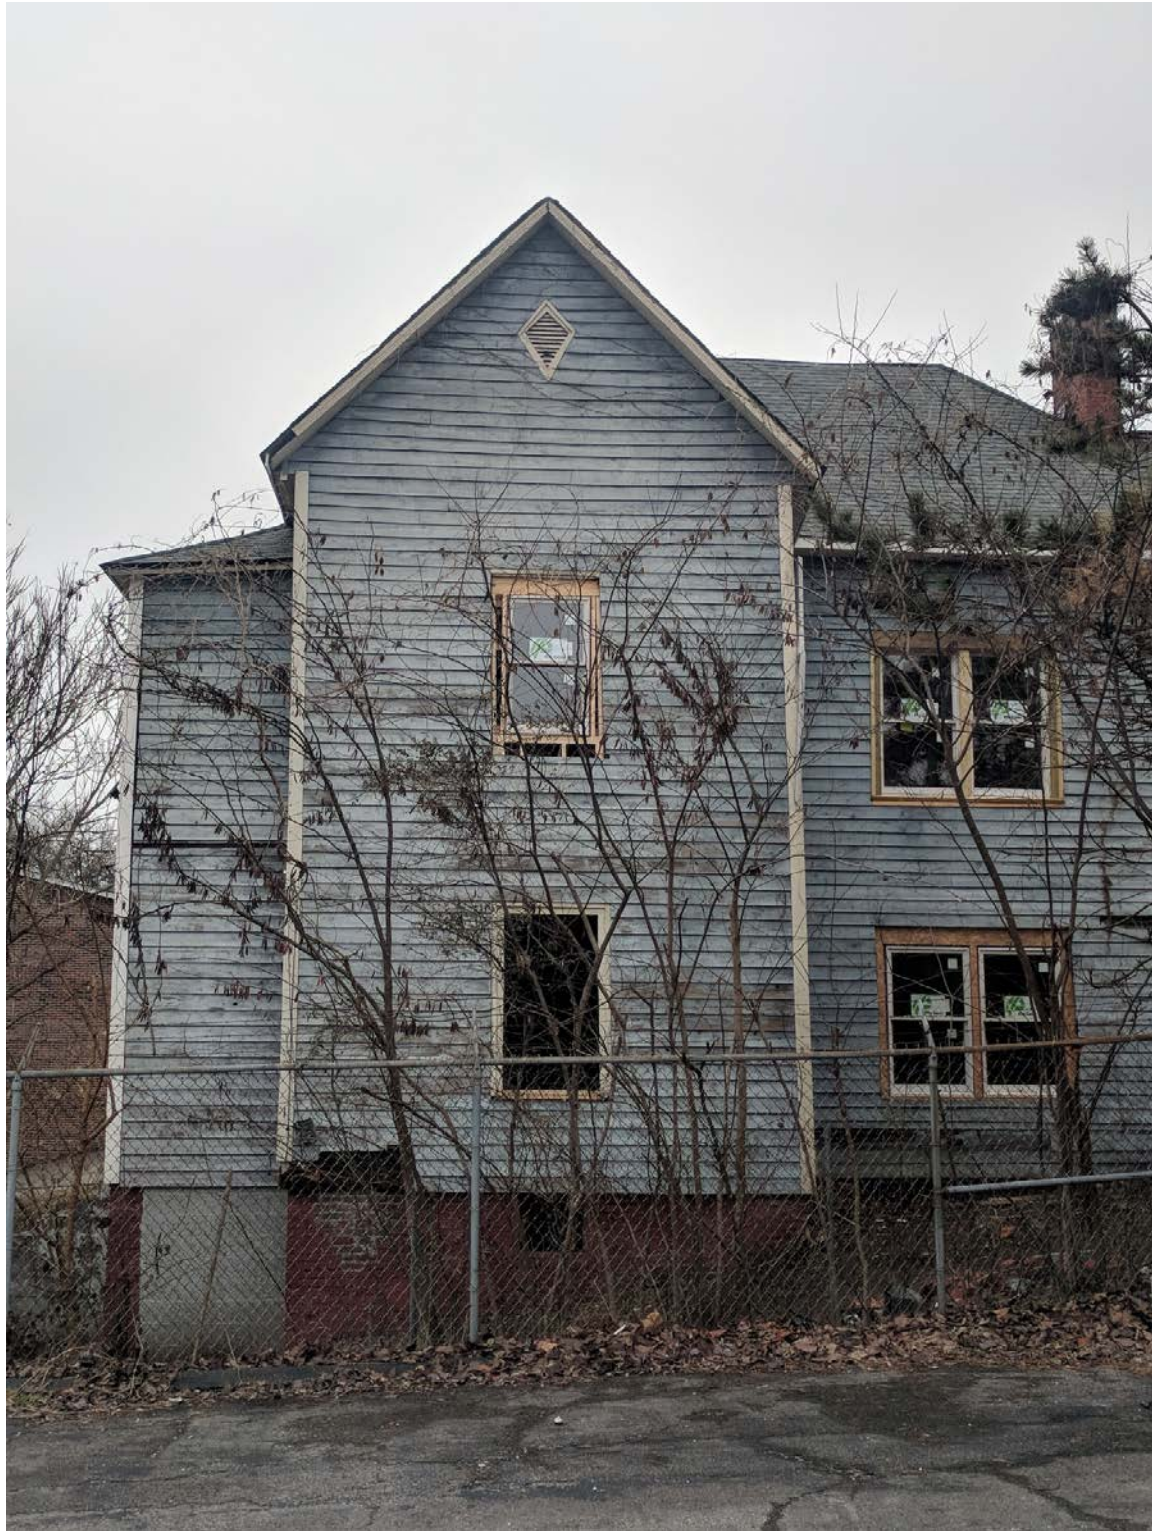
- 9) The diamond-shaped louvered attic vent in the north-side gable is an original and character-defining feature and should not be removed. To add a double -hung window in this location would be a historically inappropriate change that would be fully viewable from the public-right-of-way.

412 E. Scott - North side of 412 E. Scott showing gable proposed for new window

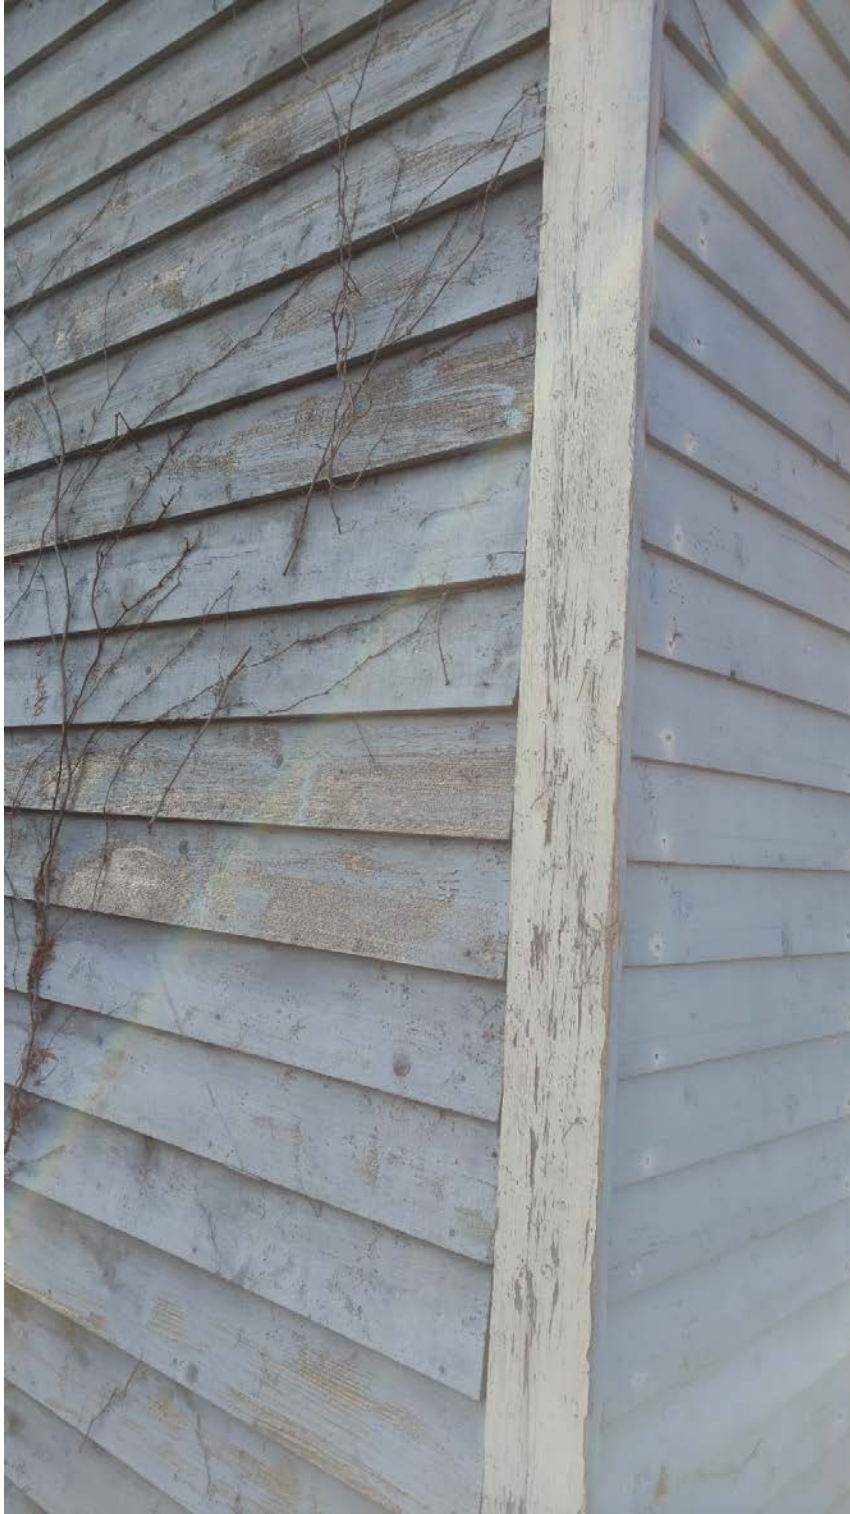
2) The large 1/1 window on the front of the house is original, as is the 4-1/2 inch-siding, and both will be retained and repaired.

412 E. Scott - Front (NW) corner of house showing siding that was not replaced

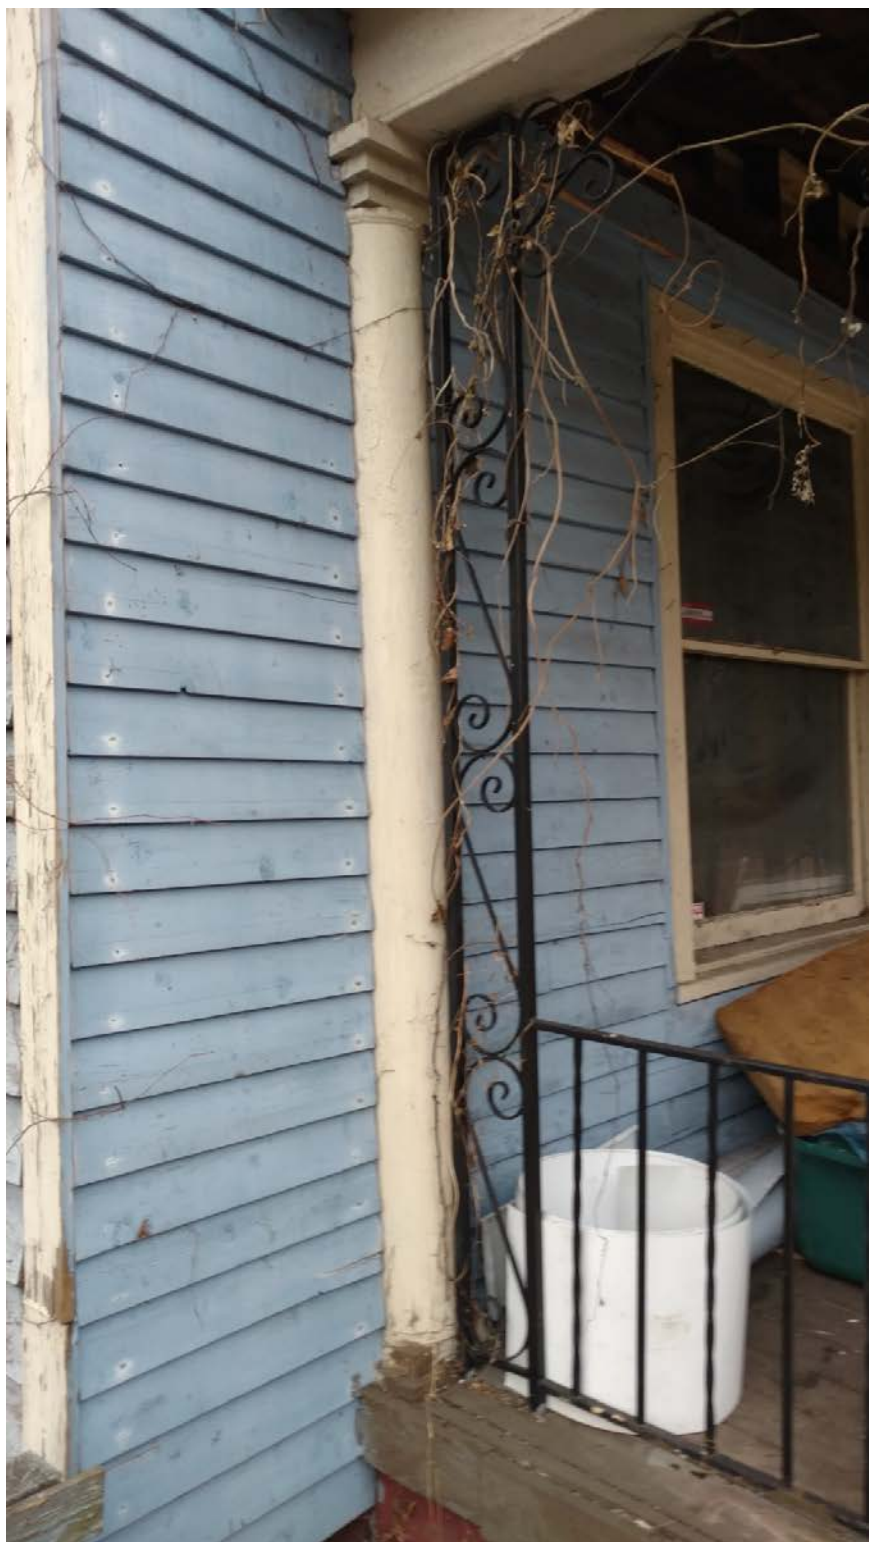
3). There is evidence in the engaged half-round column existing on the porch to indicate the design of the proposed porch columns. A balustrade may have turned or 2x2 straight pickets.

412 E. Scott - Early columned pilaster on porch

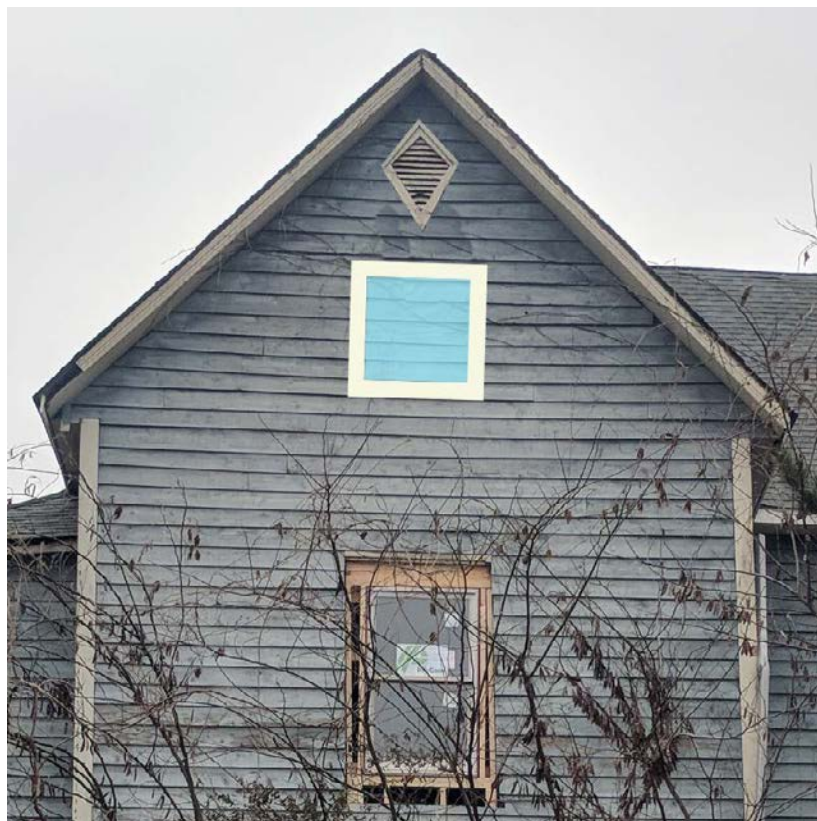
412 E. Scott north gable simulation as proposed. Relocate vent higher in gable and add square 30x30 square window for egress.

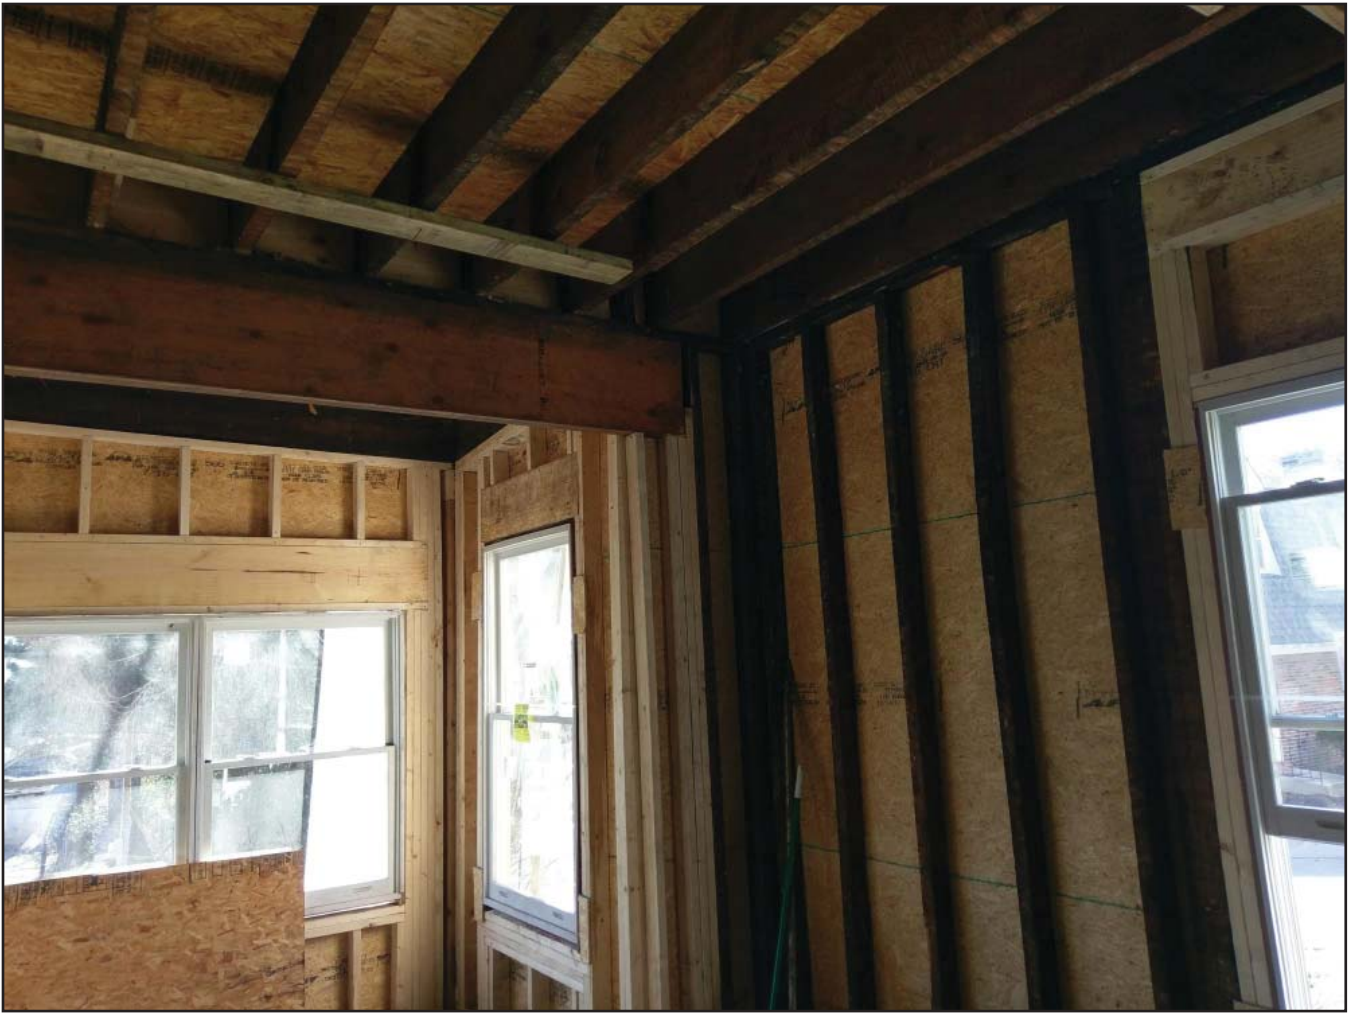
412 E. Scott Avenue
Showing new window headers
