Staff Report - Certificate of Appropriateness Application

File Number: 7-F-20-HZ

PROPERTY LOCATION: 417 E. Oklahoma Ave. / Parcel ID 81 L W 020

Proposed replacement of nine original or historic wood windows. Five windows are 1/1 double-hung wood sash, and four windows are 2/2 double-hung wood sash. Applicant states that the windows have deteriorated from "water and termite damage," "could never provide adequate energy efficiency," and are not "economically feasible for repair."

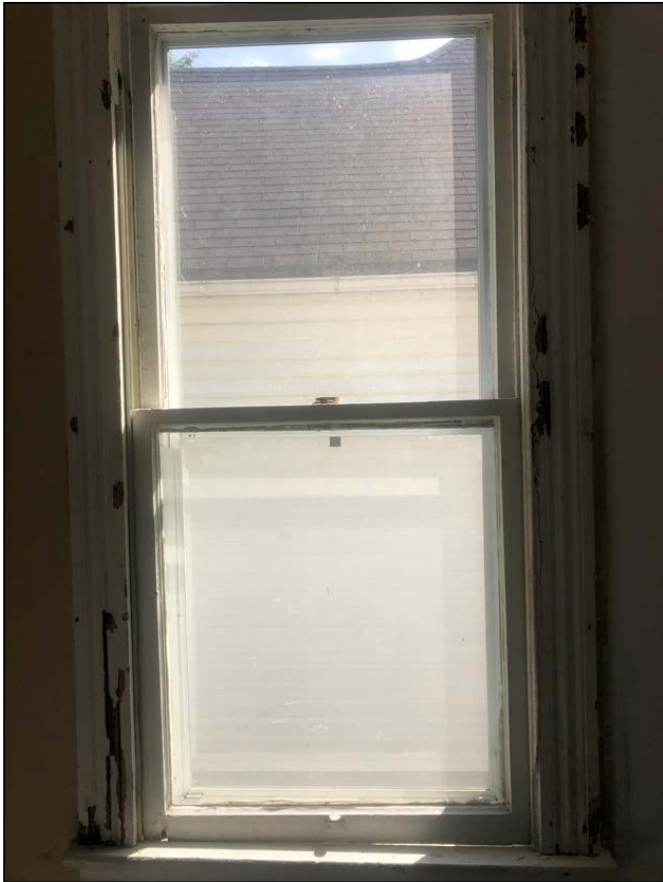
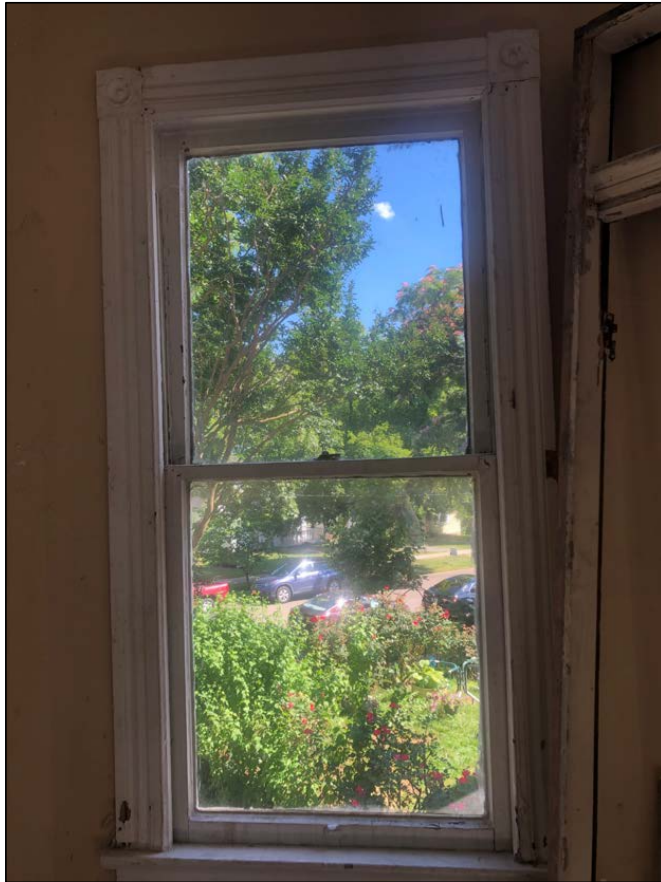
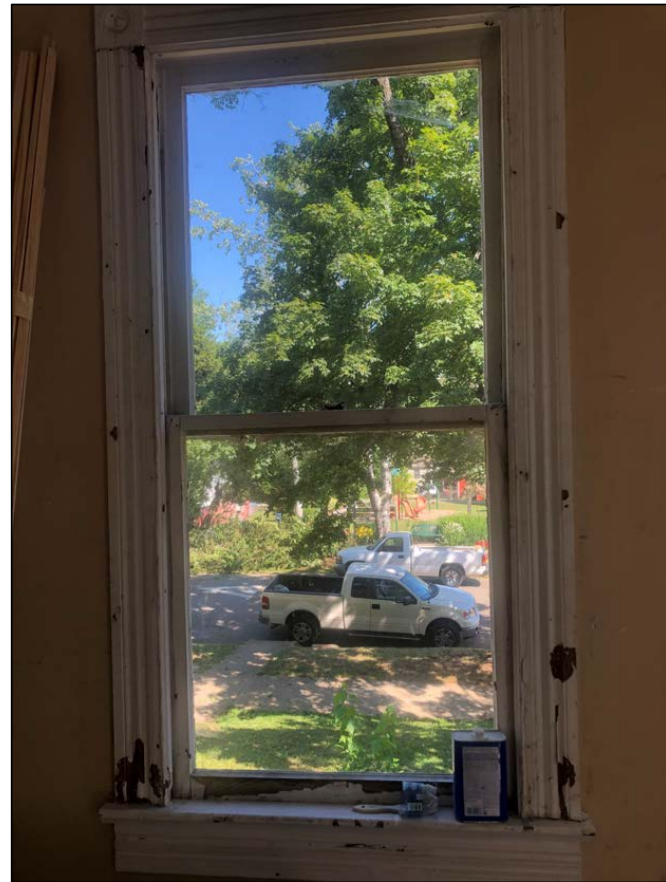
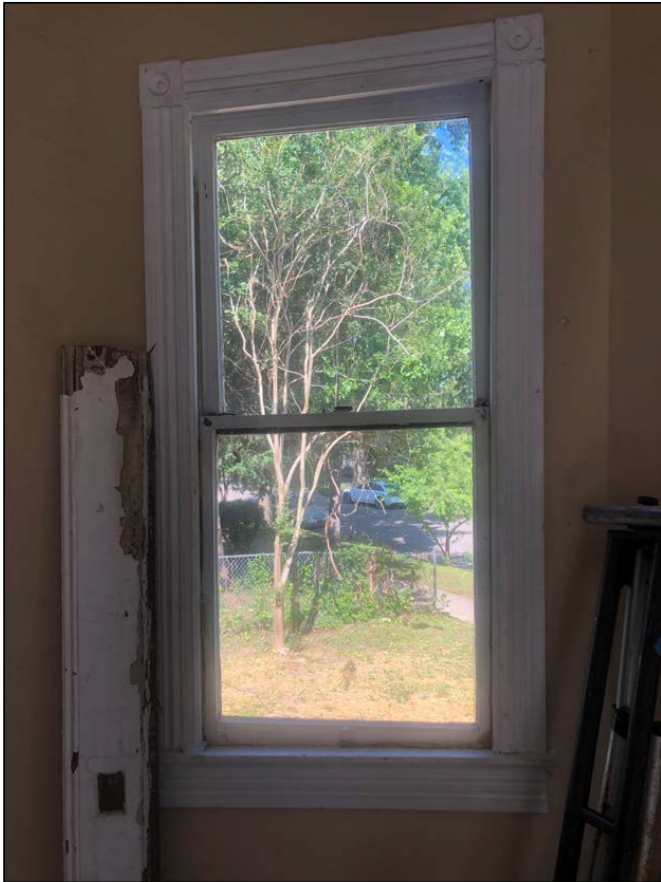
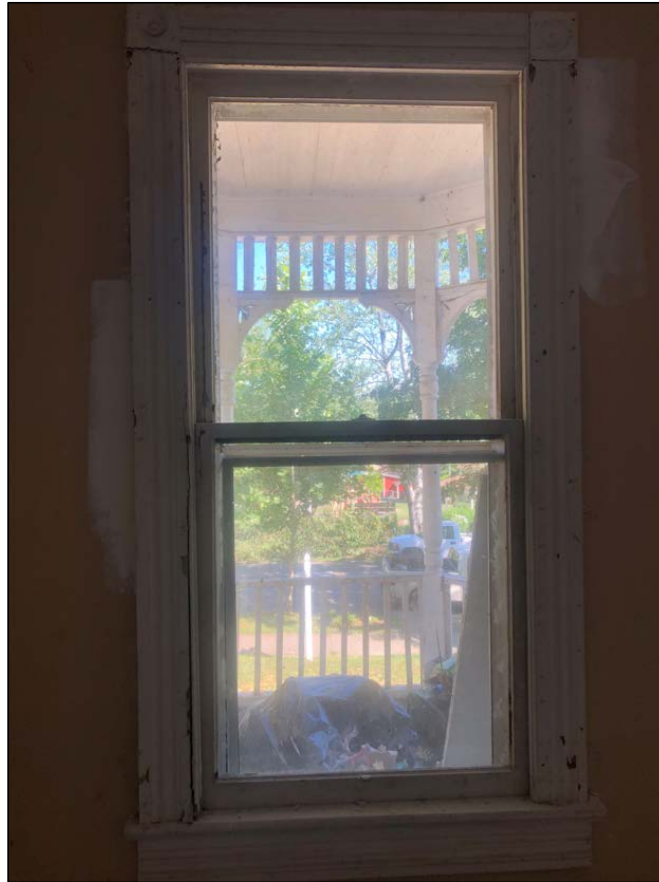
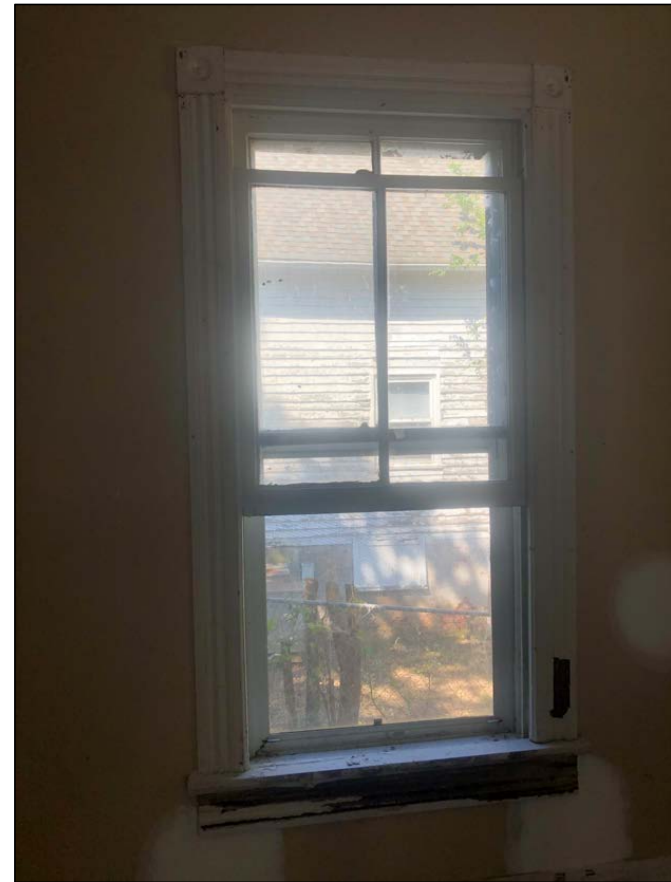
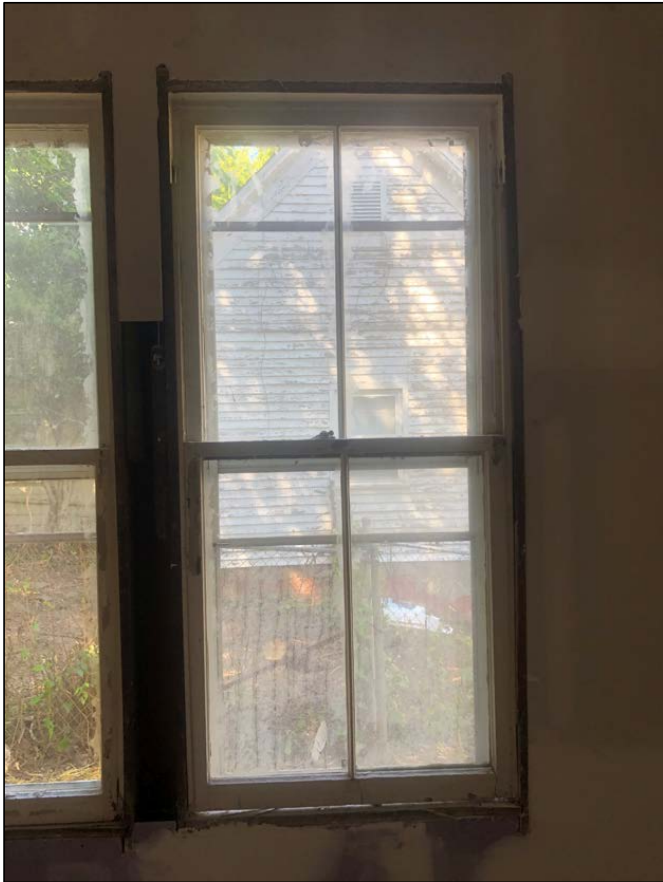
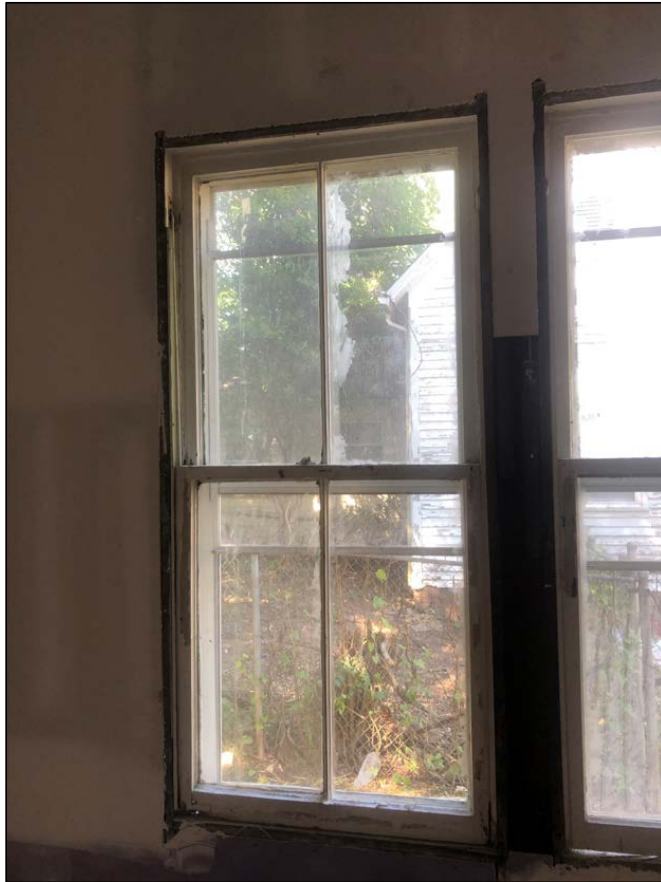
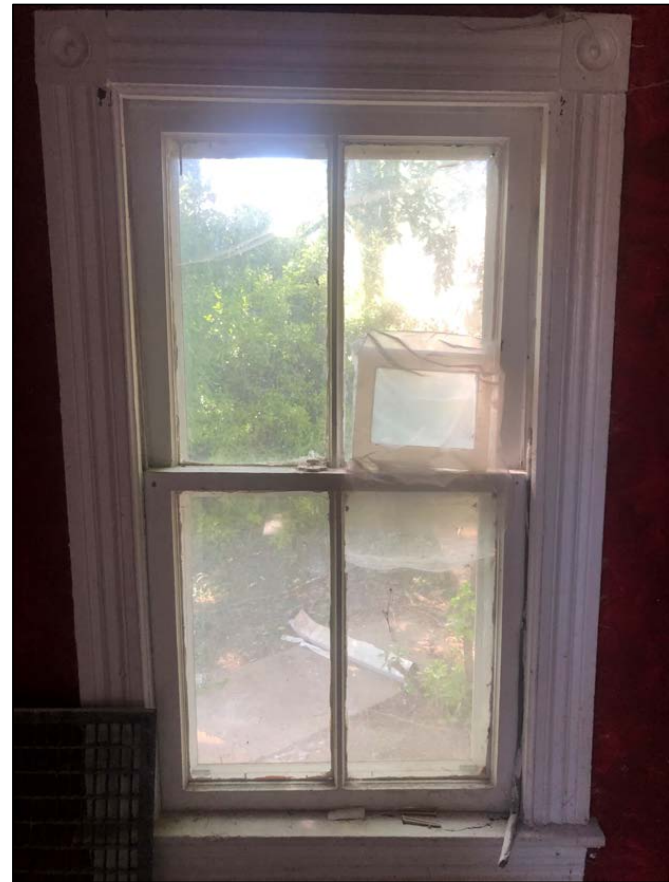
Brief description of work: There are a total of 9 windows in the house that have been heavily water and termite damaged and have deteriorated to the point of no longer being feasible to repair. There are huge gaps between the window and window sill and therefore could never provide any adequate energy efficiency. In addition to the existing windows not being energy efficient, I checked with a window repair company and it would not economically feasible .

Windows to be replaced: photos submitted by applicant.

REVISED for 8.20.20 MEETING: Applicant has proposed to repair the original wood windows. Sashes will be removed from frames and moved offsite for restoration. Glass to be removed and cleaned. Portions of the window sashes that have rot or deterioration from metal screws will be replaced and the sashes will be rebuilt, conditioned with linseed oil/turpentine mix, and primed. Glass will be set into reconstructed sash and glazed and windows will be reinstalled after the curing period.

This proposal is to restore the original wood windows at 417 E. Oklahoma Ave. A majority of the sashes have rot and other damages, including damage from screws to hold the sashes in place. Any part of the sash that is damaged due to rot will be replaced. This involves disassembling the sash, replacing the damaged parts, and rebuilding the sash.

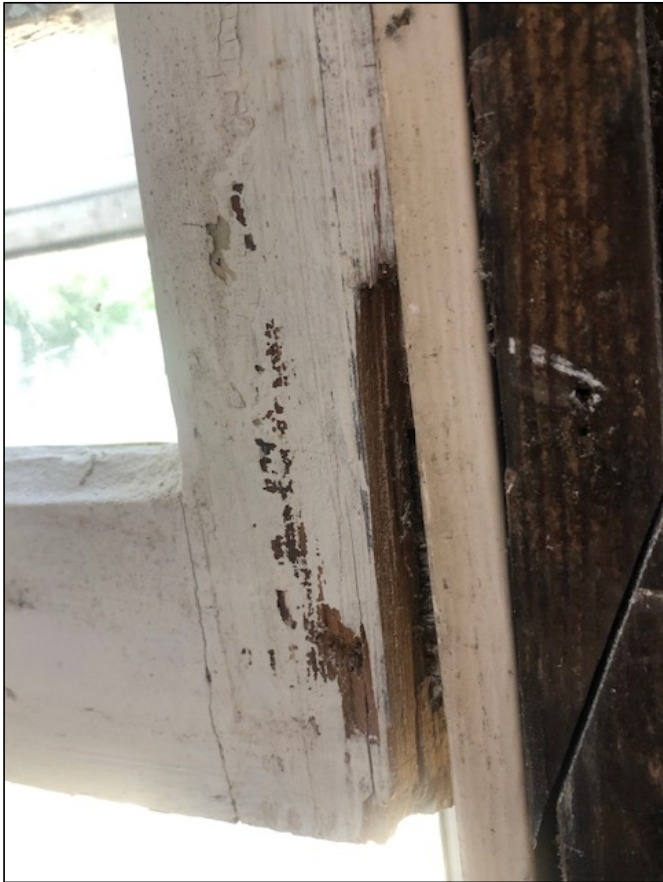
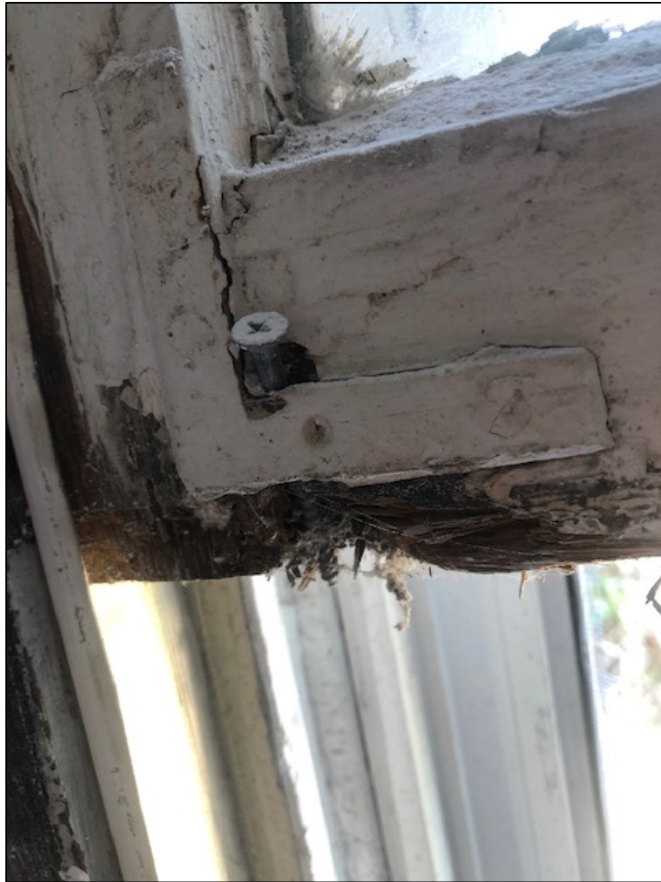
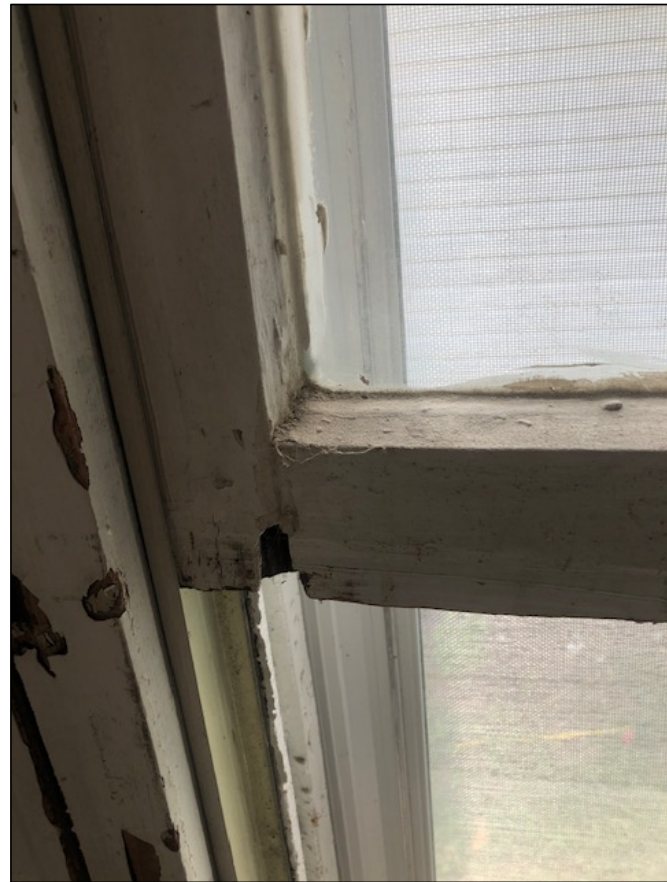
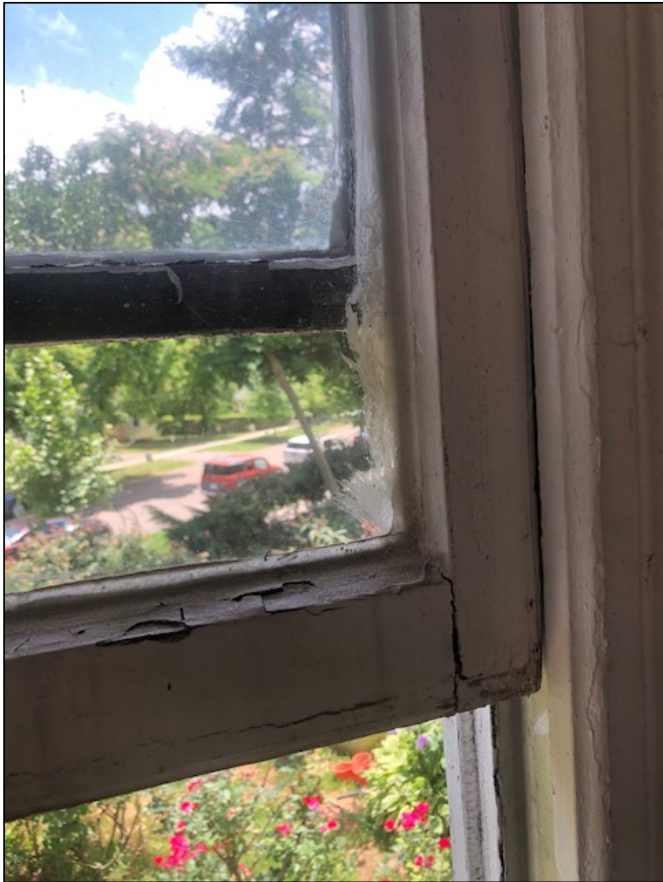
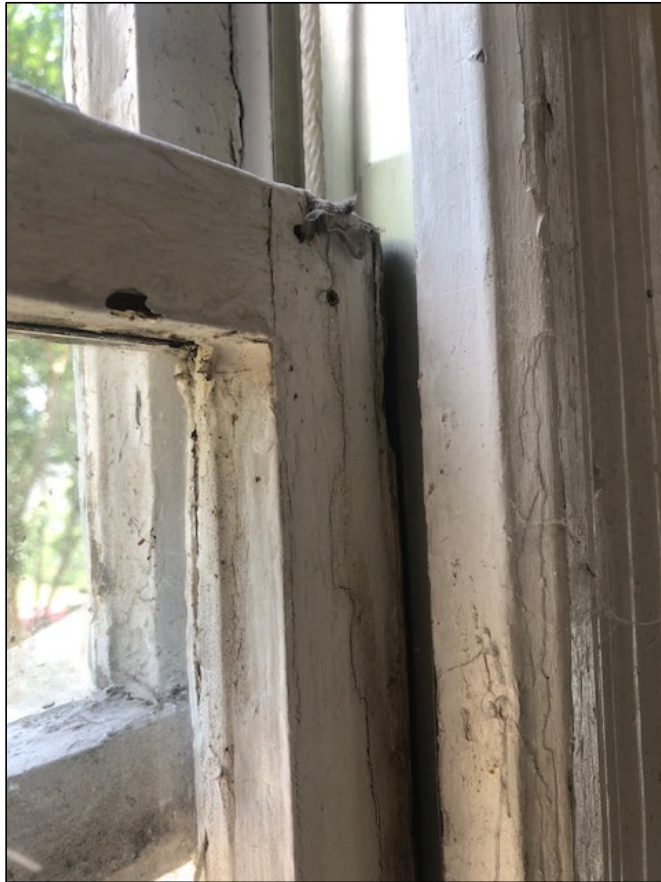
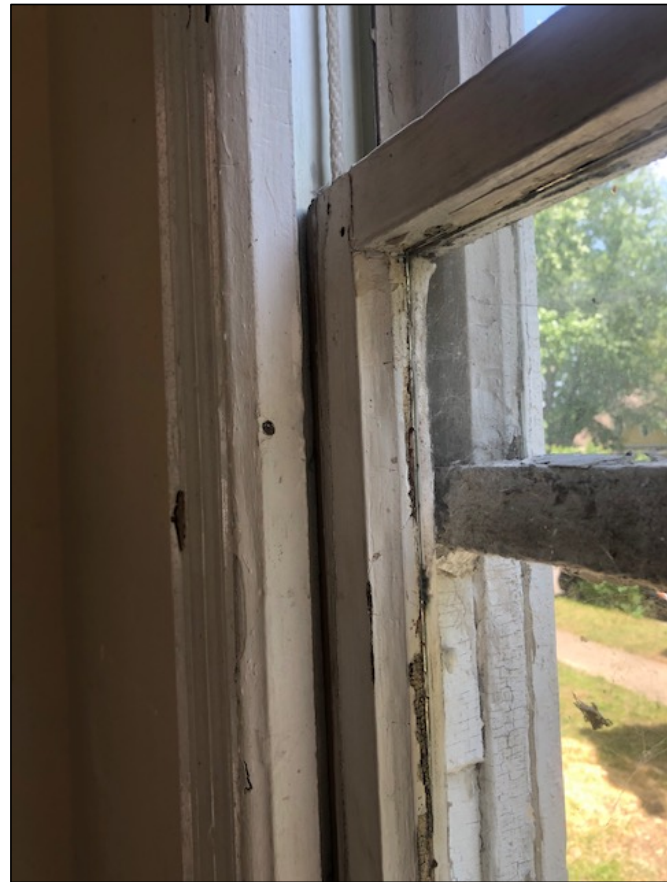
Examples of deterioration: photos submitted by applicant.

Sashes will be removed from the frame and brought back to our shop for restoration. Openings will be boarded up temporarily while the work is being done. Sashes will have all paint and putty stripped. The glass will be removed and cleaned. At this point any damage to the sash will be addressed. Once the sash is rebuilt they will be conditioned with a linseed oil/turpentine mix and primed with 2 coats of an oil based primer. Glass is then set into the sash and glazed. Glazing takes 3-5 days to cure. Once cured the sashes will be given a minimum of 2 coats of paint on the interior and 3 coats to the exterior. If you chose for us to restore the frames, they will be given the same attention as the sashes. Once this is ready, the windows will be installed using Samson #8 spot cord. The current hardware is a mix of new and old, with some damage to the old hardware. We recommend replacing hardware (unless any of the original hardware is in good condition) with new hardware. House of Antique Hardware has a great selection that we can look over and pick out appropriate hardware to match the home. Prices average around \$25 per window. This should be decided on prior to starting the work.
