6-J-20-HZ
APPLICATION FOR CERTIFICATE OF APPROPRIATENESS

238 E. Oklahoma Ave. 37917
Old North Knoxville H-1

Staff Report - Certificate of Appropriateness Application

File Number: 6-J-20-HZ

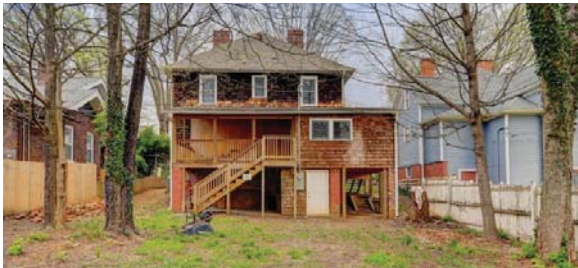
Before - Existing porch

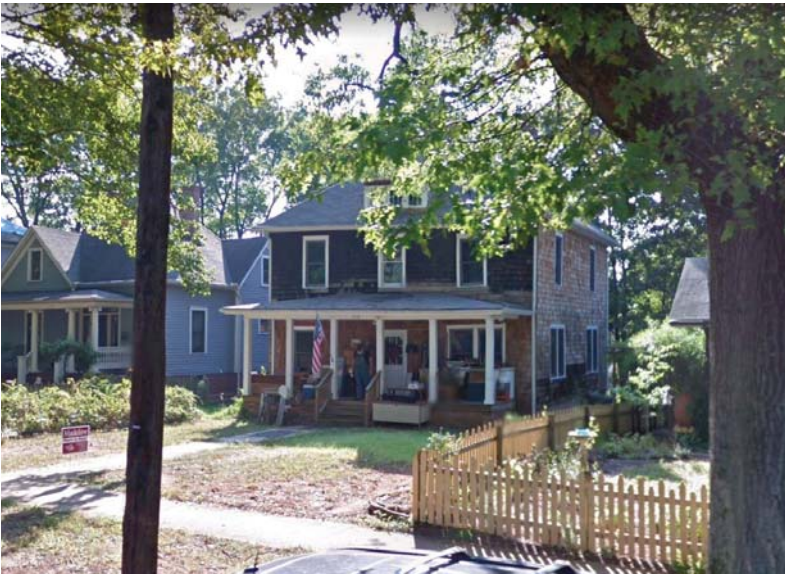
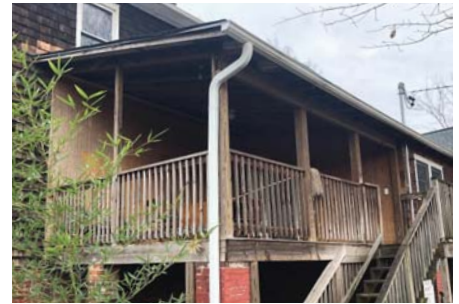
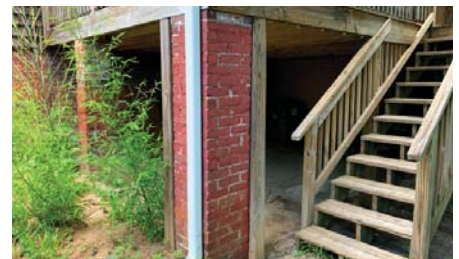
Street View from 2007 shows that even without vegetation, porch is not visible from the street. The siding under the porch is not original, implying what we see is not historic and no historic material will be removed. It also is possible that this was once a closed in porch that was converted to a covered porch.

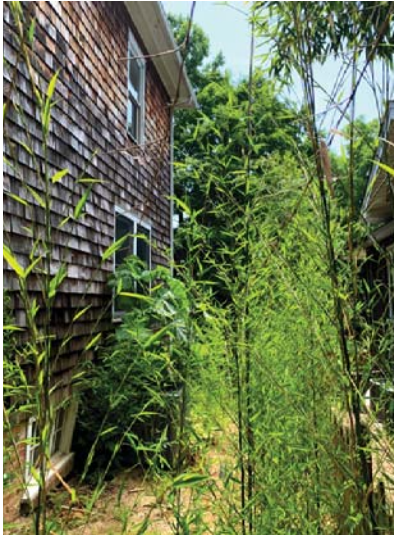
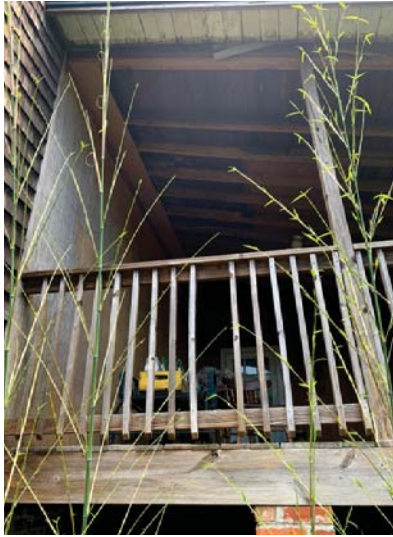
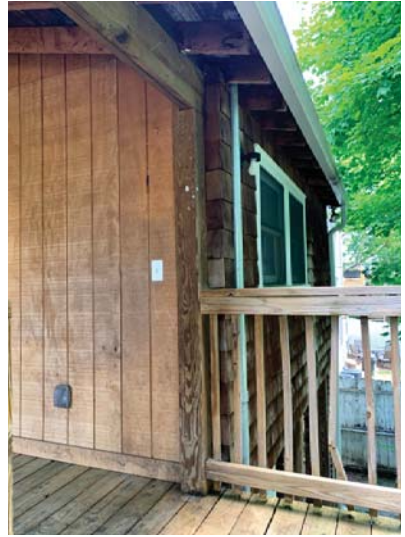
Porch visibility, unoriginal material, and damage. Also visible in left photo, foundation damage.

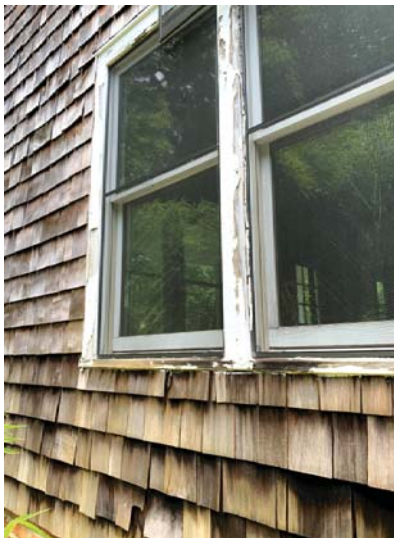
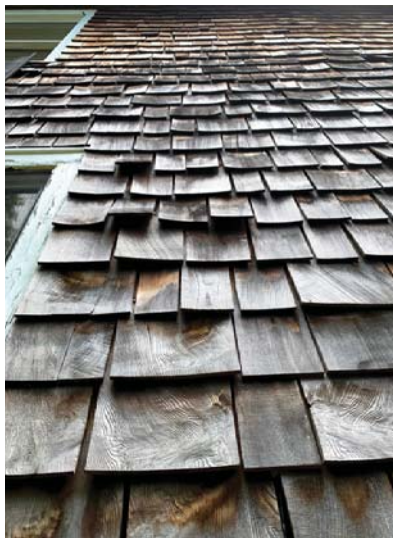
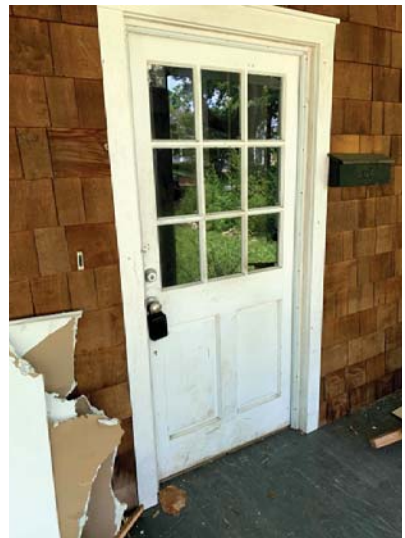
3. The front door is a non-historic modification and replacement with a door that better fits the house's design is appropriate. Specifications on the proposed replacement door should be submitted to staff for review.

Siding and window damage, unoriginal front door from early 2000's.

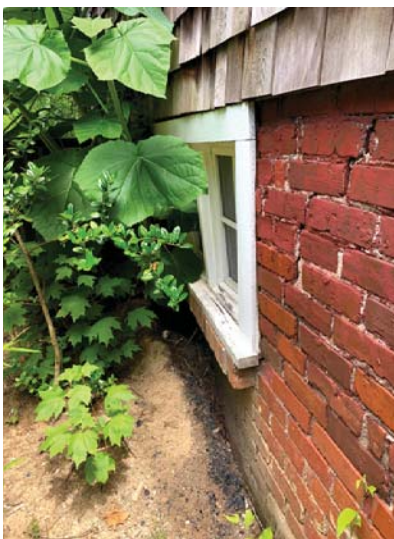
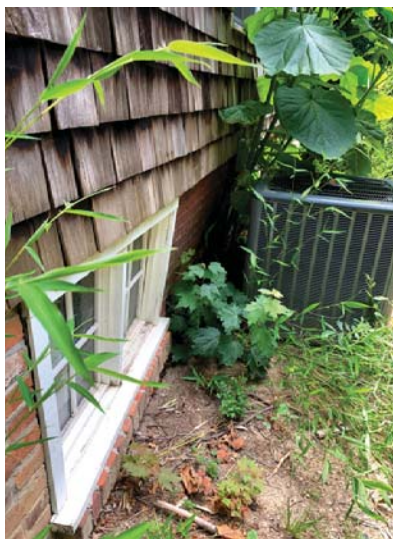
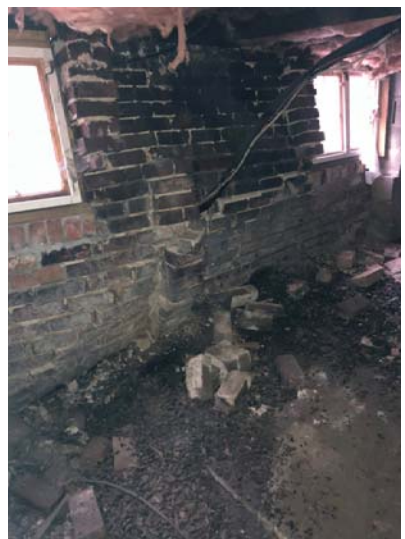
1. 238 E. Oklahoma Avenue is a contributing resource to the ONK National Register Historic District and local historic overlay.
2. Repairs and replacement in-kind in patches of the depicted deteriorated cedar shakes are appropriate within the guidelines. Repair to the masonry foundation, including reconstruction of one section of foundation wall with existing bricks and repointing appropriate mortar meets the guidelines; masonry repointing should meet the specifications of Preservation Brief 2 and utilize mortar with a lime content more appropriate for historic masonry.

Significant foundation damage, inside and out.

Staff recommends approval of the work as proposed, with the following conditions: 1) use mortar more appropriate for historic bricks, type O or type K depending on age of masonry; 2) front door specifications be submitted to staff for approval; 3) a metal roof be selected that better resembles historic standing seam metal originally found in the neighborhood, with a color to meet design guidelines, with approval by staff.
