Staff Report - Certificate of Appropriateness Application

Knoxville Historic Zoning Commission

File Number: 3-F-20-HZ

PROPERTY LOCATION: 215 Sixteenth St. / Parcel ID 94 N E 019

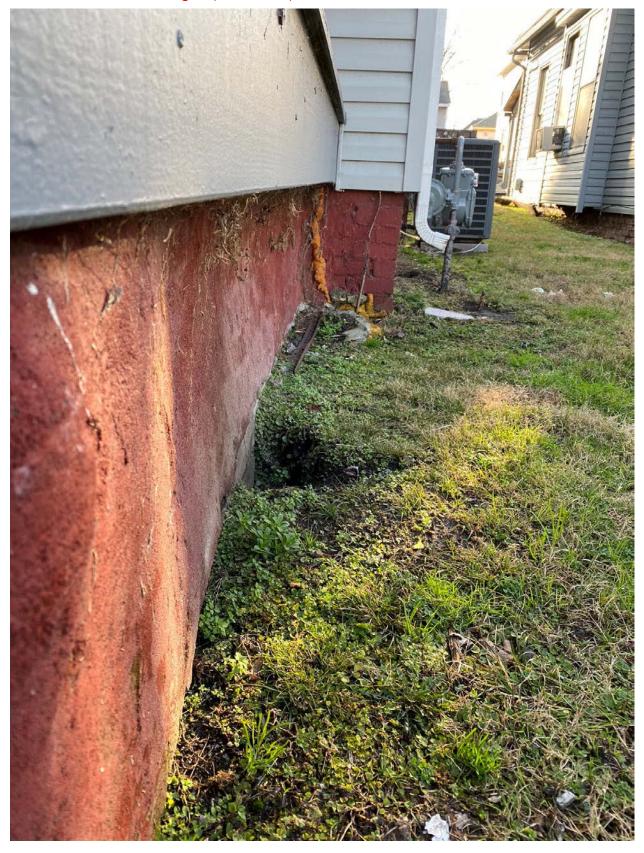
New foundation under window box, it is currently supported with assorted blocks and bricks.

Front foundation collapsing (East) Supported by piecemeal brick and block
