4-G-21-HZ
APPLICATION FOR CERTIFICATE OF APPROPRIATENESS

404 E. Oklahoma Ave. 37917
Old North Knoxville H

Original Print Date: 4/6/2021
 Knoxville/Knox County Planning -- Historic Zoning Commission

Level II Major Repair or Replacement

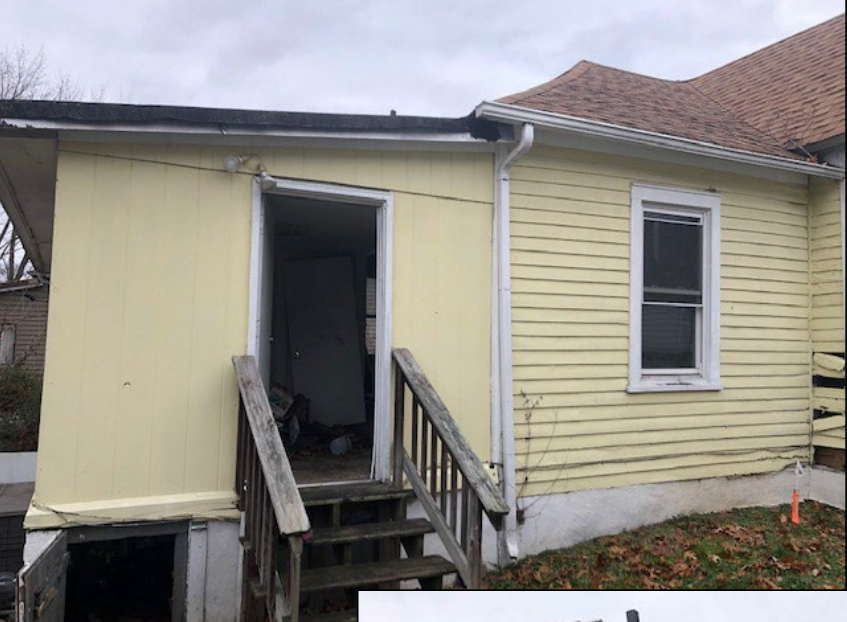
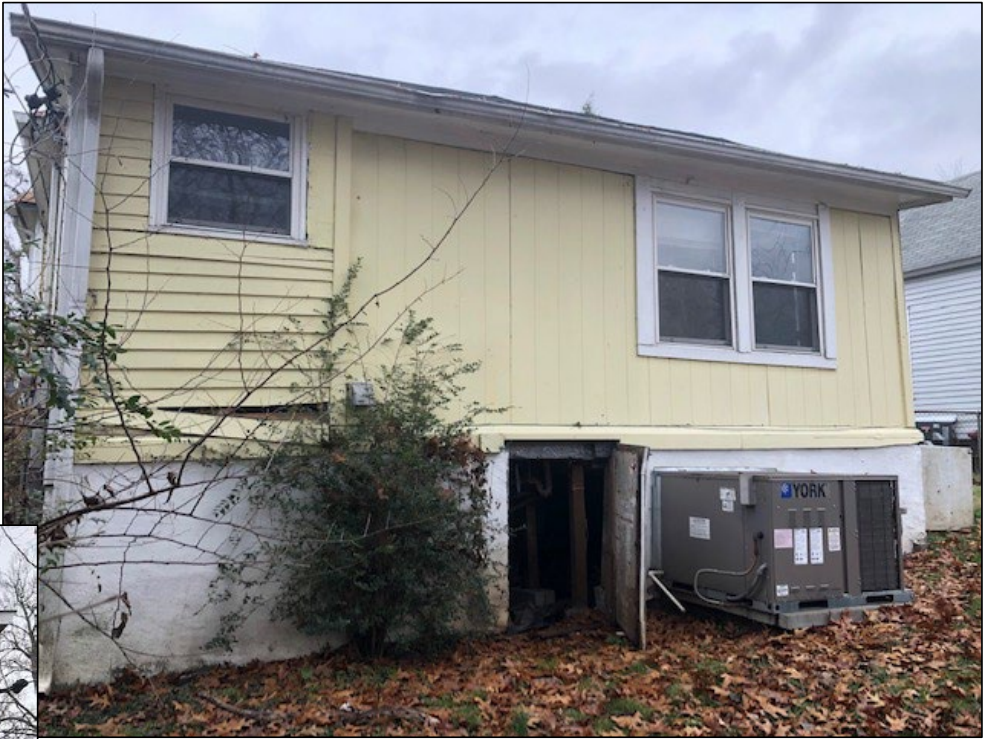
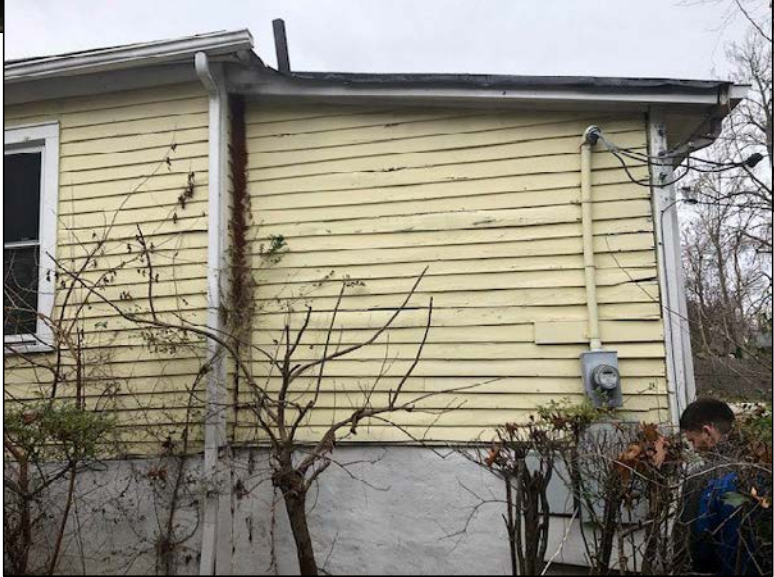
Previous rear addition

Photos of the previous rear addition show a small (under 1 foot) inset on the house's right side. The addition has now been constructed flush with the primary residence, with a flat roofline continuing from the primary hipped roofline.

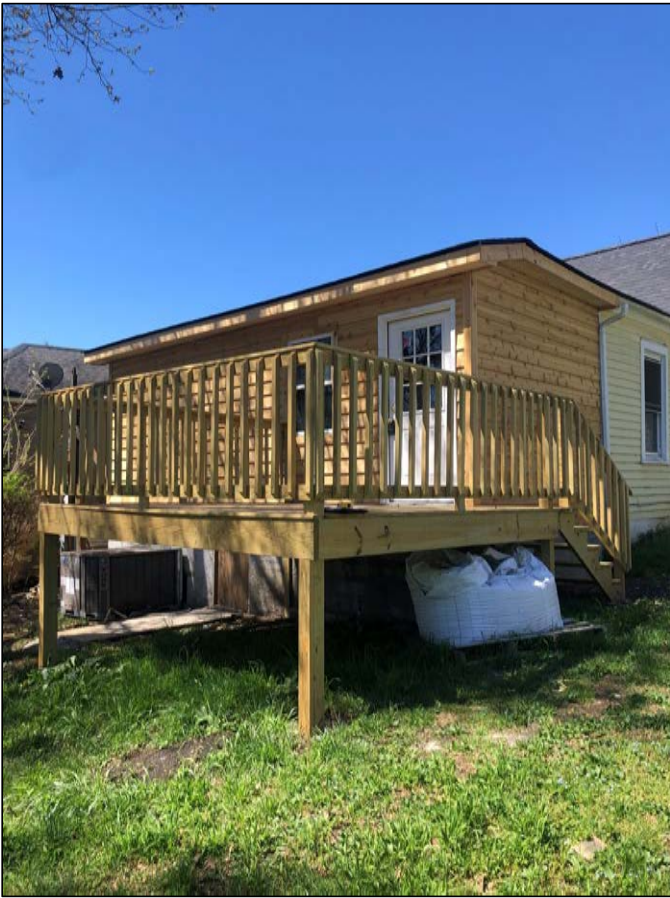
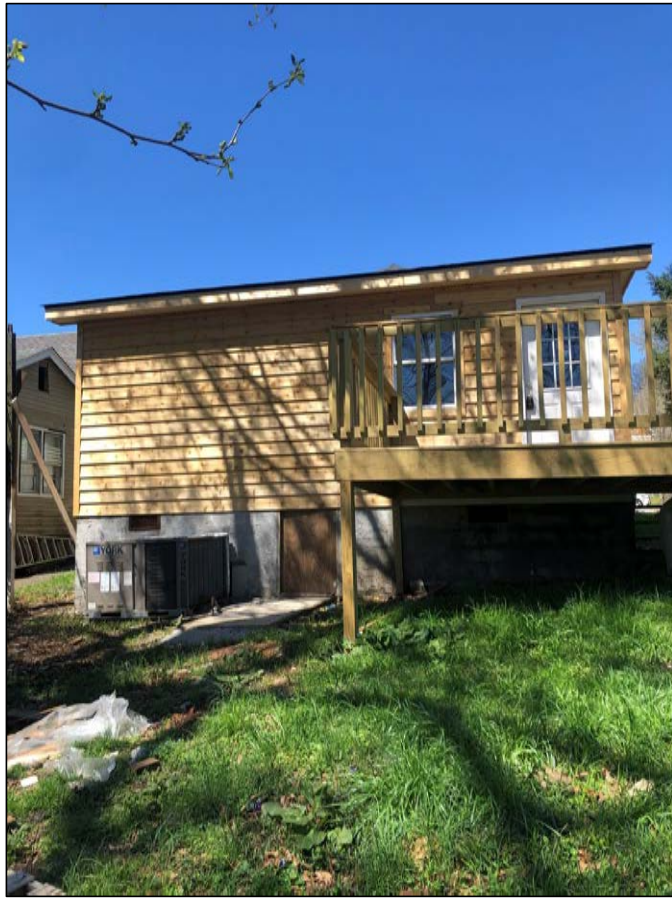
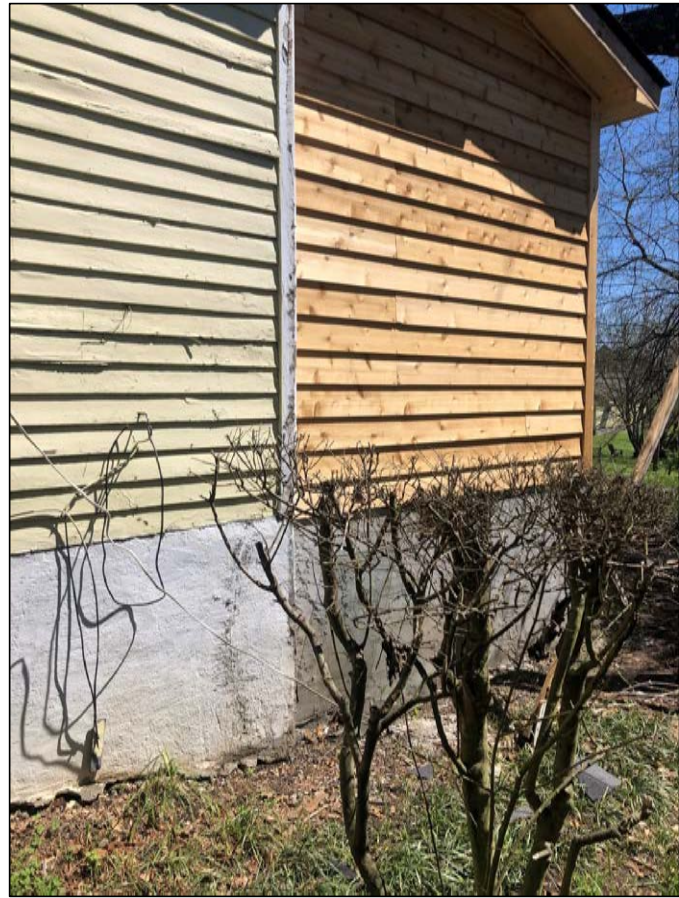
Rear addition and deck

New addition extends flush with the side elevation walls, with a primarily flat roof with a small shed-roof section sloping to the rear. The new addition is clad in wood siding with a ~6-8" overlap (compared to the 4-5" overlap on the existing house) and rests on a stuccoed foundation. A multi-light, fiberglass or vinyl door is located on the rear elevation, adjacent to a one-over-one, double-hung vinyl window.

A new rear deck has also been constructed, described in the application as 11' by 12', and 40-48" off the ground. The deck features square pickets attached to the sides of the rails, and a staircase that extends towards the front of the property line. The applicant is proposing to remove the deck and install a 4' by 4' wood stoop with steps to access a rear entry door (see site plan).

The Commission should discuss whether the new rear addition is sufficiently differentiated from the primary house, and what other tactics the applicant may take to differentiate the new addition from the original house. At minimum, the applicant should incorporate wood cornerboards (vertical trim piece) to differentiate the new addition from the primary house. The rear addition should also feature an additional window on the left side of the rear elevation, which is currently a large expanse of siding with no transparency. The Commission may choose further recommendations regarding the rear addition to meet the "additions" section of the design guidelines.

Staff recommends approval of the removal of the deck and construction of a 4' by 4' wood stoop, with specifications of stoop materials, height, support posts, balustrade, and stair rails should be submitted to staff for approval. Staff also recommends approval of enclosing the recessed corner façade entry and replacement of the plywood enclosing the primary entry with a new door; staff recommends denial of the submitted Craftsman-style door and submittal of a Queen Anne/Folk Victorian-style door to staff for approval.

The Commission should discuss the current rear addition's differentiation from the original house. At minimum, staff recommends the installation of vertical trim mimicking cornerboards to separate the two massings, and the installation of an additional one-over-one, double-hung wood window on the left side of the rear elevation.

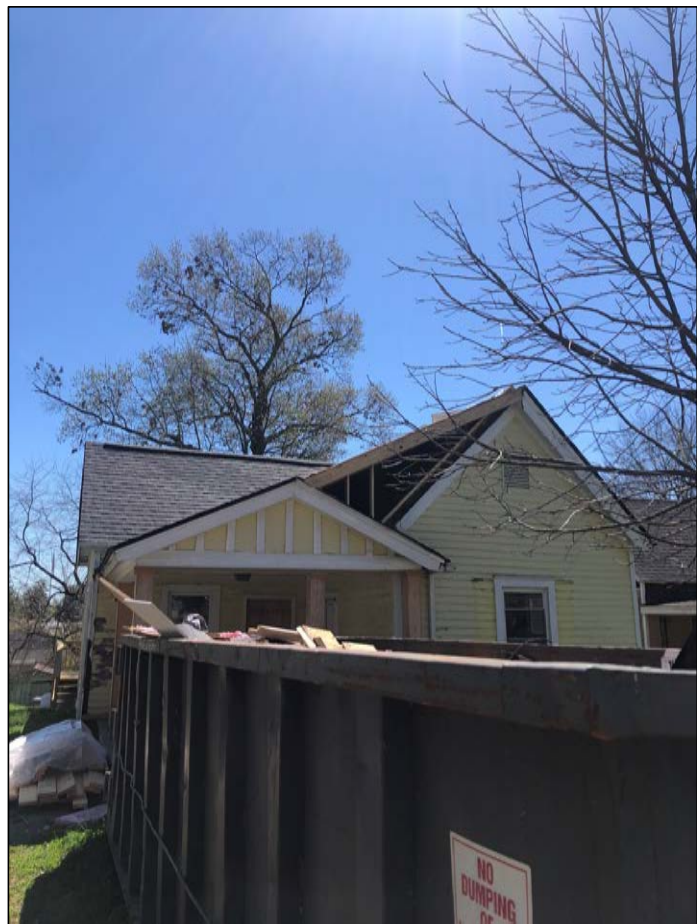
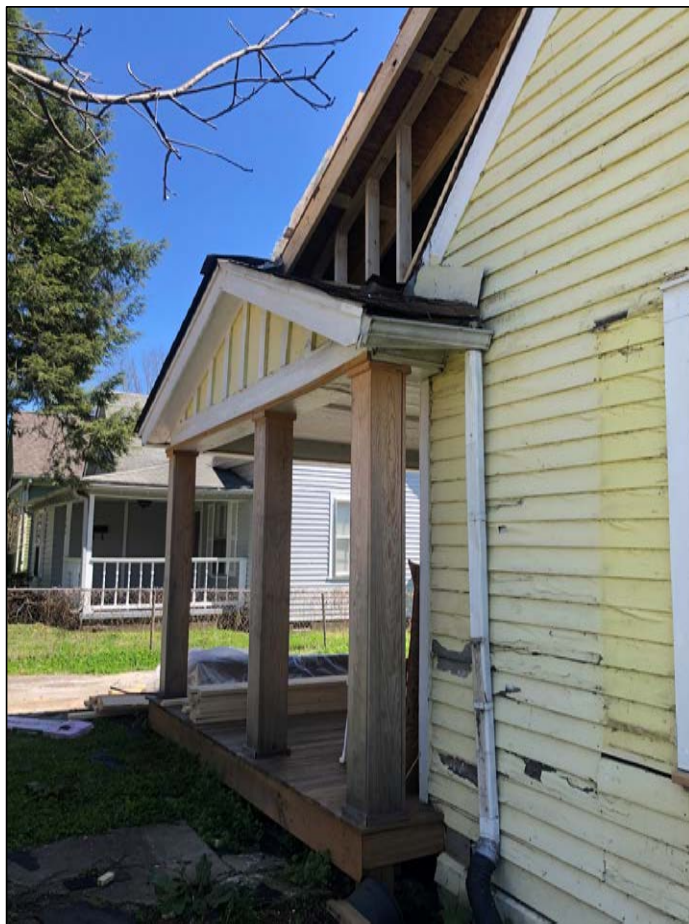
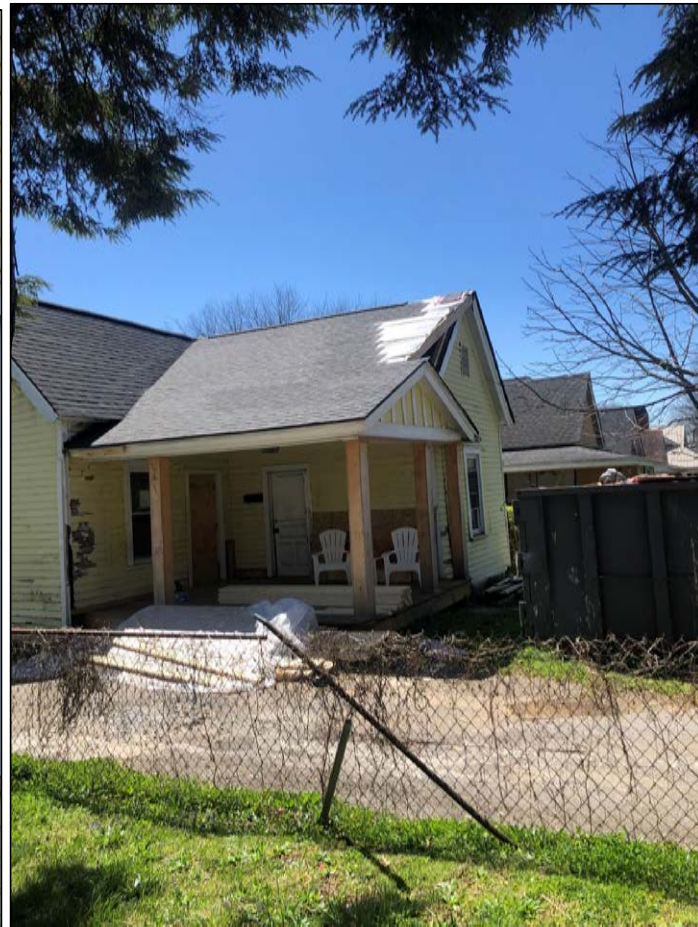
Roofline modifications

Before roofline modifications, the house featured a primary front-gable roof massing projecting from the right half of the façade, intersecting with a front-gable roof porch projecting from the left half of the façade. The applicant built a new roof section to connect the right-side gable-roof massing with the porch roof. To rectify this, the applicant is proposing 1) keeping the roofline modifications as currently installed or 2) installing a pitched "iceshield" element and covering it with asphalt shingles.

4. The roofline modification as completed (proposed as Option 1) does not meet the design guidelines and should be removed. The house is a Folk Victorian, with numerous comparable designs in the block and neighborhood. The 1917 Sanborn Fire Insurance Map shows the porch's original footprint, which was an L-shaped corner porch. Similar houses in the neighborhood feature low-pitch hipped or shed rooflines. The front-gable roof porch, projecting approximately 1' out from the primary house, was a non-historic modification. The front-gable porch roof intersects with the main front-gable roof and creates a flat section without drainage, contributing to roof leaks and deterioration. The small, non-draining section at the roofline intersection is the element the applicant aims to mitigate.

Staff recommends removal of the unpermitted roofline modifications and postponement of the review of further modifications to the roofline to allow for further information to be presented to the Commission.

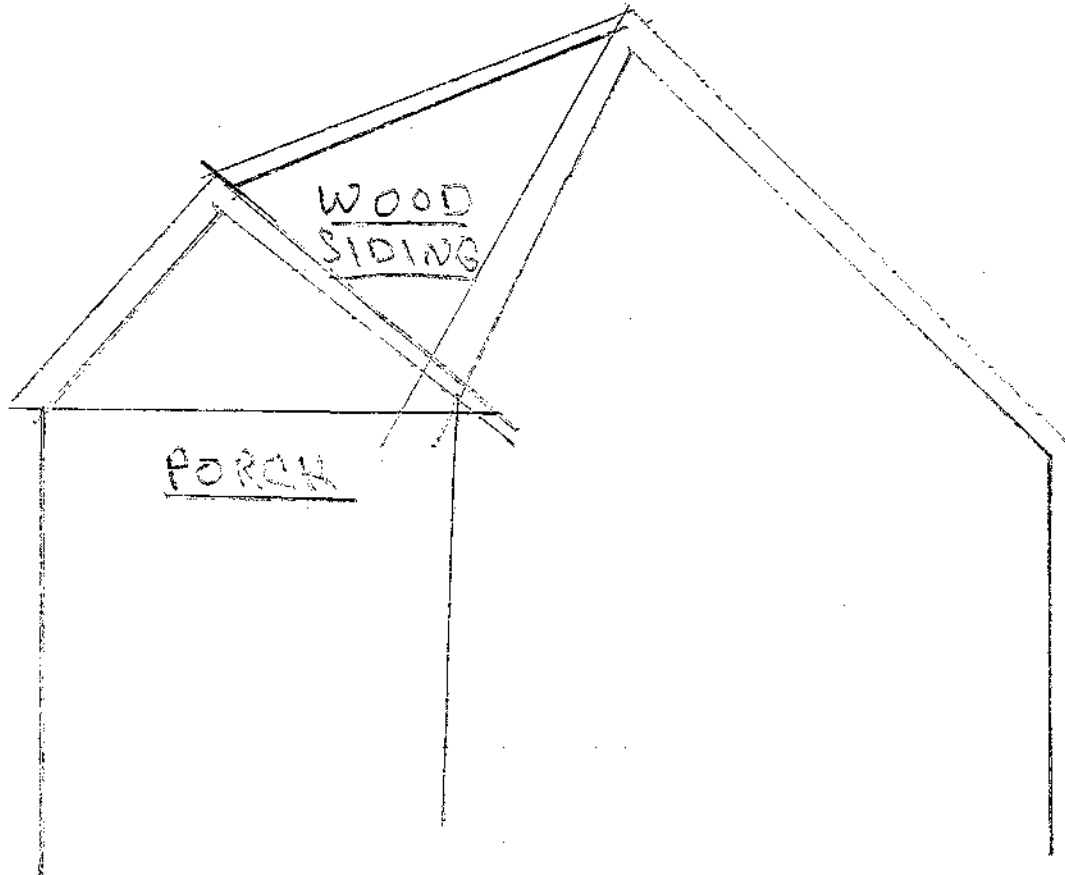
OPTION 1

This is the way it is now.
See similar homes in this
neighborhood with like
roof lines. Several framers
and roofers we have consulted
with. All agreed this is the best
way to solve the water and
roof drainage problem, and comply
with design guidelines.

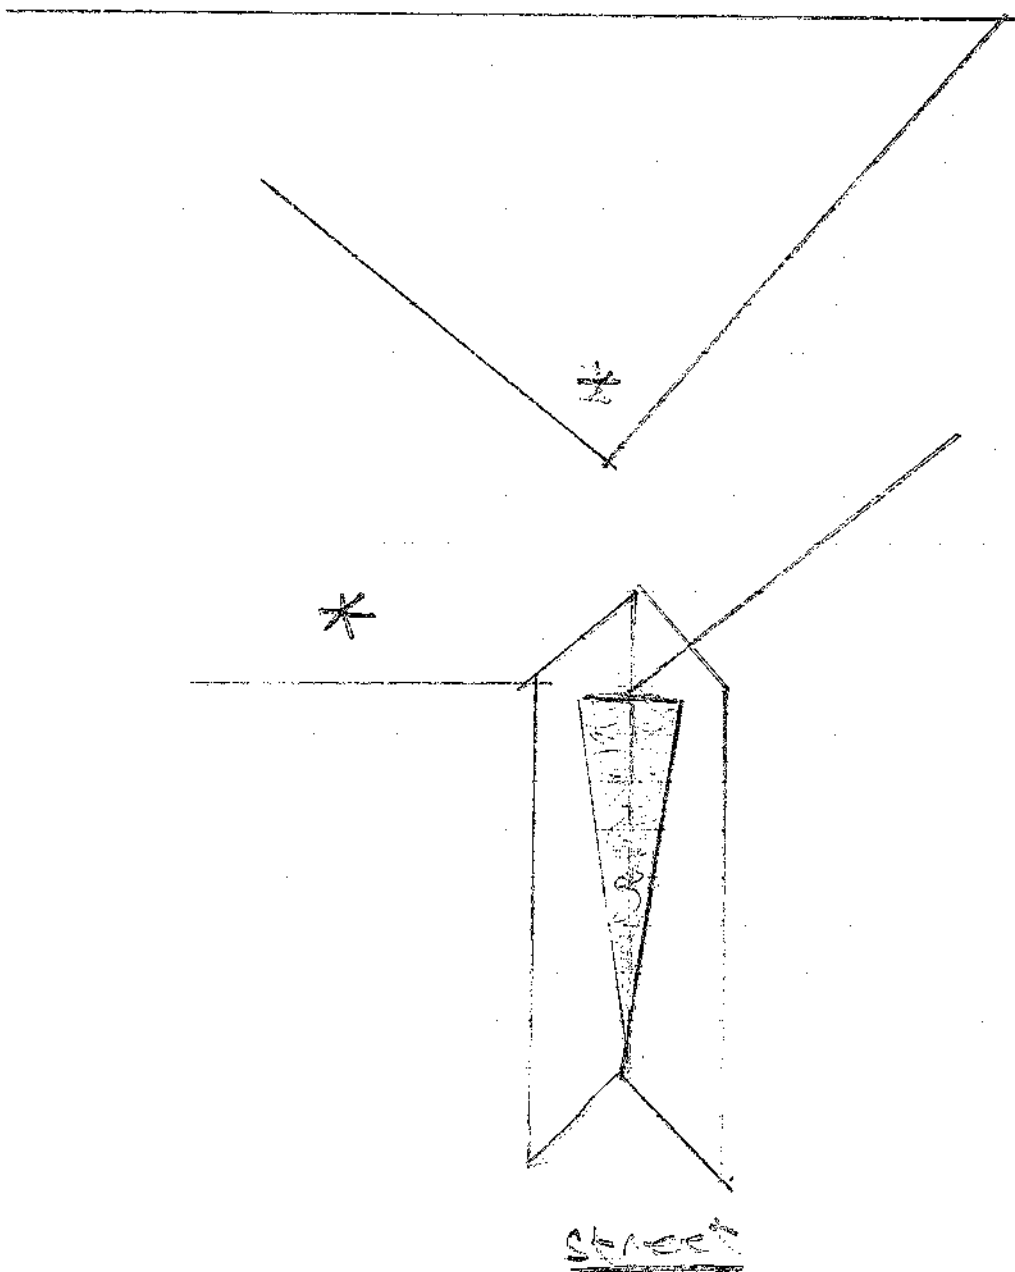
OPTION 2

Further information on Option 2 is needed, including specifications of the "iceshield" element and a rendering showing that the new element and shingles would not be visible from the street.

put back like it was with Icesfield
and covered with shingles with
slight pitch, not visible from street.
