8-A-21-HZ
APPLICATION FOR CERTIFICATE OF APPROPRIATENESS

1404 Kenyon St. 37917
Old North Knoxville H

Original Print Date: 8/9/2021
 Knoxville/Knox County Planning -- Historic Zoning Commission

Level I/II Routine Repair, Major Repair or Replacement

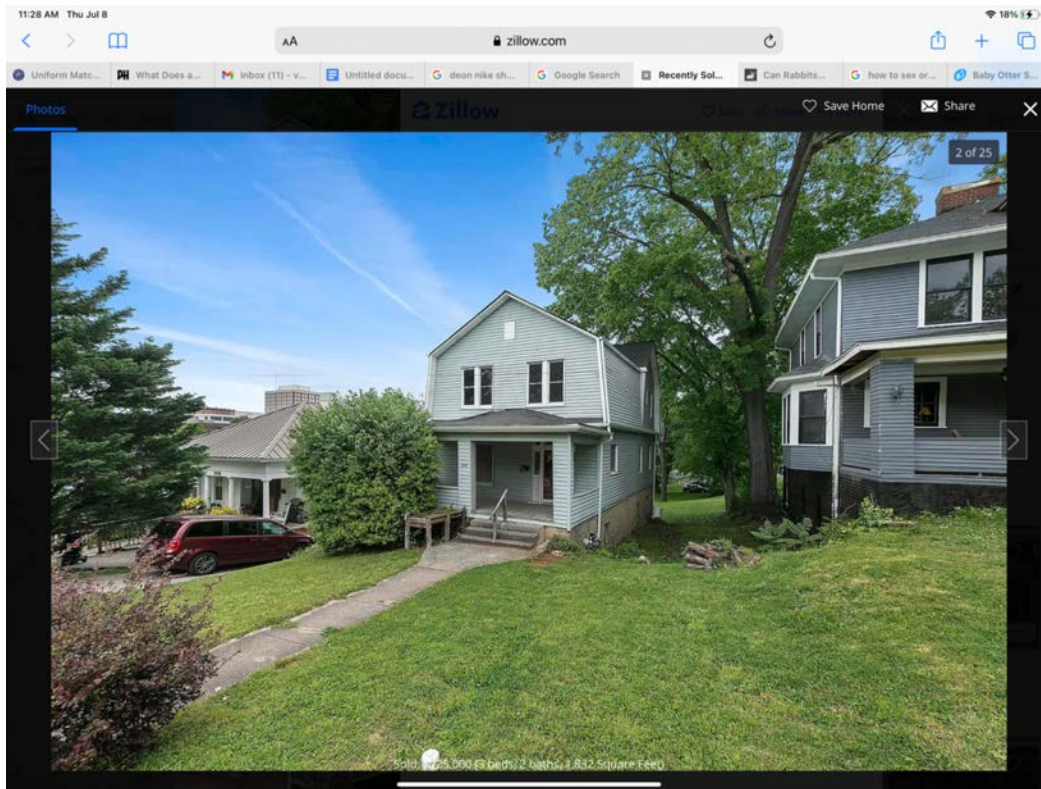
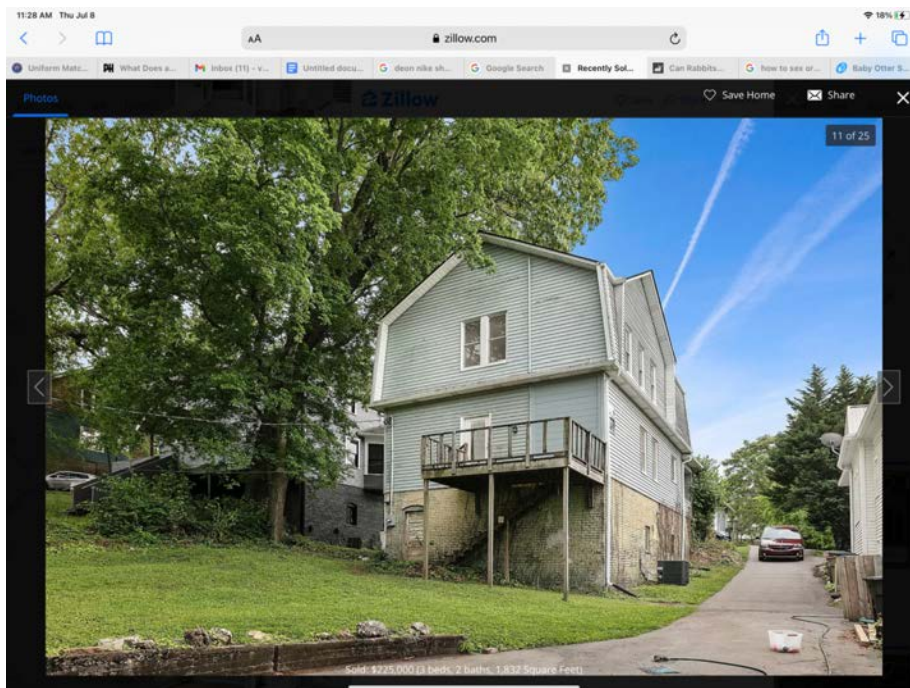
Description of work: When we took ownership of 1404 Kenyon Street the first and second story of the house was wrapped in vinyl siding. The previous owner had also put an addition on the back of the house, which they sided in Hardie siding on the rear of the house, and plywood on the northeast corner. Upon removal of the vinyl siding, we have found that the original siding on the first story was retained, while the original siding on the second story had been completely removed. The siding on the first story is in varying condition, most of which is salvageable. The original exterior window trim seems to remain on most windows. The foundation consists of the original brick, which is intact.

Fig. A and B: 1404 Kenyon exterior from listing photos front facade (above) and rear facade (below), sided in vinyl.

Other plans to the exterior include replacing the Hardie siding and plywood on the addition of the house with lap siding to match the existing siding on the first story. We will be repairing the existing siding where needed, and replacing or filling in small areas of the siding where it's missing. We will be re-supporting the deck on the rear of the house, and fixing the stairs so that they meet the requirements of the current building code. All existing exterior doors, windows, and trim is to remain, but will be repaired if needed. All repairs will be done in the style of the existing trim. The attic vent on the front gable of the house will also be repaired, or reconstructed.

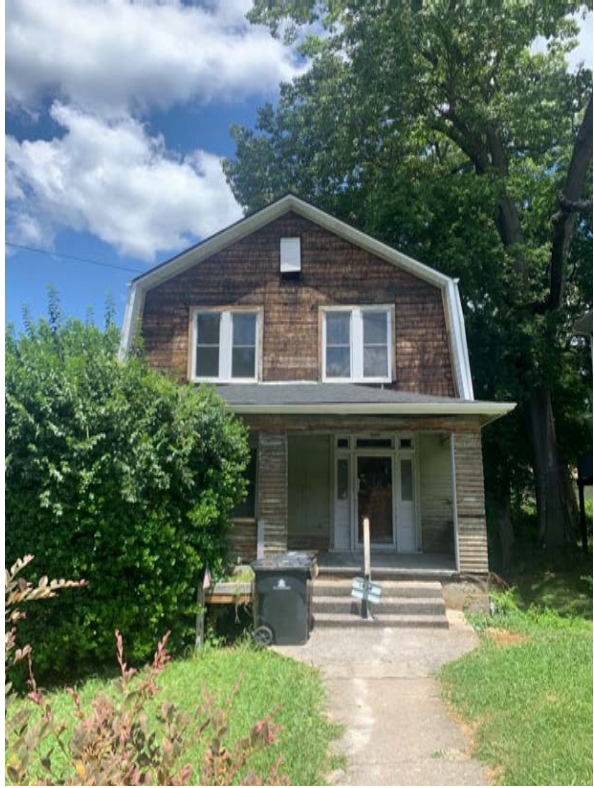
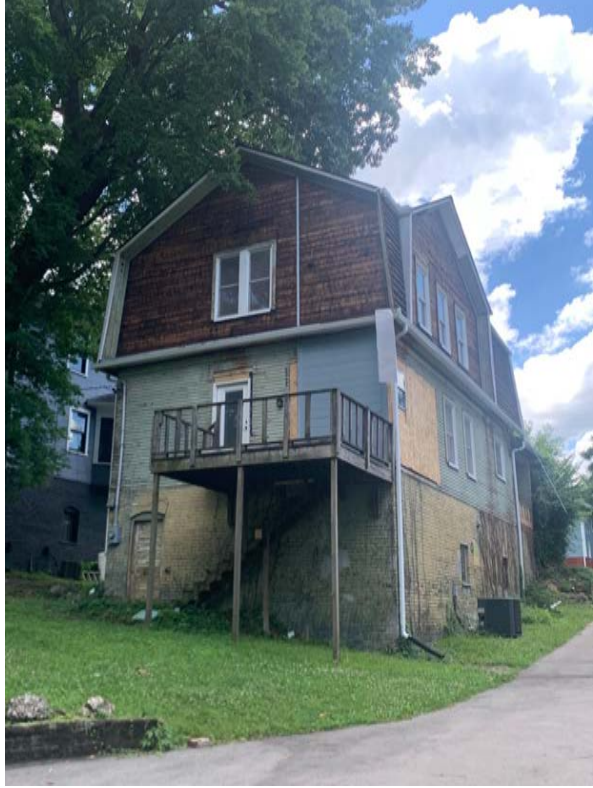
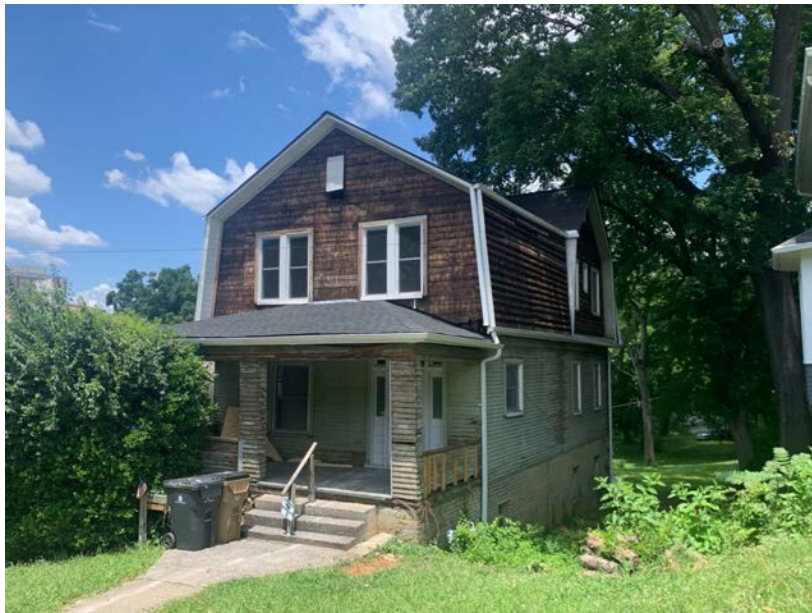
LEVEL 2 SCOPE OF WORK: No siding currently exists on second-story elevation; removal of vinyl siding uncovered wood sheathing only. Applicant requests to install wood shingle siding, replicating general size and pattern of historic siding, on façade elevation gable field only. Side elevations would receive wood lap siding to match the first story.

Fig. C, D, and E: 1404 Kenyon upon removal of vinyl siding from front (left) and rear (right), and southwest corner.

We propose to install cedar shake on the front gable of the house, to match the historic photo, and lap siding on the sides and rear of the house to match the existing siding on the first story. The house sits between two other houses, there is no driveway and no public access to either of the sides or rear of the house. There is an alleyway that runs behind the house; however, this alley was abandoned by the City decades ago and has been taken over by neighboring properties. The alleyway is not accessible from any public right-of-way, and is blocked by fencing installed by neighboring properties, and views of the house from nearby public areas are blocked by other houses and mature vegetation. Thus, the rear of the house is not visible, nor is it accessible, from any public right-of-way. The lots on this street are narrow, which constrict the view of the sides of the house as well.

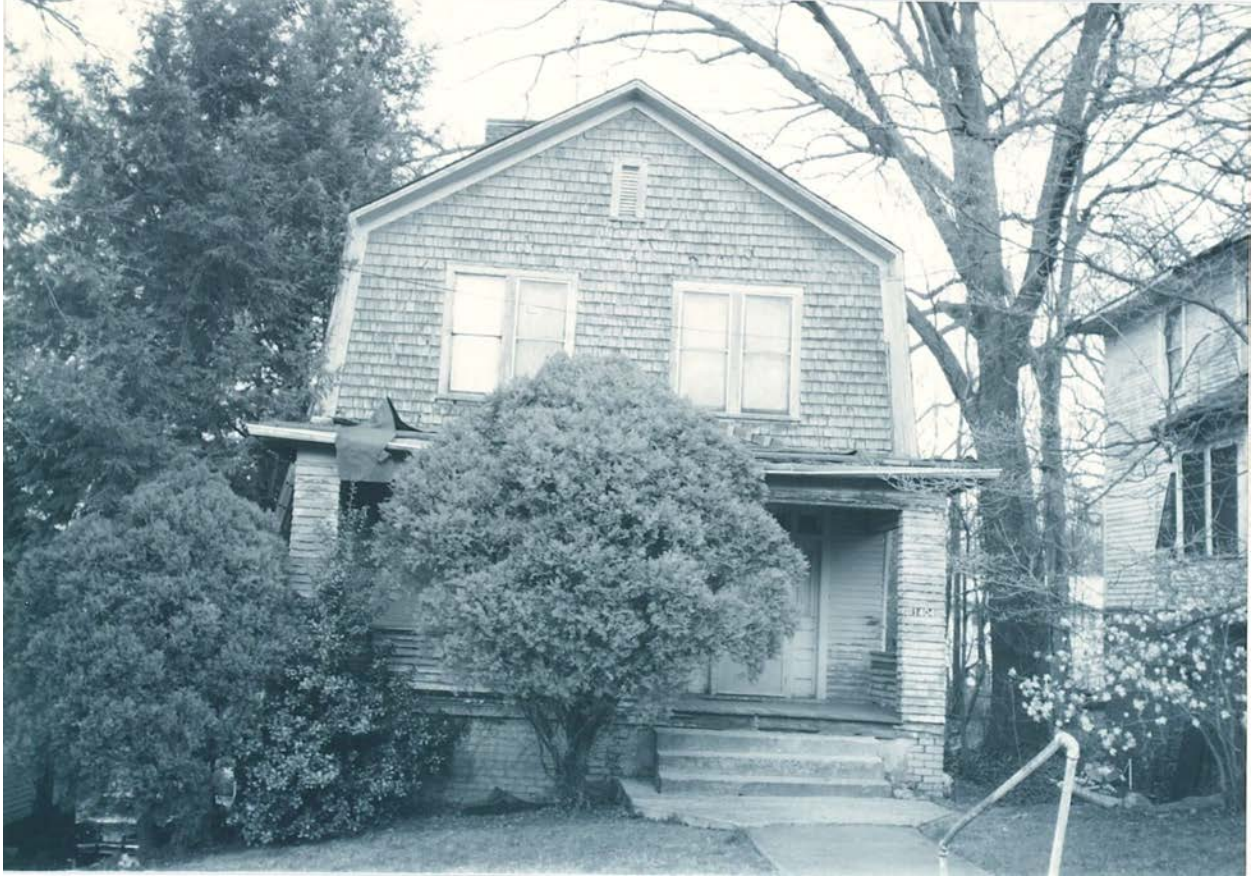
3. An archival photo from 1992 shows the façade's second story clad in wood shingle siding. Dating to 1992, the NR nomination also lists the weatherboard and wooden shingle wall covering" as character-defining feature of the house.

Figs A and V below show the house as it was purchased from the MLS, and Fig C, D, and E show the exterior of the house after the vinyl siding was removed. The only known historic photo of the house was produced by the City (Fig F) which is estimated to have been taken in 1990. It shows the front gable sided in cedar shake, but does not show any other side of the house. No historic photos showing the original siding on either the sides or rear of the house have been found.

Fig. F: Earliest known photo of 1404 Kenyon, taken sometime around 1990.

Staff recommends approval of the installation of new siding, with the front, side, and rear gable fields to receive wood shingles to reflect the original siding pattern; providing for discussion between the Commission, applicant, and neighborhood on the second-story sections outside of the gable fields.
