3-K-21-HZ
APPLICATION FOR CERTIFICATE OF APPROPRIATENESS

1319 Grainger Ave. 37912
Old North Knoxville H

Original Print Date: 5/5/2021
 Knoxville/Knox County Planning -- Historic Zoning Commission

Level 2 scope of work, for HZC review 5.20.2021: Proposed replacement of three porch columns: two corner columns on the first-story porch (east and west) and one leftmost (west) corner column on the second-story porch. Two-story porch features six round fluted columns on the first story and five round fluted columns on the second-story porch. Due to water intrusion from weather, failing gutters, and adjacent large trees, three corner columns have rotted. Applicant is proposing the installation of fiberglass reinforced polymer columns instead of wood. On the first-story porch, round fluted columns will measure 9' overall in height and 12" in diameter, with a slight taper to match the existing columns. On the second-story porch, columns will measure 8' overall in height and 10" in diameter. Columns will be smooth-finished on top of square base. Historic capitals to be retained, repaired, and installed on top of new columns. Historic wood railing to be retained.

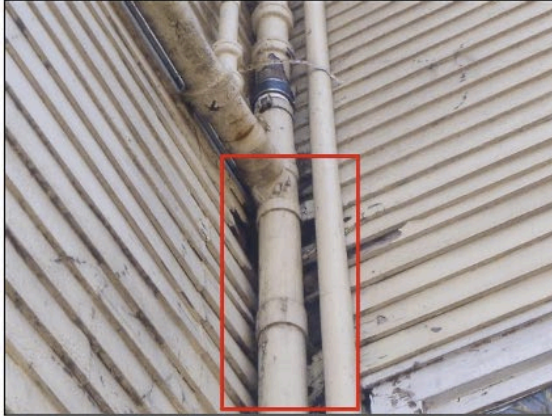
- Areas of significant wood rot in the siding around the house
- Missing siding on the left side of the house

2.0 Picture 1 Areas of significant wood rot in the siding around the house

Recommend a licensed contractor evaluate, repair or replace as necessary

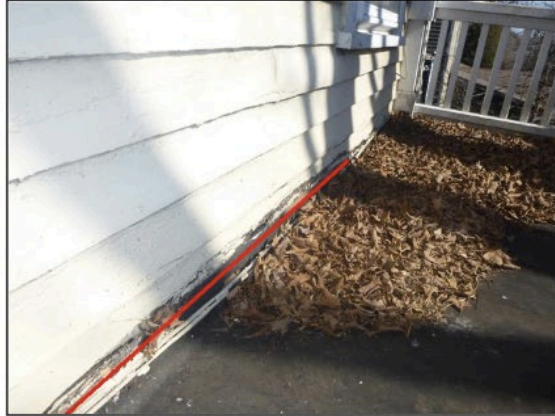
2.0 Picture 2 Areas of significant wood rot in the siding around the house

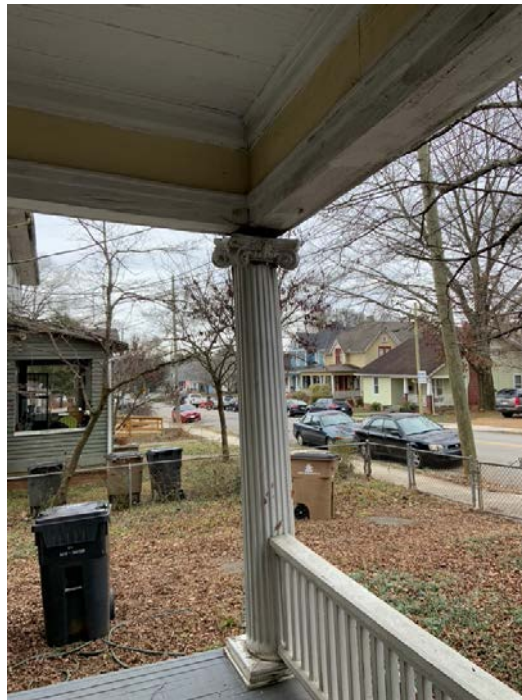
Column Repair—Due to gutter malfunctioning, a bottom porch column has rotted out from water damage. It is no longer supporting the above veranda. A new wooden column matching prior specifications will be put in place after above wood rot and gutter repair is completed.

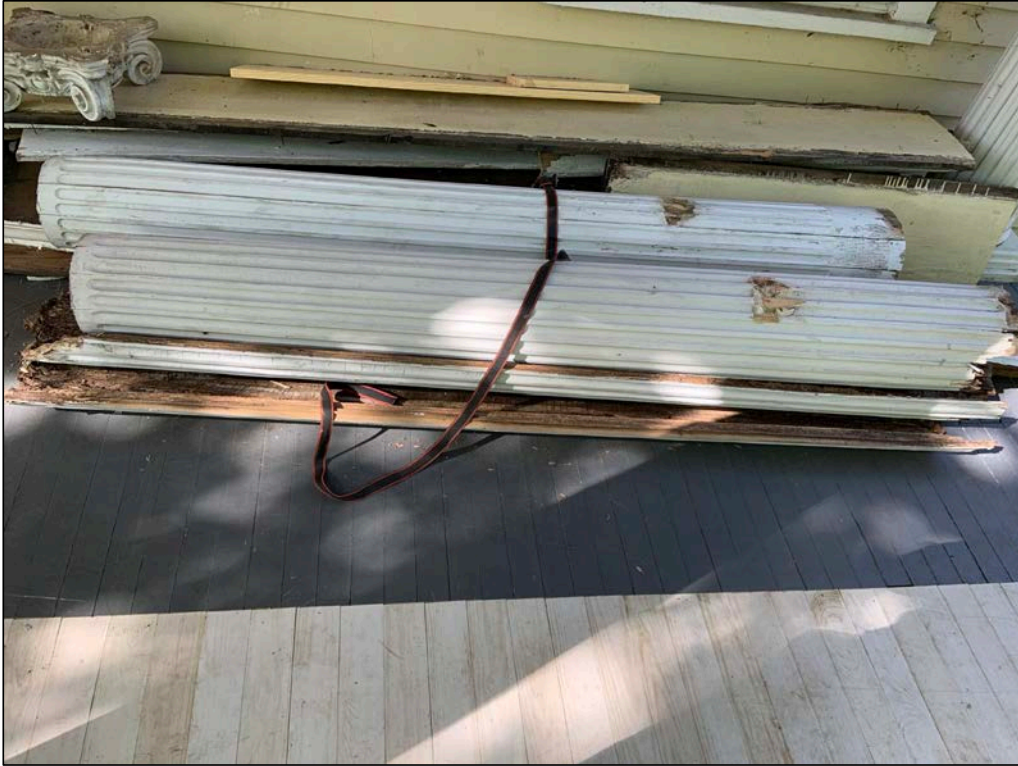
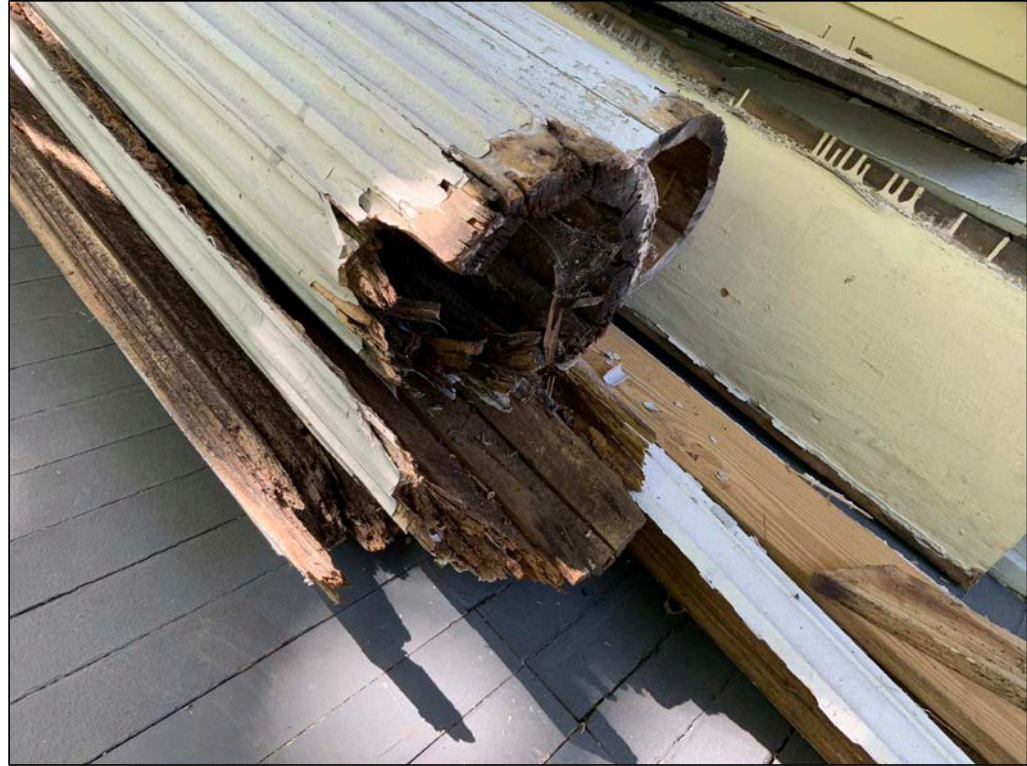
3. The exterior of the house experienced some deferred maintenance, especially in due to a unique gutter system which ultimately failed and has fed a significant amount of water along the corner columns for several years. The two-story front porch is also surrounded by older-growth maple trees, which contributed to the gutters clogging and water runoff into the columns.

4. The applicant has provided several photos showing the columns' deterioration, especially the rot along the bottom, where the columns would attach to bases. Photos show the east first-story column leaning; the contractor has stated the column was approaching a point where it could not support the second-story porch. The columns were temporarily removed to move forward with porch flooring and gutter repairs.

Photos of columns submitted by applicant

- 1) retain and reinstall existing railings; retain, repair, and reinstall original capitals; and install bases with placement, dimensions, and design to match existing;
- 2) replacement columns be confirmed to match size, taper proportions, fluting detail of wood columns;
- 3) confirmation of color, surface texture, and reflective surface to be compatible with the existing columns;
- 4) information to be provided to staff on column ventilation to minimize expansion/contraction issues which could negatively affect the original capitals.

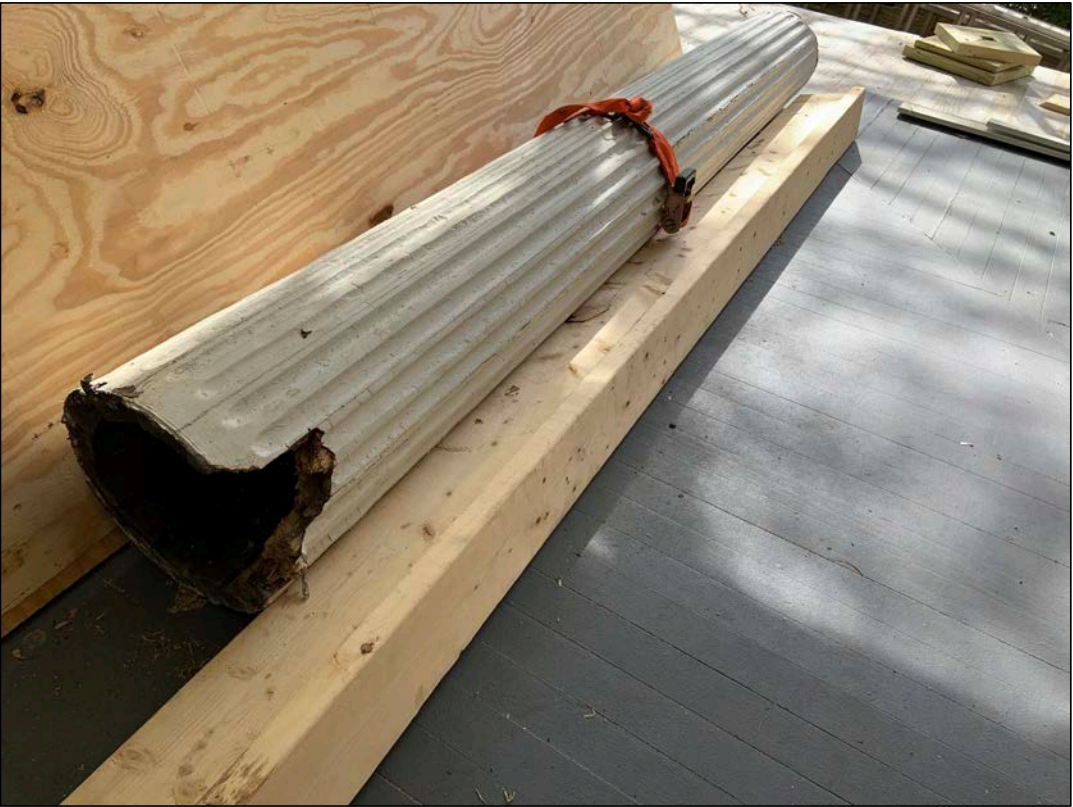
Photo of columns submitted by applicant
