9-B-21-HZ
APPLICATION FOR CERTIFICATE OF APPROPRIATENESS

**317 E. Oklahoma Ave. 37917**
Old North Knoxville H

Original Print Date: 9/1/2021
 Knoxville/Knox County Planning -- Historic Zoning Commission

Level II Major Repair or Replacement
Porch rehabilitation project.

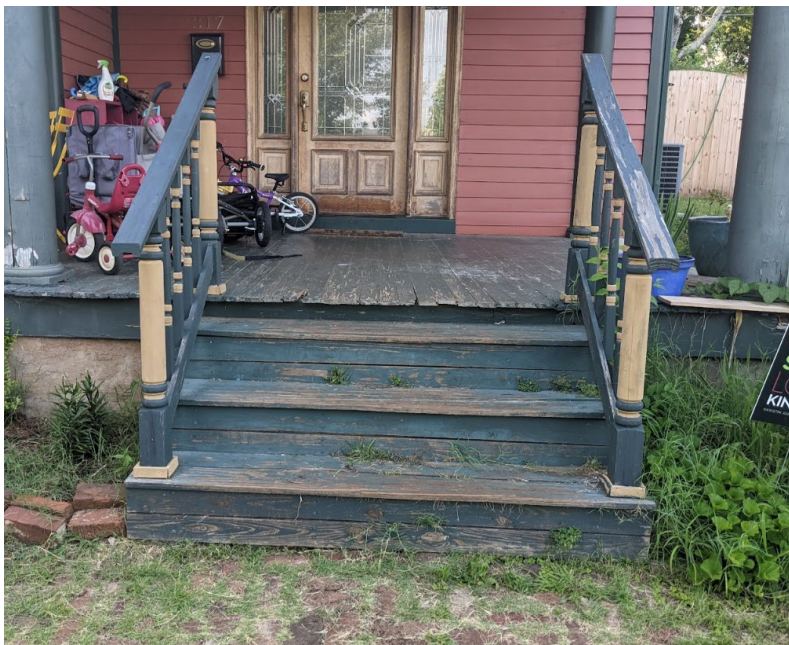
9. The handrails and wood flooring covering the concrete stairs are not original to the house and removal is appropriate. The expansion of the steps' width will make the steps more proportionate to the overall façade width. The 13" thick cheek walls are modest in design, can be seen on comparable properties throughout the district, and will not detract from the house's overall integrity.

Deteriorated wood overlay on concrete steps

In addition, this proposal includes removal of the improperly installed wood hand railing and overlay mounted to the existing concrete stairs, and expand the stairs from the current 5.5' width to a 10' width. Inclusive in the proposed expansion is the addition of adjoining cheek walls on either end of the stairs. This design aligns the stairs to run from the eastern most column to the next column to the left. These cheek walls are found commonly within this and adjacent neighborhoods on similar home styles, and would match well to the styling of this house. The expansion of the steps will conceal the asymmetric location of the main entrance to the home as seen between the two eastern most columns, and provide easier to use and more stable access to the home.

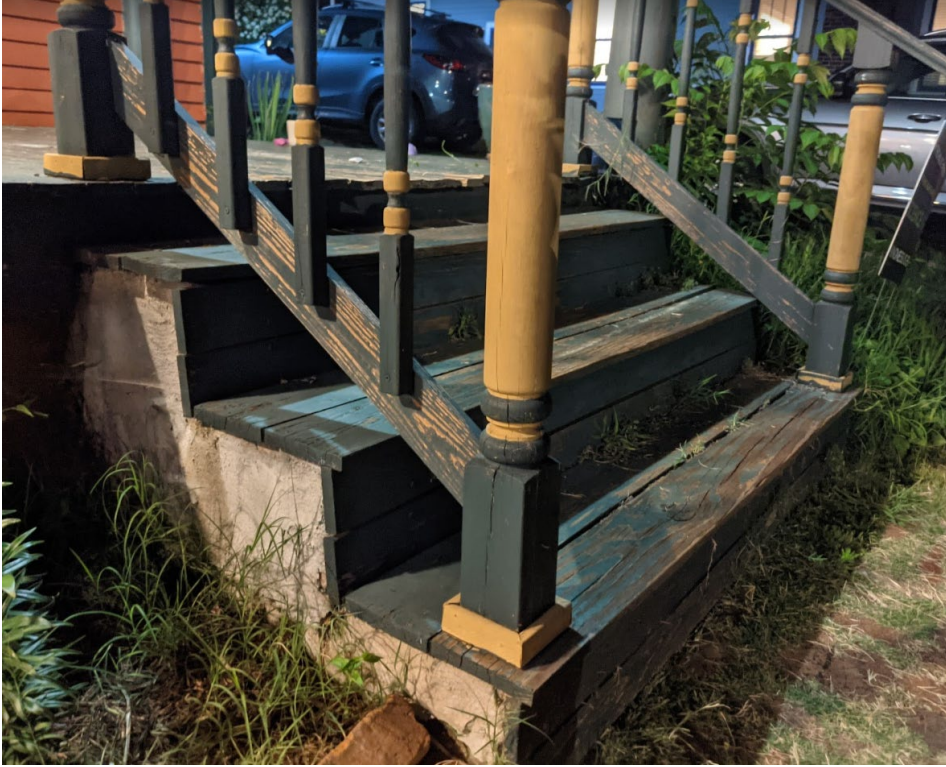
Wood overlay on concrete steps and improperly secured handrails

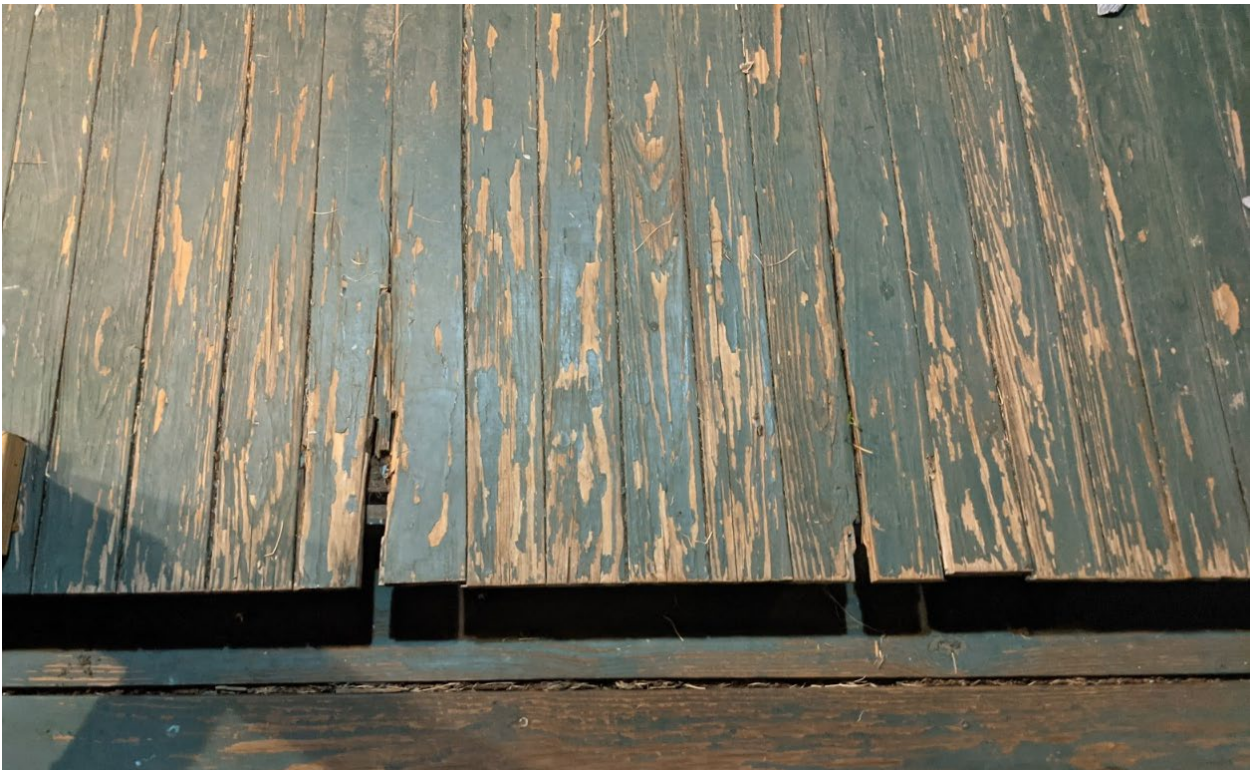
3. The applicant has provided documentation of the wood tongue-and-groove porch flooring's deterioration due to rain damage and sun exposure, especially along the front edge of the porch.
4. The proposed material, Aeratis Traditions composite flooring, is almost identical to the Aeratis Heritage composite flooring material which has been previously approved on 240 E. Scott Avenue (August 2018) and 215 E. Oklahoma Avenue (August 2020). The material is solid extruded PVC planks, which are faux-wood-grained to simulate wood flooring. The Aeratis flooring system can be completed with a chamfered- half-round, or quarter-round nosing as an edge trim.

Deterioration of decking.

Flooring: replacement of wood tongue-and-groove flooring with Aeratis Traditions composite tongue-and-groove porch flooring. Aeratis Traditions flooring measures 3-1/8" wide and 7/8" thick.

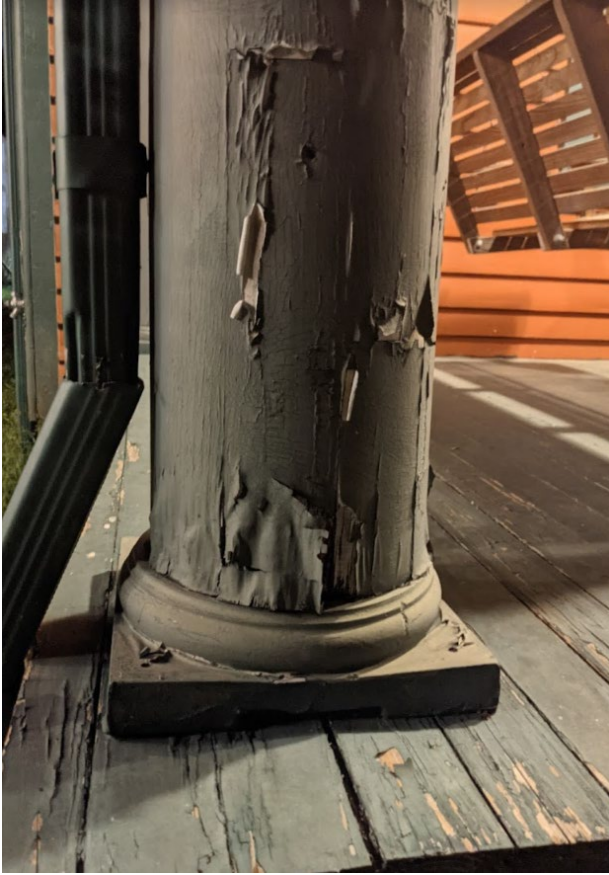
5. The applicant has provided documentation of rot on several columns, sinking columns due to rotting decking, and holes in the capitals due to animal damage. The rightmost two columns may be older elements, but the left columns were installed around 2004. The columns to be replaced are modest round columns with Tuscan capitals. Replacement columns will not result in the loss of historic material.

Rot damage of western most column.

Columns: replacement of four round wood columns with four round fiberglass columns. Applicant will select replacement columns with diameter (approximately 10" at base), height (96"), and general design to match existing columns. Replacement columns will use square bases and Tuscan capitals to match existing.

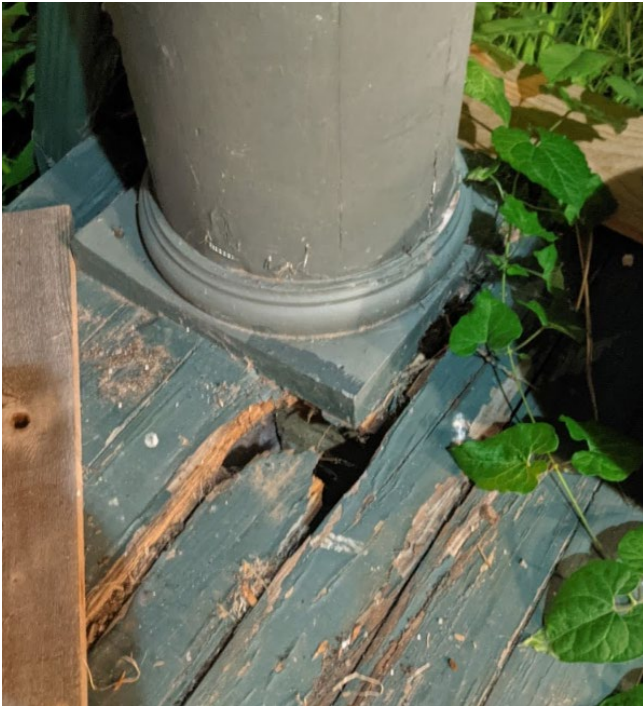
Decomposition of decking around eastern most column, rear side of column

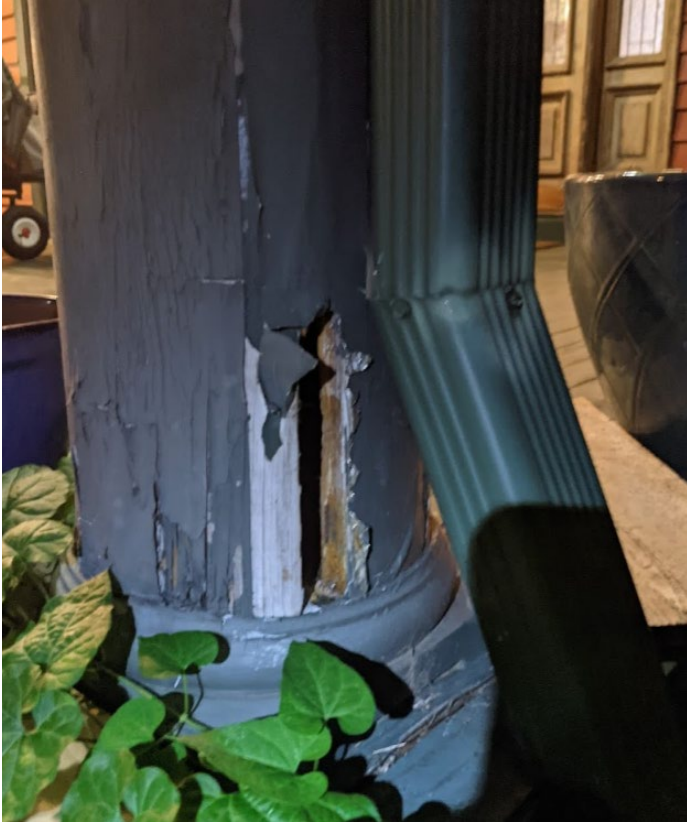
Decomposition of eastern most column due to combination of weather and animal nesting.

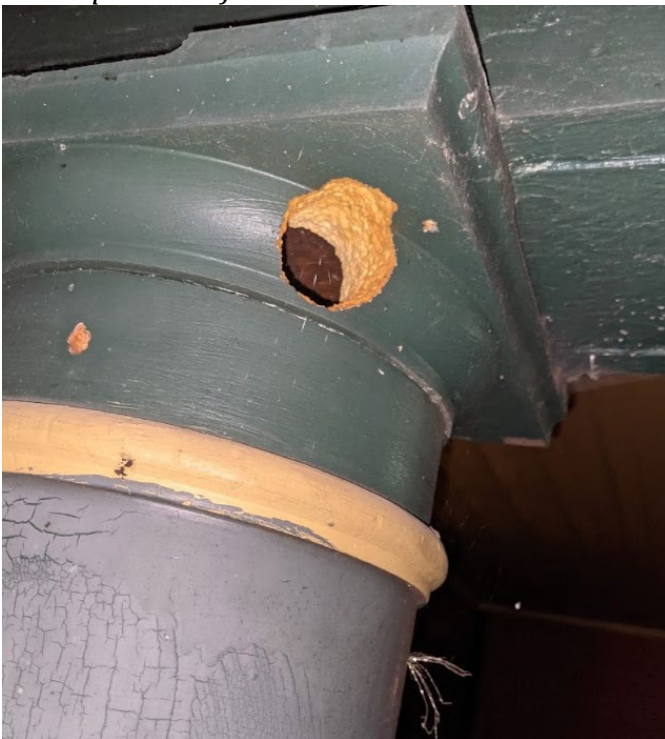
Example of bird damage to top cap of columns (Representative of damage on all 4 columns)

The existing columns on the property are a 10" base diameter smooth, tapered, Romanesque design and are 96" tall. The base and capital are also of a simple Tuscan design. The capitals will require replacement as all four have damage from birds pecking holes into the sides, 2 of which are far beyond repair due to this damage. While the bases look like they may be reusable, there is a risk that damage done to the columns has caused stresses or damage to the bases. If replacement is needed for the bases, the design will be of a similar, simple Tuscan design.

The preferred material for these columns would be to use a modern high quality fiberglass material, painted to match the existing aesthetic design of the house. Due to the extreme damage experienced on these columns, even with routine maintenance, we believe the change of materials will provide the necessary longevity of materials to justify the investment in work.
