## APPLICATION FOR CERTIFICATE OF APPROPRIATENESS

10915 Lake Ridge Dr. 37934

# **Staff Report**

File Number: 5-C-22-HZ

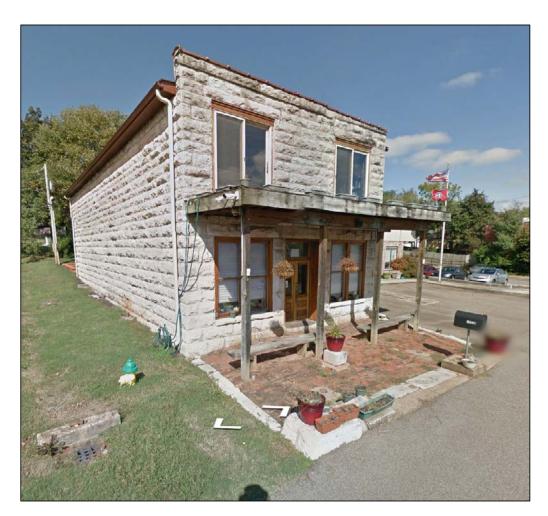
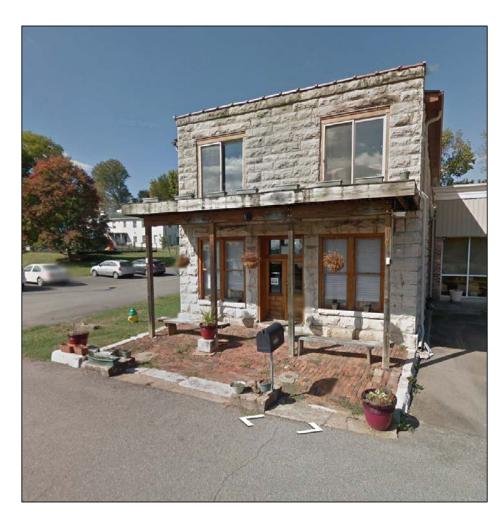
Google Streetview images of porch prior to work

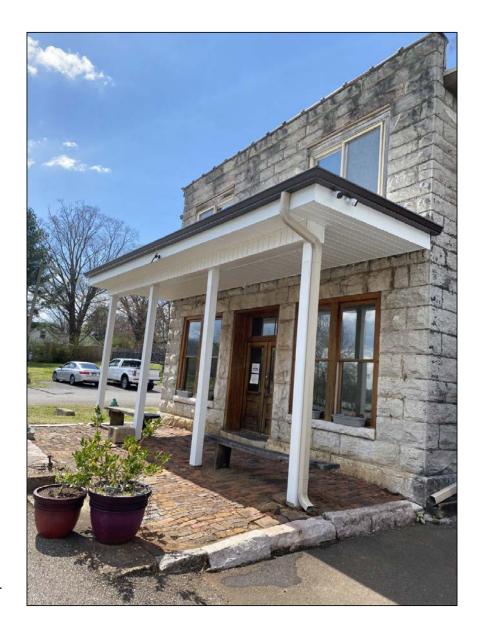
- 4. The front porch elements, while most likely not original to the building, did adhere to the design guidelines as using wood elements instead of synthetic materials. The design guidelines state "porches ... shall be repaired or replicated in size and design using wood materials for [...] posts and columns so that they duplicate the original size and design." Guidelines also state that reconstruction in order to achieve a uniform or 'improved' appearance is inappropriate, along with noting the "application of synthetic or substitute materials such as vinyl or aluminum over original wood siding is not appropriate." While these are porch elements and not siding, general preservation principles (and the Secretary of the Interiors Standards) discourage enclosing wood elements with synthetic materials for simply aesthetic purposes.

Photo of work completed, submitted by contractor

Staff recommends approval of the work as completed, with the condition that the applicant remove the vinyl and aluminum porch elements and provide a revised porch design which meets the guidelines, with approval by staff.
