9-C-22-HZ
APPLICATION FOR CERTIFICATE OF APPROPRIATENESS

1335 Armstrong Ave. 37917
Old North Knoxville H

Staff Report

After-the-fact review of removal of three dormers on the east and south roof slopes, and replacement of asphalt shingle roof cladding with new roof.

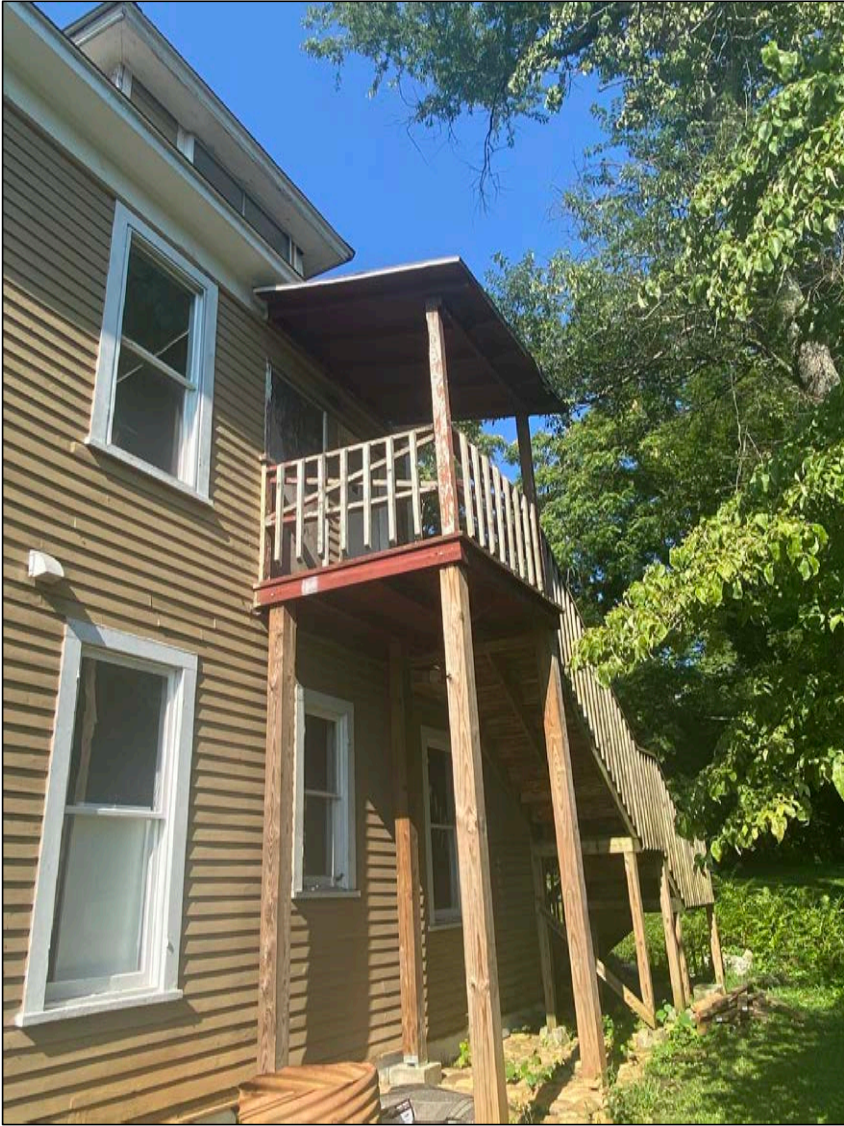
1

- 1) is a the added on access to the attic 'living' area. Obviously not original and doors were cut in to provide access. No interior access to attic is currently in place

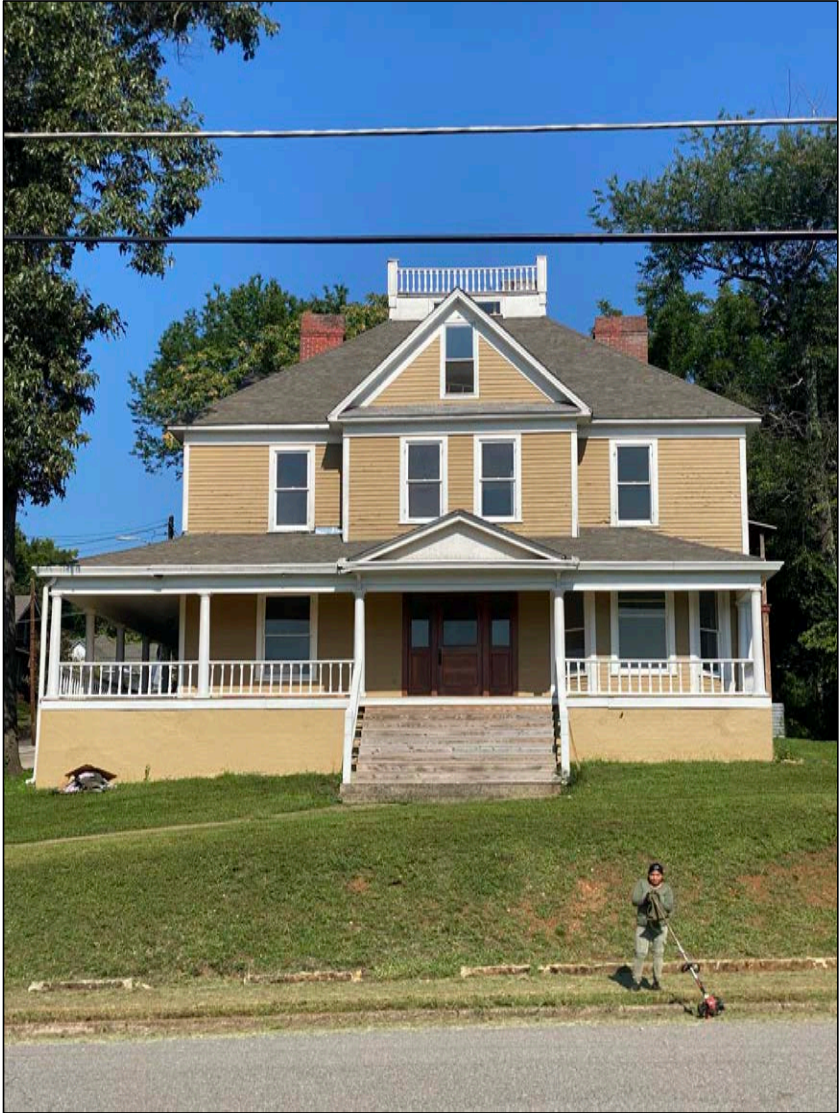
2

- 2) this is after the dormers were removed due to the miscommunication. This can serve as plans/ drawings for the desired product being applied for.
- 3) this is the framing of the dormers. Much newer lumber than what should be there had the dormers been original.

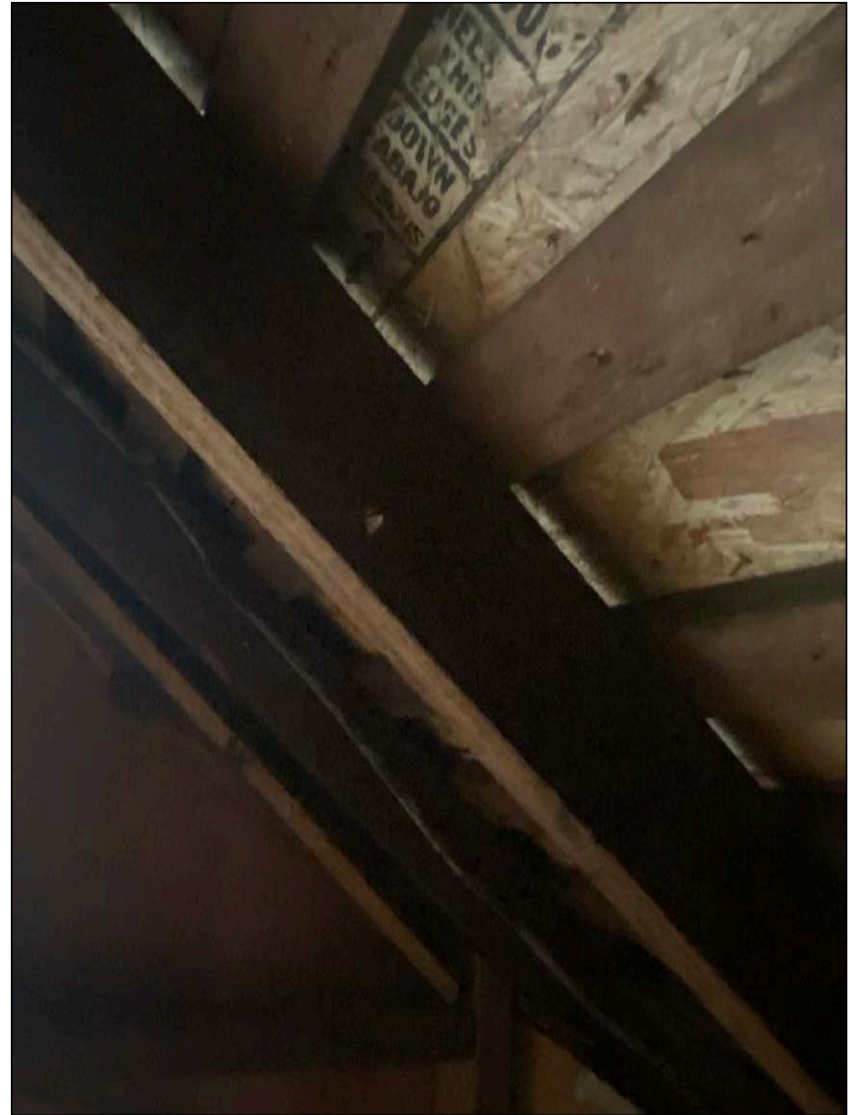
4

- 4) this is in connection to picture 3 and shows the framing of the roof that is original.
- 5) picture of the window installed in the new dormers. These do not match the rest of the house and are single pane storm windows.

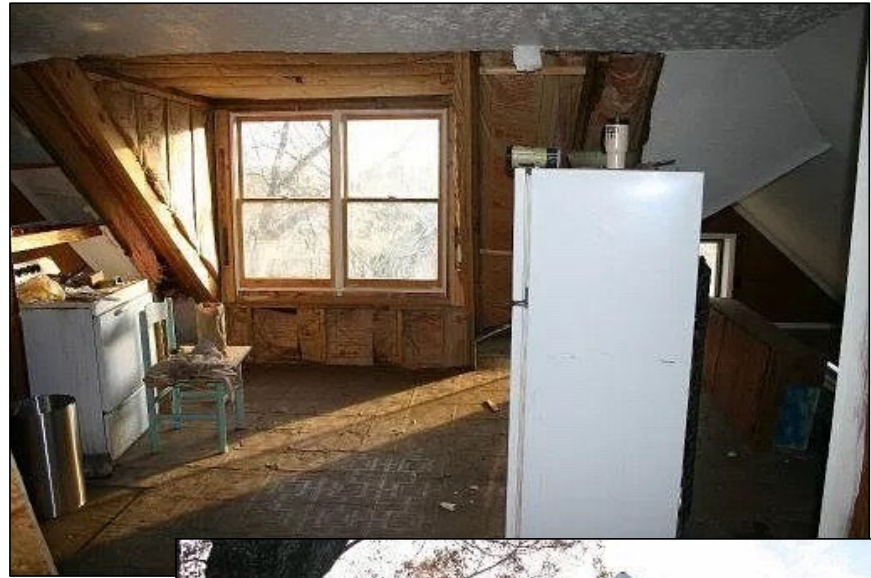
6

- 6) this is a picture taken from Zillow that shows the construction of one of the dormers. Reiterating that these were added on and not original
- 7) is prior to roof work and removal of the dormers. The two in question are right and left of the gable end
