4-E-23-HZ
APPLICATION FOR CERTIFICATE OF APPROPRIATENESS

1009 Gratz St. 37917
Fourth and Gill H

Staff Report

1009 Gratz St. COA Application

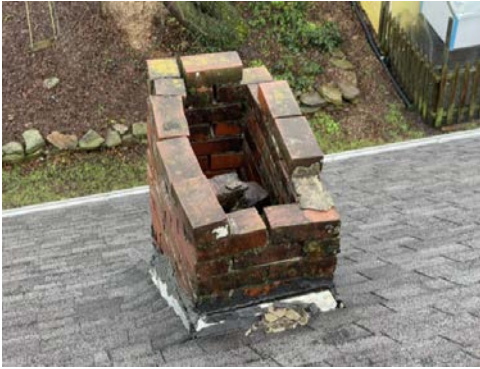
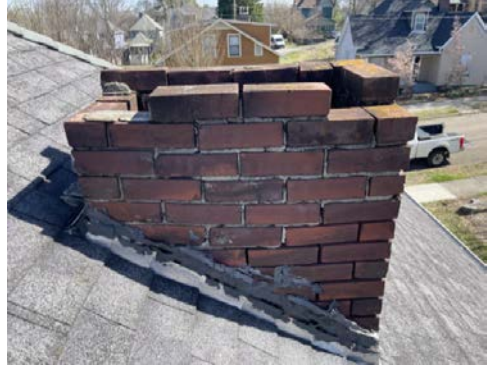
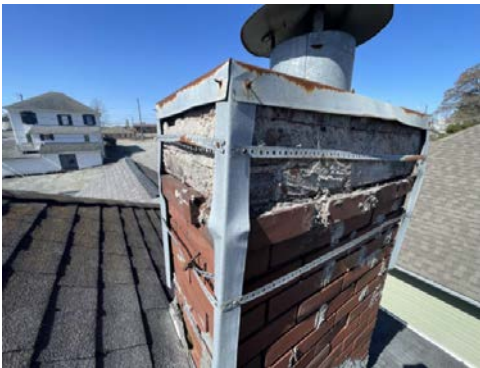
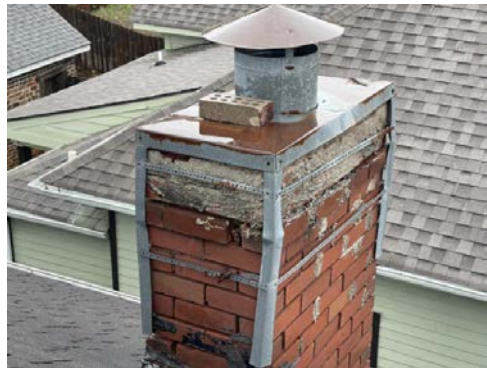
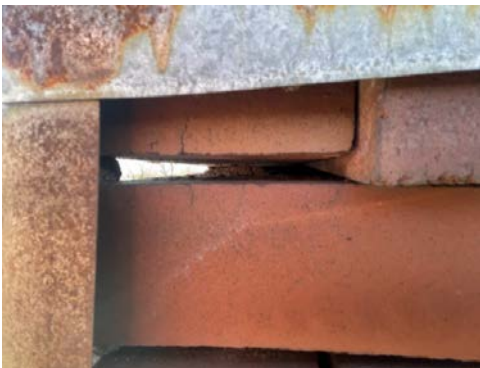
Proposed removal of two interior brick masonry chimneys on side roof slopes. Chimneys are evenly spaced along side roof slopes, with one chimney missing a top course of bricks and one supported by aluminum framing with a round aluminum flue. Scope of work also includes replacement of existing asphalt shingle roof cladding with new dimensional shingle cladding, along with installation of new ridge vents and drip edge along roof eaves.

1. 1009 Gratz Street is a contributing resource to the Fourth and Gill National Register Historic District and local overlay.
 2. The two interior side chimneys are original to the house, though deteriorated due to neglect and minor alterations (including patches of Portland cement mortar and aluminum framing). Fourth and Gill design guidelines note "chimneys should not be removed or altered if they are original and should match the original design if they must be replaced or have been removed."
 3. Characteristic of the house's style, the rectangular chimneys are modest in design, with no additional detailing, and height, not extending past the primary roof hip.
 4. The associated roof repair and replacement work meets the design guidelines and would otherwise be approved administratively as a Level 1 COA.
-

Existing chimneys need to be removed to maintain habitability of residence. Existing chimneys have fallen into such a state of disrepair by previous owner they can be considered already demolished by neglect (photos 01-05). Rehabilitation or renovation of existing chimneys in current condition is unreasonable and will cause an undue burden on the current homeowner.

The current chimneys have entered a state of demolition by neglect (photos 01-05). This due on no part to the current owner as she has owned the property for five months. Previous owners are solely responsible for the neglect and deterioration of the chimneys and roof. Furthermore, this demolition by neglect is now affecting the health safety and welfare of the current owner, the property, and the tenant. The water damage caused by the complete deterioration of the chimneys and roof is causing damage in other parts of the structure (photos 14-16) which will lead to future repairs if left in its current state. It is also creating health and safety concerns for the tenant and the owner as the water is leaking into the residence, potentially creating mold or other hazardous living conditions (photos 9-13).

Staff recommends approval of the roof replacement and associated repair work, and repair to (or reconstruction) of the original chimneys, with design and size to match the original.

Remove existing chimneys at roof projection, frame over new openings, installation of 7/16" OSB decking, installation of synthetic underlayment, installation of GAF Timberline HDZ dimensional grade shingles.
