**7-C-23-HZ**  
**APPLICATION FOR CERTIFICATE OF APPROPRIATENESS**

**1202 Luttrell St. 37917**  
**Fourth and Gill H**

Original Print Date: 7/11/2023  
 Knoxville/Knox County Planning -- Historic Zoning Commission

Level II Major Repair or Replacement

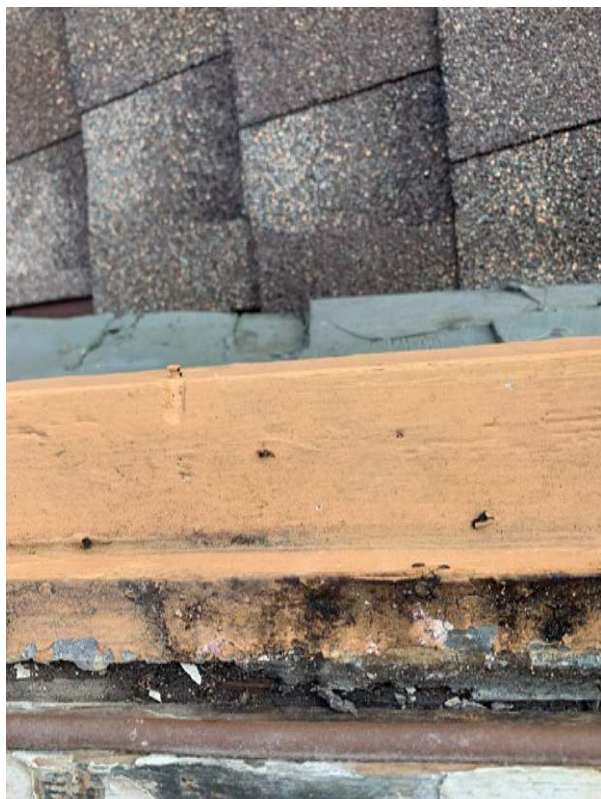
North 1

North side of home, bathroom

- #1. Double casement. Sill has rotted under metal flashing. Header is cracked where lock is, indications of rot also. Many of the TDL panes have been replaced with much newer glass.
- #2. DH, balance cords have been cut. Top light screwed into place as the keeper rail wood is rotted so screws will hold the lock keeper. Lower handle rail shows significant exterior rot. Interior grids are very soft, indicating rot not just on the inside but the exterior as well.
- #3. Double casement, office. Bottom of the sash and sill are rotting, operating hardware missing rendering window inoperable. Interior grid rot appearing on TDL grids. Several pieces of glass have been replaced.

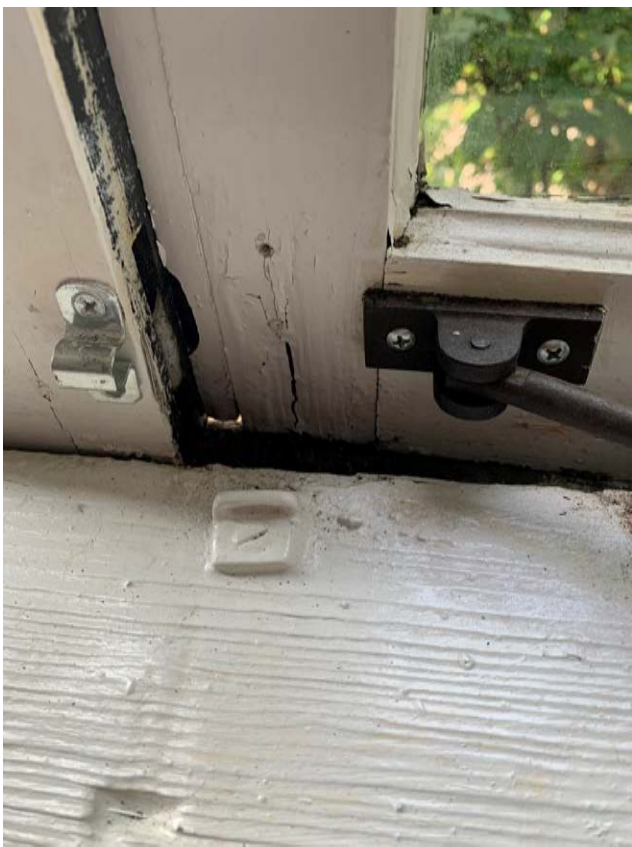
South 1

South side

- #1. Master BR, double casement. Sashes are rotted and will not hold screws. Hardware on left side is missing. Glass has been replaced but no grids were put in.
- #2. Master BR, DH. Exterior sill rot beginning to show. Balance ropes have been cut and top light screwed into place. Both lites have new glass but we're also done without grids.
- #3. Bedroom, double casement. Both sashes are rotted at the bottom. Newer operating hardware (still very old) has been installed. I pulled on it and the screws were ready to pull out because of the rot, unit will operate. Many pieces of the glass have been replaced.

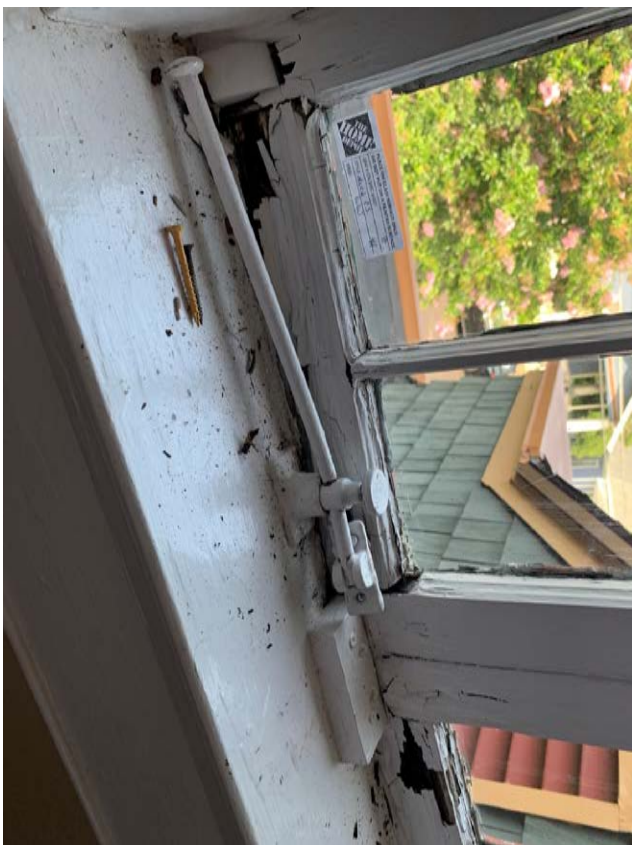
West 1

West side office

- #1. Office, double casement. Sashes and frame have rotted. Unit also contains new glass.
- #2. Office, DH. Lower sash and frame showing significant rot, in fact the sashes are literally falling apart. Unit has many pieces of new glass that have been replaced.
- #3. Master BR, DH. Lower sash, exterior wood and jamb stops are rotten. Only one balance is operating and it does not carry the weight of the sash which is coming apart. Top lite is nailed in indicating sash balances have been cut or broken. Window has no lock keeper. Unit contains several pieces of newer glass.
- #4. Master BR, double casement. Sashes are rotted inside and out. Unit has no operating locks.

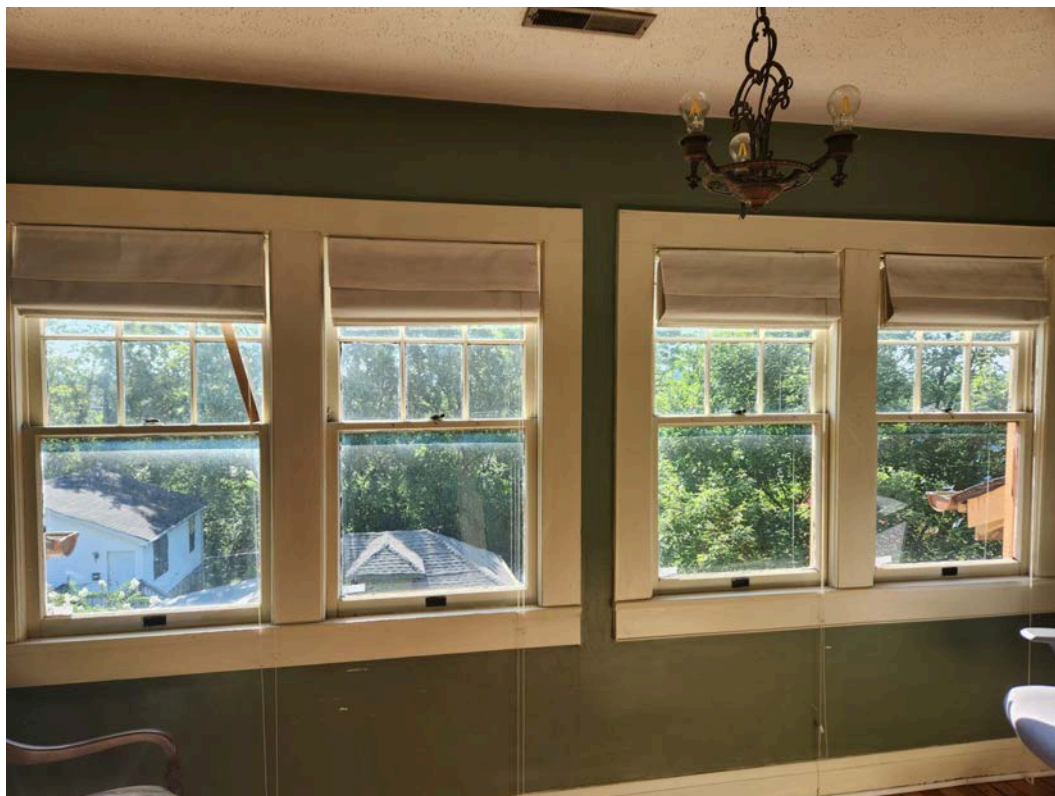
East 1-4

East side, all in sunroom.

- #1 significant exterior frame rot. Lower lite glass has been replaced.
- #2. Significant frame rot, rot showing on lower lite exterior handle rail. balance cords have been cut. Frame rot on right side, lower sash handle rot showing exterior rot, sill showing rot. Several pieces of glass have been replaced.
- #3. Frame rot on sides, lower handle rot is there, sill rot also obvious. Unit contains many pieces of new glass. One balance cord has been cut. Top light held in place by a stick because top lite keeper rail rotted and screws will not hold in the keeper rail..
