5-J-24-HZ
APPLICATION FOR CERTIFICATE OF APPROPRIATENESS

1730 Jefferson Ave. 37917
Edgewood-Park City H

Staff Report

INSPECTION REPORT
1730 Jefferson Ave
Knoxville TN 37917

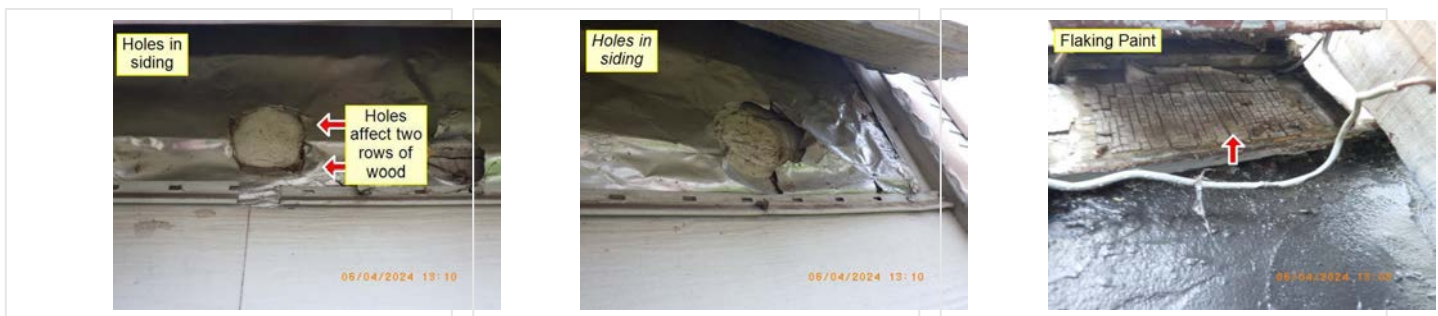
(1) Siding consists of wood lap siding boards on most of the exterior walls covered with aluminum on the left side and vinyl on the right side of the home. Another comment will cover the portion of the exterior walls which do not appear to have wood lap siding boards under the metal siding. This evaluation of the siding is an attempt to predict what obstacles may be present if an attempt is made to restore the original wood siding boards under the metal and vinyl sidings.

Only small areas of the wood siding are visible. Of the visible areas of the siding the following observations were made.

- Small areas on the left and right side of house were found to have loose metal/vinyl siding at the same height above the ground. At these areas there are roughly 2–3 inch round holes drilled through the siding which are filled with foam. These holes are spaced roughly 6 to 8 inches apart and continue laterally at all visible areas. The purpose of the holes was likely to install foam insulation inside the exterior walls. This impacts the restoration of the siding in the following ways.

- Removing the damaged boards will damage the spray foam insulation causing the need for further repairs.
- Visible portions of wood siding was found to have flaking paint. The flaking is consistent with aging lead based paint. Remediation of the lead based paint will significantly increase the cost of restoring the original wood siding.

- All damaged boards will need to be removed and replaced. This consists of, at minimum, two rows of boards around the entire perimeter of the home. If a second row of holes was drilled near the top of the wall, then two more rows of boards will need to be replaced.

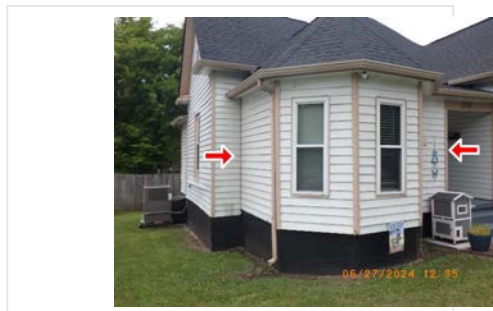
(2) Front left corner of the home from the front porch to the interior corner on the left side of the home appears to be an addition that was added later. The siding at this location is about 10–15% of the exterior walls. The siding at this location appears to consist of a insulation foam board covered with metal siding. There is no visible wood lap siding at this area of the home.
