**5-H-24-HZ**  
**APPLICATION FOR CERTIFICATE OF APPROPRIATENESS**

**129 E. Oklahoma Ave. 37917**  
**Old North Knoxville H**

# Staff Report

File Number: 5-H-24-HZ

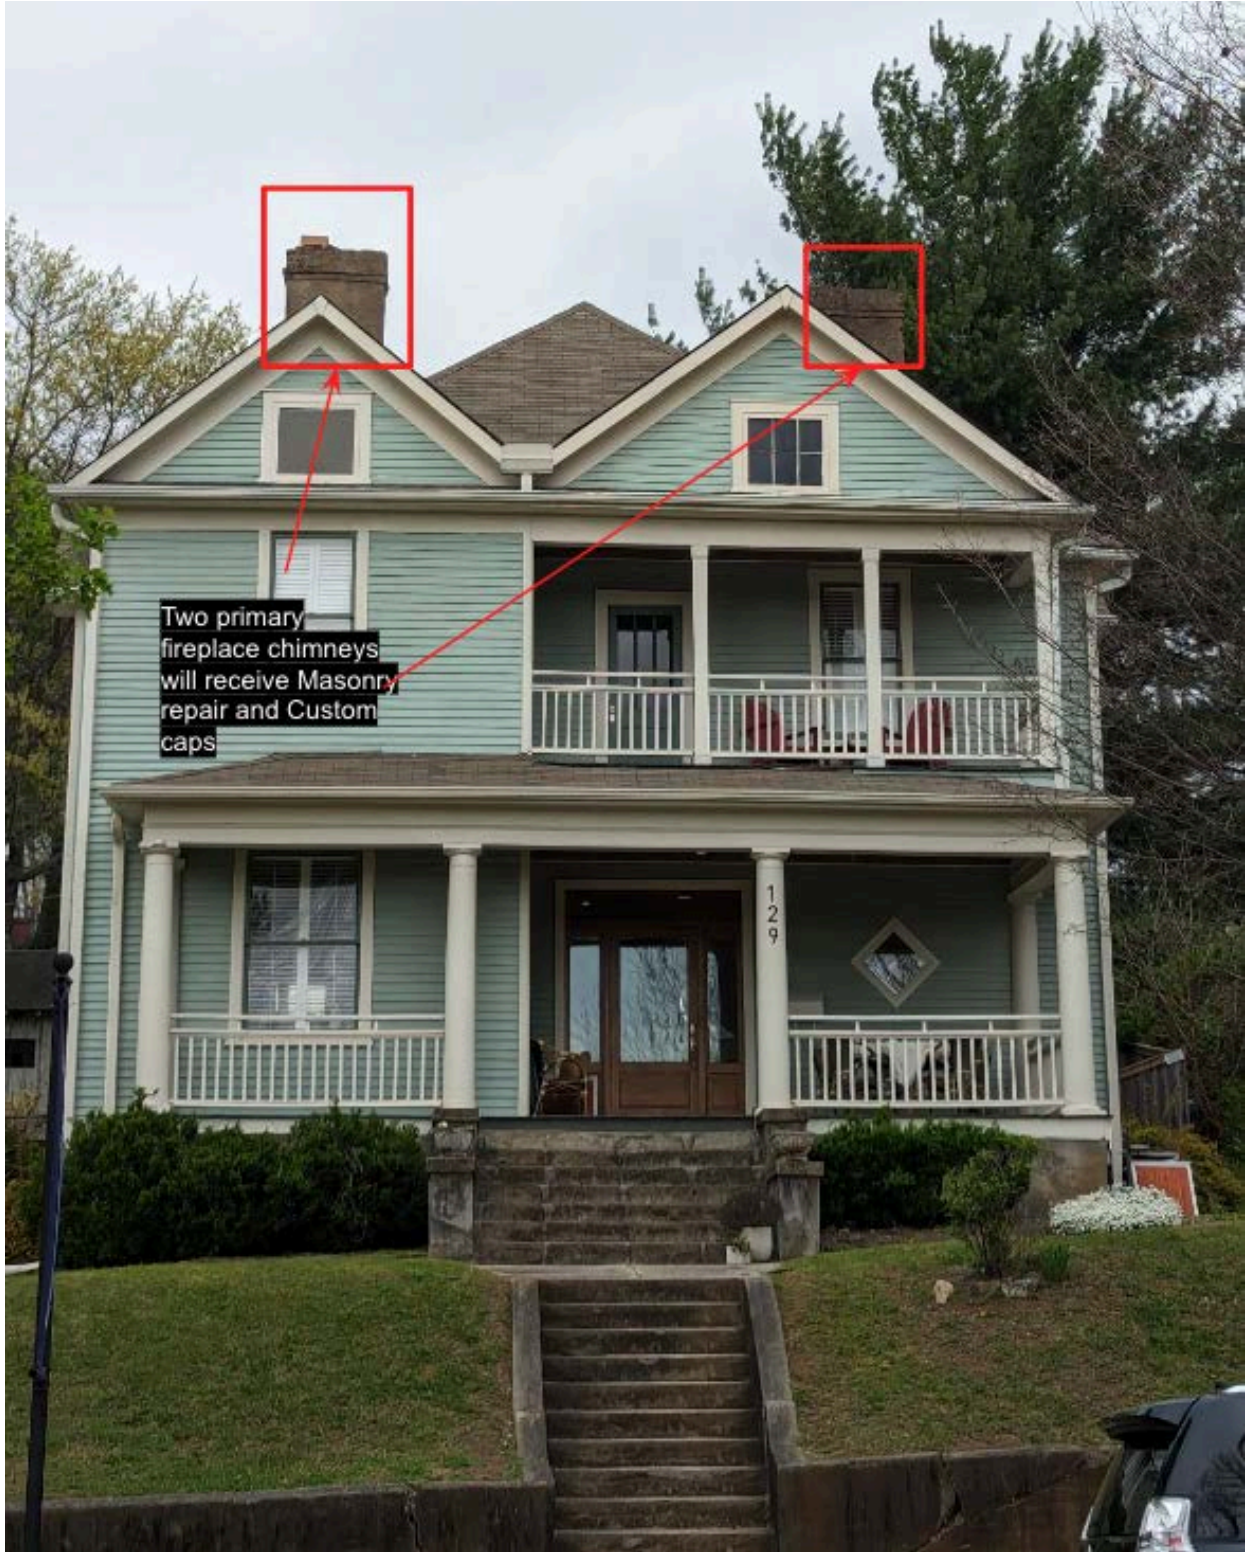
Two primary  
fireplace chimneys  
will receive Masonry  
repair and Custom  
caps

4. The two chimneys on the primary roof slope will be retained, and will receive masonry repair, repointing, waterproofing, and new chimney caps.

The two primary fireplace chimneys will receive a full exterior masonry restoration. This includes repair to any parts of damaged masonry on the chimneys, by tuck pointing them, repouring or repairing the concrete at the top, applying a heavy duty waterproofing material to the masonry to help keep water from absorbing above the roofline, and then installing full coverage caps on the chimneys to protect the chimneys.

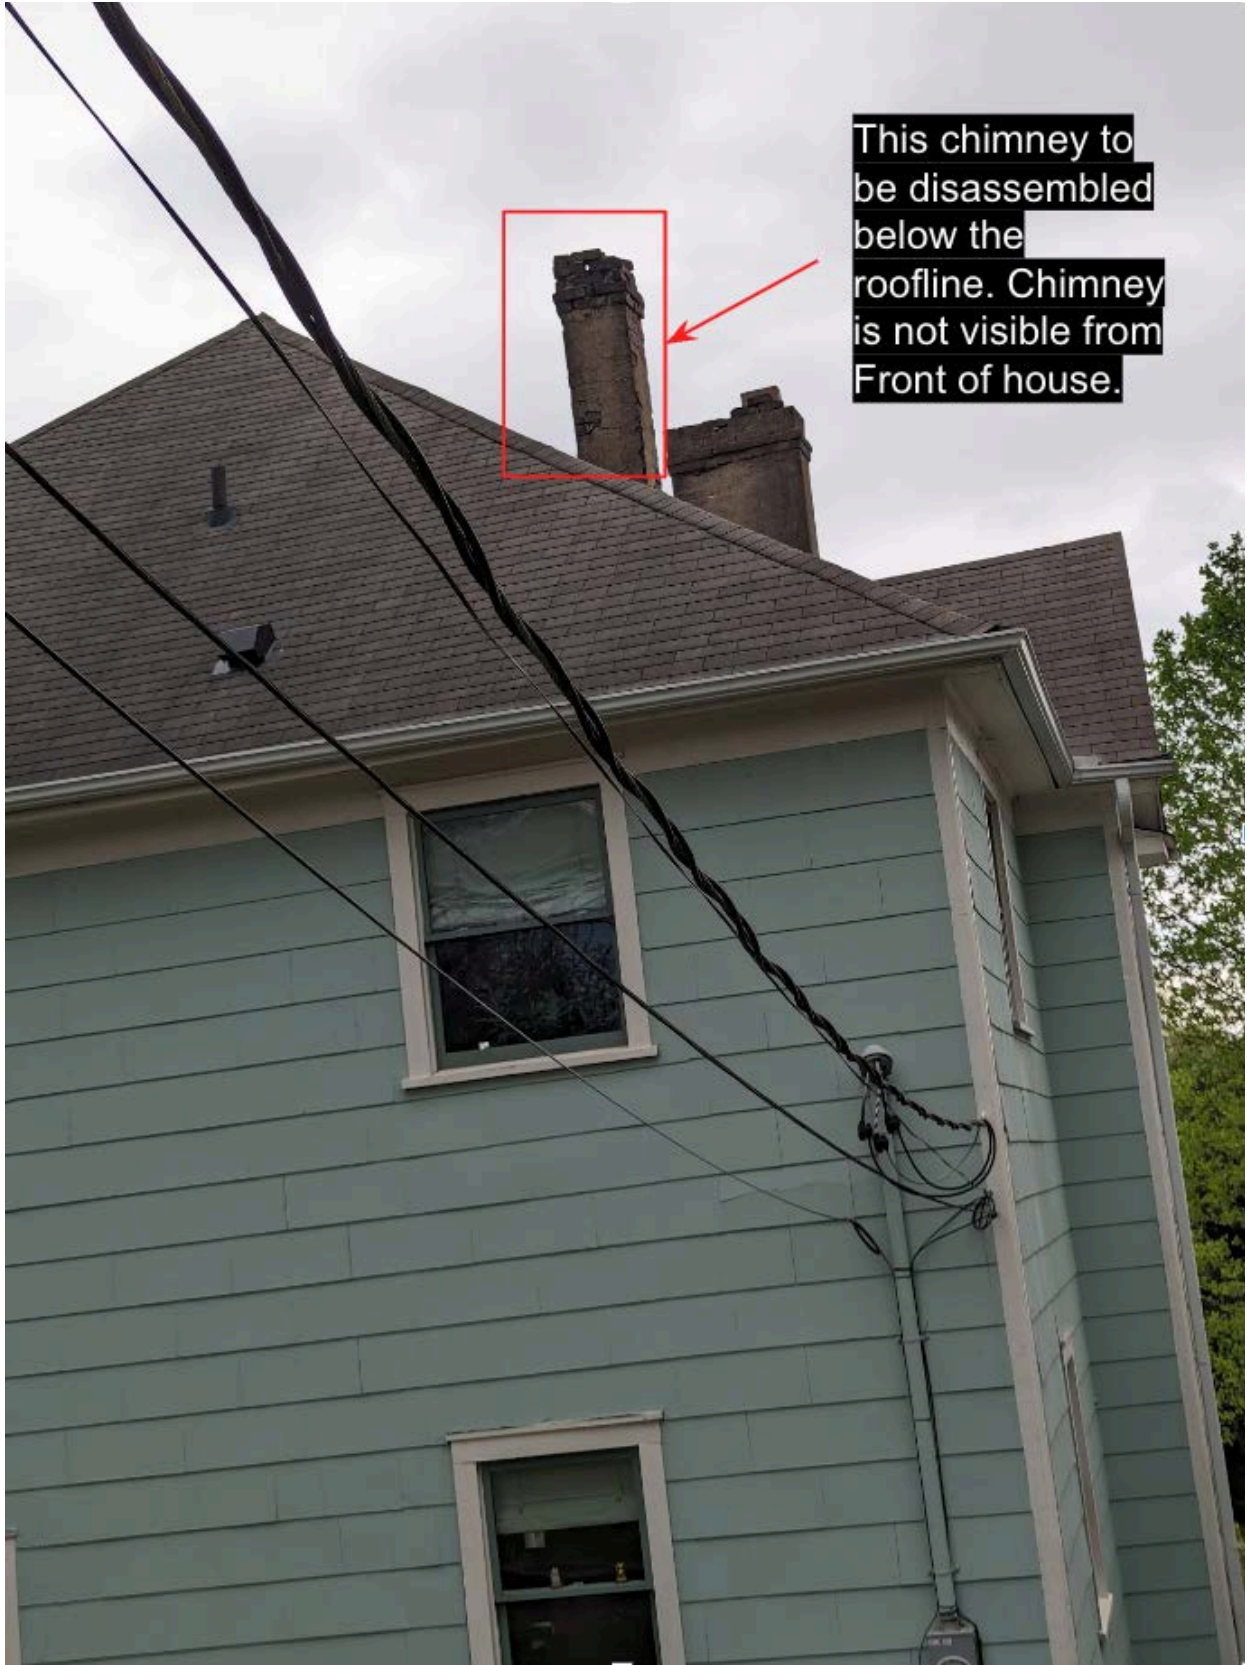
3. The proposed chimney to be removed is a secondary chimney, smaller in size than the primary chimneys on the front roof slope, and located on the rear roof slope. The chimney is minimally visible from the right-of-way on Oklahoma Ave.

Hello, my name is Will Pearson and I reside at 129 E Oklahoma Ave. We are having some water intrusion issues with one of our chimneys, which is badly deteriorated. I had Ashbusters Chimney Service come out for an inspection and their recommendation is removal of the damaged chimney below the roofline.

This chimney to be disassembled below the roofline. Chimney is not visible from Front of house.

The chimney in question is an old wood stove or furnace chimney that is not visible from the street. Our house has two additional large chimneys that we would like to repair (but not remove). The damaged chimney will be disassembled to a level below and the roof and capped with masonry cement. The roof hole will be repaired with new plywood sheathing, water shield, and new matching shingles.
