Meeting: 12/18/2025
Applicant: Allie Chamberlain, Arena Construction LLC
Owner: Benji Pollan

Location: 209 Deaderick Ave. **Parcel ID** 94 K D 024
District: Mechanicsville H
Zoning: RN-2 (Single-Family Residential Neighborhood)
Description: Italianate, c.1880

12-E-25-HZ
APPLICATION FOR CERTIFICATE OF APPROPRIATENESS

209 DEADERICK AVE - WINDOWS

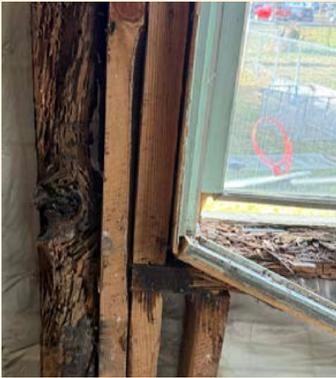
newer replacement window
west facing facade - termite
damage

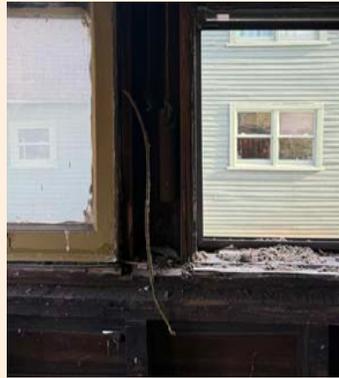
original wood window
east facing facade - termite and
water damage

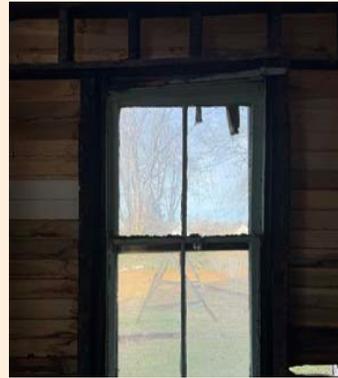
original wood window
north facing facade - frame col-
lapsed and damaged from load

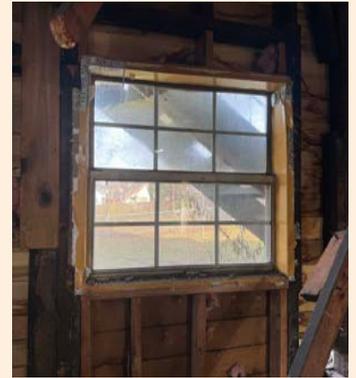
replacement vinyl widow
north facing facade - kitchen
replace with wood

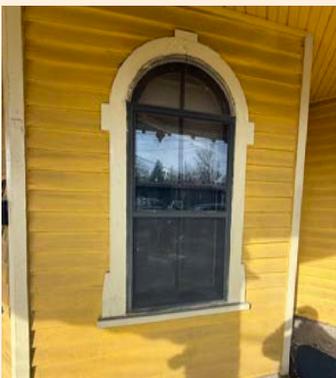
original wood window with arch
south facing facade - remove rec-
tilinear storm window, replace to
match mirroring window

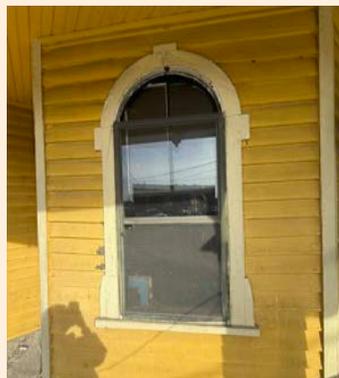
original wood window without arch
south facing facade - remove rec-
tilinear storm window, replace to
match mirroring window

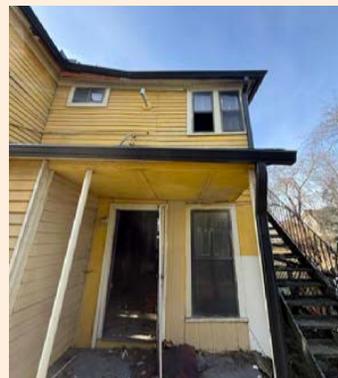
original wood windows
west facing facade - replace in
kind, same size

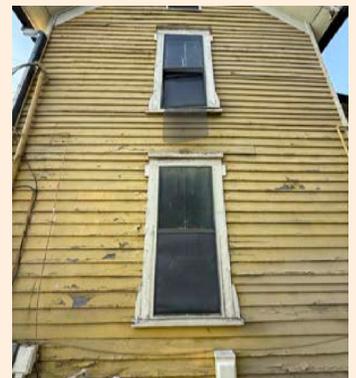
original wood windows
west facing facade - replace in
kind, same size

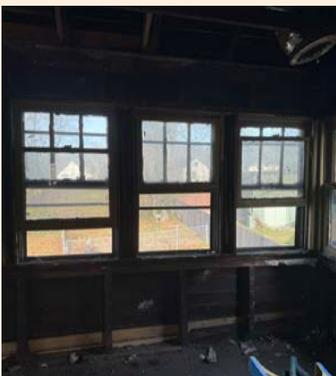
original wood window with arch
north facing facade - remove storm
window, replace in kind, same size

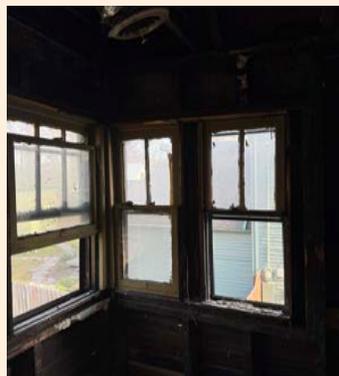
original wood window with arch
north facing facade - remove storm
window, replace in kind, same size

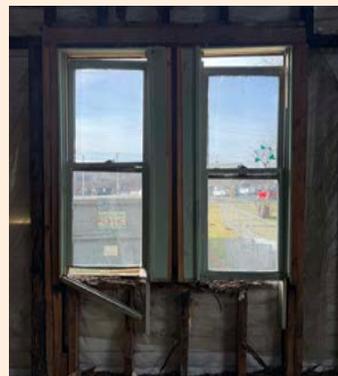
replacement wood windows
west facing facade - replace in
kind, same size

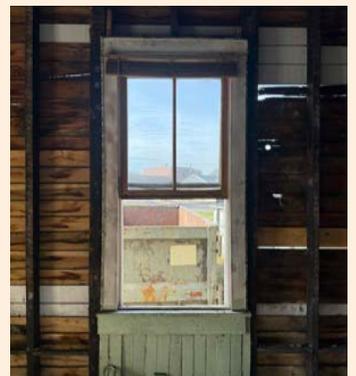
replacement wood window
west facing facade - replace in
kind, same size

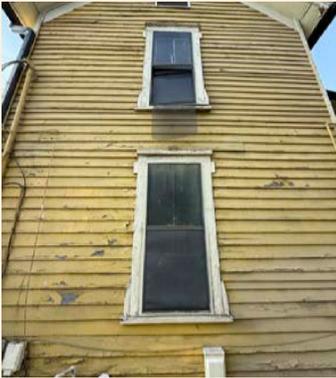
REPLACE SIDING + TRIM
in kind - wood lap siding, match
all trim

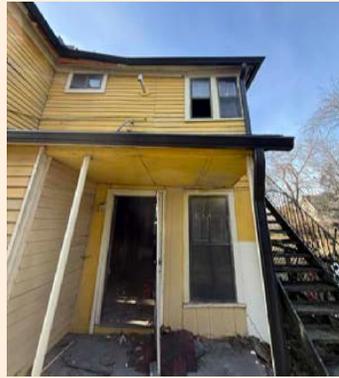
REPLACE SIDING + TRIM
in kind - wood lap siding, match
all trim (this was added)

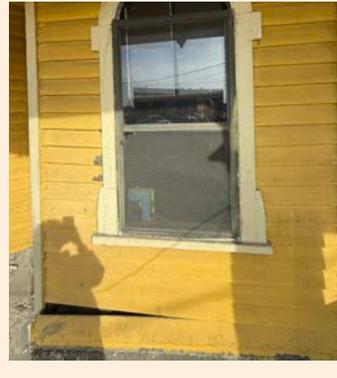
REPLACE SIDING + TRIM
in kind - wood lap siding, match
all trim

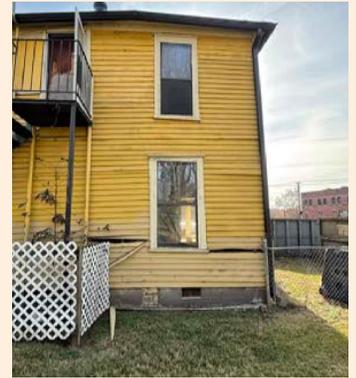
REPLACE SIDING + TRIM
in kind - wood lap siding, match
all trim

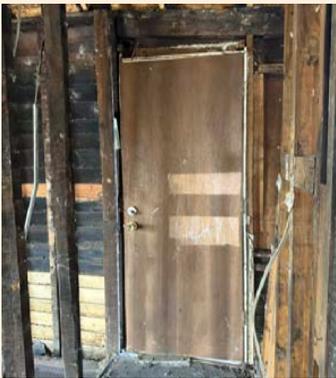
interior door added as upstairs
egress - request to remove and fill -
not original to the house

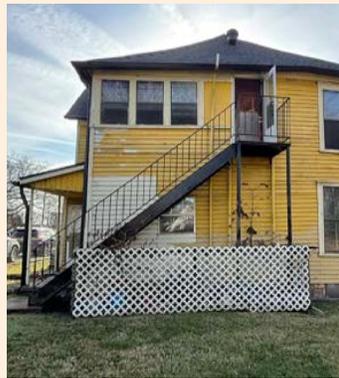
remove exterior door upstairs and
remove stair - not original to the
house

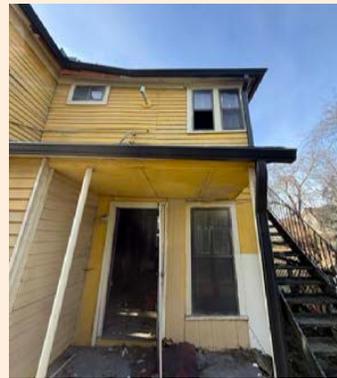
install new exterior solid wood door
- within design guidelines.

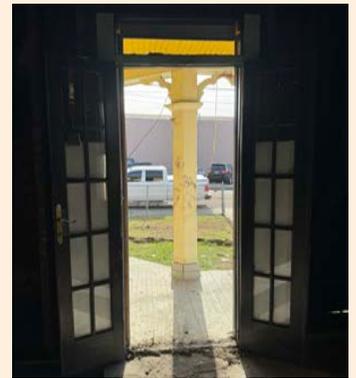
retain, and restore double doors on
front exterior

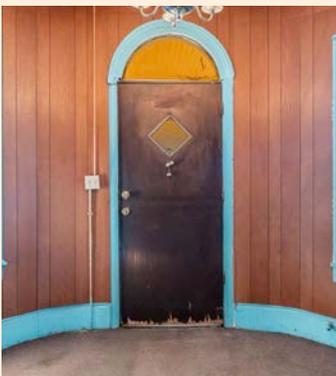
replace front door (currently an in-
terior hollow core door) with solid
wood front door compliant with de-
sign guidelines

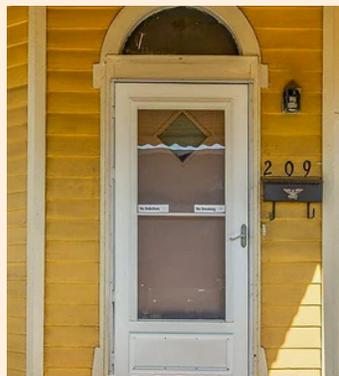
replace front door (currently an in-
terior hollow core door) with solid
wood front door compliant with de-
sign guidelines

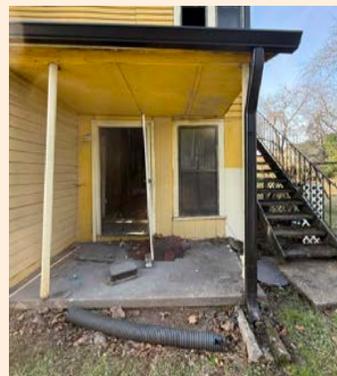
replace porch ceiling within design
guidelines, replace columns with
wood columns.
