Meeting: 4/16/2026
Applicant: Thomas Turner
Owner: John Collins & Allison Greaney

Location: 2112 Jefferson Ave. **Parcel ID:** 82 O A 017
District: Edgewood-Park City H
Zoning: RN-2 (Single-Family Residential Neighborhood)
Description: Craftsman with Tudor Revival, c.1910

3-C-26-HZ
APPLICATION FOR CERTIFICATE OF APPROPRIATENESS

KEHI INSPECTION

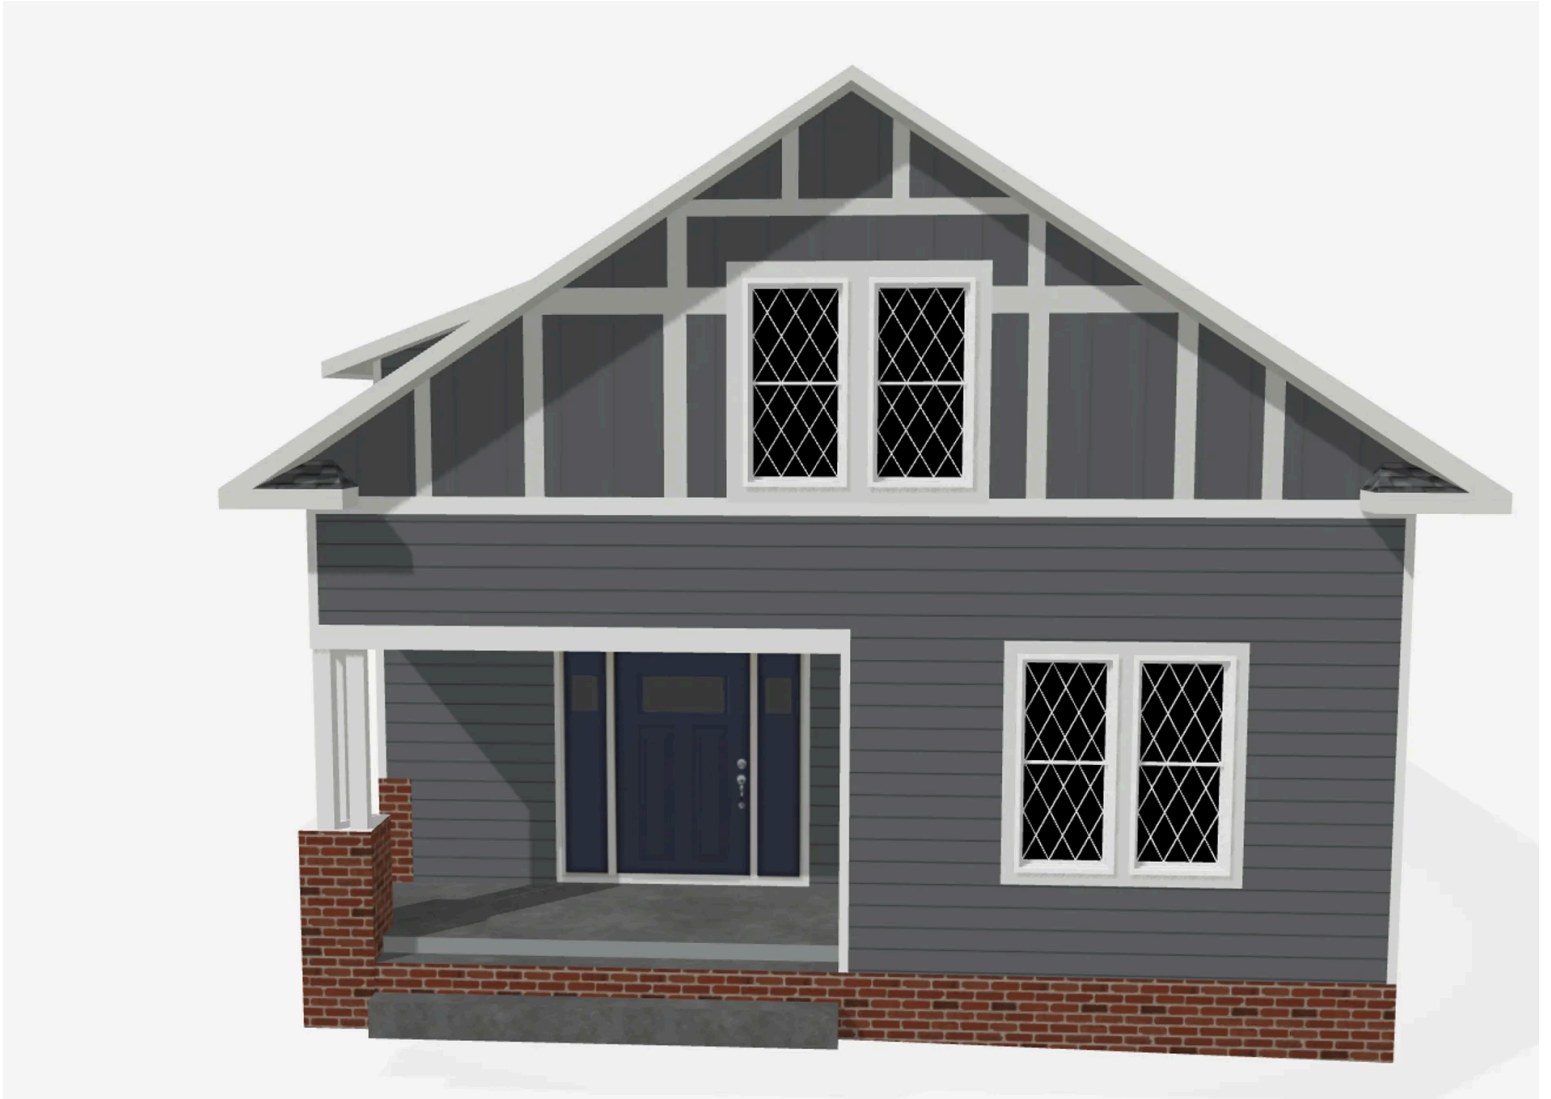
Photo Description: This rendering shows the intended design using James Hardie materials. The walls beneath the gables will be finished with 5 1/4-inch lap siding with a 4-inch reveal. The gables will feature smooth Hardie panels with trim to replicate the home's existing Tudor-style aesthetic in a similar color. The model currently displays a 7-inch lap profile due to software limitations, but the specified and estimated product is 5 1/4-inch lap siding. All materials will be smooth-texture James Hardie fiber cement with no wood grain pattern.

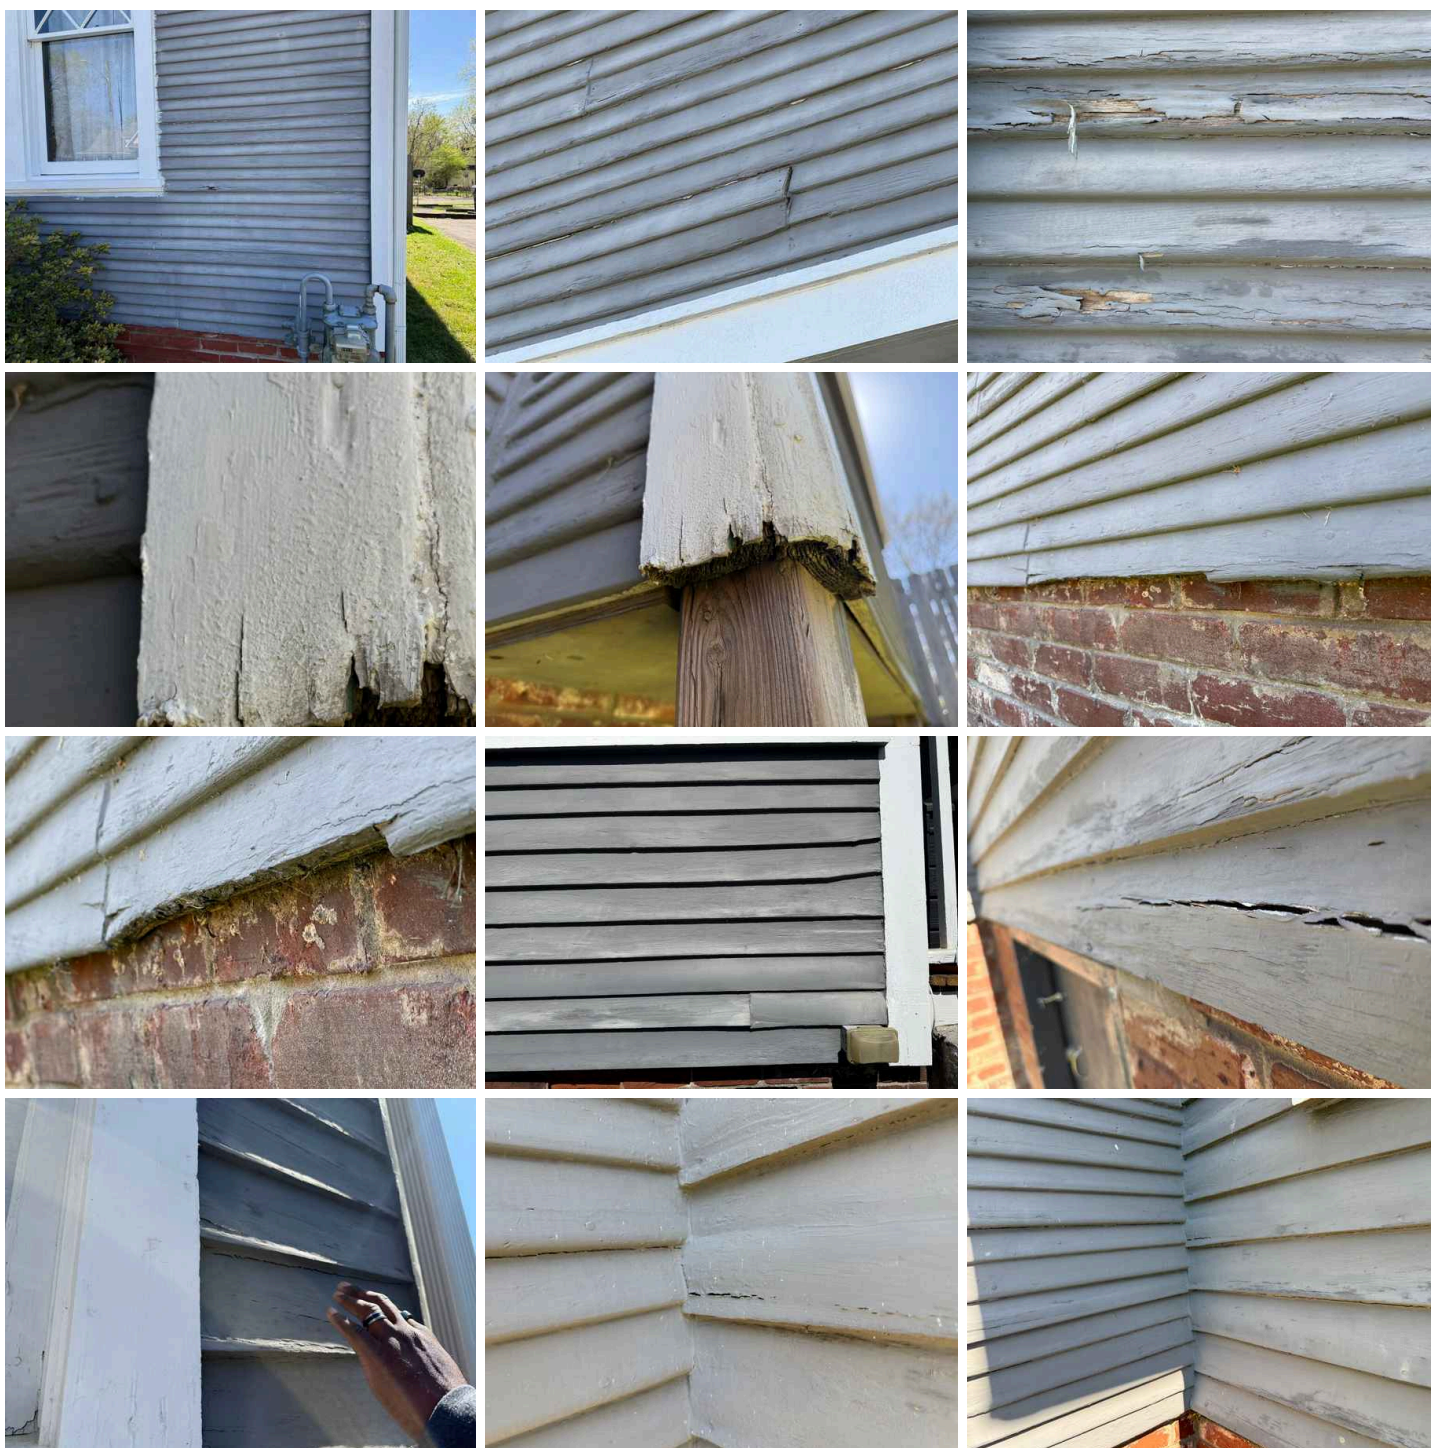
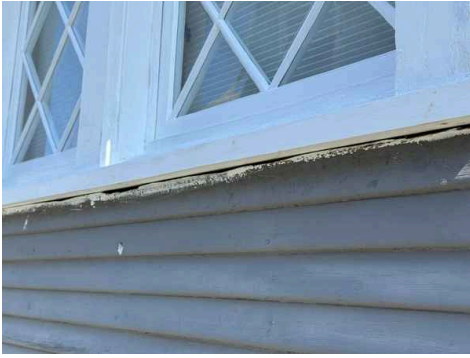
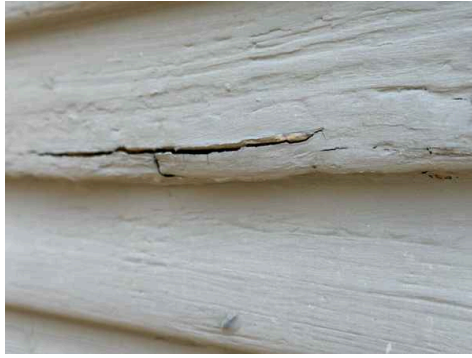
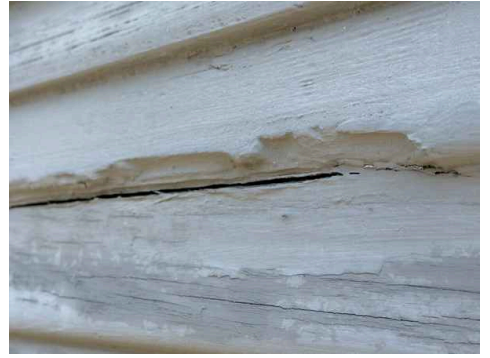
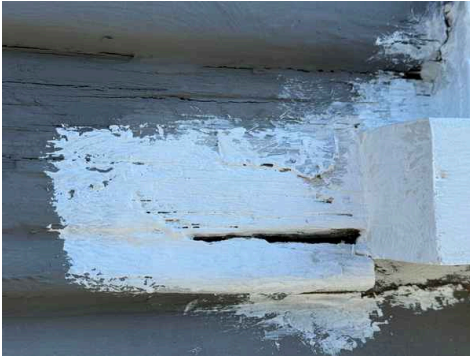
3.1.1 Exterior Walls / Trim

SIDING ON EXTERIOR WALLS - DETERIORATED WOOD

The original wood siding on this over 100-year-old home shows widespread damage and deterioration. Defects observed include extensive rotten wood, chipped and cracked boards, patched areas that don't match the siding of the rest of the home, and numerous areas of swollen siding caused by moisture intrusion.

Due to the age and condition of the existing siding, patching or spot repairs are not recommended. Any patch material will not visually match the historic wood siding, resulting in a mismatched appearance that detracts from the home's historic character.

Complete replacement of the wood siding is advised. Replacing the siding will restore the home's original appearance, correct the current moisture-related damage, and help preserve both the structural integrity and historic aesthetics of this significant property for future generations.

A qualified contractor experienced in historic home restoration should perform the work to ensure proper detailing and material selection that matches the original in profile, texture, and finish.

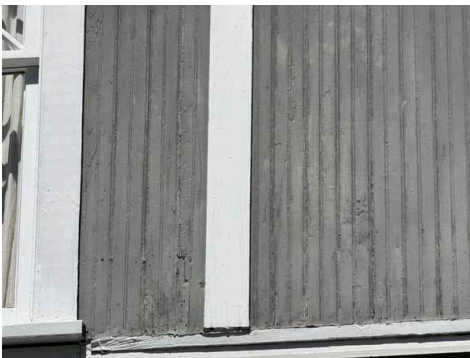
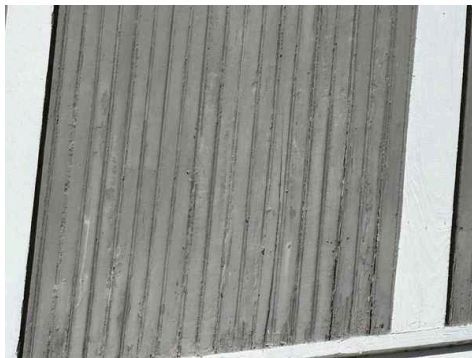
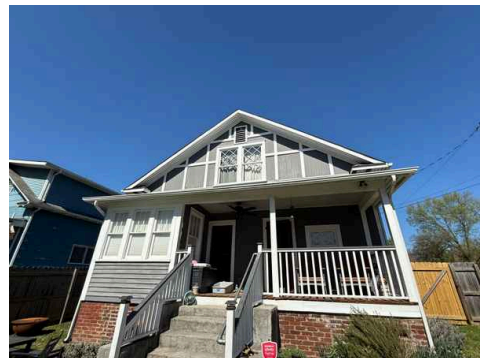
3.1.2 Exterior Walls / Trim

SIDING ON GABLE ENDS - DETERIORATED WOOD

The original wood siding on this over 100-year-old home's gable ends shows widespread damage and deterioration. Defects observed include extensive deterioration, and numerous areas of swollen siding at the edges caused by moisture intrusion.

Due to the age and condition of the existing siding, patching or spot repairs are not recommended. Any patch material will not visually match the historic wood siding, resulting in a mismatched appearance that detracts from the home's historic character.

Complete replacement of the wood siding is advised.

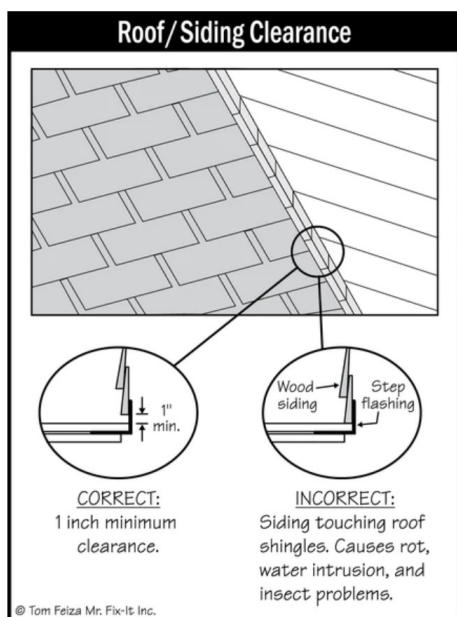
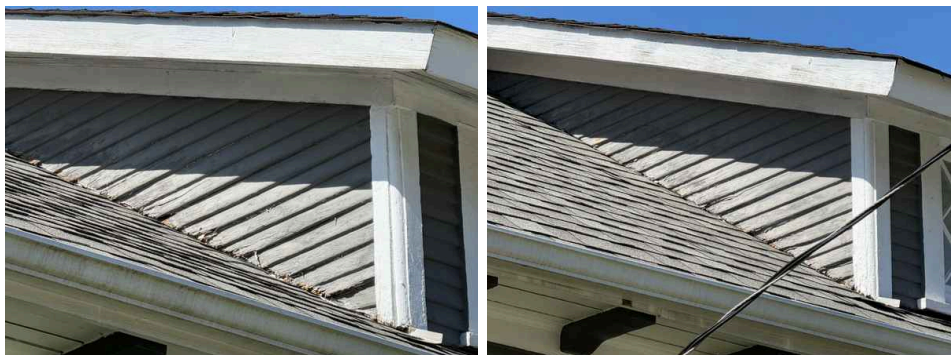
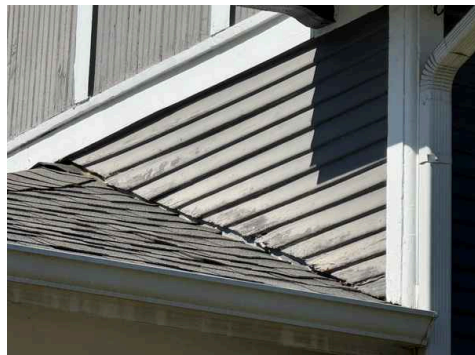
4.6.1 Maintenance / Other

CLEARANCE- SIDING / TRIM

ROOF DORMERS

Siding / Trim was within an inch of the roof surface. **Actually, it was touching.** Damage to the siding can occur by water wicking. Damage appears to affect up to 5" from the shingles, so simply cutting a gap will not work because too much material has to be removed.

Complete replacement of the wood siding on the dormers over the roof is advised. Replacing the siding will restore the home's original appearance, correct the current moisture-related damage, and help preserve both the structural integrity and historic aesthetics of this significant property for future generations.

A qualified contractor experienced in historic home restoration should perform the work to ensure proper detailing and material selection that matches the original in profile, texture, and finish.
