Staff Report

File Number: 5-H-26-HZ

Re: **Limited Structural Evaluation**
Site Location: 1634 Forest Ave. Knoxville, Tennessee 37916
Project No.: S26085W- Fourth Ave 31685 (UR)
Client: University Real Estate c/o Suzanne Moll

Re: **Limited Structural Re-Evaluation (of Repairs)**
Site Location: 1634 Forest Ave Knoxville, TN 37916
Project No.: S22351C(RE) – Forest Ave 22428 (Sheats)
Client: Aaron Sheats

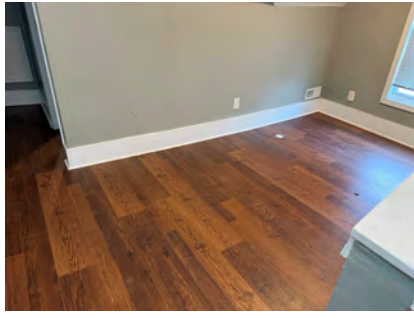
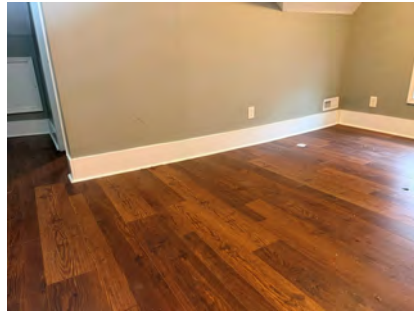
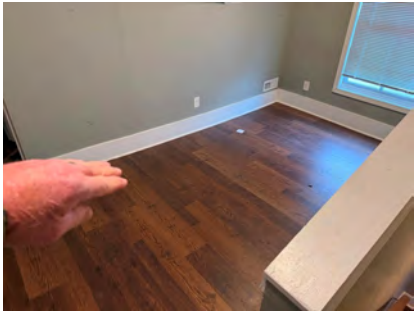
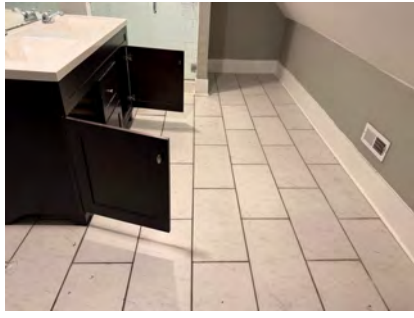
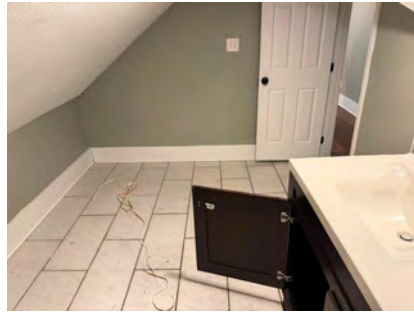
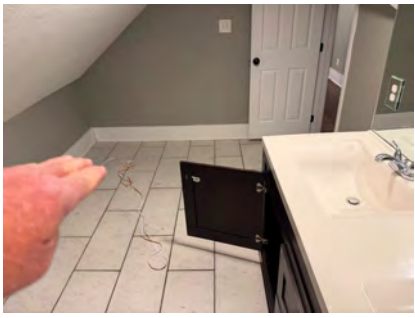
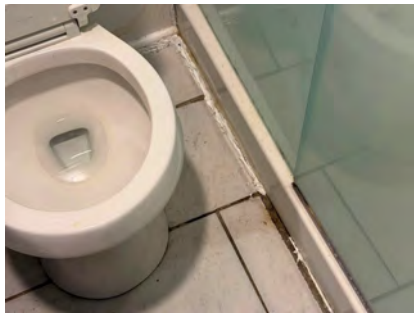
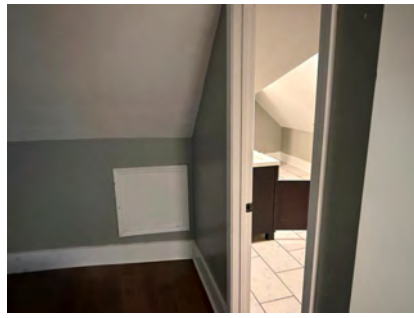
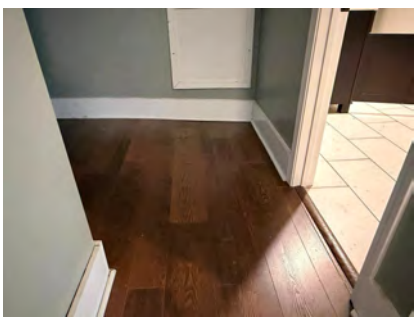
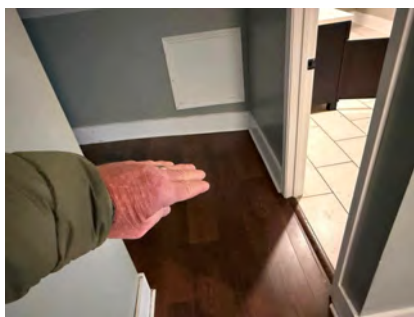
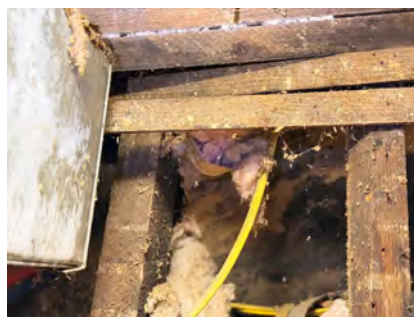
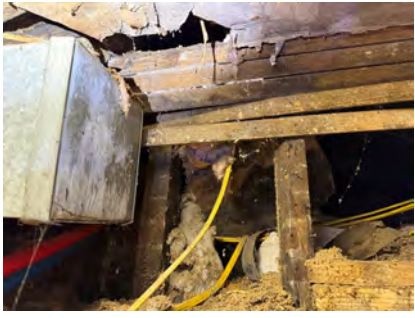
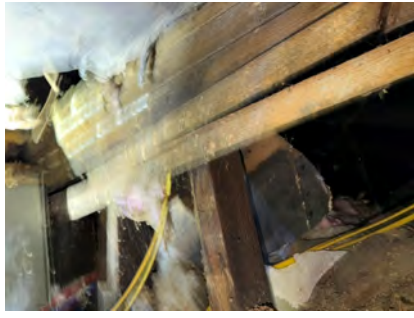
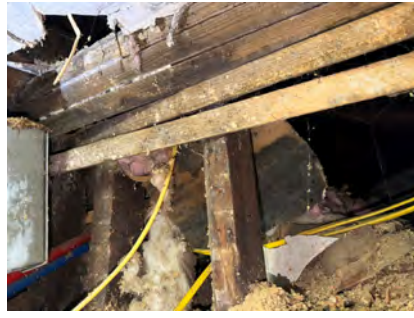
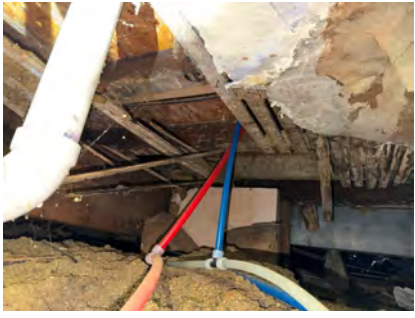
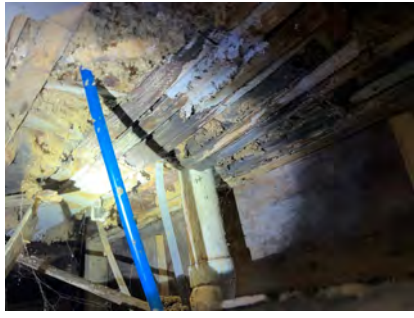
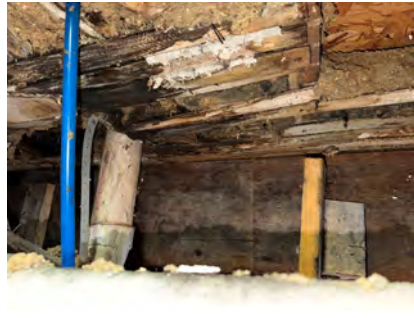
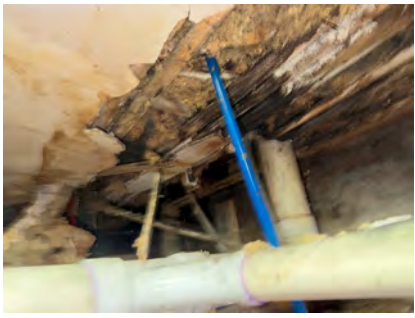
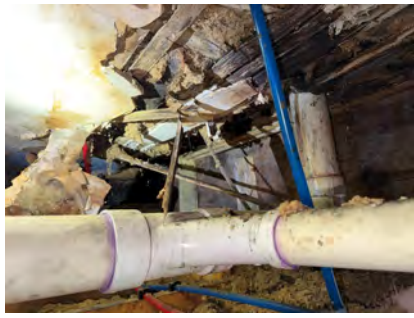
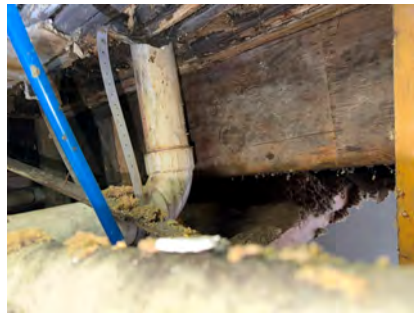
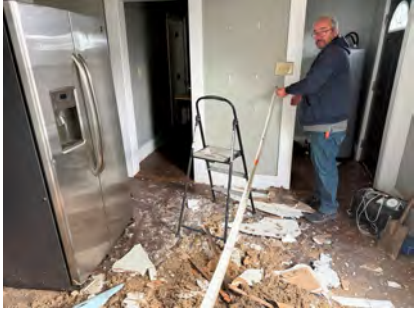
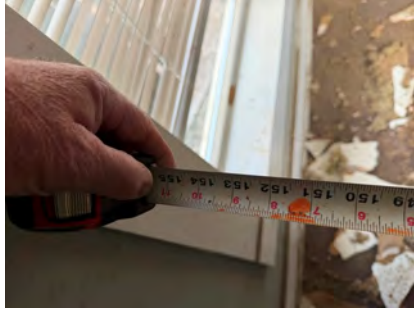
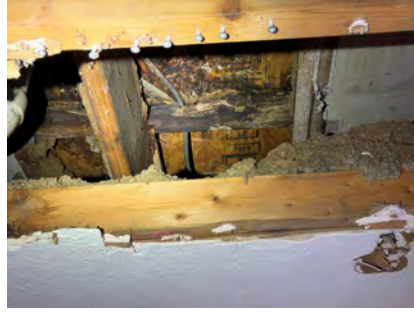
1. The floor on the second floor outside the bathroom and inside the bathroom is sagging excessively. It appears the bathtub and sink plumbing in the bathroom has leaked over time causing the floor joists and frame support walls in the surrounding floors to deteriorate and sag. Repairs are needed due to the poor structural condition of the floor joists and support walls. (See Photos 2-26)

- a) Removing the rotted floor joists, subflooring and any frame walls that have wood rot damage in the second floor hallway and bedroom on the right rear of the second floor.
- b) Repair or replace all defective plumbing that is leaking.
- c) Install new 2x10 floor joists spaced 16" o.c. that span under the hallway and bedroom and are supported on the exterior wall and the interior bearing wall.
- d) Install new 3/4" floor sheathing after the joists are replaced.

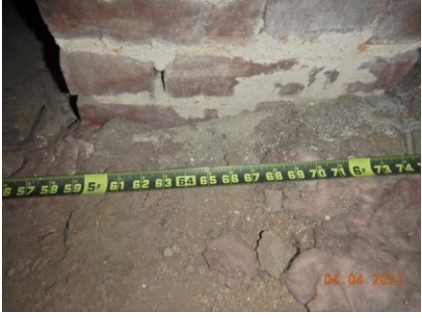
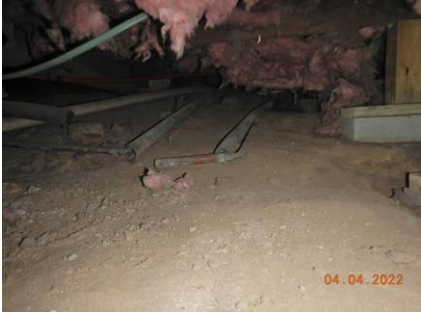
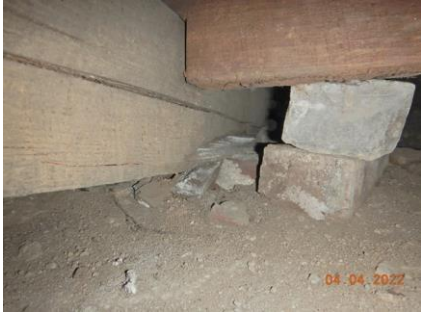
Photo # 73	Photo # 74	Photo # 75

2. The floor system consists of a central 6"x4" girder beam supported by masonry brick piers that have settled and leaned due to a lack of a permanent concrete footing. The end of the girder beam towards the back of the floor structure, where the floor joists are in contact with the ground, has water/insect damage where it is in close contact with the ground. (Photos #66-75) Recommend :

a) temporarily support the floor joists on both sides of the damaged girder beam. Remove the damaged girder beam in sections and replace with new triple 2"x10" wood girder beams with a nail pattern of three nails every 8" o.c. alternating sides and installed under the existing floor joists.

b) The new girder beam should be supported on intermediate piers which consist of double 8" stacked (OR single stack 12") mortared blocks with a solid cap on top and pressure treated wood (OR metal) flat shims (no wedges) for leveling on 6' centers (OR steel columns (structurally rated)).

c) The new piers should be supported on concrete footings 30"x30"x10" deep. Any splice joints in the girder beams must be centered over the new piers/posts.
