**KNOXVILLE HISTORIC ZONING COMMISSION
STAFF REPORT - CERTIFICATE OF APPROPRIATENESS APPLICATION**

PROPERTY ADDRESS: 28 Market Square 37917

FILE NO.: 8-I-14-HZ

PROPERTY DESCRIPTION: Commercial Vernacular (1905)

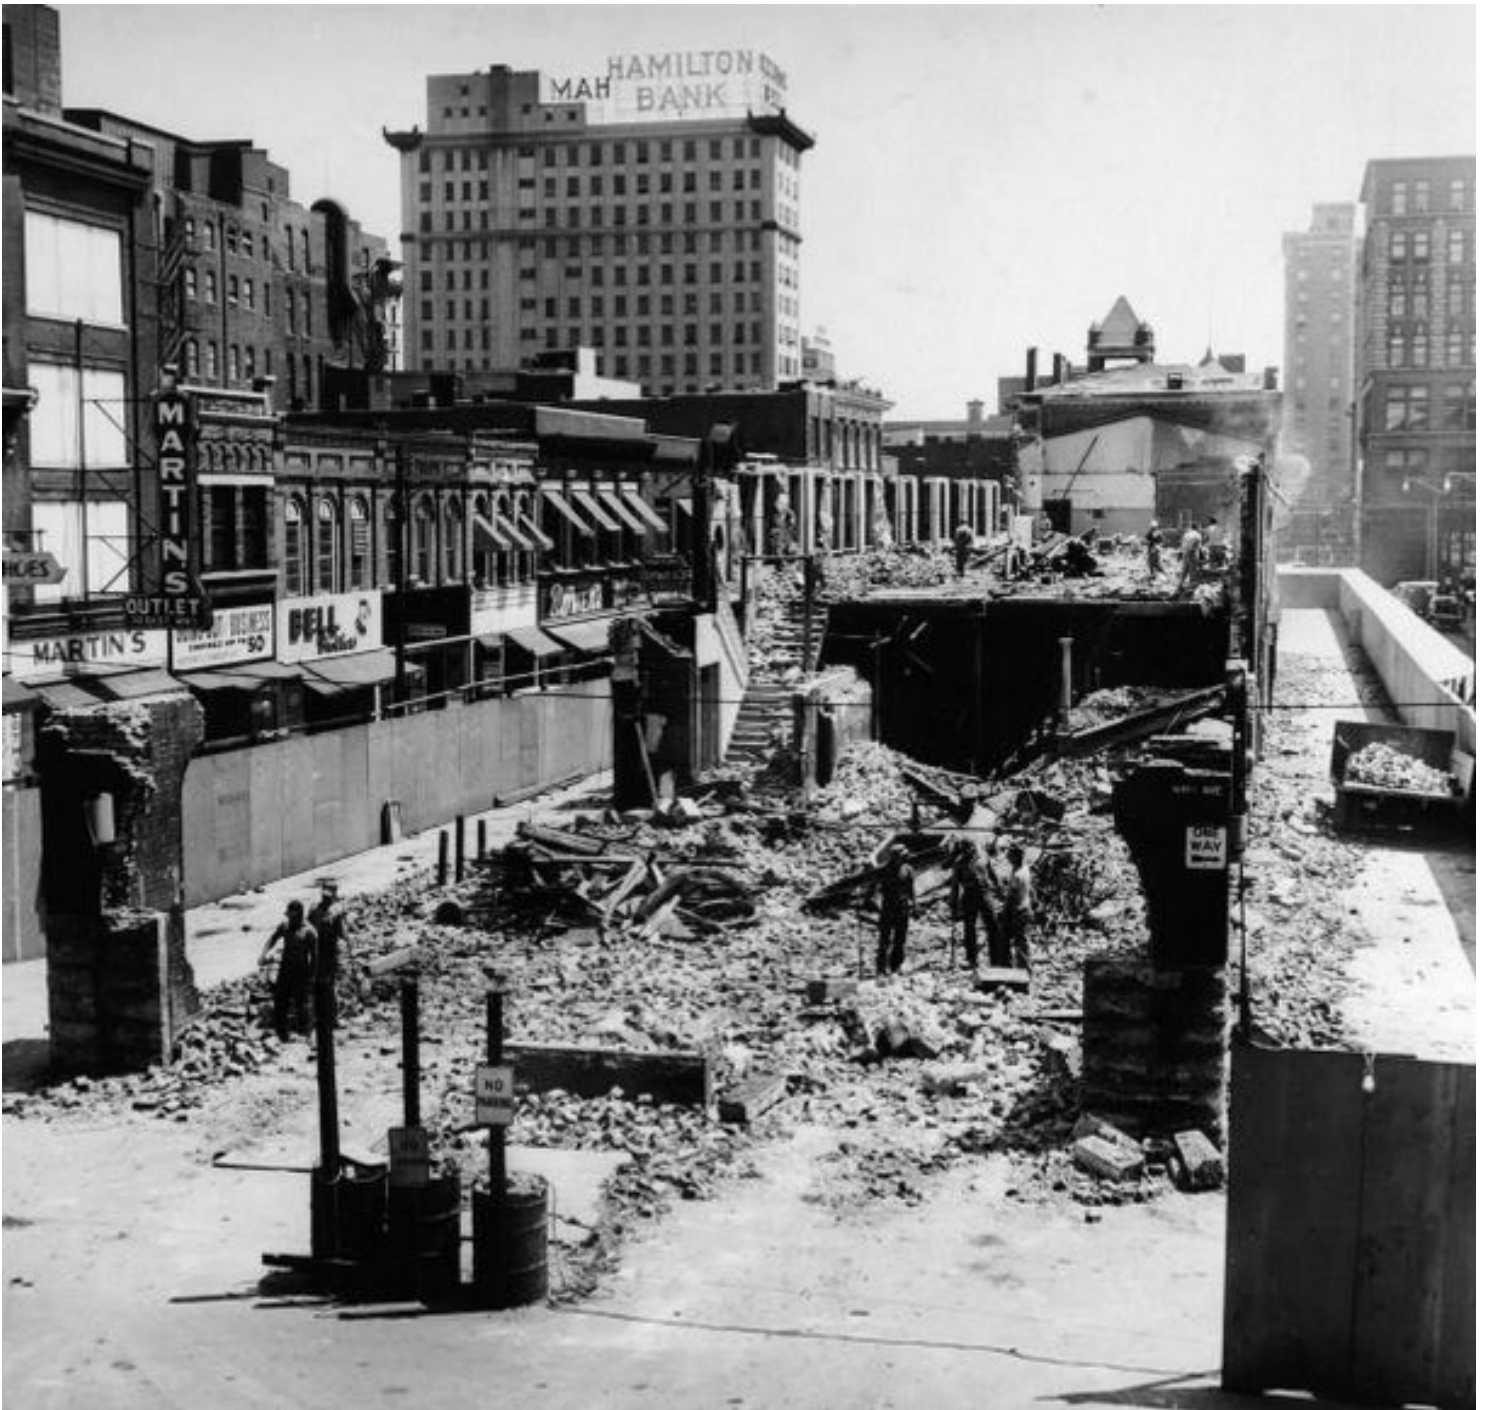
Second building from the left – past the “Martin’s” sign is 28 Market Square. There appears to be a simple cornice or fascia board above the mid-level transom windows, which are covered. [In a May 6, 1960 photograph, workers demolish the ruins of the Market House which was gutted by fire five months earlier (KNS Archive)]

- 1) The lower storefront façade of 28 Market Square has been heavily altered since its construction c. 1895; however, the transom windows are original and have a unique opaque gridded glass design. They are a character-defining feature of the building and should be retained and protected.
- 2) An early photo of the building indicates that some type of molding was in the mid-building-level location.
- 3) Other buildings in Market Square from the same general era do exhibit a cornice over the storefront -- some are simple and some have dentil molding; therefore, a dentiled cornice at this location on the building is not inappropriate, although may not be an original feature since the actual design is not known.

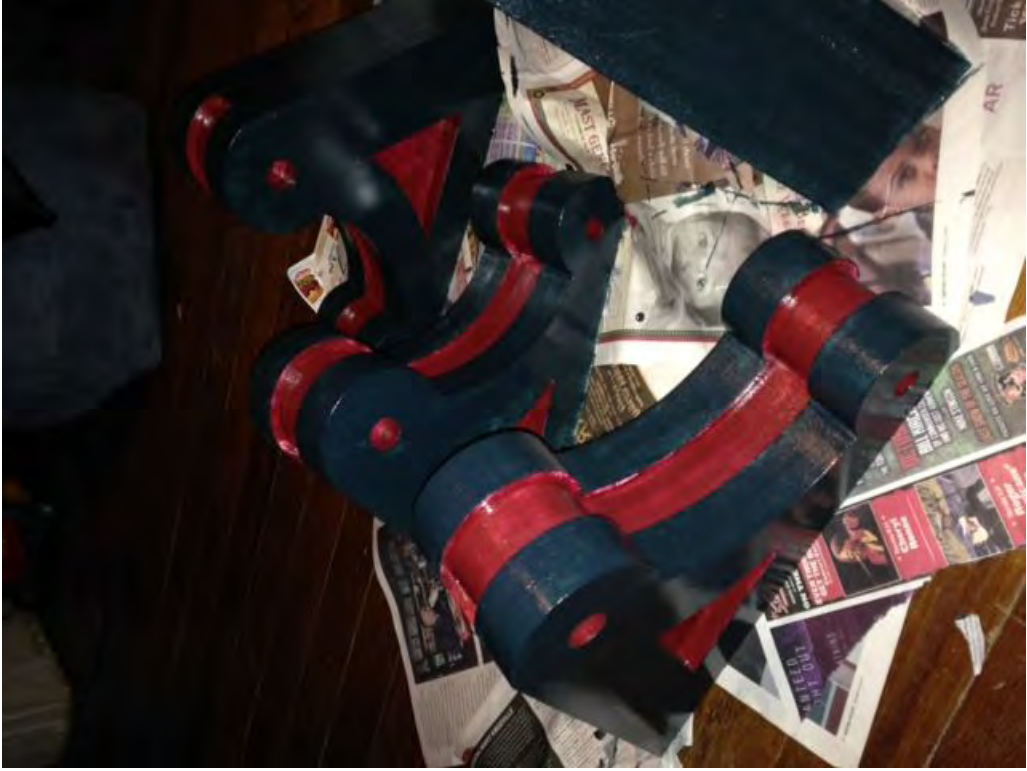
28 Market Square - Brackets for cornice

Design of proposed wooden storefront cornice to be simple molding with a fascia board below, similar to that of 18-22 Market Square. Cornice to be installed directly above the three original multi-light transom windows where there is currently a 30-inch high wood panel spanning the facade. Heavy curved custom wooden brackets under the cornice to be spaced to align with the existing divisions in the transom and to also have 12-inch high dentil molding evenly spaced between brackets. Metal flashing to be installed behind cornice to divert water away from transom window.

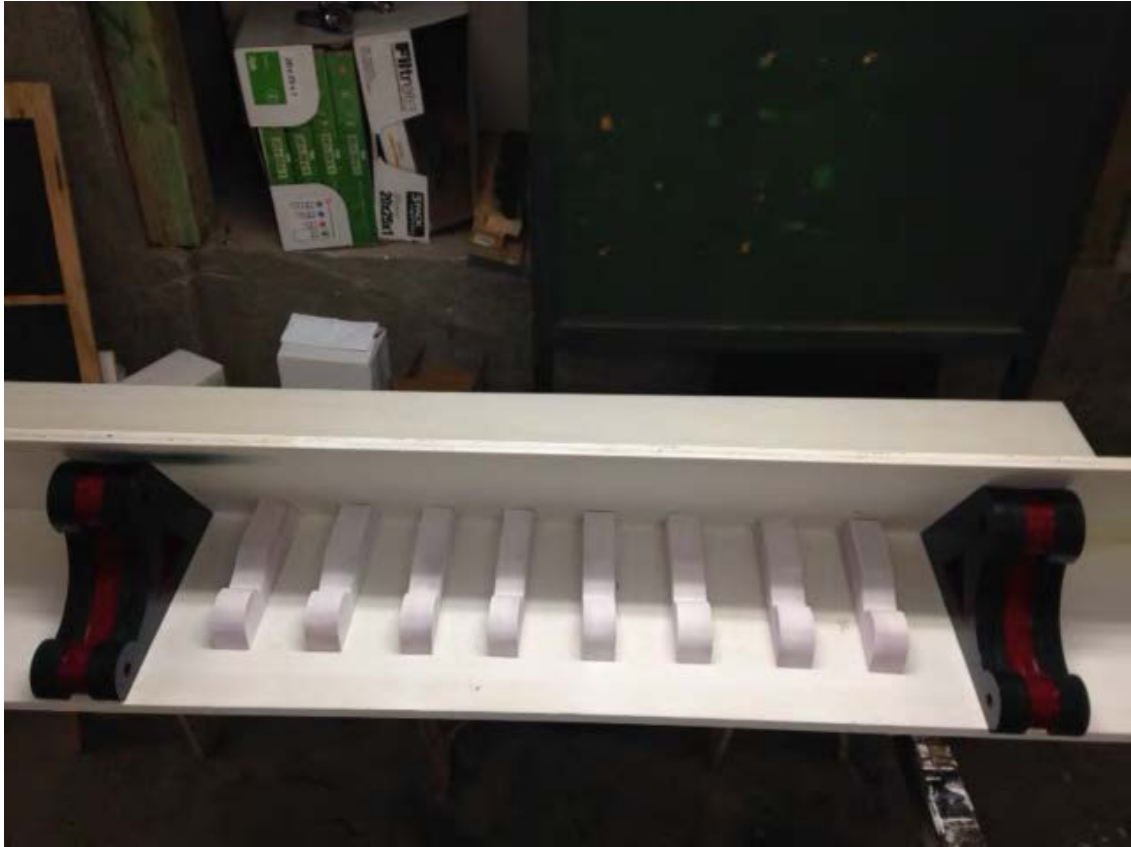
28 Market Square - Partially painted cornice mock-up

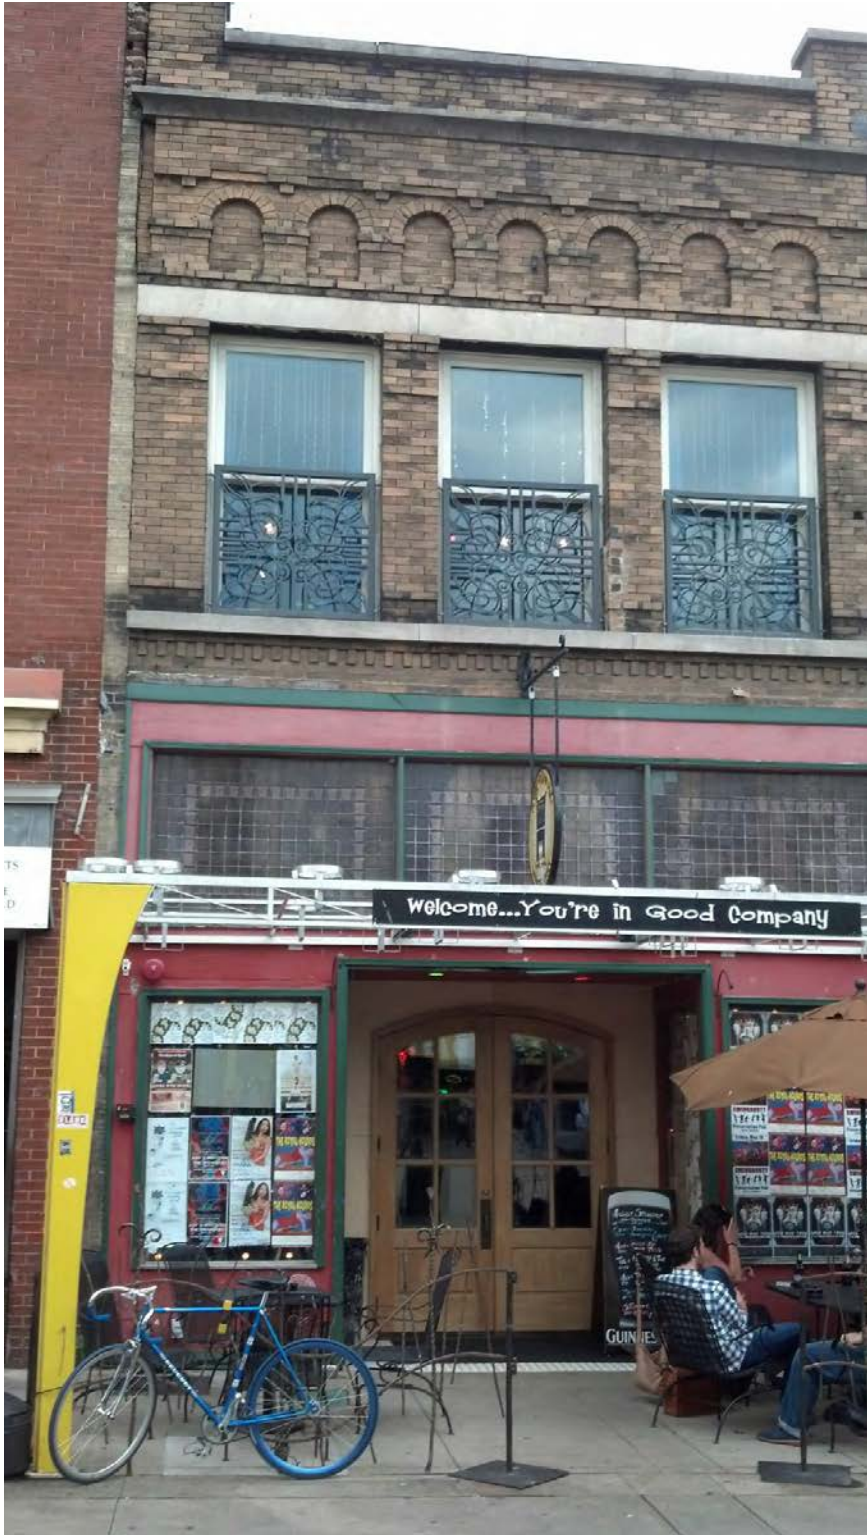
28 Market Square - Facade

The applicant asserts that water is infiltrating the transom windows at the top of the frames and causing water damage. The cornice is proposed as a device to divert the water away from the window frames.

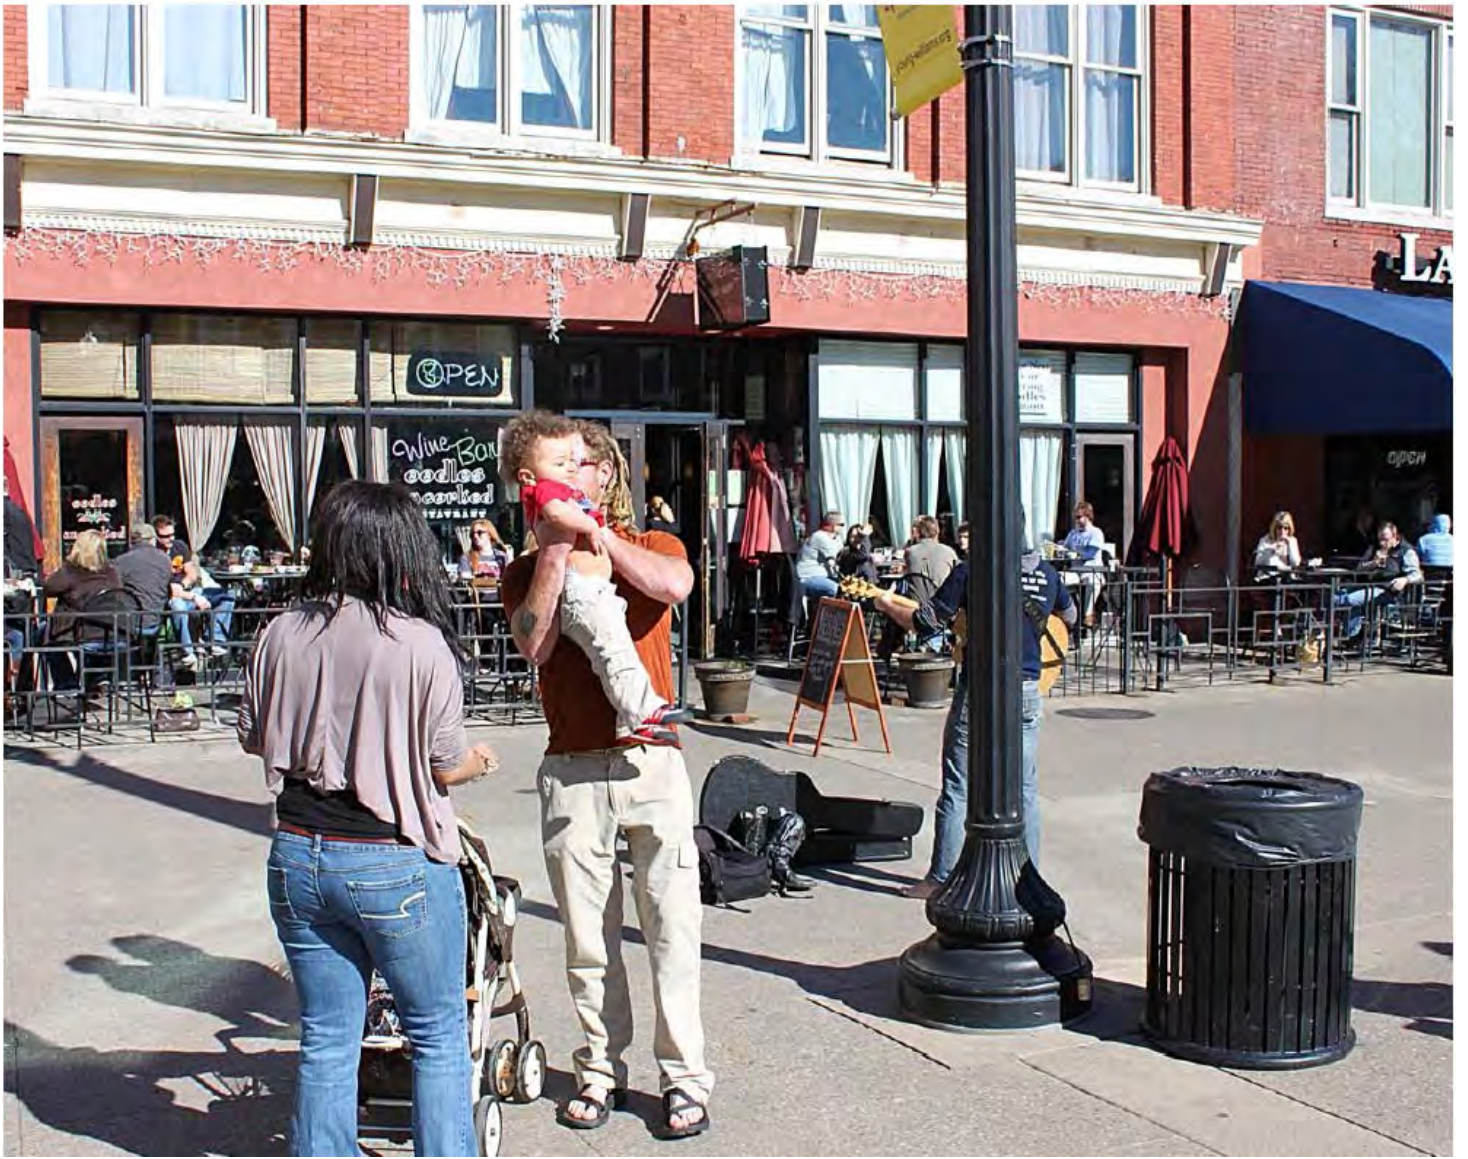
18 Market Square cornice (c. 1895) (east side)
