**KNOXVILLE HISTORIC ZONING COMMISSION  
STAFF REPORT - CERTIFICATE OF APPROPRIATENESS APPLICATION**

**PROPERTY ADDRESS:** 910 Luttrell St 37917  
**DISTRICT:** Fourth and Gill H-1

**FILE NO.:** 6-K-16-HZ

**MEETING DATE:** 6/16/2016  
**APPLICANT:** Cody Farmer Angela Starnes-Anglea (owner)  
**LEVEL OF WORK:** Level II. Major repair or replacement of windows and doors

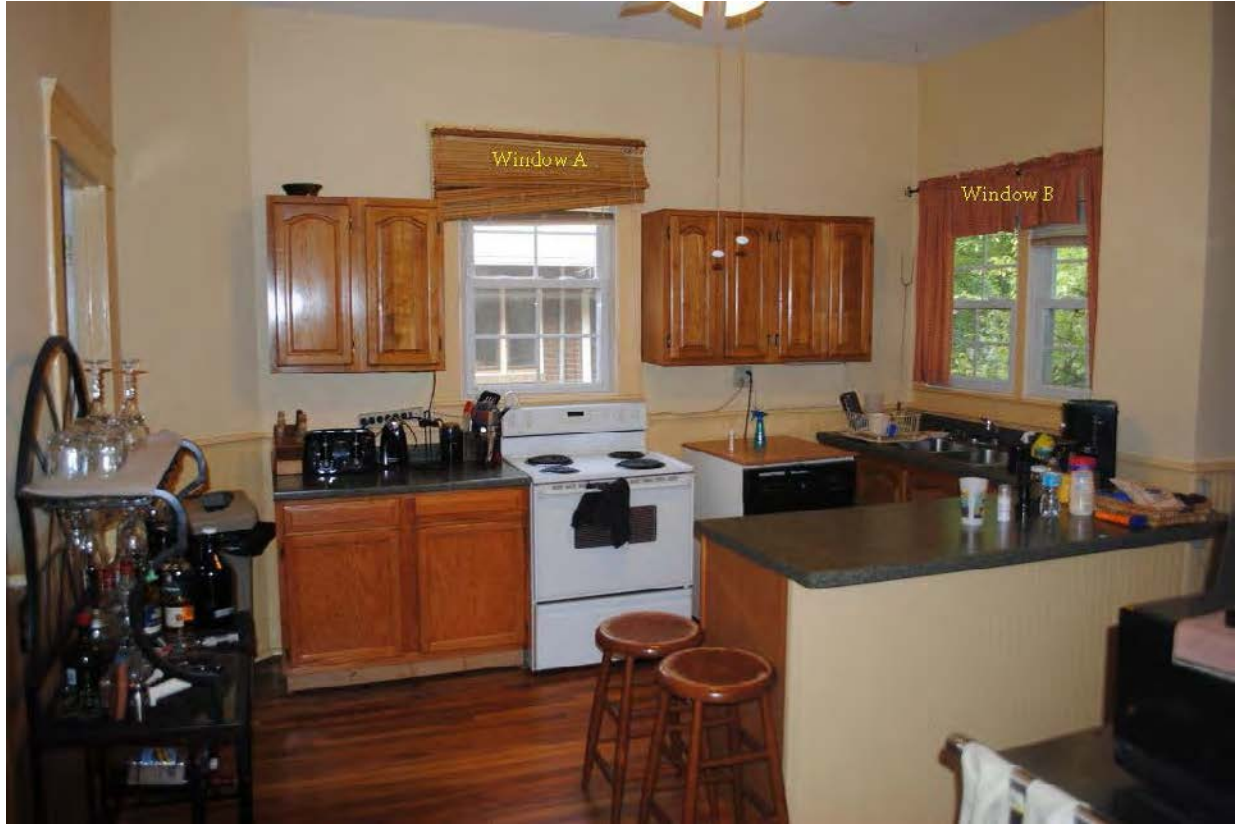
Photo 1

The home was purchased on April 22, 2016 with a 203(k) as part of the mortgage, allowing for the renovation of the largely non-functional kitchen, photos of which are provided below (**Photo 1**). Due to space constraints, non-square corners, and door placement, the removal or movement of (3) non-original windows that are not viewable from Luttrell Street is required. Additionally, we would like to remove the non-original white rod-iron doors that are on the front and back of the house (**Photo 4 and 5**)

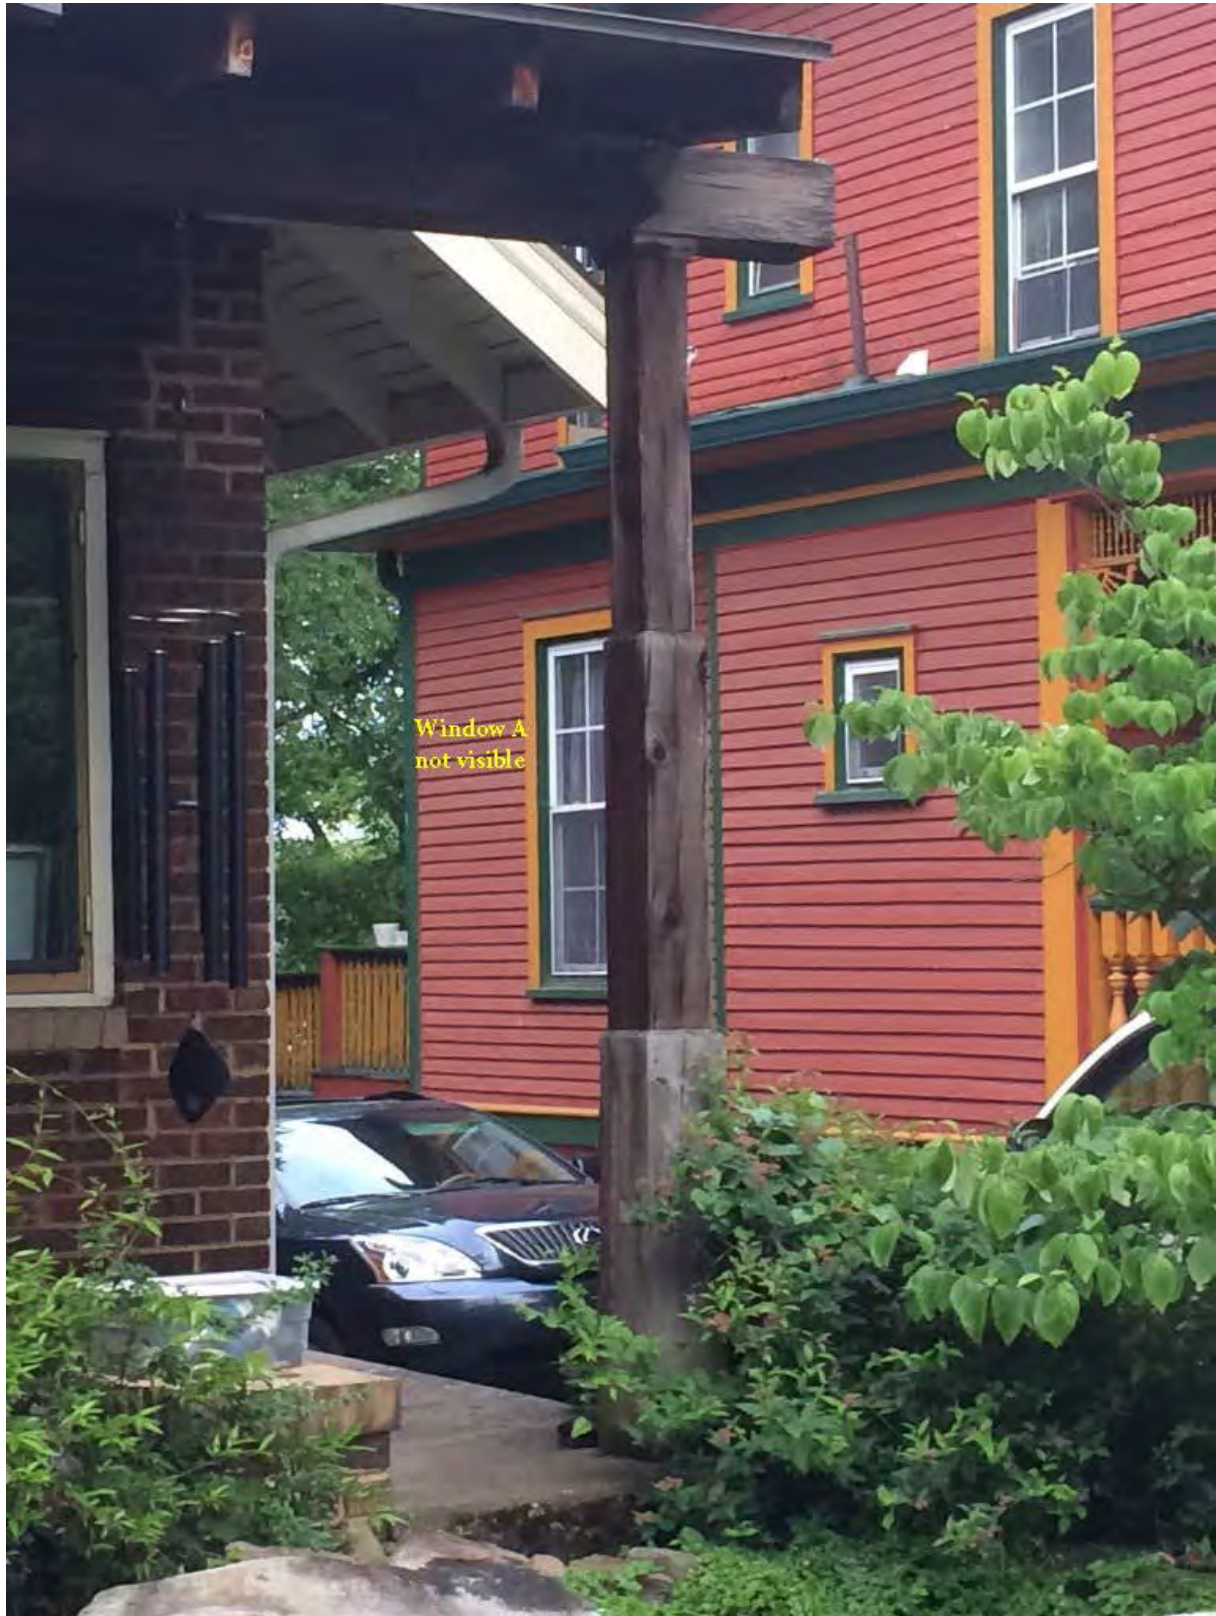
Photo 2

- 1) All windows are non-original vinyl windows.
- 2) Window A (faces north) is not visible from Luttrell Street. (See submittal photos 2, 3, and 4). The window opening may have been altered because it is a smaller size and a different proportion than others, and it appears that the original frame and sills are not in place.

Window A is around the corner on the rear inset portion and is not visible from Luttrell Street.

- **Remove Window A and patch exterior siding to match adjacent.**
  - Window A is a non-original vinyl window that faces north and is not visible from Luttrell Street (See **Photos 2, 3, and 4**)

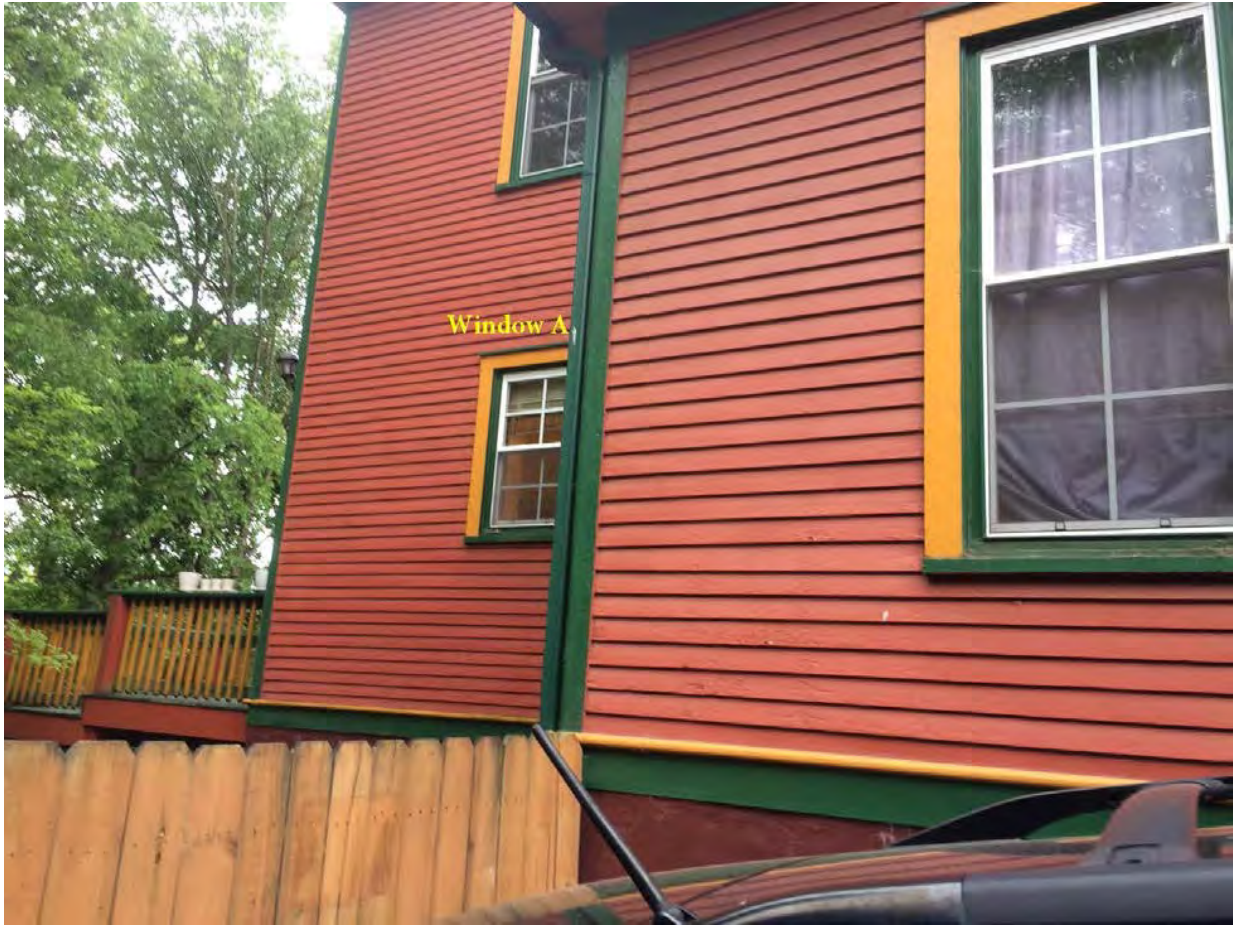
Photo 3

Window A is shown on rear inset portion as viewed from north side of house.

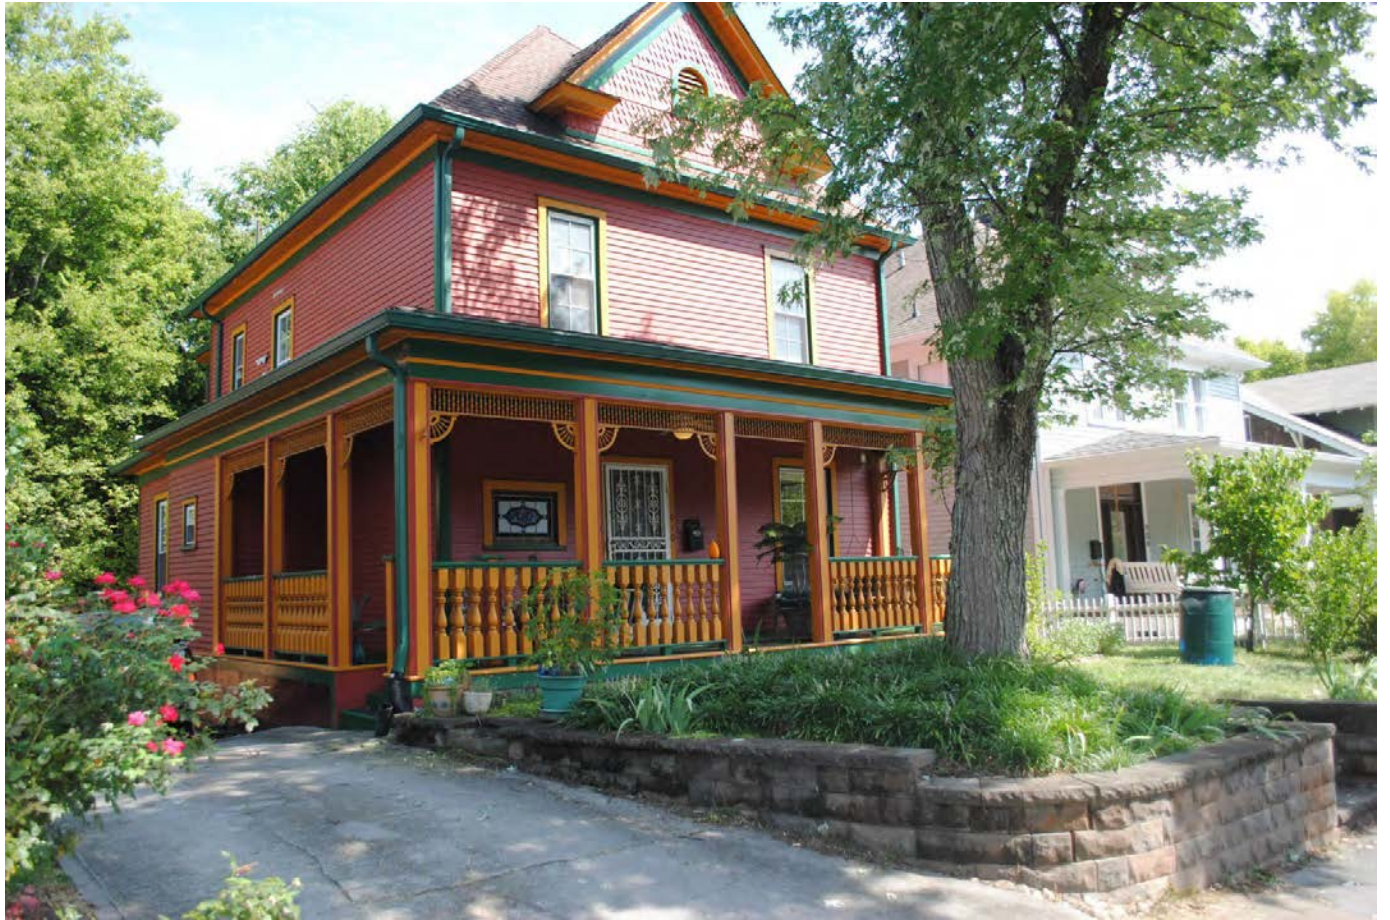
Photo 5

- 6) Removal of the two inappropriate wrought iron security doors on each the front and rear will allow the wooden doors to be visible.

Front of 910 Luttrell Street –Window A is not visible.

- **Remove (2) rod-iron doors. Repair or replace rear-door with like-door.**
  - Remove two rod-iron doors, allowing for the wooden doors to be visible from outside, including the west door which is visible from Luttrell Street. (**Photos 4 and 5**)

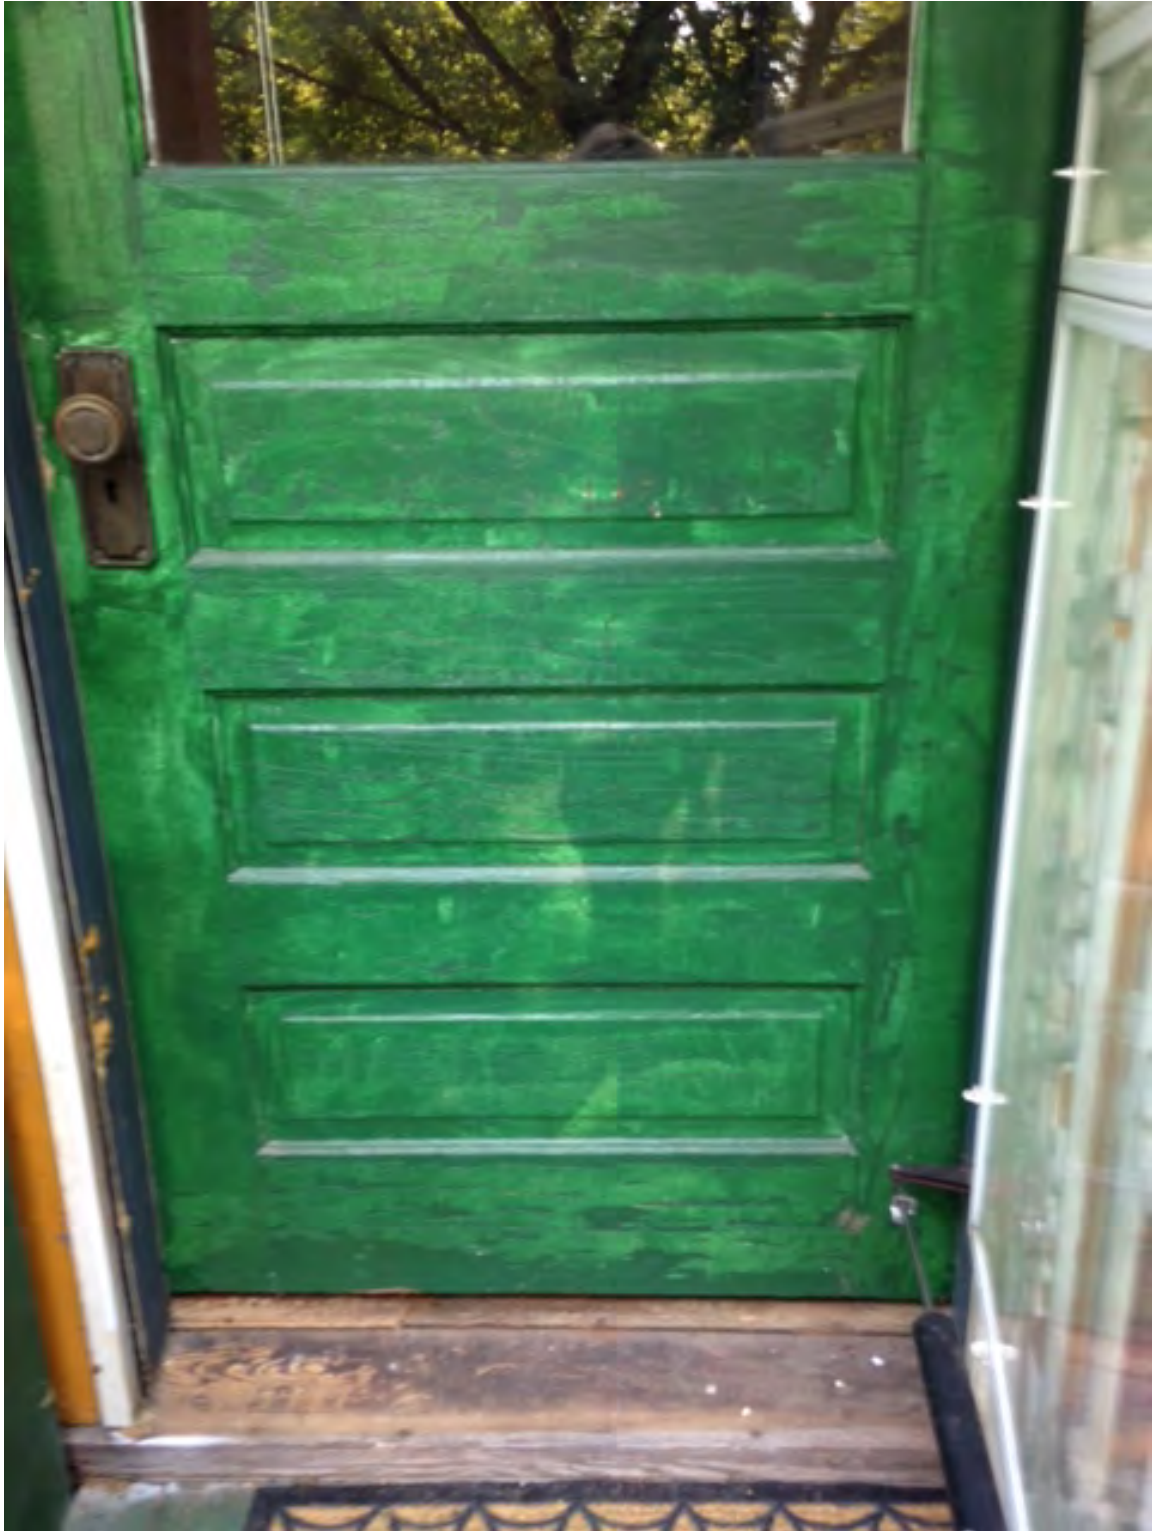
910 Luttrell – Back door

- 5) The rear, east-facing wooden door appears to be early, but the applicant asserts that it is water damaged, especially bad at the locking mechanism, and that it doesn't fit properly and it has been improperly repaired with caulking and foam.

- Rear, east-facing wooden door has been painted to match the house and is damaged beyond repair. The east facing rod-iron door cannot be removed until this door is repaired or replaced.
