**KNOXVILLE HISTORIC ZONING COMMISSION
STAFF REPORT - CERTIFICATE OF APPROPRIATENESS APPLICATION**

PROPERTY ADDRESS: 515 Lovenia Ave 37917

FILE NO.: 11-D-16-HZ

Replace set of original or early 3/1 wood double-hung twin windows with set of vinyl-clad sliding glass doors within opening of same width, but enlarging window opening to the ground to accommodate doors.

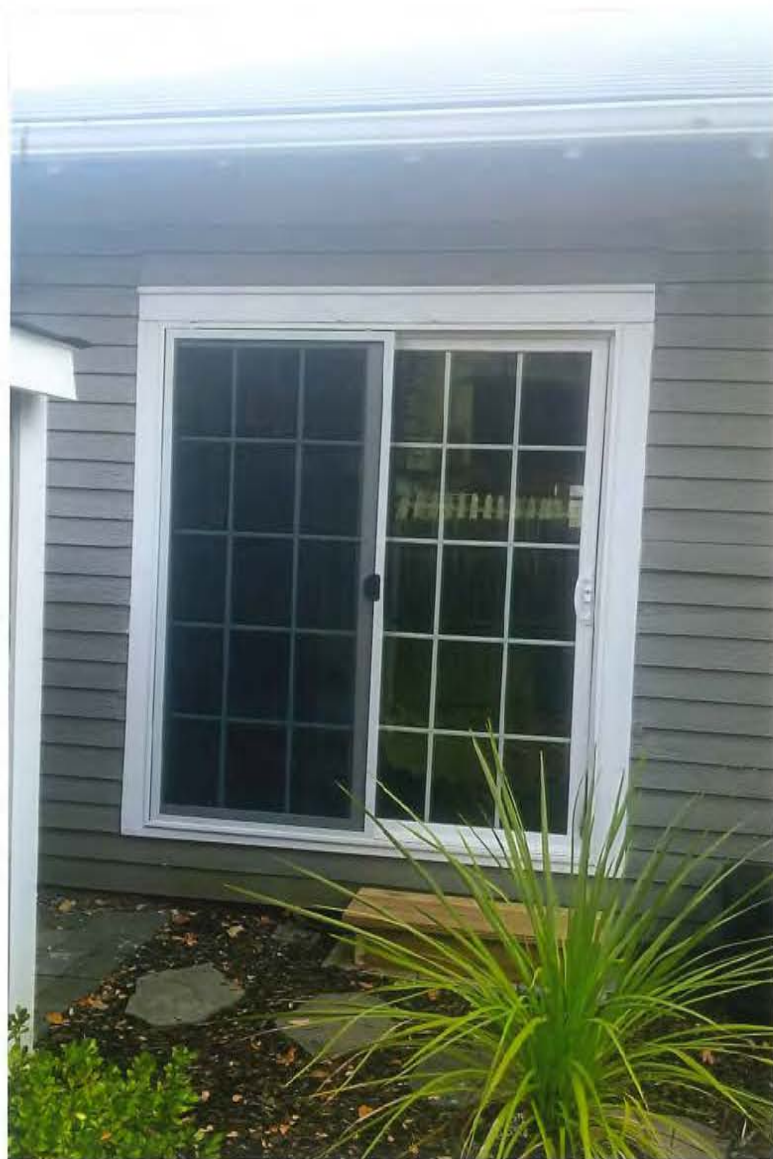
The early or original windows have already been disposed of and the sliding glass doors have already been installed. The applicant relays that there was a small plywood and drywall door that had been earlier installed in place of one of the windows. The door was water damaged and molded inside.

515 LOVENIA AVE. SLIDING
GLASS DOORS REPLACING TWIN
3/1 WOODEN WINDOWS
10/2016

Recommendation of denial of existing vinyl sliding glass doors. The applicant may propose a different type of / location for egress doors if needed or if another egress is desired.

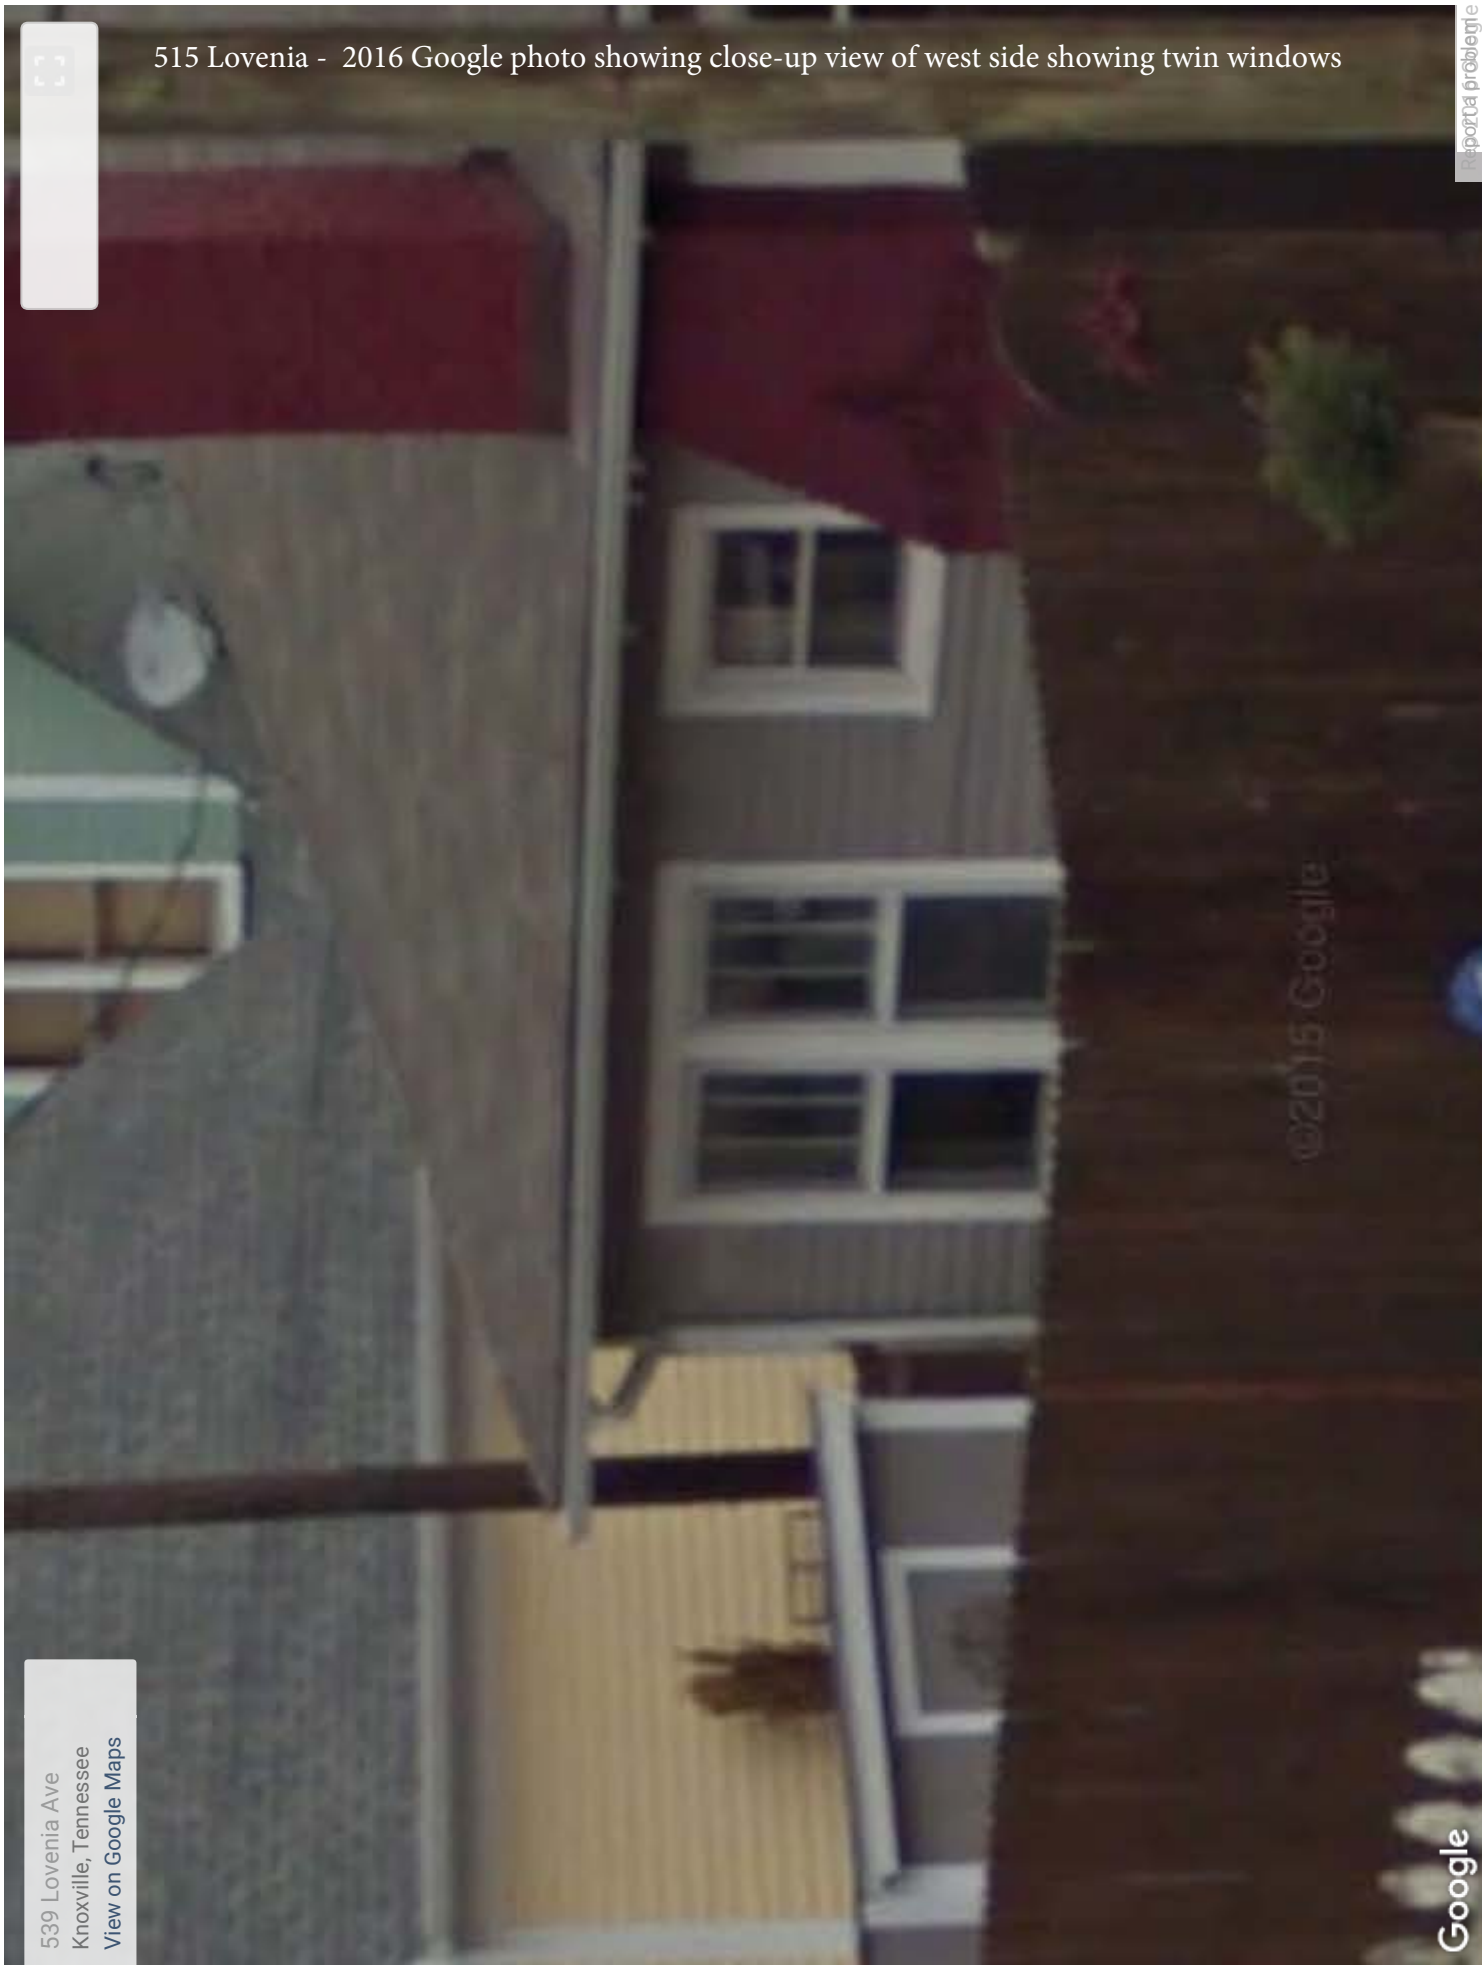
515 Lovenia bird's-eye view of west side showing twin windows
