**KNOXVILLE HISTORIC ZONING COMMISSION
STAFF REPORT - CERTIFICATE OF APPROPRIATENESS APPLICATION**

PROPERTY ADDRESS: 605 Caswell St 37917

FILE NO.: 9-O-17-HZ

DISTRICT: Fourth and Gill H-1

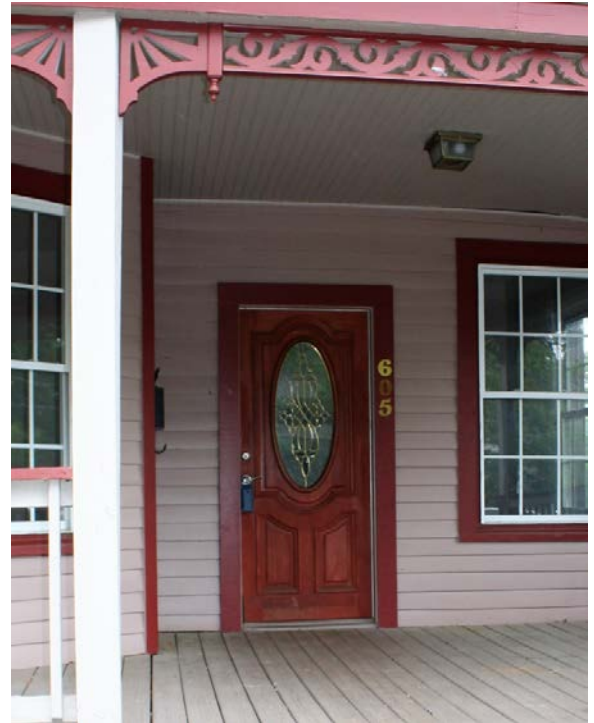
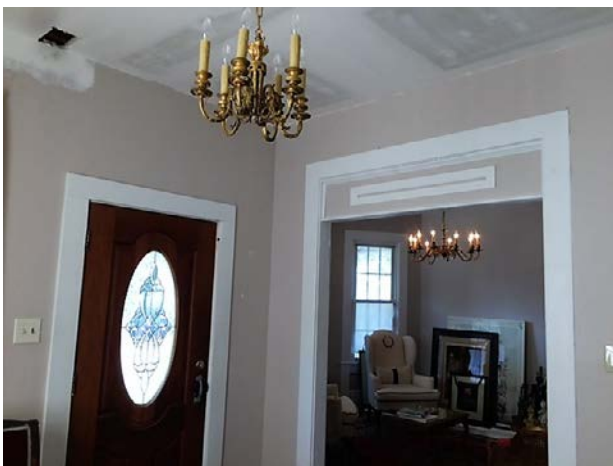
result. It is possible the original door was taller and matched the height of the flanking windows. Supporting evidence exists in that the wood siding on the house above the door is slightly thinner (modern era milling) compared with the remainder of the siding on the house in the door area. Additional evidence of an original transom is found inside. Upon entering the house to the left is the living room and as is shown below, there is evidence of a transom over

the passageway. A fixed transom window, single light, framed in directly above the door would bring the height of the door up to the height of the windows. It is not unreasonable to consider that there was a matching transom over the front door. And, finally, transom windows

Restore transom over front door. The current door is not original and is a standard 6' 8" door. Also, it is shorter than flanking windows with a disconcerting

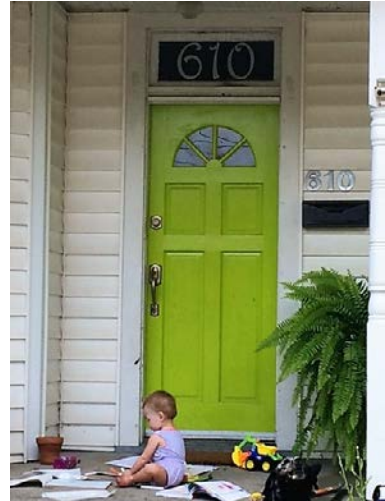
occur on every house on Caswell Avenue between Gratz and Luttrell, for example, 610 Caswell Avenue, pictured here. Apparently, it was the norm.

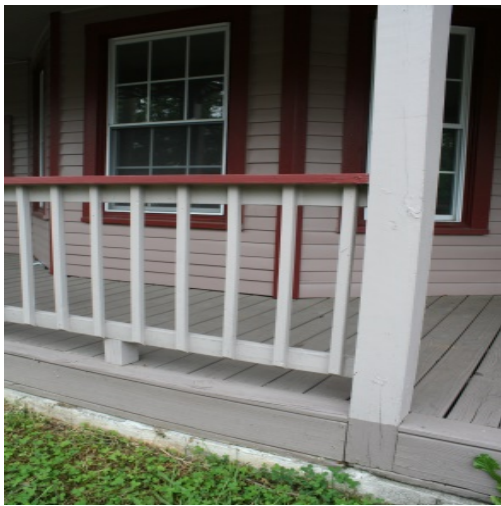
2. Front porch railing. The approximately 41' of balustrade on the front porch can be refined with both the introduction of

horizontal banding on the upper front and bottom that matches the dimension of the boards on the interior side. The proposed banding will conceal the attachment ends of the balusters. The current pickets are spaced 5 1/2" apart and do not meet the current code requirement of no more than 4" of spacing in between. Additional pickets would be placed in between

Wall ... 2 1/8" space ... 1.5" picket...2 1/8" space ... 1.5" picket... 2 1/8" space ... 1.5" picket

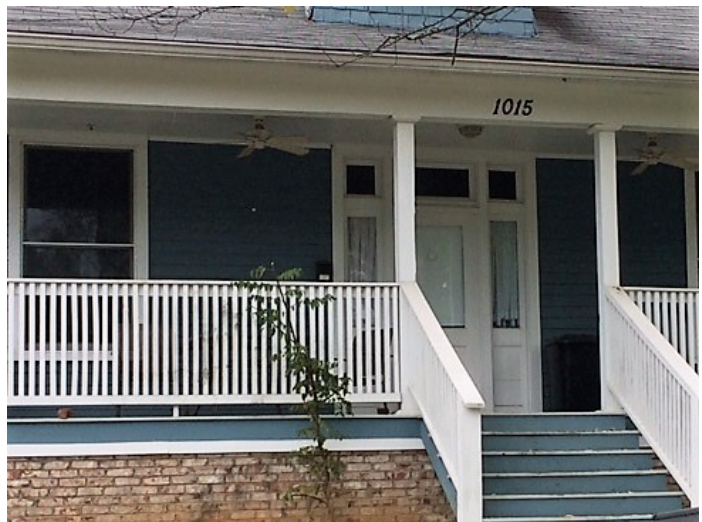
A Gratz Street house exhibits a similar, compressed pattern:

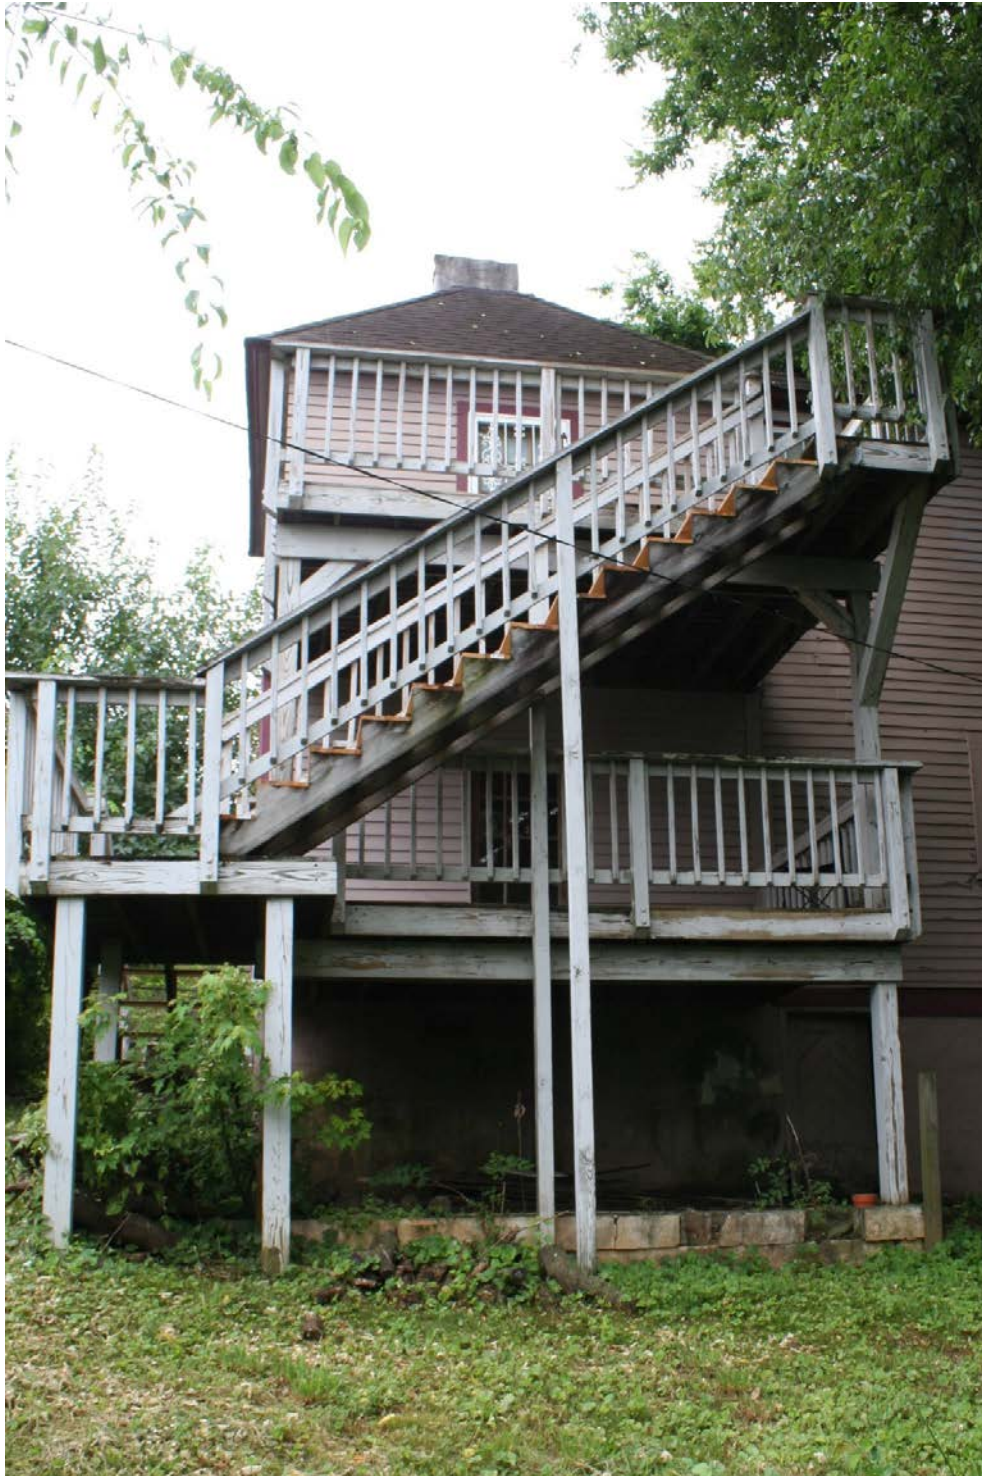
3. **Rear double deck partial dismantle, conversion to screened-in porch.** In the mid-1990s, double decks were installed at 605 Caswell Avenue, a window on the second floor removed and replaced by a door to that level deck. By then, the property had become a rental, decks likely installed to attract college student renters. The result, below, was not subtle.

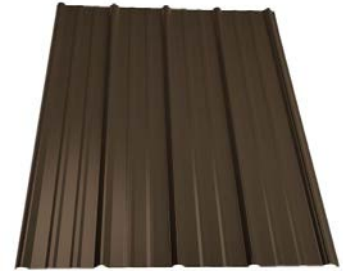
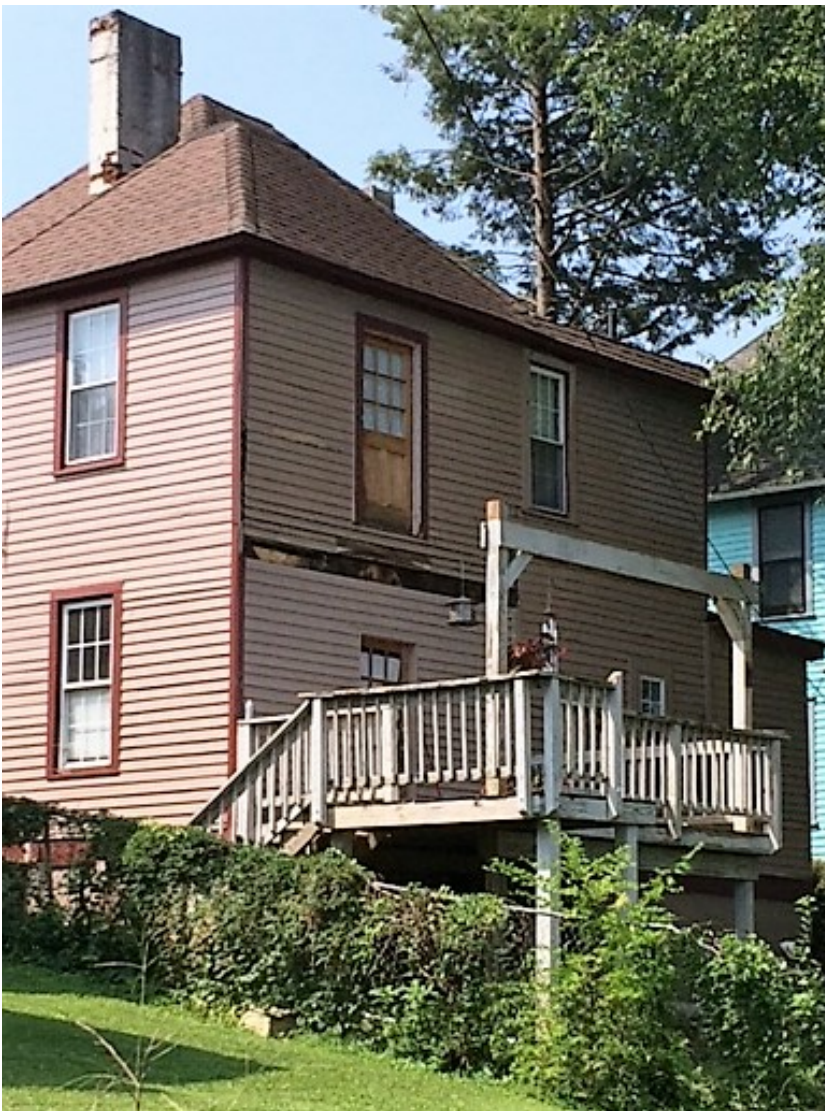
The deck has since been dismantled, the wood carefully removed for re-use. Only the floor of the bottom deck remains along with two vertical members and a lateral which will support the metal roof to be used in porch creation. The footprint of the existing deck will not be increased for the screened porch but remains at 11' deep, 14' wide. **And, no architecturally significant elements will be obscured by the addition of the porch.**

The dismantled deck is shown below and three scaled drawings (east, west and south elevations) are included as **Attachments 2, 3, and 4.** The proposed porch roof is 5-v crimp black metal

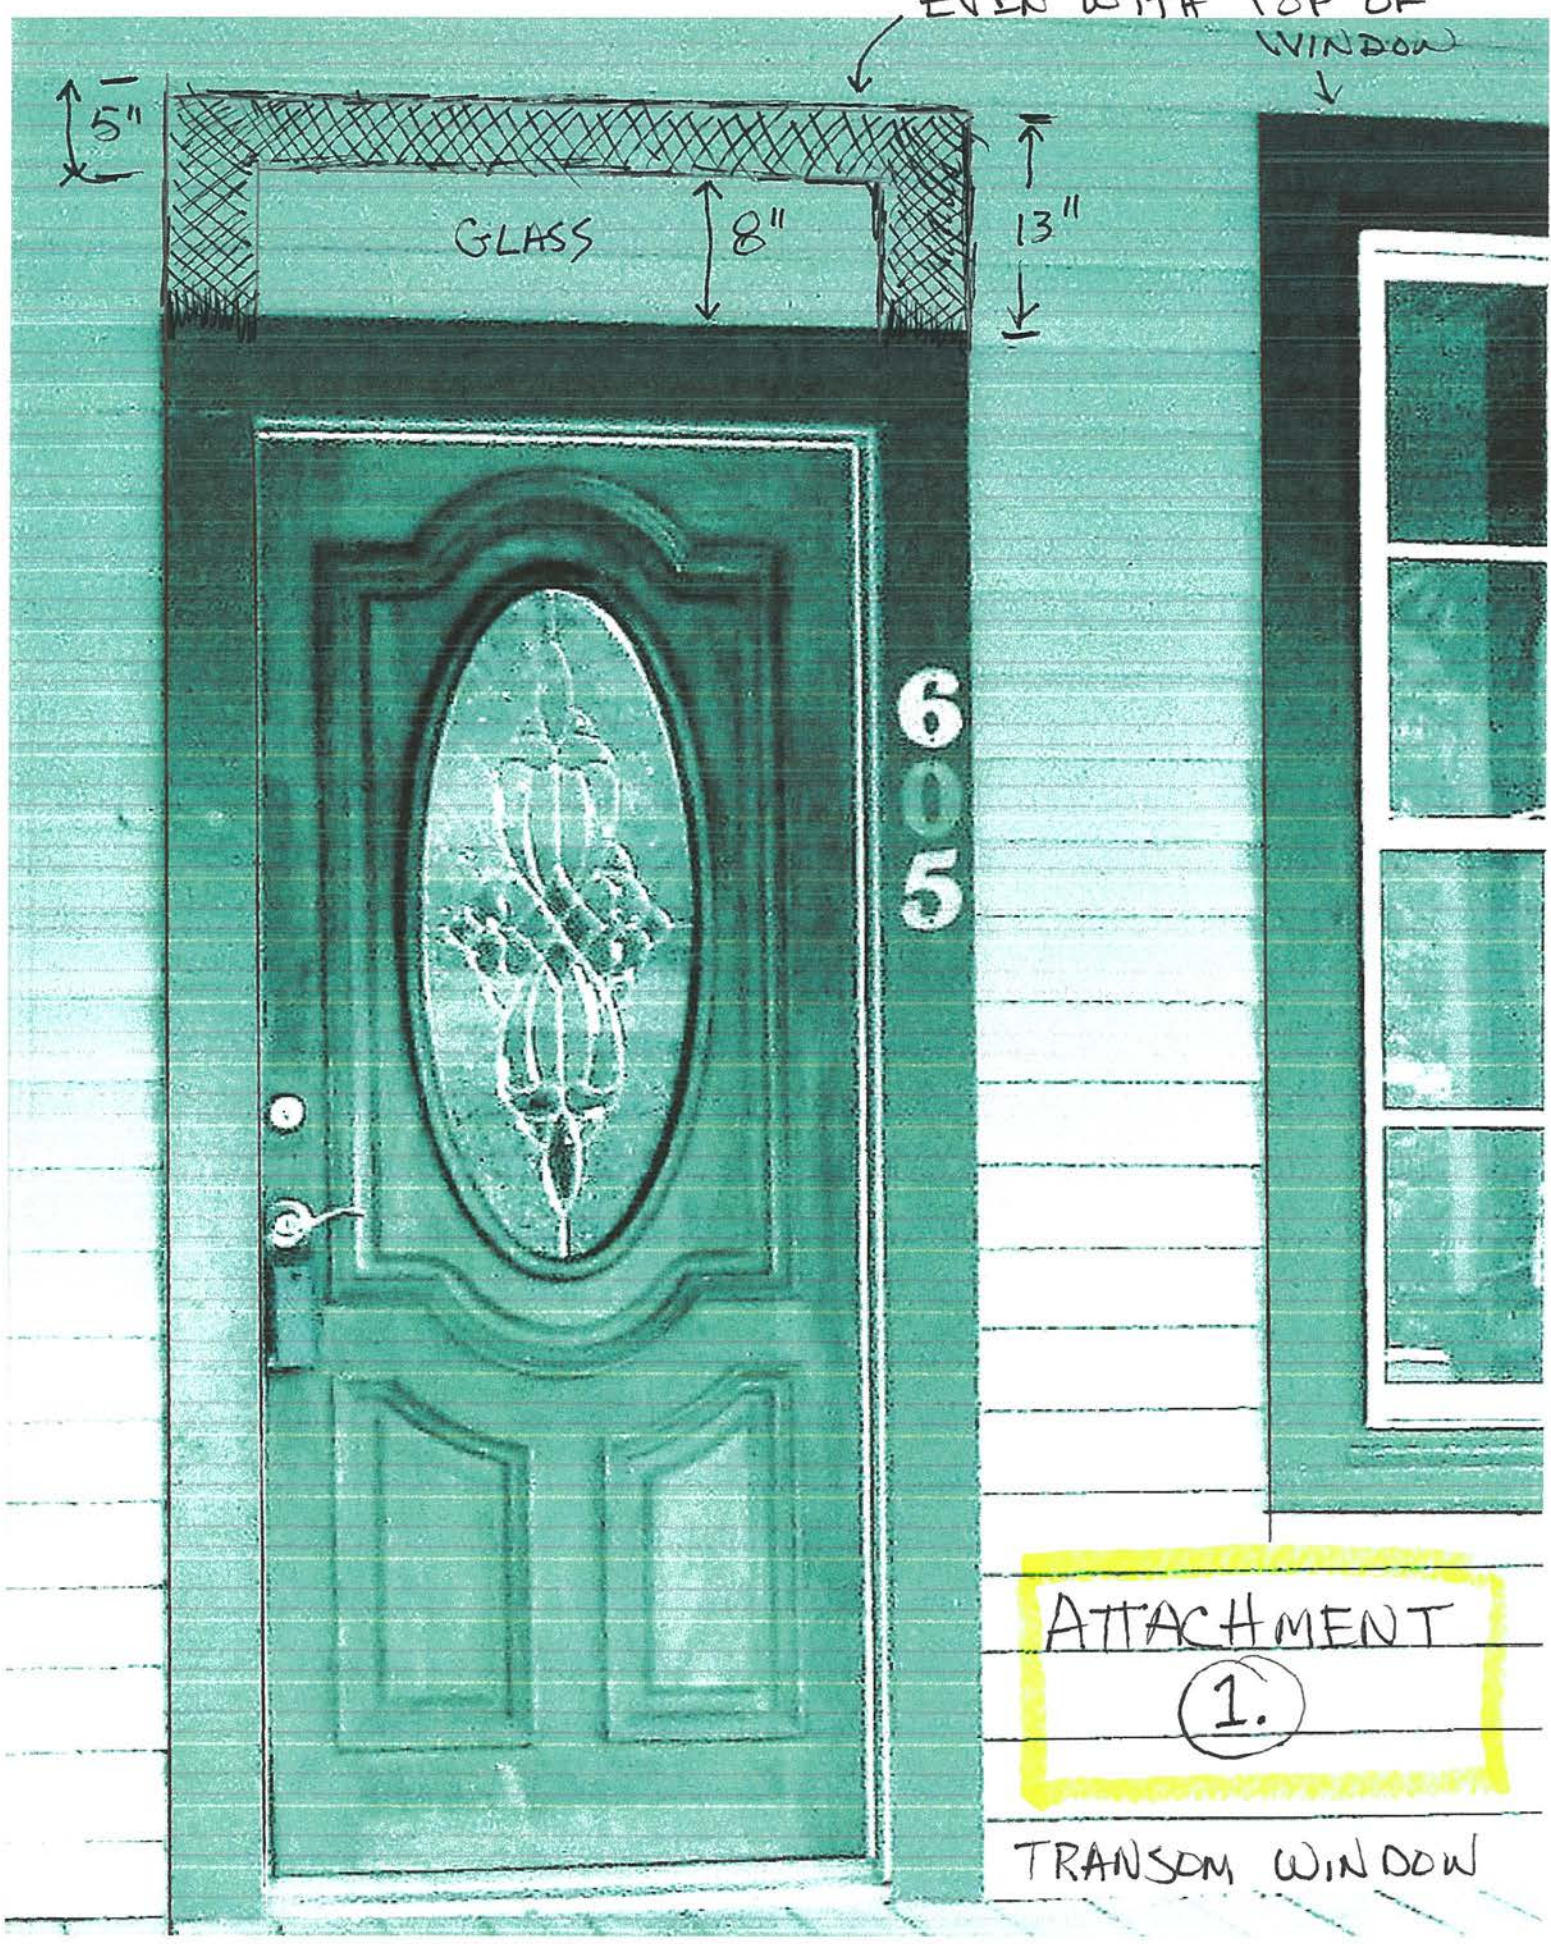
TRANSOM WINDOW

EVEN WITH TOP OF WINDOW

GLASS

See Attachment 1 for dimensioning.

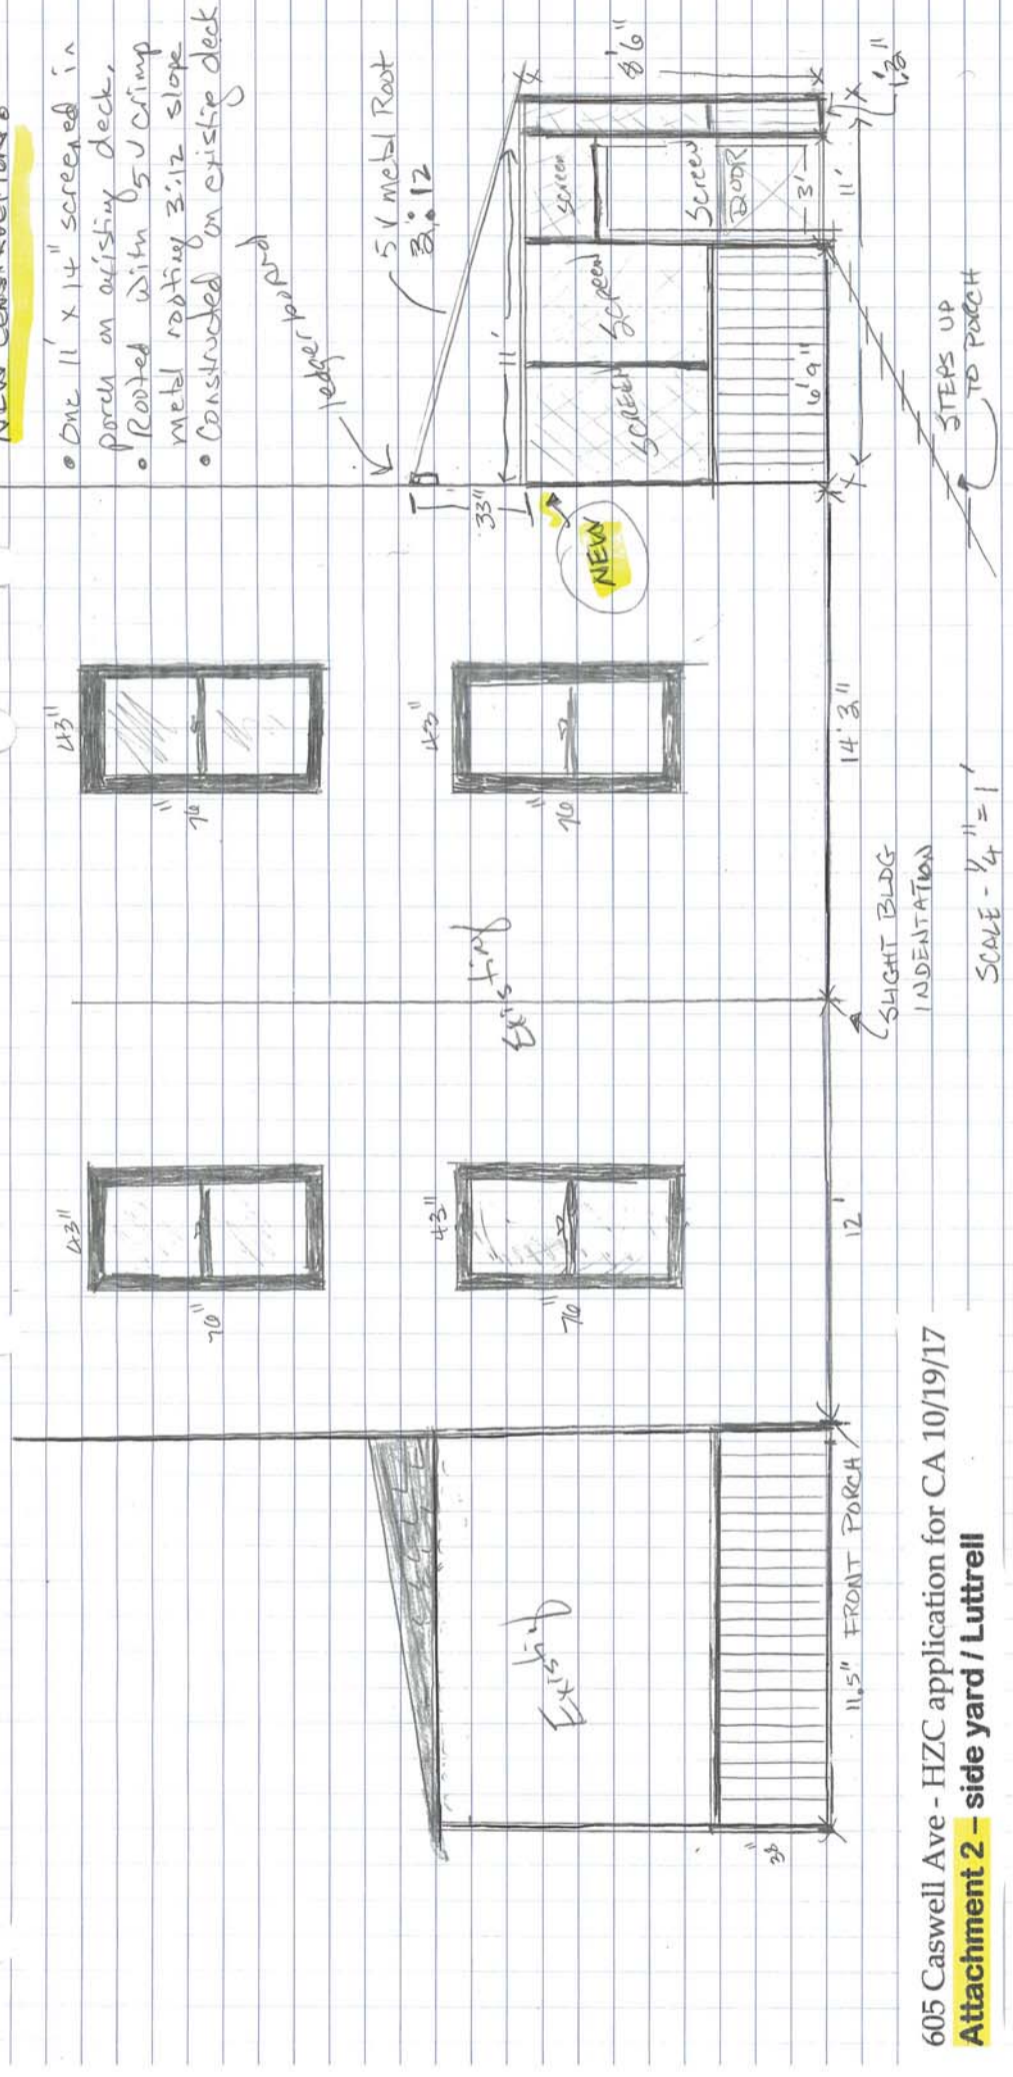
605 Caswell Ave - HZC application for CA 10/19/17
Attachment 2 - side yard / Luttrell

- One 11' x 14" screened in porch on existing deck.
- Routed with 5 V crimp metal roofing 3:12 slope
- Constructed on existing deck
