**KNOXVILLE HISTORIC ZONING COMMISSION
STAFF REPORT - CERTIFICATE OF APPROPRIATENESS APPLICATION**

PROPERTY ADDRESS: 26 Market Square 37902

FILE NO.: 3-E-19-HZ

LEVEL OF WORK: Level II. Construction of rooftop addition

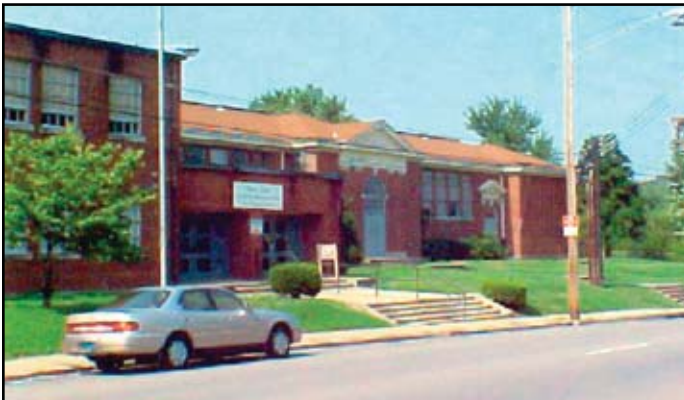
Application 1 (*Incompatible treatment*): A school built in 1923, and expanded in later years, was proposed to be rehabilitated for continued educational use as a community

The school prior to rehabilitation.

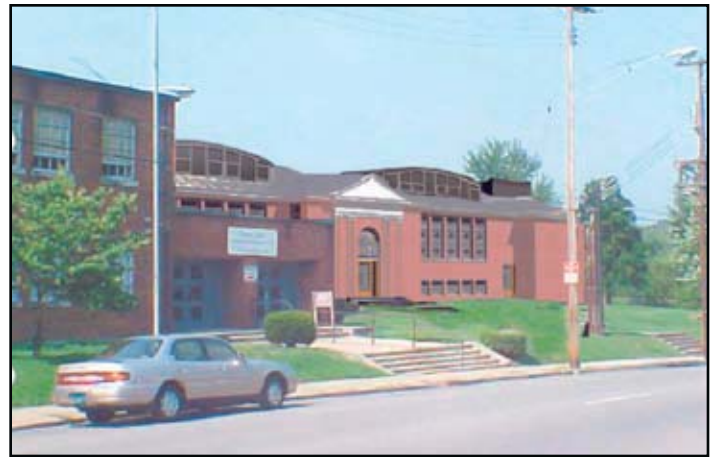
Proposed rooftop additions to school building.

resource center, a housing complex for senior citizens, a day school, and a boarding school. The building was less than three stories, sat prominently on the street and was visible on all elevations. Under the initial proposal, boarding students would live in the historically unoccupied attic of the original, 1923, portion of the school.

Because the attic lacked adequate headroom, dormers were proposed for the visible front and side elevations. The Stan-

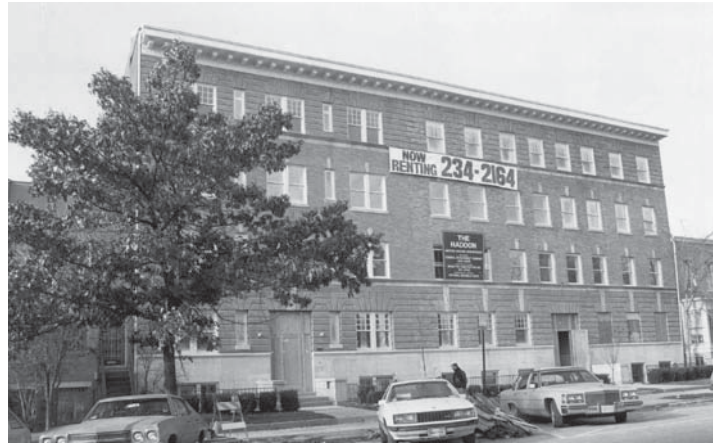
This early twentieth century apartment building was actually constructed as two buildings of harmonious but slightly different design.

Application 2 (*Compatible treatment*): A rooftop addition was proposed for a four-story apartment building that was being rehabilitated for continued residential use. The building was constructed in 1914 in a simply articulated, Classical Revival style with a slightly-raised limestone base, a brick facade, beltcourses, and some decoratively-carved keystones on the first floor. It is capped by a simple but prominent dentilled cornice. This building is one of several large apartment buildings located in a primarily small scale, single-family residential neighborhood. It is surrounded on both sides and across the street by two to two-and-one-half story rowhouses, and therefore is highly visible within the district. For this reason alone, it might appear that the addition of any more height to this building would not meet the Standards.

However, a new floor was added that is only minimally visible on the **non-significant side elevations and is imperceptible from directly across the street.** Setting the new floor into the flat roof plane lowered the profile of the addition to the height of a half story. The slanted front edge further minimized the appearance of the addition and concealed integral skylights. The mass blended with the solid, unadorned side walls of the historic building. This rooftop addition does not impact the historic character of the building and is in conformance with the Standards.
