**KNOXVILLE HISTORIC ZONING COMMISSION
STAFF REPORT - CERTIFICATE OF APPROPRIATENESS APPLICATION**

PROPERTY ADDRESS: 629 Luttrell St 37917

FILE NO.: 5-E-19-HZ

PROPERTY DESCRIPTION: Queen Anne Cottage (c. 1895)

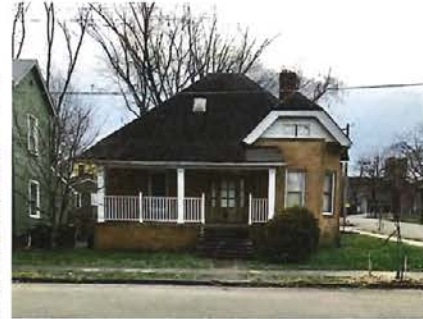
PRIMARY ELEVATION
Luttrell Street - Existing conditions

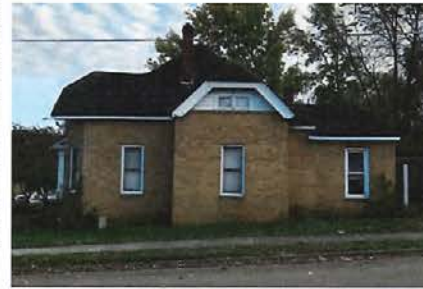
SECONDARY ELEVATION
3rd Avenue - Existing conditions

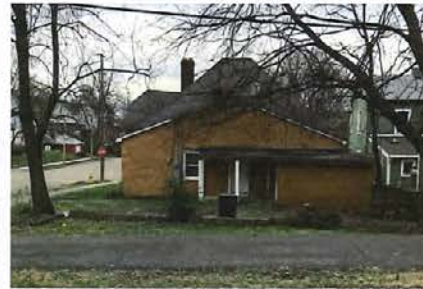
SERVICE ALLEY ELEVATION
Existing conditions

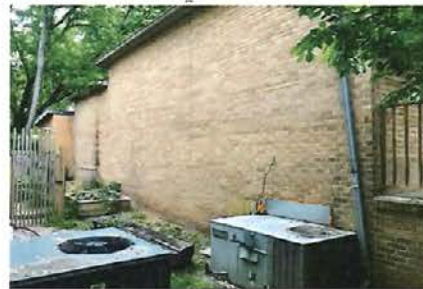
SIDEYARD ELEVATION
Existing conditions

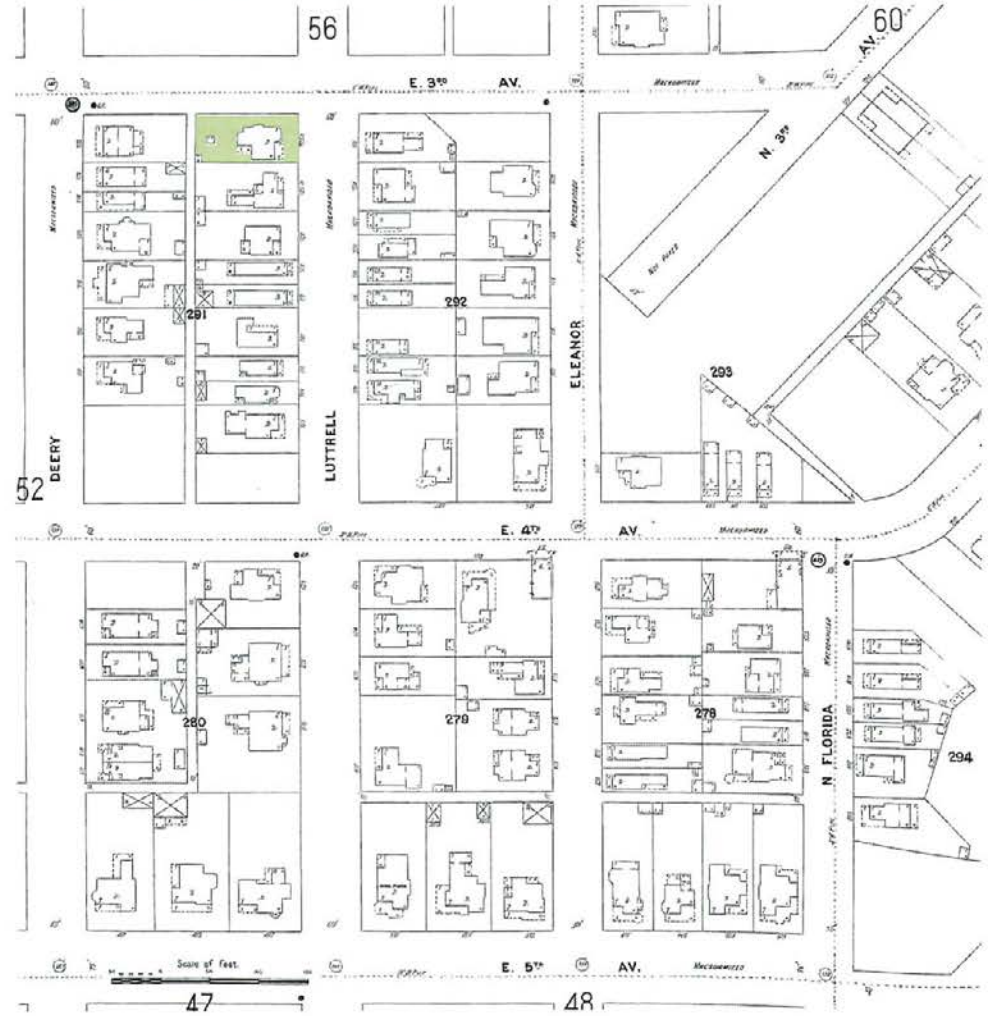
HISTORICAL CONTEXT [1903]
 1903 Sanborn Fire Insurance Map, Sheet 53

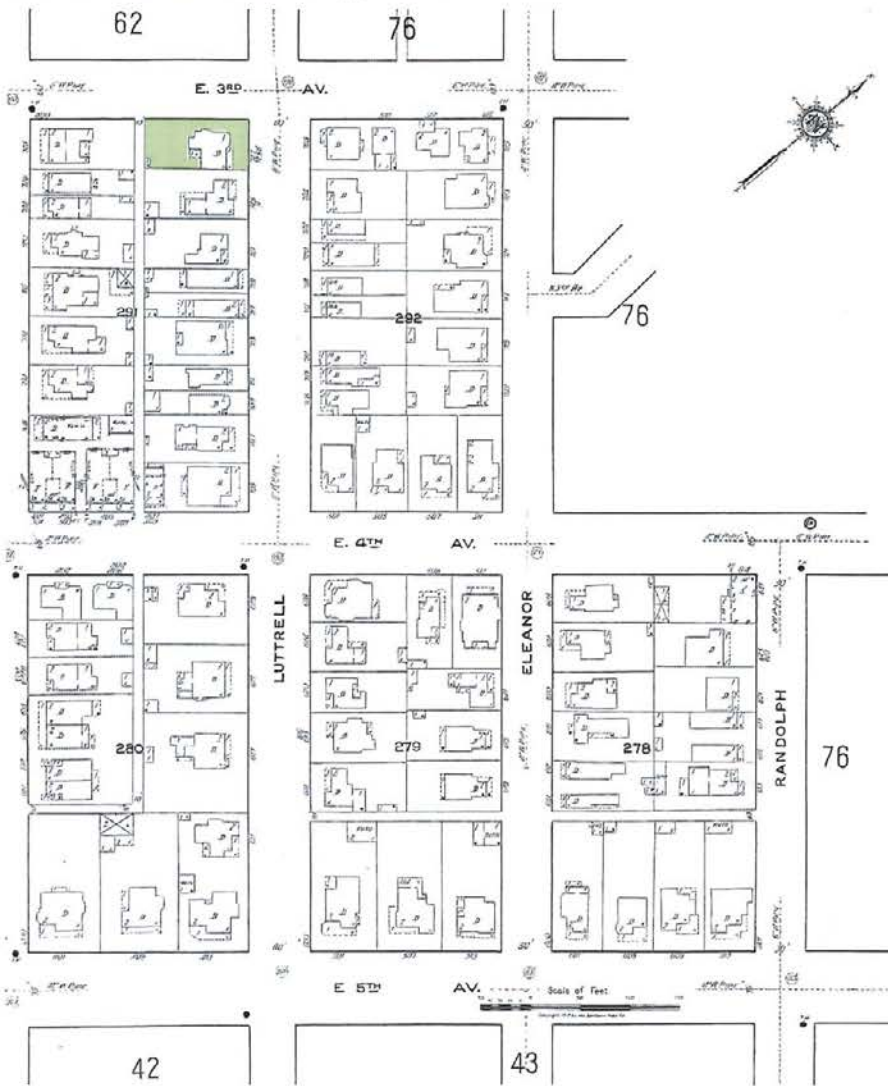
1917 - 1924 Sanborn Fire Insurance Map, Sheet 50

HISTORICAL CONTEXT [1917-1924]

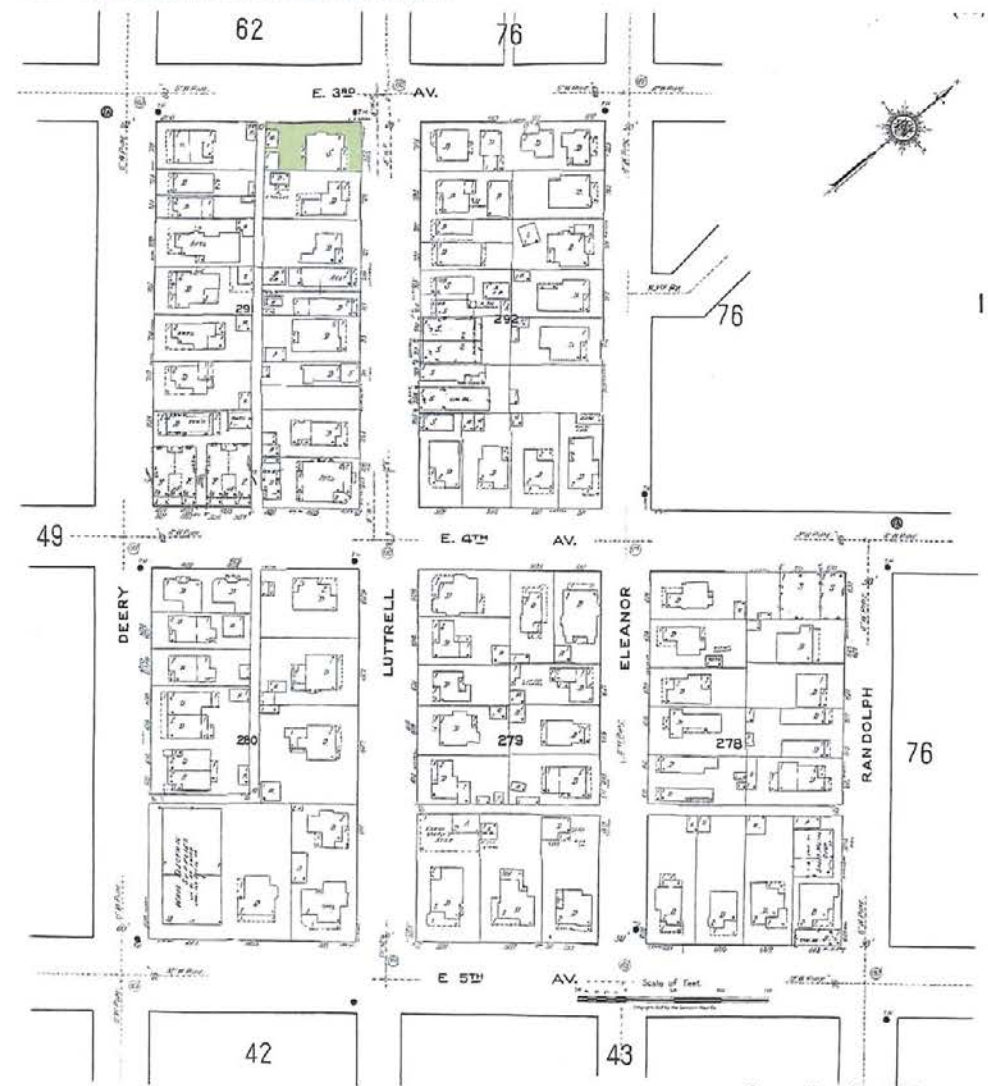
1917 - 1950 Sanborn Fire Insurance Map, Sheet 50

HISTORICAL CONTEXT [1950]

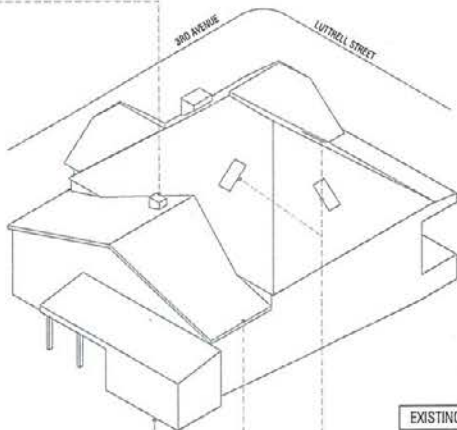
ASPHALT SHINGLE & YELLOWED SKYLIGHTS, CURBLESS

EXISTING

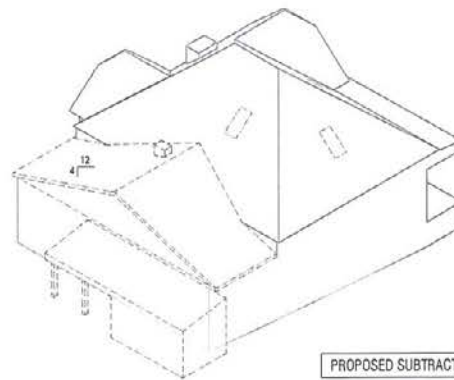
PROPOSED SUBTRACTION

--- BUILDING ELEMENTS REMOVED

Sanborn maps and roof geometries indicate that the rear gabled structure is an addition. The pitch of this roof is significantly shallower than typically seen in the neighborhood. The stucco-clad concrete masonry unit (CMU) laundry space in the rear is likely an even later addition. The structure of the gabled rear addition is failing; with all of the rafters either completely or partially pulled away from the ridge board.

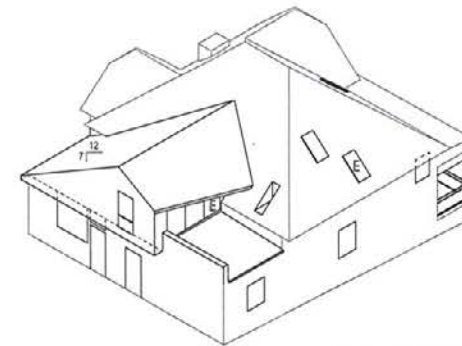
PROPOSED ADDITION

E EGRESS

The proposal removes the failing low-slope gable and replaces it with a partial gable with a higher slope and a small green roof. This accomplishes

several things – structurally repairs the roof, allows for an egress opening facing the adjacent property, and more closely matches the slope of the historic roof. The partial gable is clad with rounded shingles creating a sympathy with the historic gables yet, as required, is clearly denoted as new construction with its geometry and fenestration pattern. The partial gable also provides a slope optimized for future photovoltaics facing away from the street, while the volume's cantilever provides cover for entry doors below. A small recessed window is added in the historic roof to provide light and air to a new bathroom.

In the rear of the house the proposal removes the concrete masonry unit (CMU) laundry room and canopy. An existing solid flush entry door into the guest suite is also removed and replaced with a glazed door. Another glazed door, transom, and fixed window are added to the rear to connect the relocated kitchen with the rear garden. The new door provides an accessible entrance to the house. As required, all of this work is denoted as new through its composition and size of glazing. All of these new openings are placed in the non-historic addition.

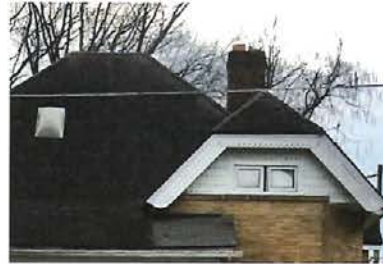
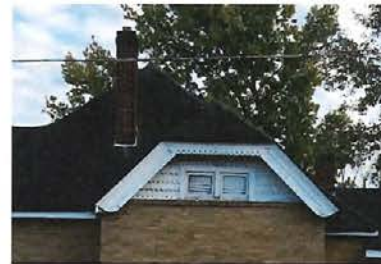
Renovations to a Queen Anne cottage at 629 Luttrell Street. Its current condition is layered and complex. Sanborn maps and roof geometries indicate that the rear gabled structure is an addition. The pitch of this roof is significantly shallower than typically seen in the neighborhood. The stucco-clad concrete masonry unit (CMU) laundry space in the rear is likely an even later addition. The structure of the gabled rear addition is failing; with all of the rafters either completely or partially pulled away from the ridge board.

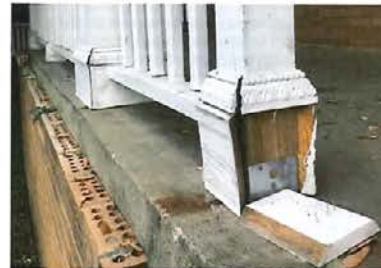
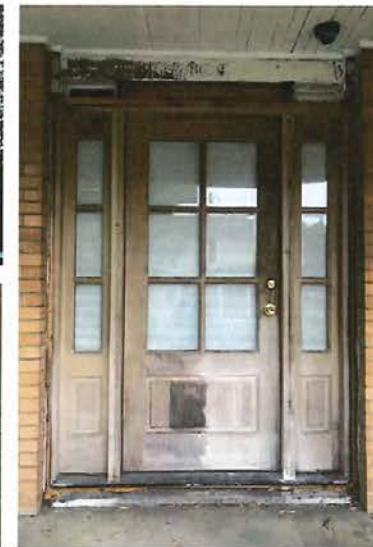
The house was clad in buff-colored brick sometime in the mid to late 20th C. (The original wood cladding and red brick foundation can be glimpsed in places.) This brick is not a historical type as the materials to make it ("fire clay" with higher silica and lower ferrous content) are not found locally in any economically recoverable amounts and are most often extracted from eastern Ohio and western Pennsylvania. It is very different from local brick made largely of East Tennessee clay and shale. This brick cladding obscures the house's likely Queen Anne detailing leaving it visible only at the eaves and the surfaces of a couple of dormers.

(Left to Right)
Luttrell St. dormer, original timber shingle, trim material, detailing and operable double casement windows;
3rd Ave dormer, original timber shingle, trim material, detailing and operable double casement windows;
Front door and sidelights, inappropriate replacement

(Left to Right)
Porch ceiling and double-hung window, original
Porch columns and railing, recent & inappropriate
Concrete porch, brick veneer, likely mid-20th c changes.

The previous owners undertook unauthorized and inappropriate changes to the front porch balustrade, columns, and front door. There is no known evidence of the original columns, balustrade, and front door. Curbless acrylic skylights were added to the roof at some time. These have yellowed with age and exposure to UV radiation.

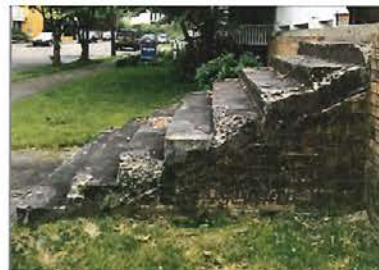
(Left to Right)
Concrete stoop, likely mid-20th c.;
Brick masonry porch foundation, likely original though concealed by brick veneer, likely mid 20th c.;
Double hung windows, partly original, partly replaced, clad, or altered with storm windows, metal or plastic sills, etc.

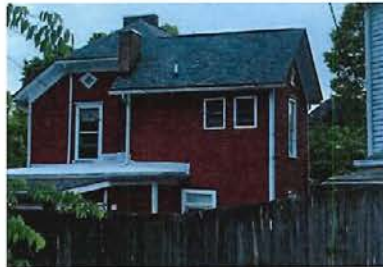
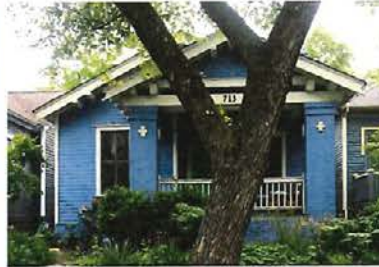
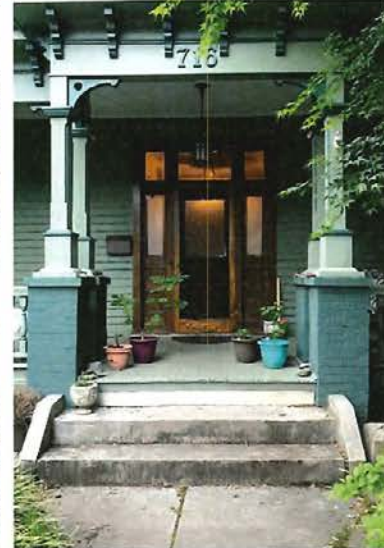
(Pictured, Left to Right)
822 Deery Street
715 Deery Street
716 Deery Street

Homes in the surrounding blocks demonstrate: informal rear yard/alley massing & elevations; painted brick facades; square 4" painted wood porch columns; concrete front steps with curbs.

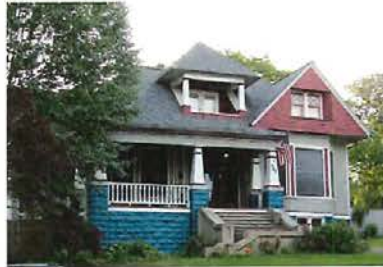
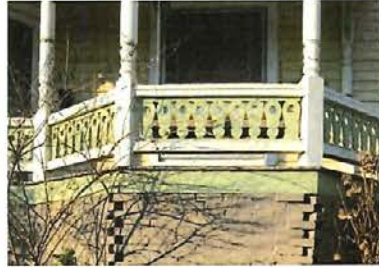
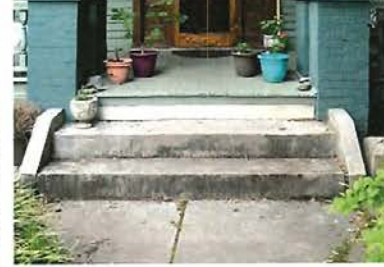
(Pictured, Left to Right)
927 Luttrell Street
703 Eleanor Street

Homes in the surrounding blocks demonstrate: cantilevered gables with shingle siding and deep-set windows; painted flat sawn balustrade, painted brick.

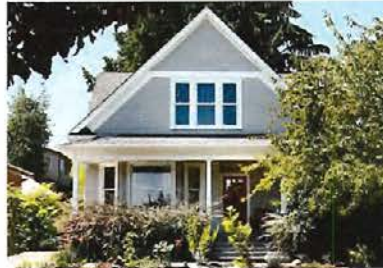
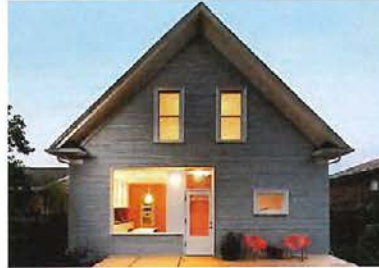
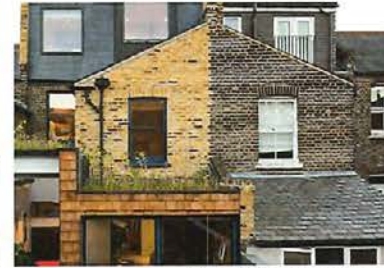
Precedent images illustrate similar approaches where restoration of historic primary elevation and new contemporary addition or modification of secondary elevations.

(Pictured, Left to Right)
1914 Craftman home restoration of primary facade (left) and modification of rear, secondary facade (middle) by SHED Architects; Planted rear roof, Fraher Architects.

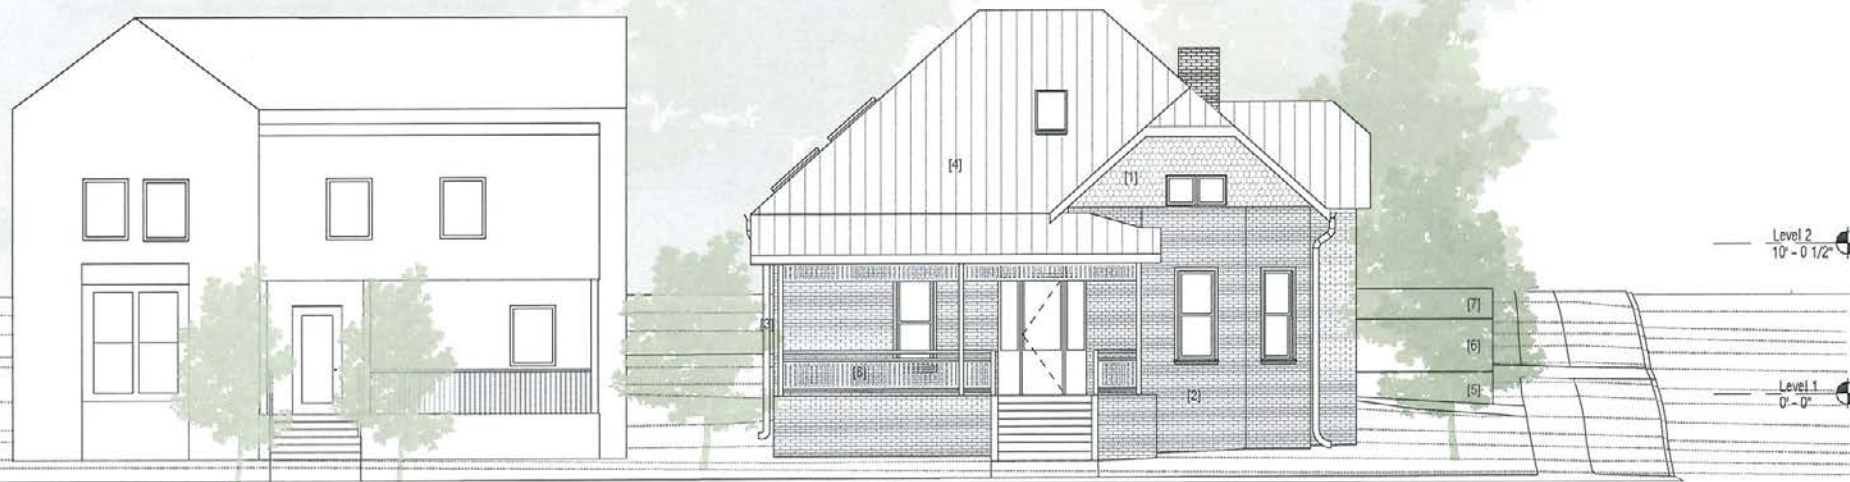
EAST ELEVATION, Luttrell Street | 1/8" = 1'

The front of the house facing Luttrell. Proposed work here deals primarily with ameliorating non-approved work performed by the previous owners. The front door is replaced with a half-lite wood door, sidelights, and solid transom panel. The front stairs are repaired and new curb edges added. As no evidence exists of the historic porch columns and balustrades the proposed elements are understated contemporary versions of Queen Anne flat sawn balustrades.

- [1] PAINTED SHINGLE, ROUNDED
- [2] PAINTED BRICK
- [3] METAL DOWNSPOUT
- [4] METAL ROOFING
- [5] CONCRETE RETAINING WALL
- [6] WOOD FENCE, SEMI-OPAQUE
- [7] WOOD FENCE, SEMI-TRANSPARENT
- [8] FLAT-CUT RAIL, PAINTED

As there is no documentation of the front porch detailing (also noted in H2C staff report) the proposal is careful not to create a false sense of history by introducing faux elements. However, there is a desire on the front porch to be particularly sensitive to the neighborhood context. The proposed response takes hints from flat sawn balustrade design that was common in the Queen Anne style, particularly the Eastlake variant. Marrying similar materials and techniques with understated details and a slightly morphing pattern that denote the work as contemporary, the intent is to pass the “first look, second look” test – fitting into the language and detailing of the neighborhood’s historic fabric on first glance, appearing subtly but clearly new upon further inspection. The existing concrete stair will be repaired where chipped and wide curbs added to the edges, a pattern that is seen several places in the neighborhood.

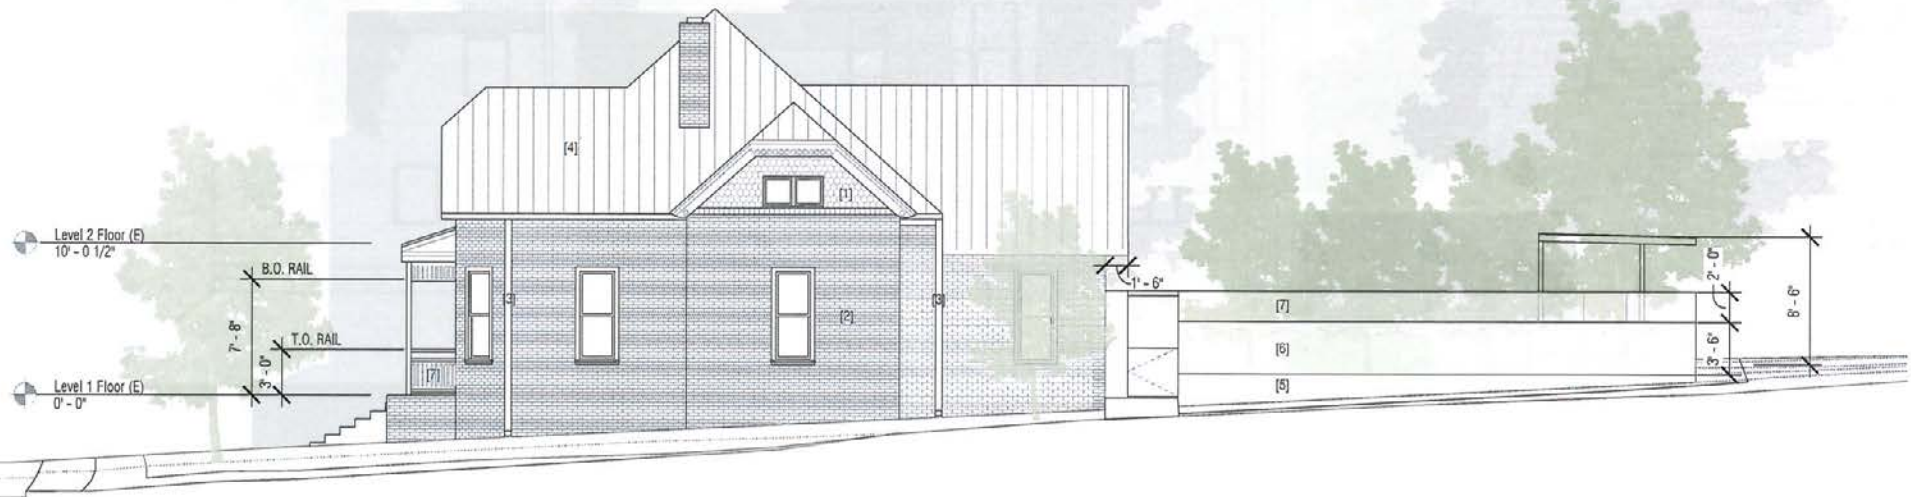
NORTH ELEVATION, 3rd Avenue | 1/8" = 1'

A prominent, street-facing elevation. No significant changes are proposed here – merely painting the non-historic brick, new gutters and downspouts, and repairing or replacing existing windows in kind.

- [1] PAINTED SHINGLE, ROUNDED
- [2] PAINTED BRICK
- [3] METAL DOWNSPOUT
- [4] METAL ROOFING
- [5] CONCRETE RETAINING WALL
- [6] WOOD FENCE, SEMI-OPAQUE
- [7] WOOD FENCE, SEMI-TRANSPARENT
- [8] FLAT-CUT RAIL, PAINTED

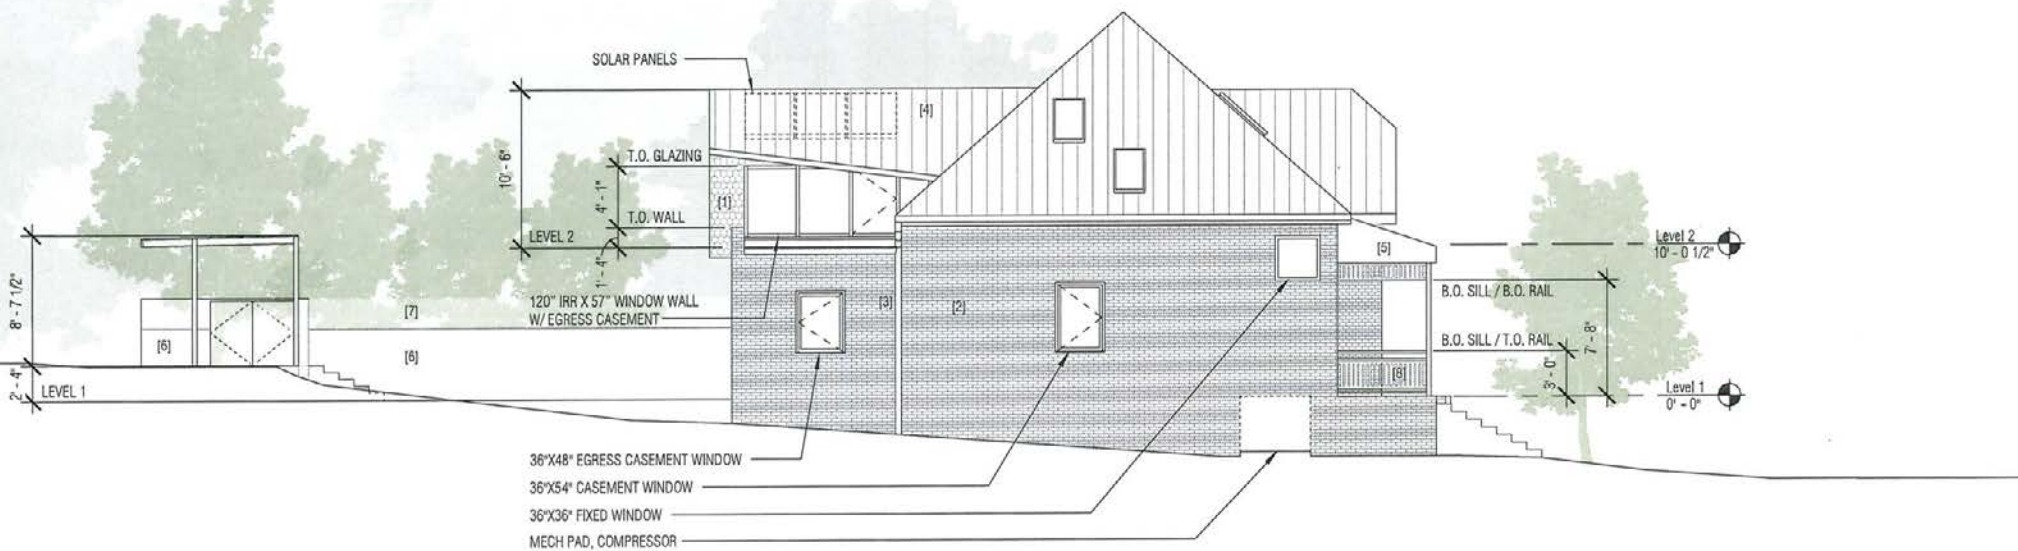
SOUTH ELEVATION | 1/8" = 1'

This is the least visible façade. As such, the proposal strives to group as many of the new interventions as possible here including all new egress windows, space for future photovoltaics, a skylight relocated from a more prominent elevation, and the small flat roof. Additionally, daylighting, vision, and ventilation windows are introduced here. Proximity to the property line prohibits either extensive additions or openings along this wall.

- [1] PAINTED SHINGLE
- [2] PAINTED BRICK
- [3] METAL DOWNSPOUT
- [4] METAL ROOFING
- [5] WOOD PANEL, PAINTED
- [6] WOOD FENCE, SEMI-OPAQUE
- [7] WOOD FENCE, SEMI-TRANSPARENT
- [8] FLAT-CUT RAIL, PAINTED
