**KNOXVILLE HISTORIC ZONING COMMISSION
STAFF REPORT - CERTIFICATE OF APPROPRIATENESS APPLICATION**

PROPERTY LOCATION: 629 Luttrell St. /
Parcel ID 94 D J 004

FILE NO.: 9-J-19-HZ

Seidler Residence Front Porch, 629 Luttrell Street, Knoxville TN

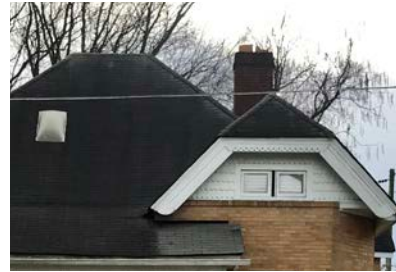
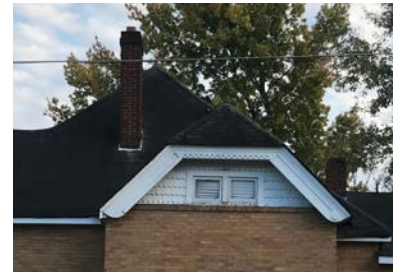
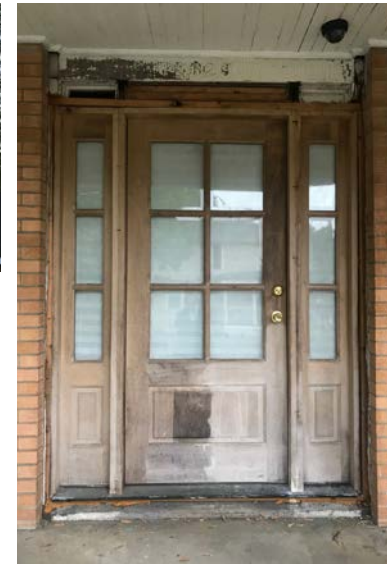
(Left to Right)
Luttrell St. dormer, original timber shingle, trim material, detailing and operable double casement windows;
3rd Ave dormer, original timber shingle, trim material, detailing and operable double casement windows;
Front door and sidelights, inappropriate replacement

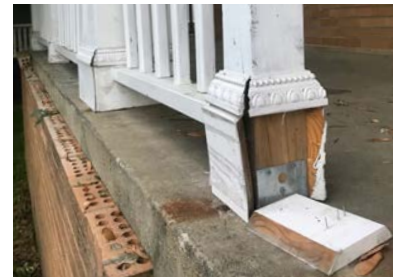
(Left to Right)
Porch ceiling and double-hung window, original
Porch columns and railing, recent & inappropriate
Concrete porch, brick veneer, likely mid-20th c changes.

The previous owners undertook unauthorized and inappropriate changes to the front porch balustrade, columns, and front door. There is no known evidence of the original columns, balustrade, and front door. Curbless acrylic skylights were added to the roof at some time. These have yellowed with age and exposure to UV radiation.

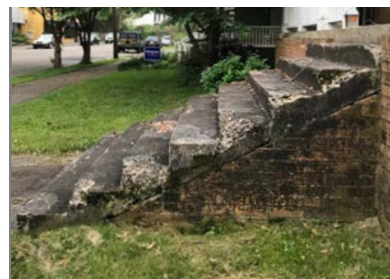
(Left to Right)
Concrete stoop, likely mid-20th c.;
Brick masonry porch foundation, likely original though concealed by brick veneer, likely mid 20th c.;
Double hung windows, partly original, partly replaced, clad, or altered with storm windows, metal or plastic sills, etc.

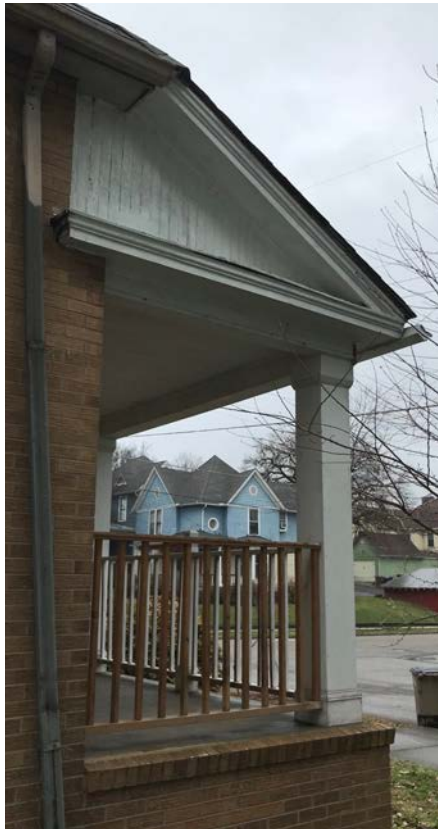
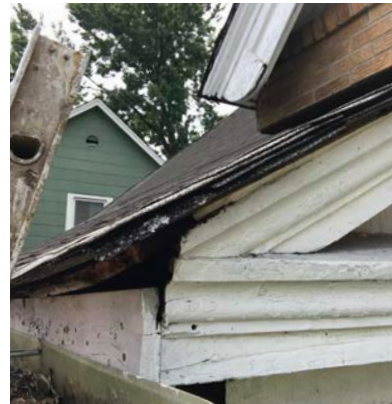
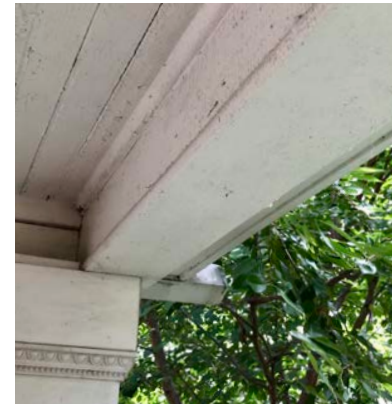
(Pictured, Top Left to Right)

Existing wood cladding and trim at side elevations of existing front porch to be repaired, maintained, and painted. Existing gutters and downspouts to be removed. New half round, pre-finished gutters and round downspouts to be installed.

Existing historic wood ceiling boards of front porch ceiling and quarter round trim to be repaired, replaced where necessary and painted. Existing trim at concealed beam to be removed for structural upgrades where existing beam and new columns connect; trim to be replaced and painted after structural work. Non historic columns to be removed and replaced.

- Existing wood ceiling boards and trim to be repaired and replaced where necessary. Existing trim adjoining the concealed porch beam to be removed for structural upgrades where existing beam and proposed new columns connect. The trim will be replaced and painted after structural work.

- Existing gutters and downspouts to be removed and replaced with new half-round, pre-finished gutters and round downspouts.
 - Replace non-historic door with two-thirds-light wood door and sidelights. Overall form of door approved at May 2019 meeting but applicant has provided specifications.
-

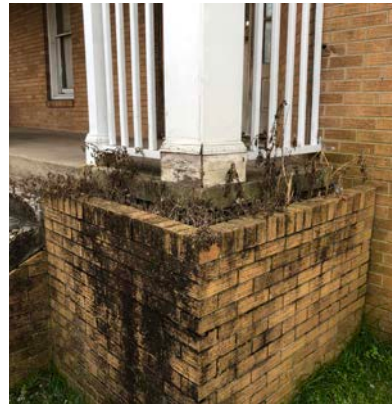
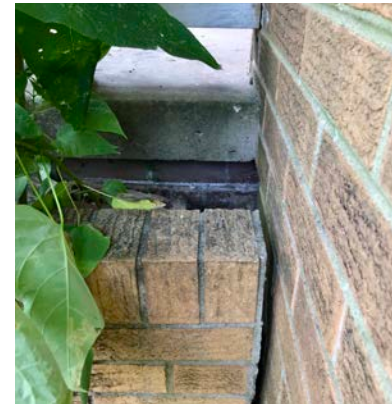
(Pictured, Bottom Left to Right)

Non-historic brick veneer and brick planter to be removed at front and sides of front porch. Historic brick to be exposed (un-painted) and joints repaired as needed with mortar to match historic mortar. Non-historic columns and railing to be removed and replaced. Existing concrete slab porch deck to be painted (Non-historic brick at locations other than the front porch to be painted per approval of a prior HZC submission.)

- Remove all non-historic brick from the porch, revealing the historic brick underneath. Clean and repoint the historic brick as necessary. Unpainted historic masonry on the porch will provide contrast with the non-historic brick on the house.

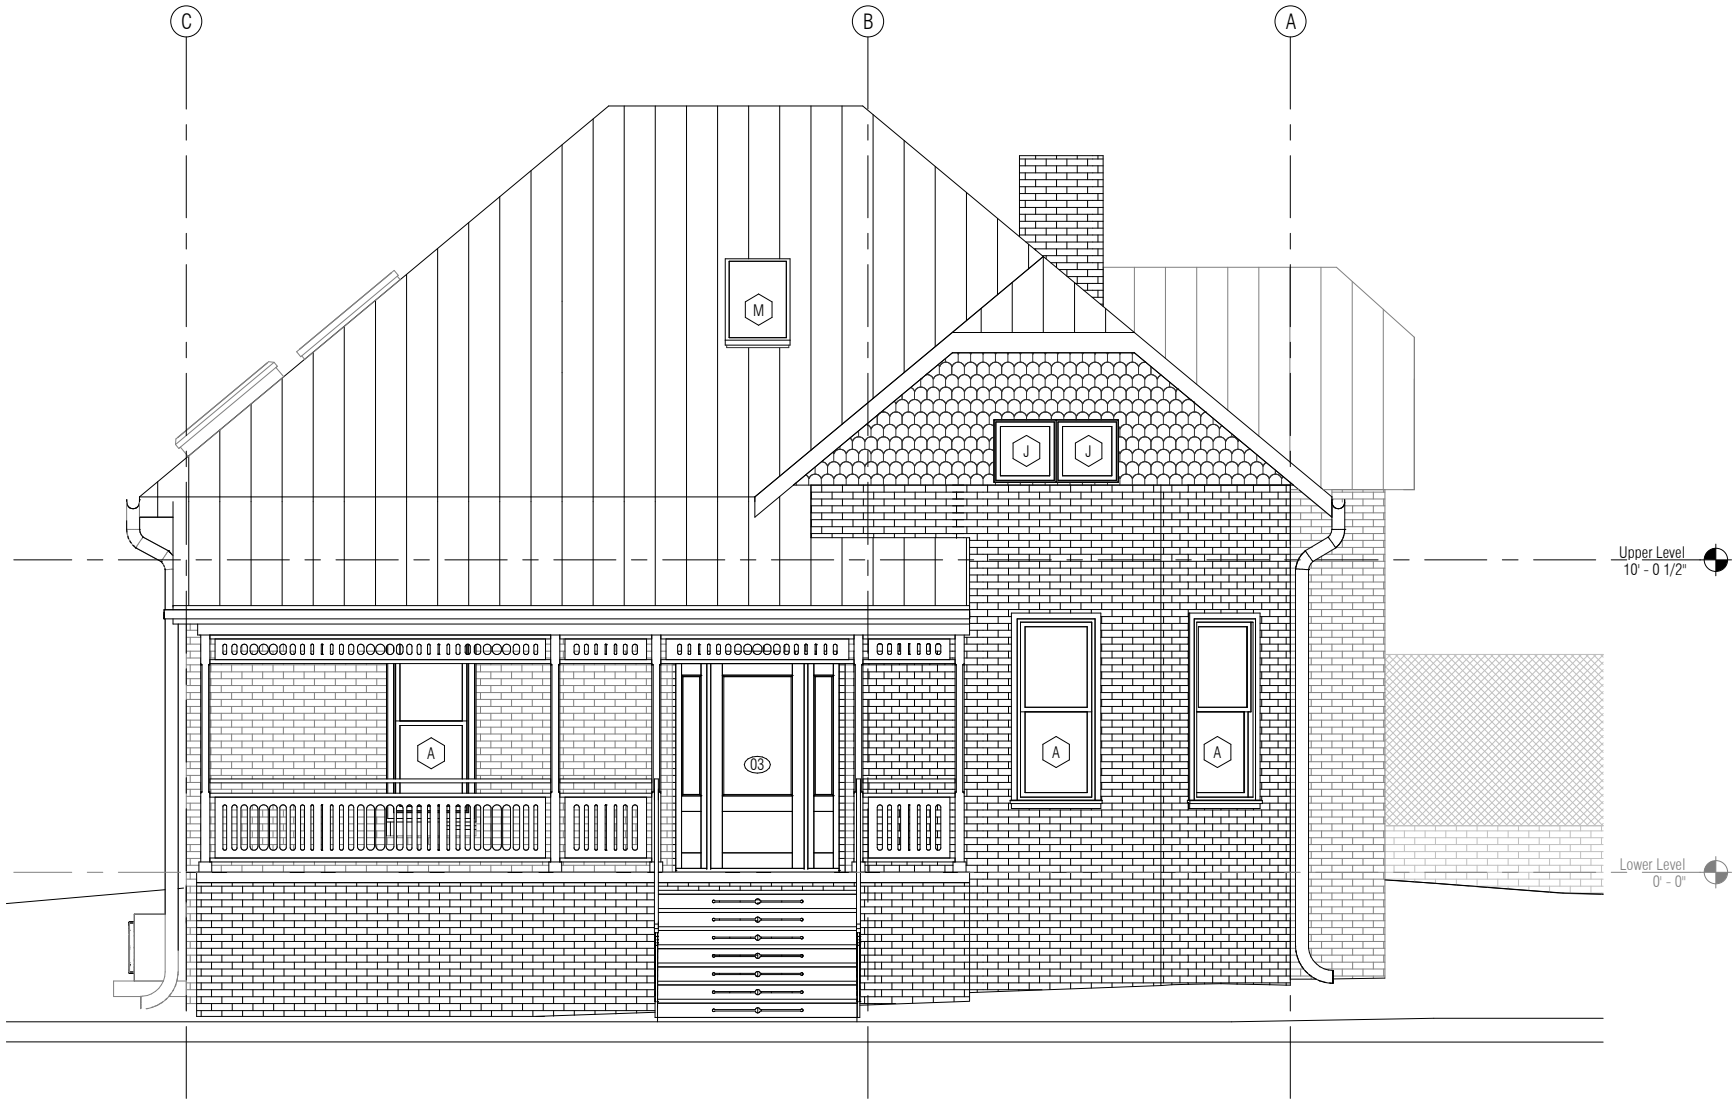
A2.2 Exterior Elevation

1. East Elevation | 1/4" = 1'-0"

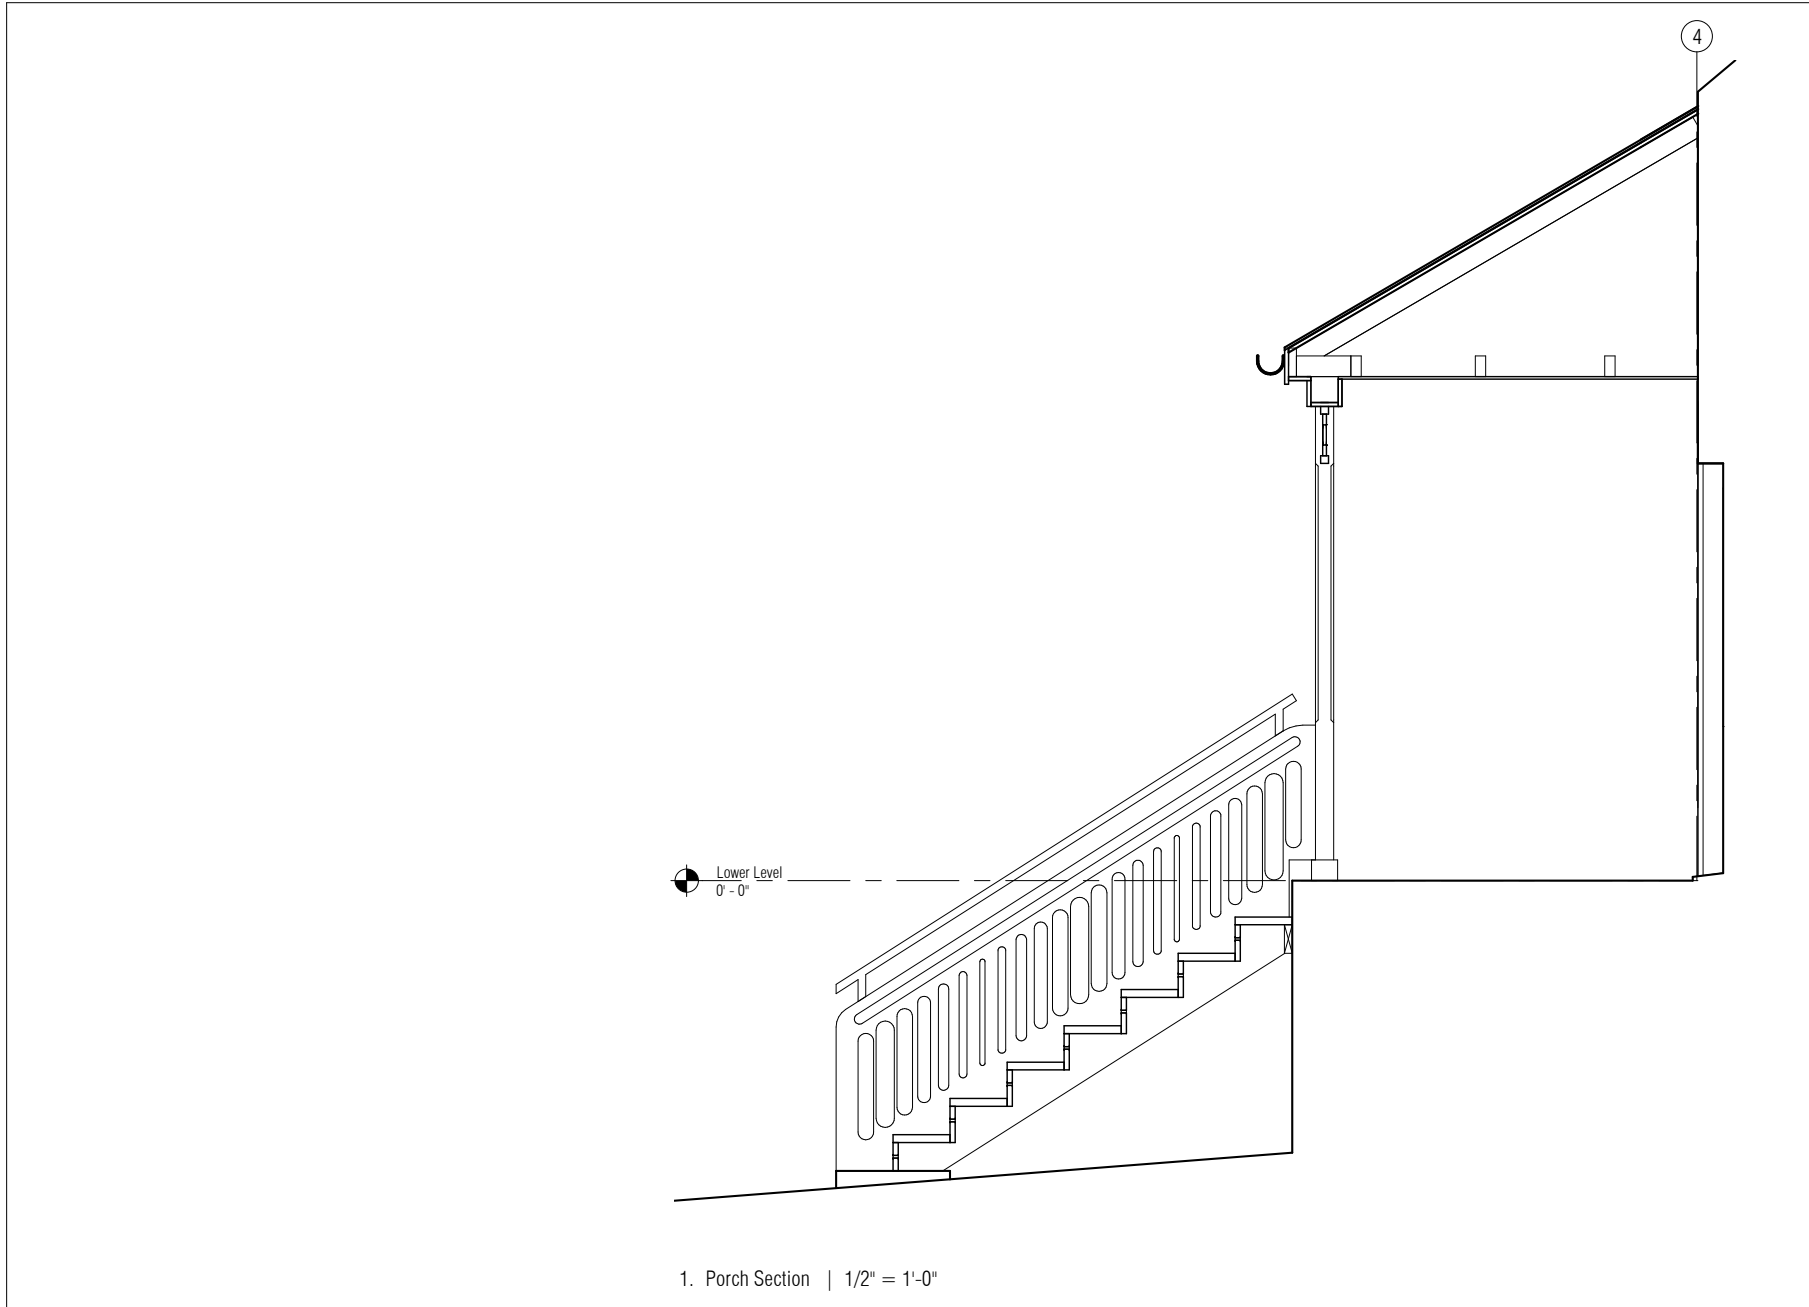
A5.6
Porch Section

1. Porch Section | 1/2" = 1'-0"

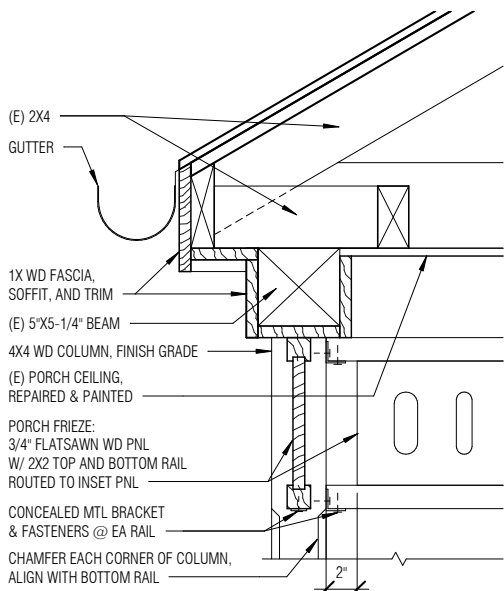
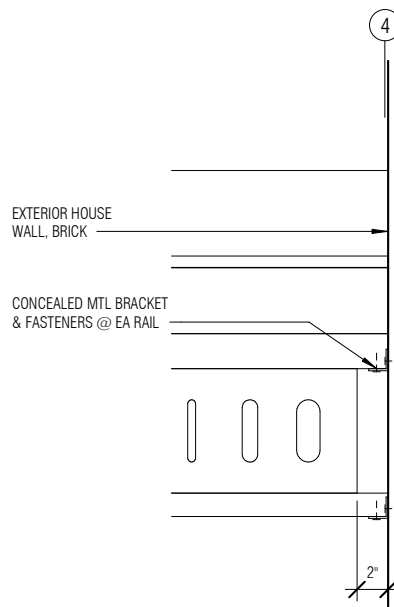
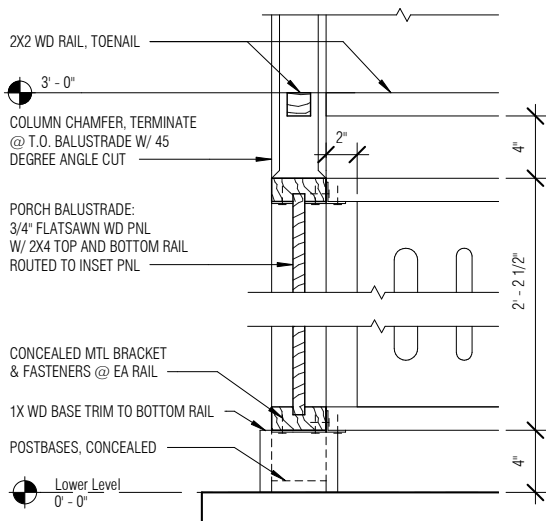
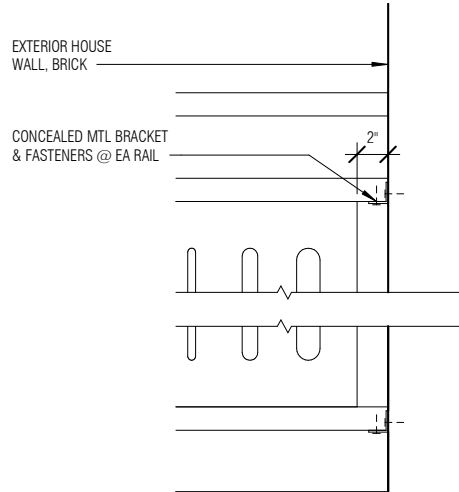
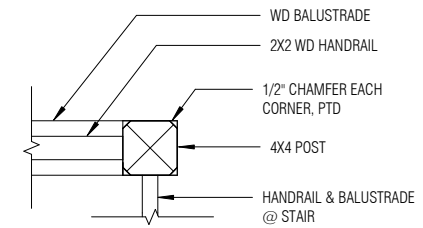
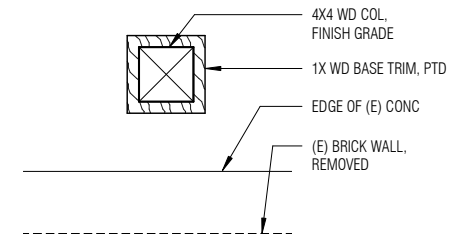
A5.7 Porch Details

7. Eave Detail @ Porch Frieze | 1 1/2" = 1'-0"

5. Detail @ Porch Frieze | 1 1/2" = 1'-0"

6. Detail @ Porch Balustrade | 1 1/2" = 1'-0"

4. Detail @ Porch Balustrade | 1 1/2" = 1'-0"

3. Plan Detail @ Post | 1 1/2" = 1'-0"

1. Plan Detail @ Post Base | 1 1/2" = 1'-0"

- Remove three square wood porch support columns (non-historic) and replace with 3-1/2" by 3-1/2" chamfered wood posts.
 - Install flat sawn wood frieze. Replace non-historic wood balustrade with a flat sawn wood balustrade and double rails. Install flat sawn wood balustrade with wood handrail along steps. Balustrade and frieze to feature rounded openings in a "slightly morphing pattern."
