6-H-20-HZ
APPLICATION FOR CERTIFICATE OF APPROPRIATENESS

428 E. Scott Ave. 37917
 Old North Knoxville H-1

Staff Report - Certificate of Appropriateness Application

Exterior rehabilitation for adaptive re-use of c.1927 commercial building, with a rear concrete block warehouse addition dating to the late 1960s. Scope of work involves: enlarging existing windows on side elevations, restoration of historic storefront, adding new windows and secondary entrances on secondary elevations, and repair to existing siding material.

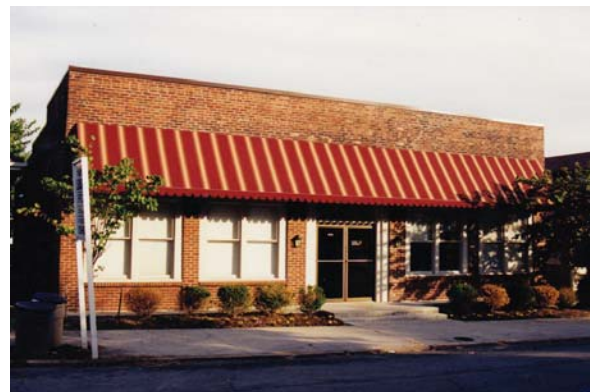
1990's renovation

At some point in the 1960s, the building was more than doubled in size by a concrete warehouse attached to the back, the historic facade was also removed to be replaced by a mansard roof and connected to a house next to it to form a large manufacturing and office facility. In the late 1990s, it was purchased by a local architect and restored to be closer to the original structure, but remained offices.

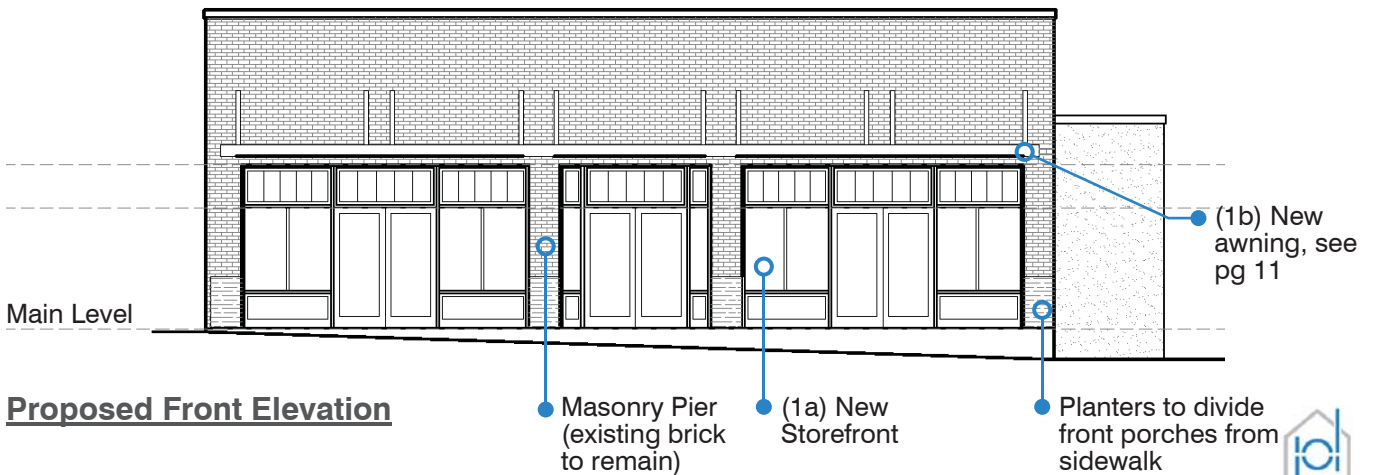
Proposed Front Elevation

Façade (north elevation): to receive two storefront systems (featuring divided-light transoms, single-pane storefront windows, and bulkheads) flanking paired single-light doors topped by a transom. Existing masonry piers surrounding main door to remain. A flat metal awning will extend the length of the storefront. Scope of work also includes decorative planters.

2. Rehabilitation of the storefront draws from a 1930s photograph and the façade of a comparable structure built in Fort Sanders in 1926. The applicant proposes to install two storefront systems flanking a full-light double door. Storefront systems will feature bulkheads and four-light transom windows. The storefront window system exhibit proportions and a design appropriate for an early twentieth-century commercial building. Design of the façade restoration is appropriate.

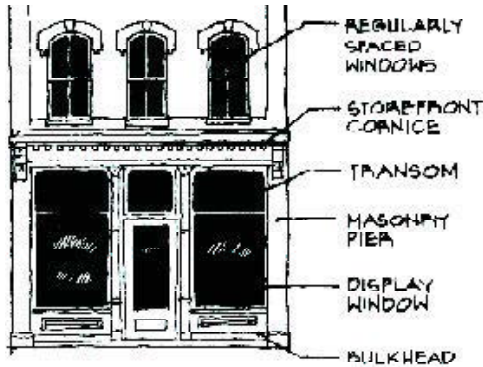
Late 1800s to Early 1900s

- SIMPLE CORNICE
- TRANSOM WINDOWS
- RECESSED ENTRANCE

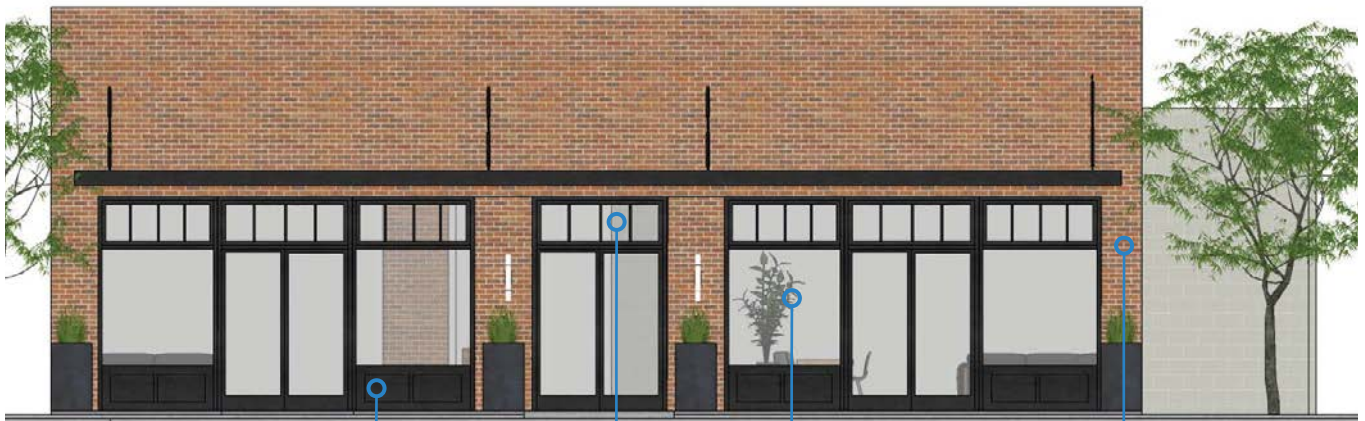
Proposed Front Elevation

- Bulkhead
- Transom
- Display Window
- Existing Masonry Pier

Based on the Dept. of the Interior's guidelines, we believe that both metal and wood would be appropriate for the storefronts. We request that Commission Grant MPC Staff authority to approve final material selection.

3. The applicant has presented options of both metal and wood storefront systems for the façade, requesting that staff be granted the final approval of material. The neighborhood has expressed a preference for wood storefront systems. In staff's opinion, wood, metal, or aluminum-clad wood would be appropriate, as long as the muntin profiles, trim, and window sizes reflect what's shown in the application.

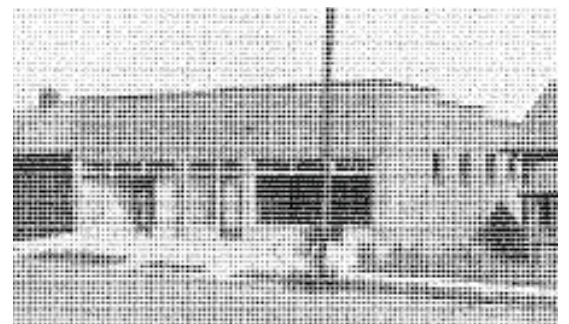
1930's photo of the building -

Of all the renovations of the front facade in the past, we would like this proposed project to be the closest to the original to date.

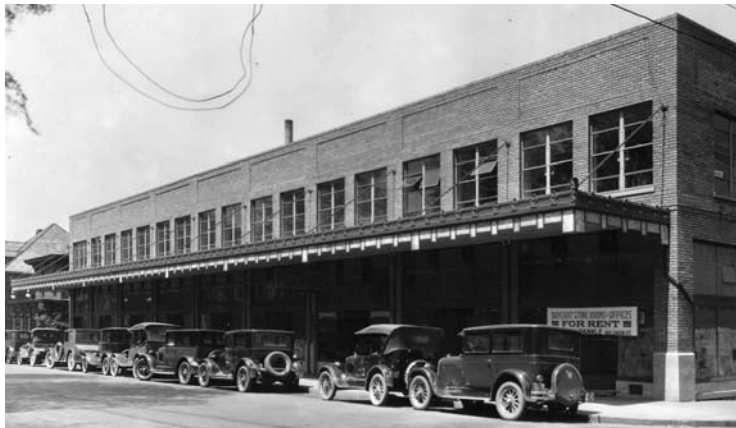
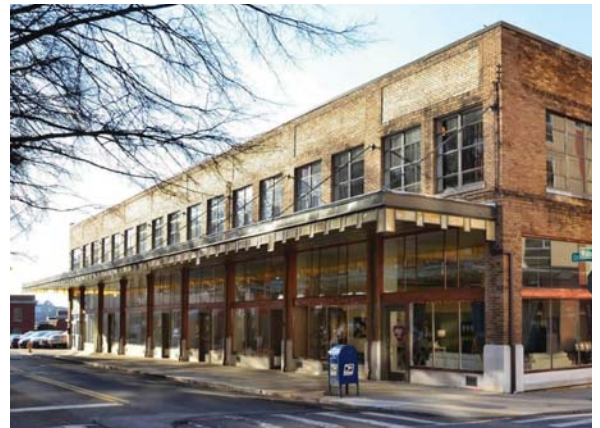
The Daylight Building, built in 1927 and located at 517 Union Ave, features a historic metal awning

4. The flat metal awning is simple in design and comparable in size, design, and materials to awnings approved on historic commercial buildings in Knoxville. The awning is appropriate for the size of the façade, extending evenly across the storefront systems and doors. The design is not overly elaborate, does not create a false sense of history, and could be removed without detriment to the historic façade.

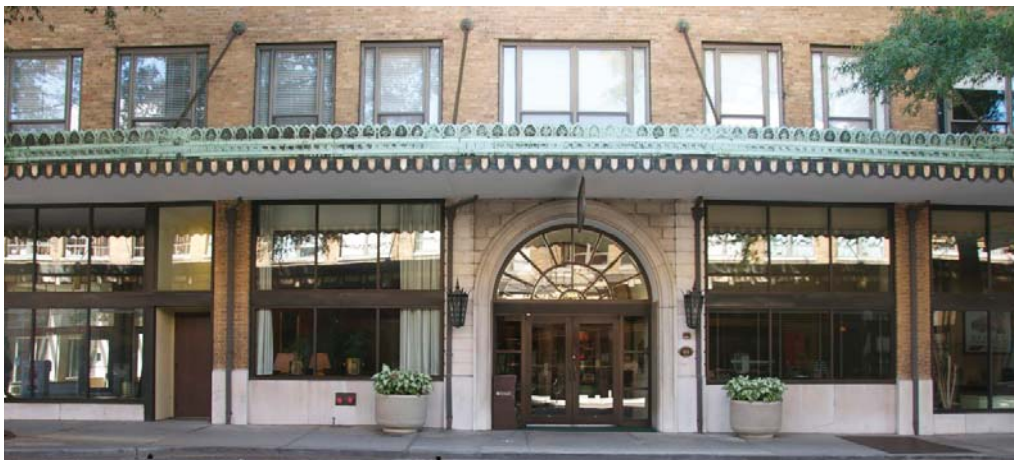
The New Sprinkle Building, built in 1927 and located at 510 Union Ave, features a historic metal awning

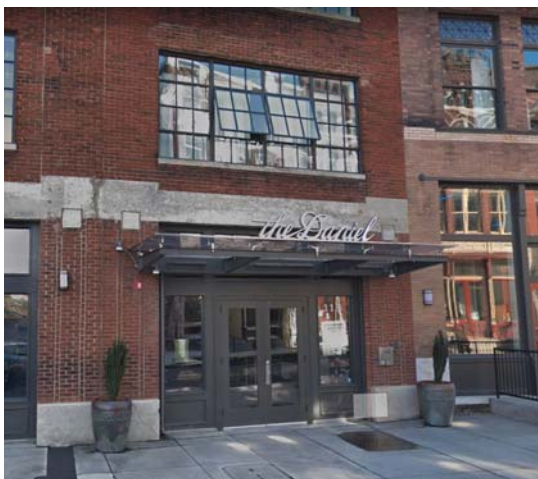
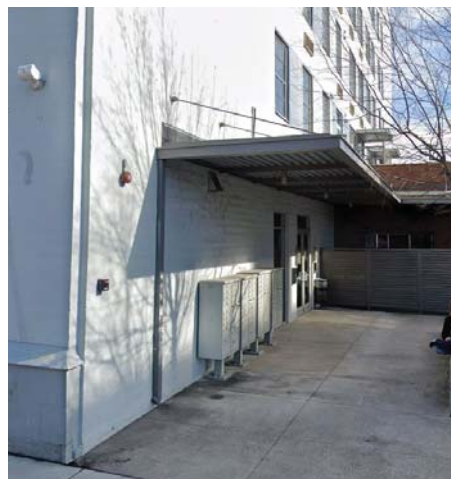
Located in the Old City, both The Daniel (left) and JFG (right) feature metal awnings over their residential entry points. Even though the awning would not be historic to either building, this shows that is desirable to provide a sheltered space for residents to enter the building.

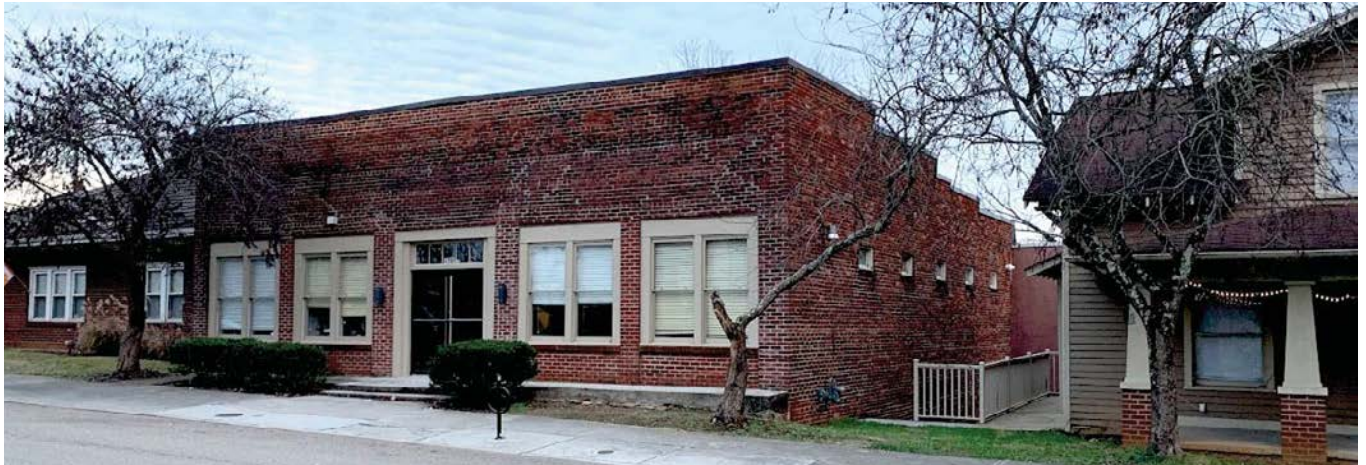
View down West Elevation from Front Elevation, the rear of the building is hidden by adjacent residence

The secondary elevations have low visibility from the street due to adjacent buildings and topography change.

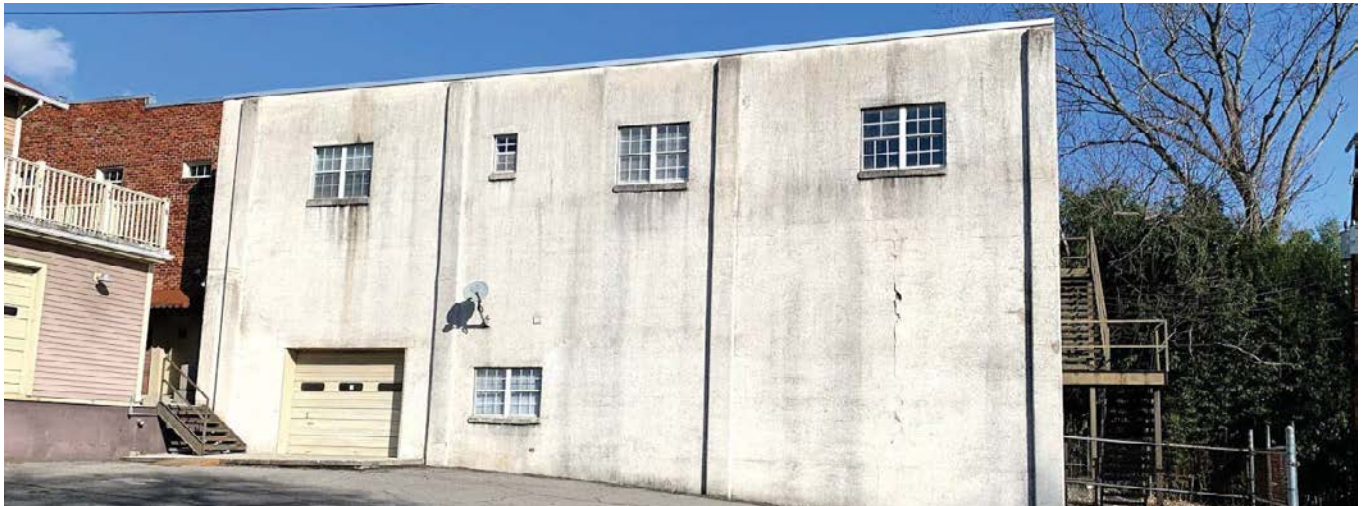
West Elevation from parking lot

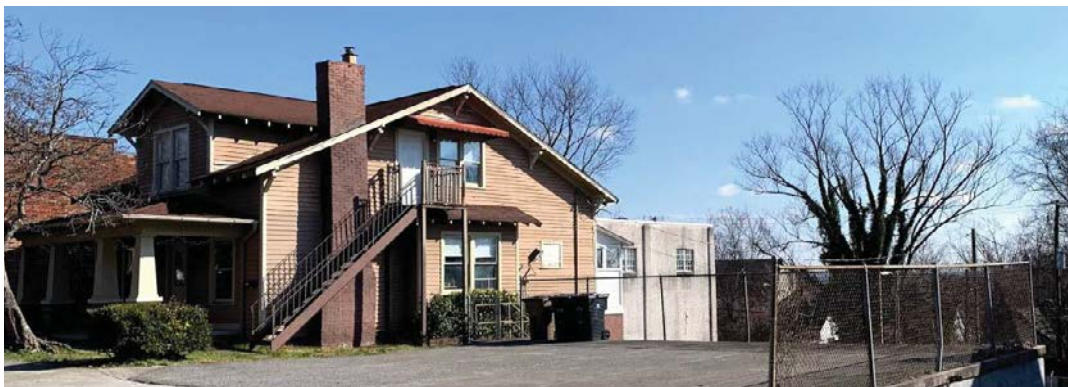
View from the street, the West Elevation is largely obscured by the existing residence.

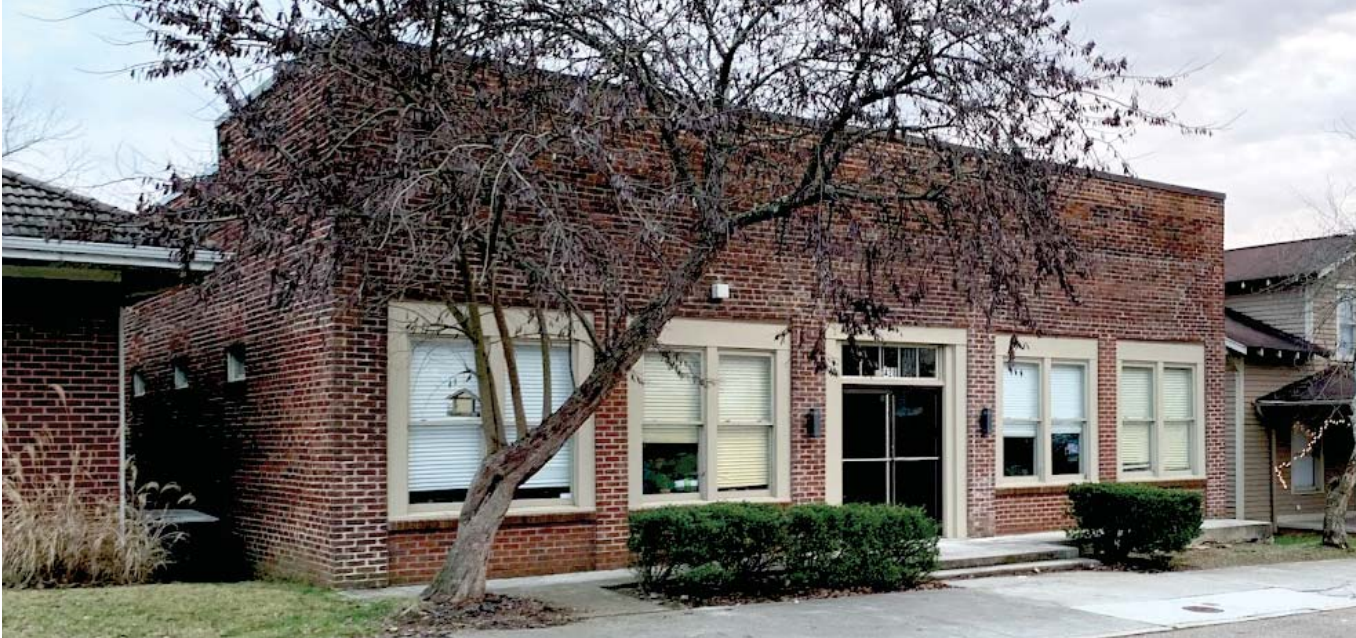
Looking down East Elevation from Front Elevation

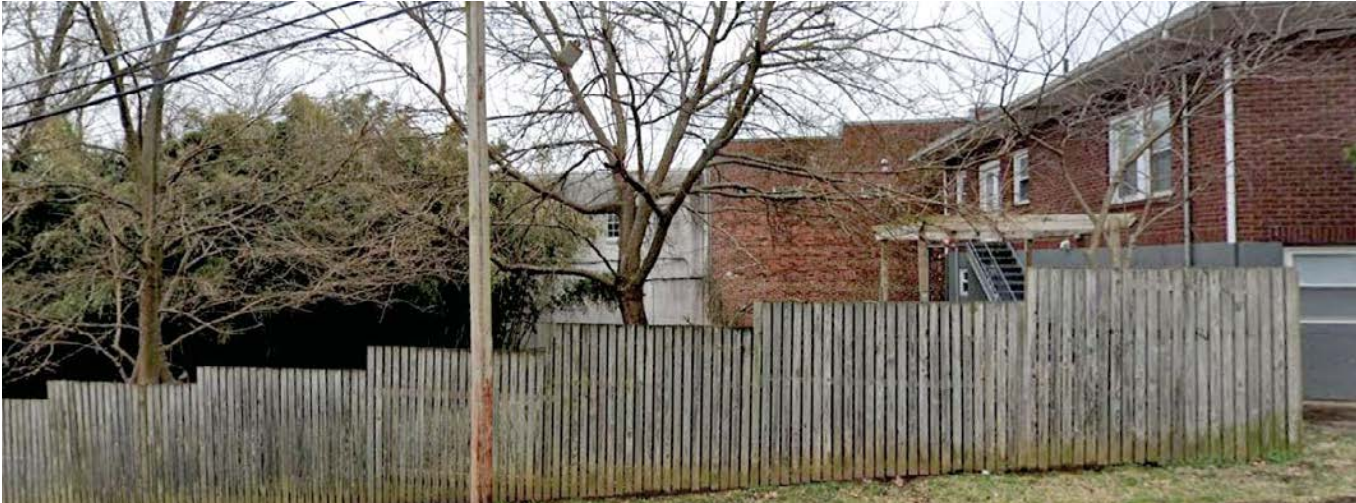
East Elevation from Harvey St, Neighboring Property in foreground. Vegetation and fencing obscure the view of the east side of the property.

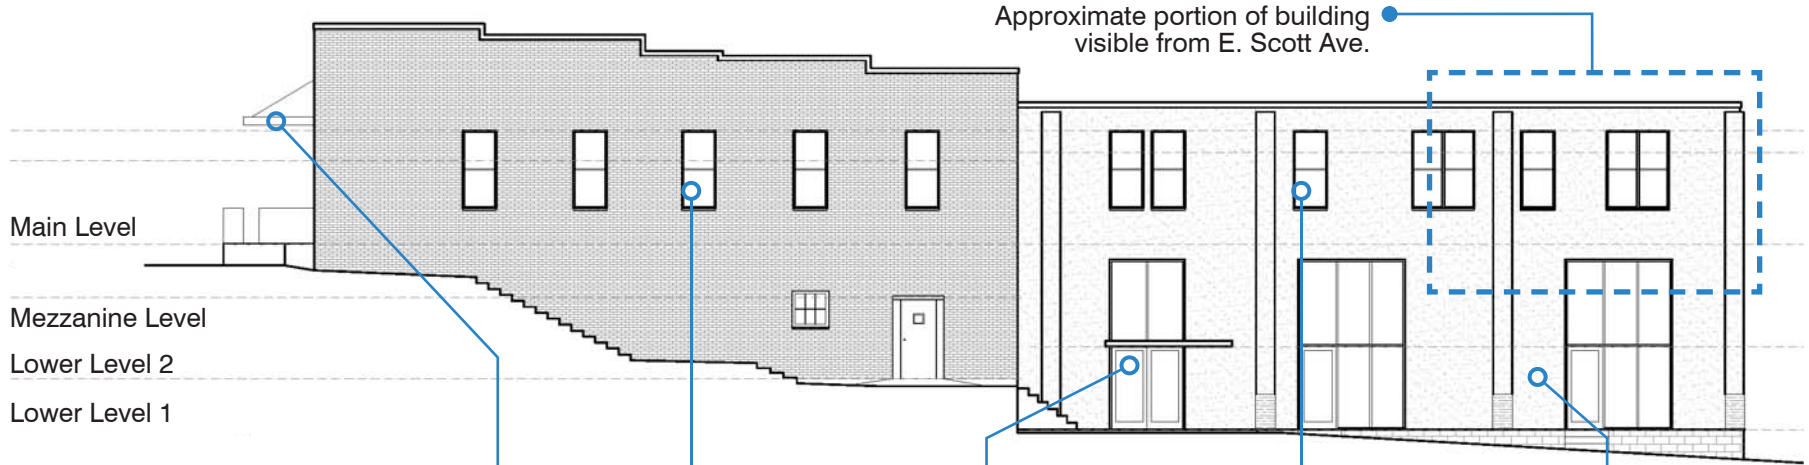
Proposed West Elevation

Right (west) side elevation: removal of non-historic clerestory windows on second-story of c.1927 structure, to be replaced with double-hung sash windows for egress; installation of three storefront systems on the first story of c.1960s section, featuring glazed doors topped by tall single-light transom windows; and installation of double-hung sash windows in place of existing windows; deteriorating gunite cladding to be removed and exterior covered in stucco.

6. The proposed one-over-one, double-hung sash windows on the west elevation are appropriate for the c.1927 section. The windows will be minimally visible from E. Scott Ave. On the warehouse section, enlarging the metal industrial windows to be one-over-one, double-hung sash for egress is appropriate, and will visually tie the rear portion to the historic structure. The neighborhood has expressed a preference for wood windows.

8. On the first floor of the warehouse section, both east and west elevations, the applicant has proposed full-light storefront systems with two adjoining levels of windows. While the windows are taller in proportion than the double-hung windows or the façade storefront systems, the rear section is a more modern structure, constructed for industrial purposes. The taller storefront systems do not detract from the overall integrity of the building, do not duplicate window patterns from an earlier period, and serve to differentiate the two sections.

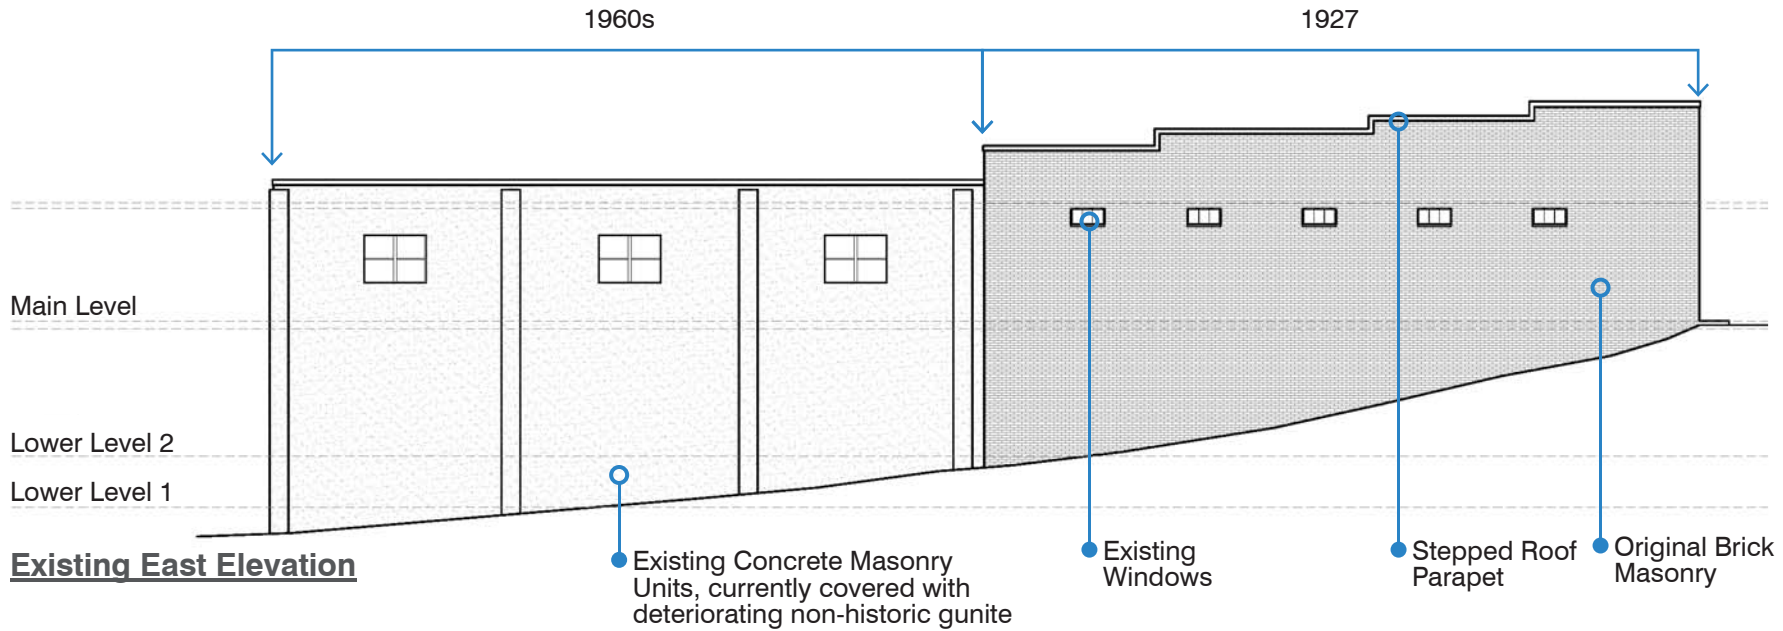
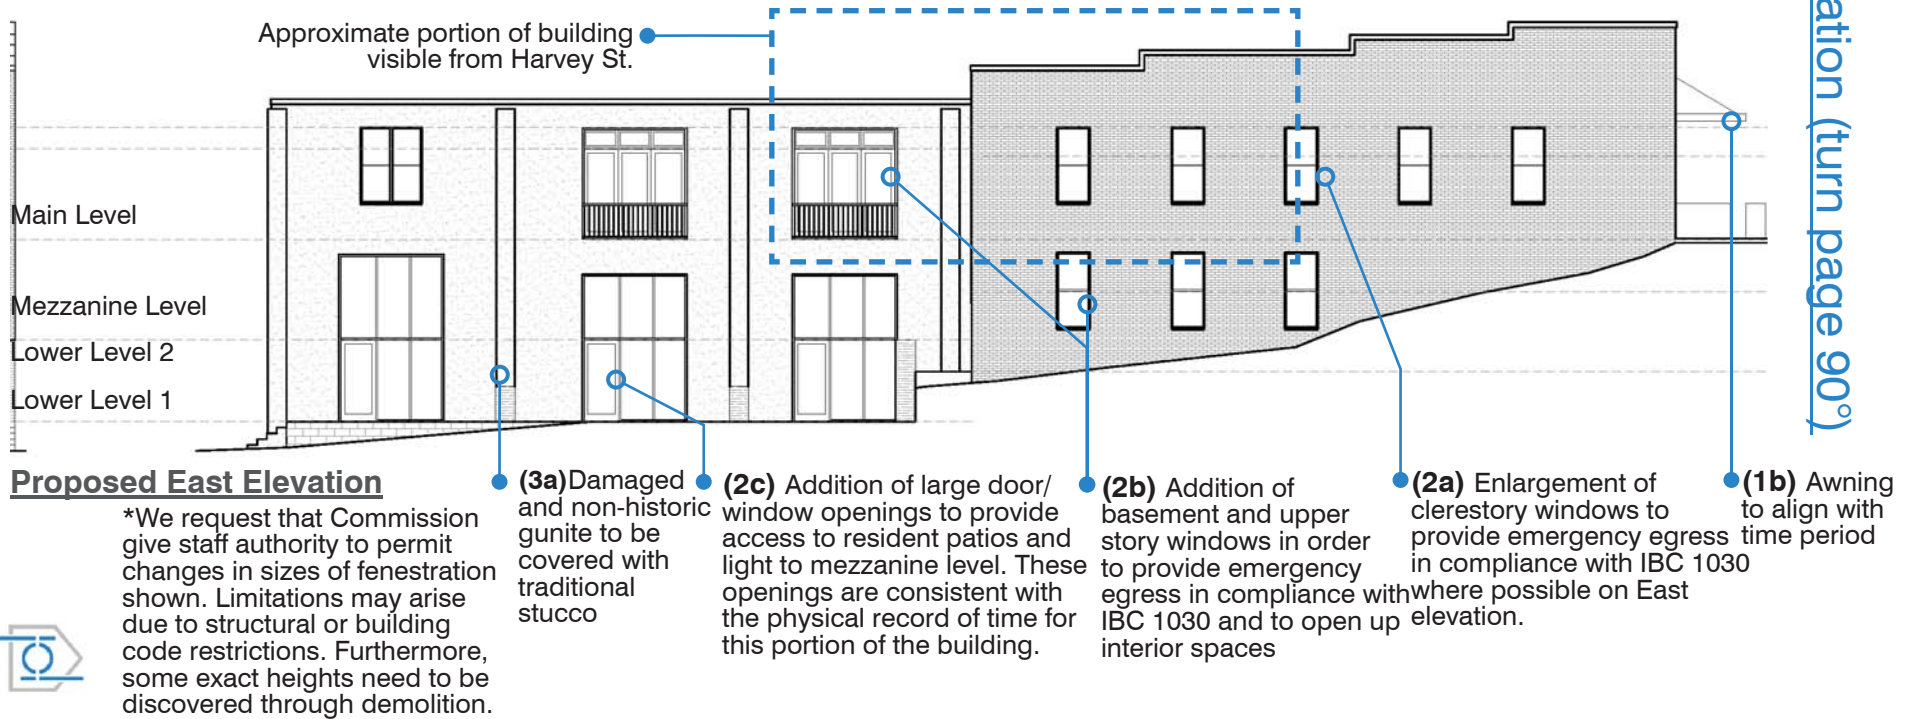
Proposed Elevations - East Elevation (turn page 90°)

Left (east) elevation: removal of non-historic clerestory windows on c.1927 structure, double-hung sash windows to be installed on two stories of original section; installation of three storefront systems on the first story of c.1960s section, featuring glazed doors topped by tall single-light transom windows; two bays of second story to receive single-light glazed doors with transoms and balconies; deteriorating gunite cladding to be removed and exterior covered in stucco.

7. One-over-one, double-hung sash windows are also proposed for the c.1927 section, east elevation. Applicant notes that these windows may not be ultimately permissible due to building code restrictions and this elevation may need to be re-designed.

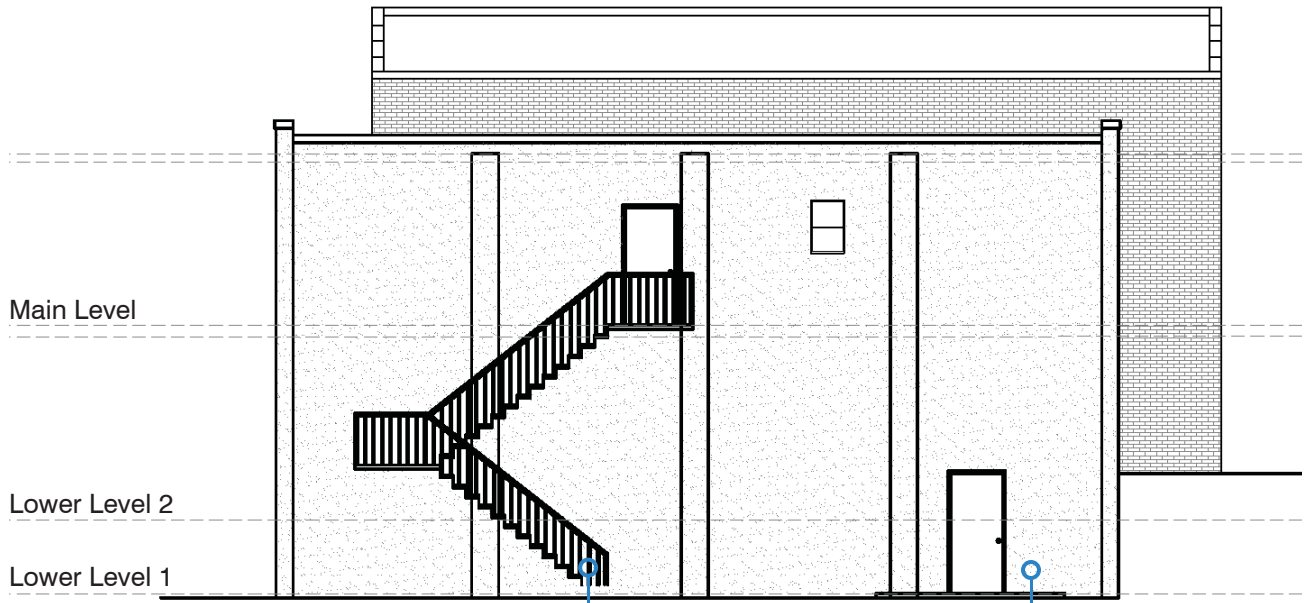
Existing Rear Elevation

Existing Metal Staircase

Existing Concrete Masonry Units, currently covered with deteriorating non-historic gunite

3. Covering existing sprayed-on gunite material on rear portion of the building. This sprayed-on, non-historic material is failing and has allowed for water damage and insect damage.

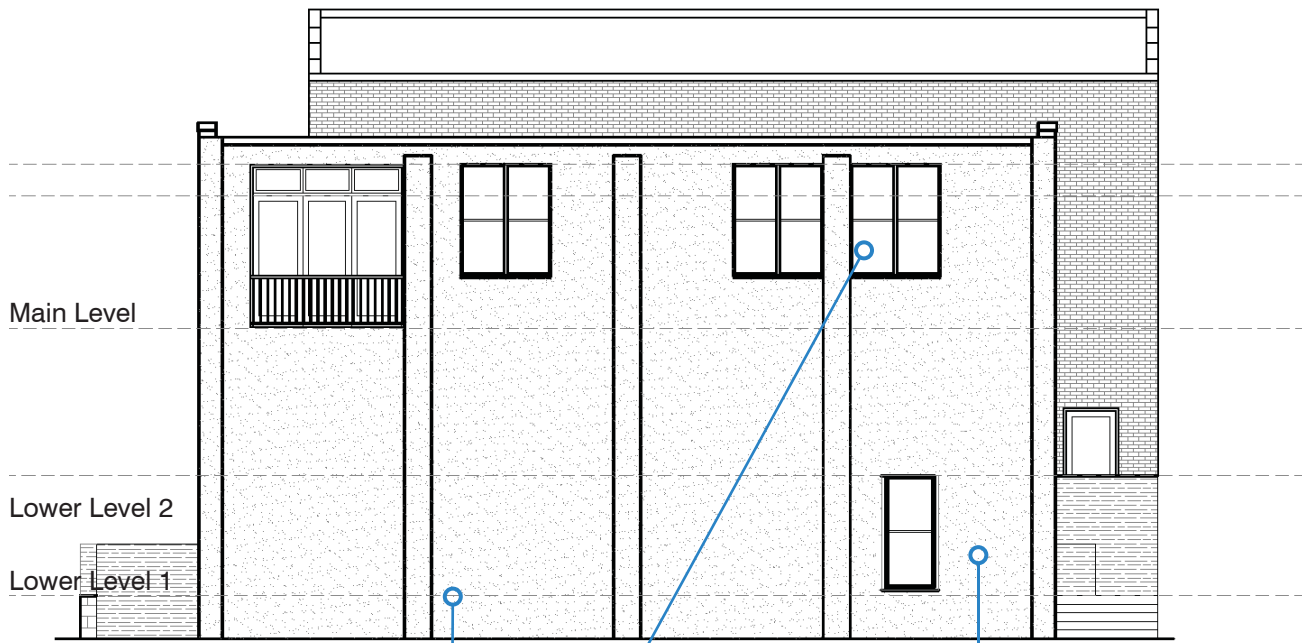
Proposed Rear Elevation

Rear (south) elevation: removal of metal staircase and non-historic rear door; installation of single-light glazed door with transom and balcony; installation of three paired double-hung sash windows on second story.

(3a) Damaged and non-historic gunite to be covered with traditional stucco

9. Rear elevation work, including the addition of double-hung sash windows, removal of metal staircase, and removal of door, is appropriate.

10. On the c.1960s section, removal of the deteriorated gunite material and covering the concrete masonry units with stucco is appropriate.

- a) We intend to remove damaged portions and repair the underlying concrete, then cover entire material with a synthetic stucco to keep the appearance of the concrete structure.

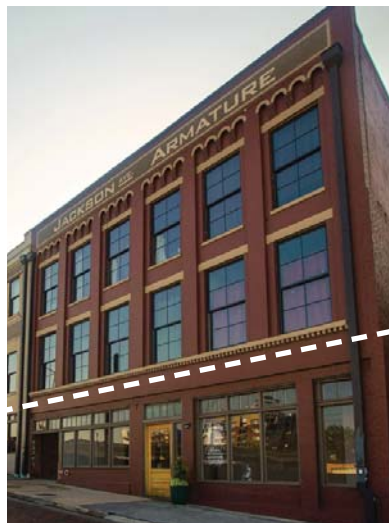
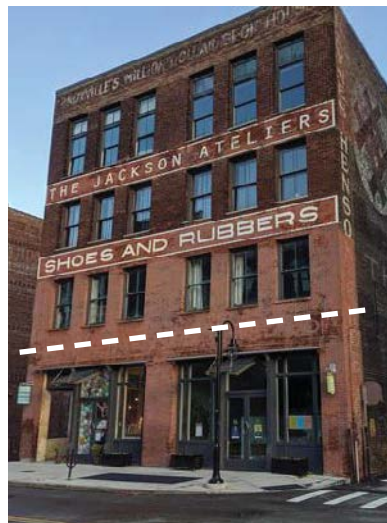
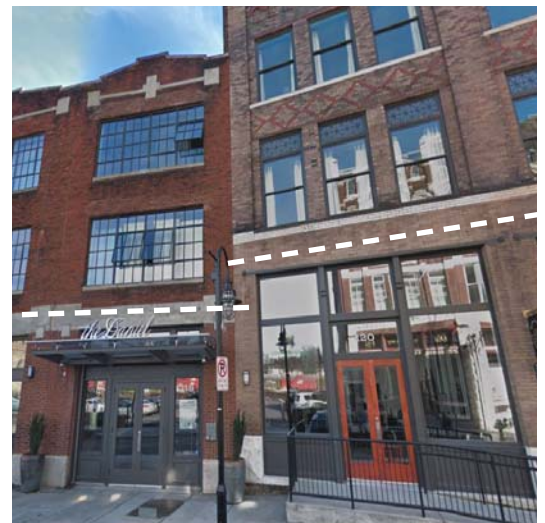
The Armature (left), Jackson Ateliers (middle) and The Daniel (right) are all historic warehouse buildings renovated into loft apartments in Knoxville. The bottom portions of the buildings feature large storefront windows while the top features more residentially appropriate double hung windows. The Lintz loft building will also use double hung windows at any window that is not storefront, which additionally helps to tie into the style of windows found in the surrounding neighborhood of Old North.

The proportions of the large storefront openings on the sides of the building are in keeping with many prominent Knoxville buildings that have been converted from warehouse/industrial buildings into lofts. The history of the use of these buildings has led to traditional window openings on the upper floors and storefront systems on the lower floor. In the renovation of the warehouse addition portion of the Lintz Lofts building, we wish to draw inspiration from Knoxville's historic warehouse lofts and use these large ground floor storefront windows to bring natural light into the Mezzanine level of the apartments as well as tie into the storefront system used on the front of the building.

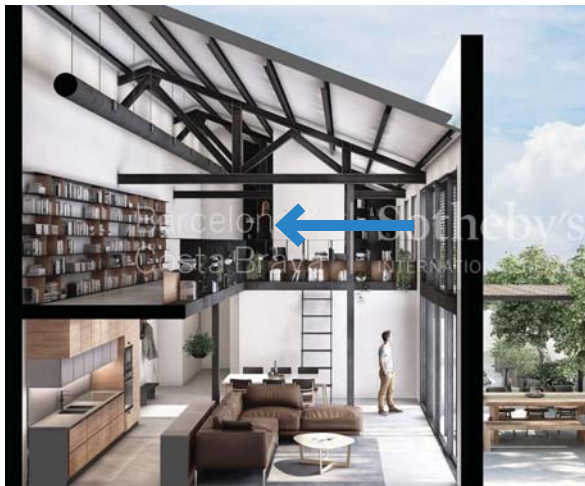
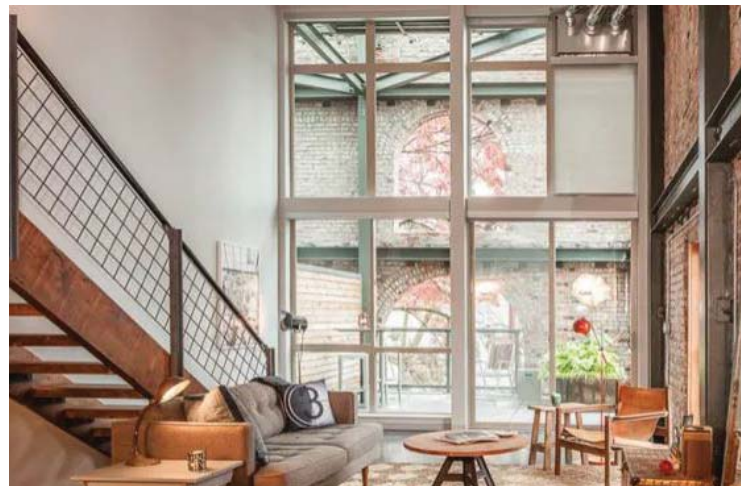
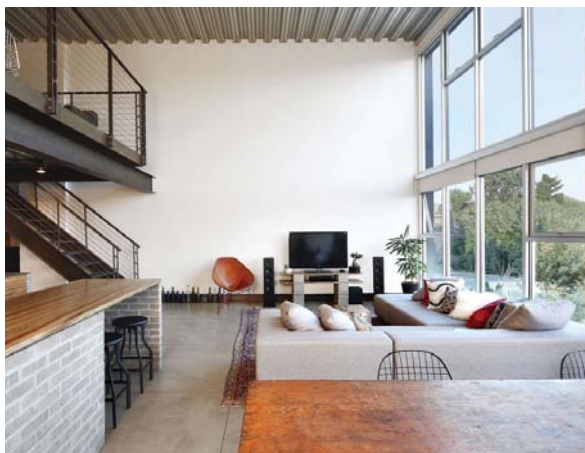
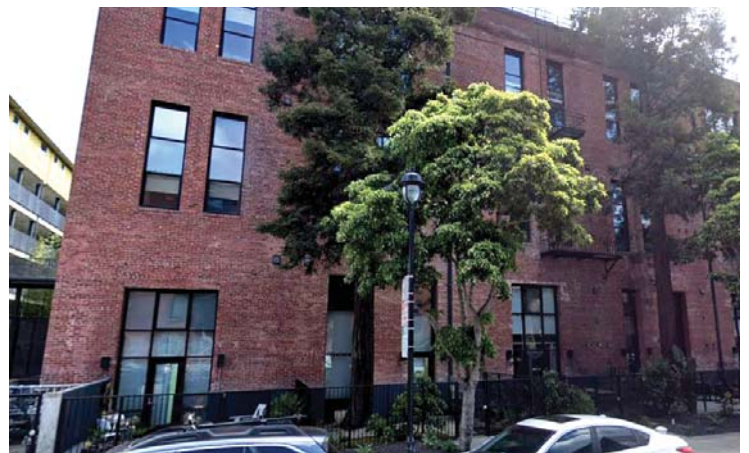
Top Left: Rendering of industrial building turned loft apartments in Barcelona, Spain
Top Right: Hollywood Lofts in Seattle, WA, a historic brick building turned loft apartments
Bottom Left: East Union, a newly built loft apartment building in Seattle, WA
Bottom Right: 851 Indiana in San Francisco, CA, a renovated brick industrial building with glazed double story entries at the ground floor

Because the rear addition is less visible from the street, we believe that it is acceptable to propose new window locations that are compatible with the overall design of the building and its original warehouse nature. In order to keep up with current design ideals and to provide vibrant living spaces for this community, we believe this is an important alteration. Below are examples of loft style residences that feature double story glazing in order to allow light to reach the mezzanine level.
