1-D-21-HZ
APPLICATION FOR CERTIFICATE OF APPROPRIATENESS

404 E. Oklahoma Ave. 37917
Old North Knoxville H

Location: 404 E. Oklahoma Ave. **Parcel ID** 81 L P 008
District: Old North Knoxville H
Zoning: RN-2 (Single-Family Residential Neighborhood)
Description: Folk Victorian, c. 1910

Level II Major Repair or Replacement

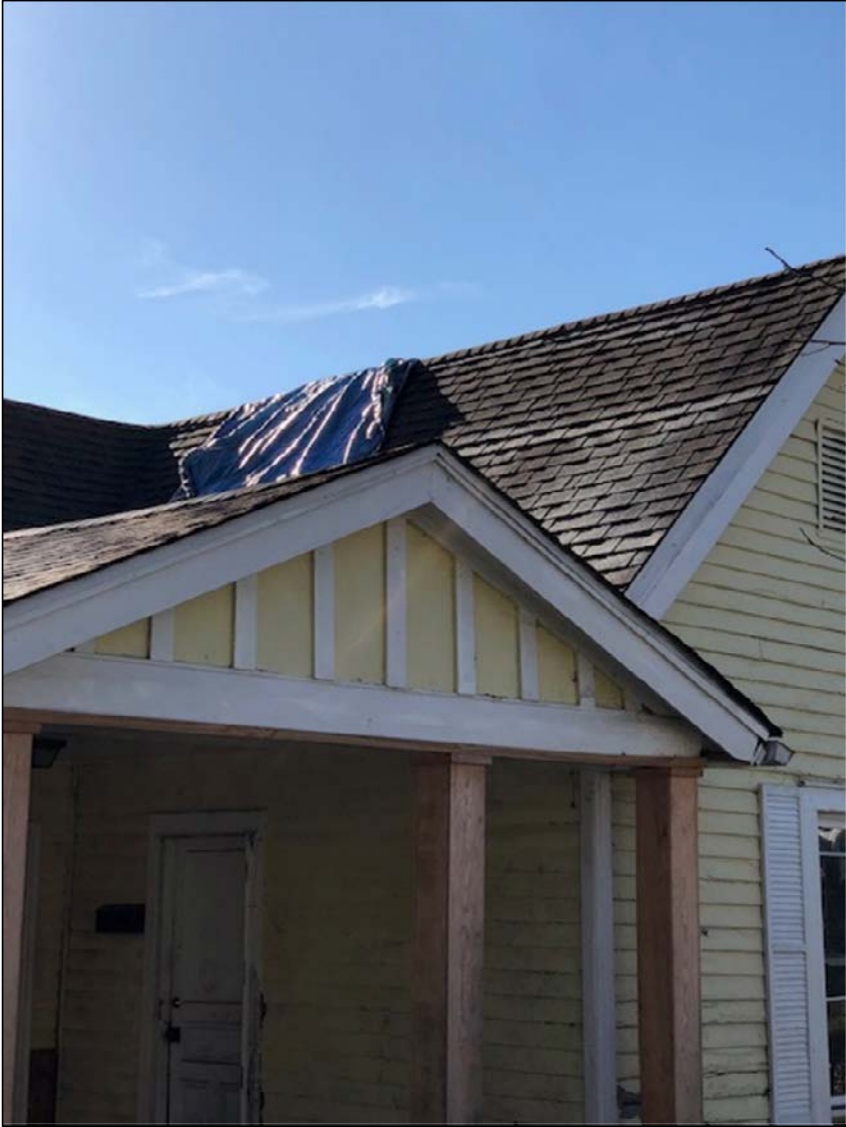
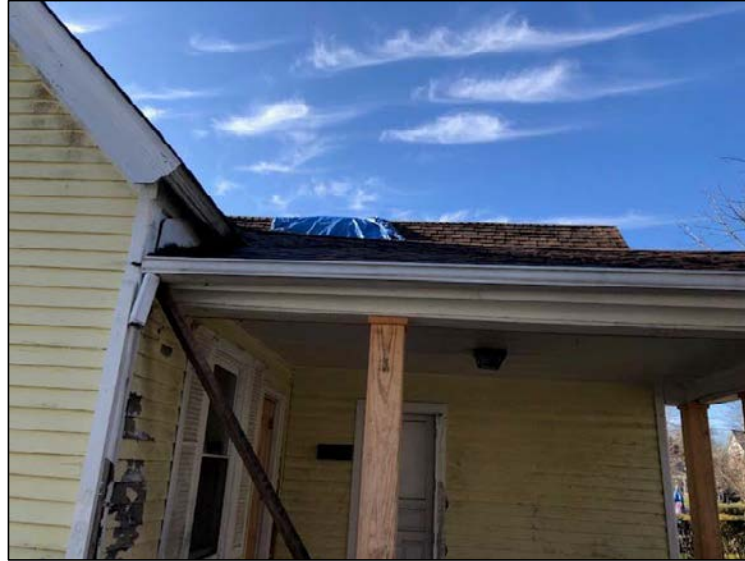
Photos submitted
by applicant

Brief description of work: **The only work I will be doing on the exterior is repair the original siding where needed, paint and install new gutters and a new roof. There is now a hole in the roof where a previous owner removed a fireplace and chimney. There is nothing left.**

The entire chimney and fireplace has been removed down to the ground. The location of the hole is where a new interior bedroom wall will be. I will not be replacing the chimney or the fireplace.

Due to the non-character-defining nature of the previous chimney and the potential damage caused by the roof remaining open for over a year, staff recommends approval of the enclosure of the roof without replacing the chimney.

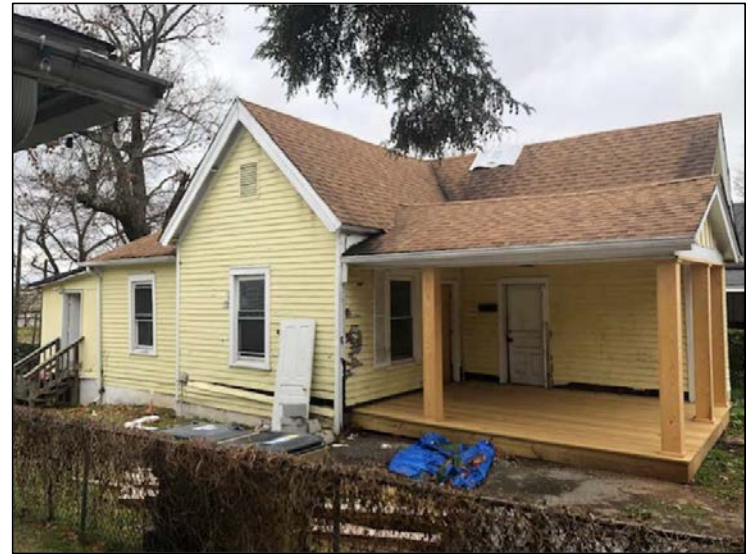
Photo submitted
by past owner

5. The new owner purchased the property in December 2020. The removed chimney has remained as a hole in the roof, covered with a tarp since its removal in summer 2019, which has likely contributed to moisture damage to roof framing and interior features.

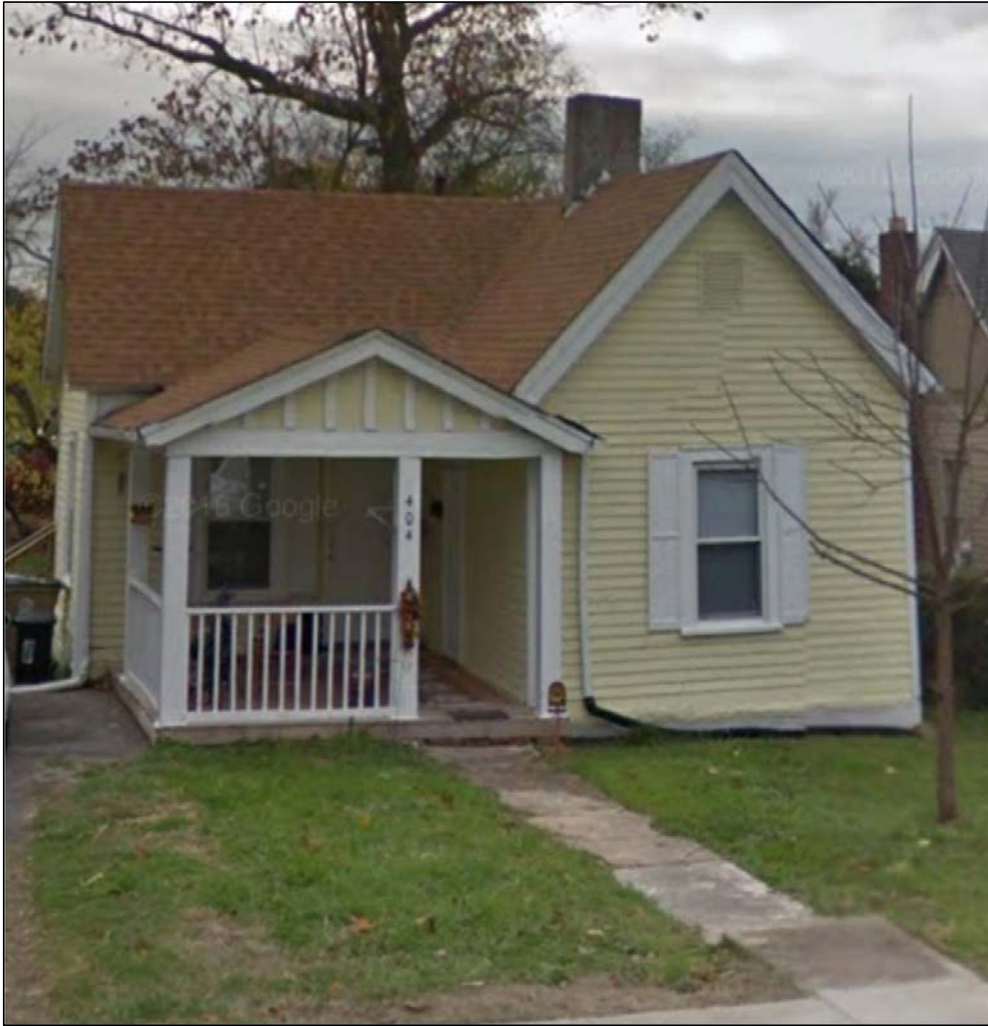
3. The chimney in question was a relatively small, modest, square, interior chimney which had been clad in stucco at an undetermined date. No detailing was visible under the stucco cladding.

Google Streetview image of previous chimney location

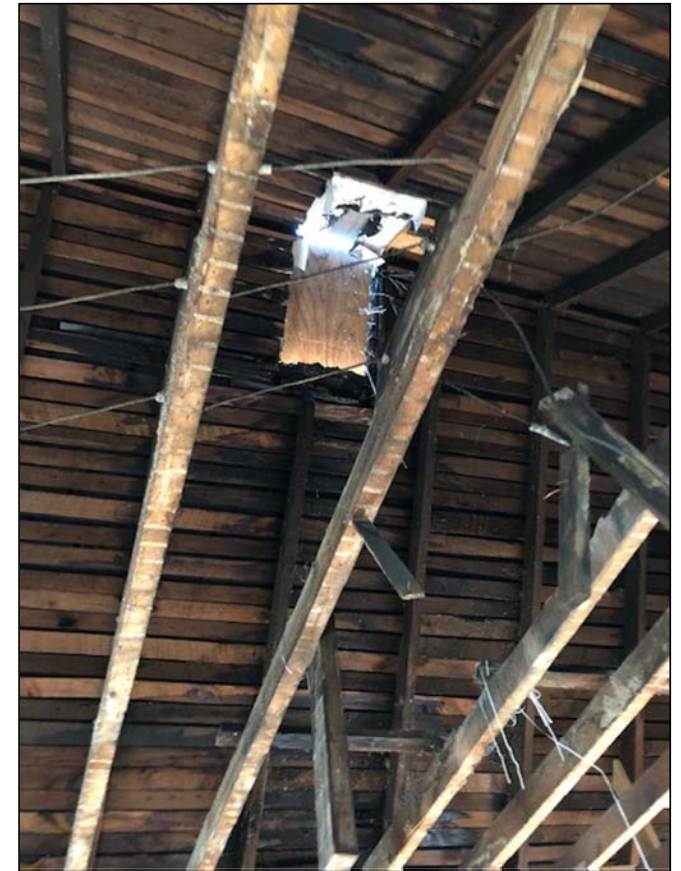
4. The chimney was removed by a previous owner without permits or a COA in June 2019. The interior fireplace structure below the chimney was also removed. The previous owner completed several reviews by the Historic Zoning Commission (7/2019, 11/2019, and 12/2019), and the most recent COA issued for the property (12-J-19-HZ) requested the roof and chimney details to return to the HZC for further review.

Interior view – chimney and fireplace removed
