**6-E-23-HZ**  
**APPLICATION FOR CERTIFICATE OF APPROPRIATENESS**

**409 E. Oklahoma Ave. 37917**  
**Old North Knoxville H**

# Staff Report

Level II Demolition/Relocation of Noncontributing Structure

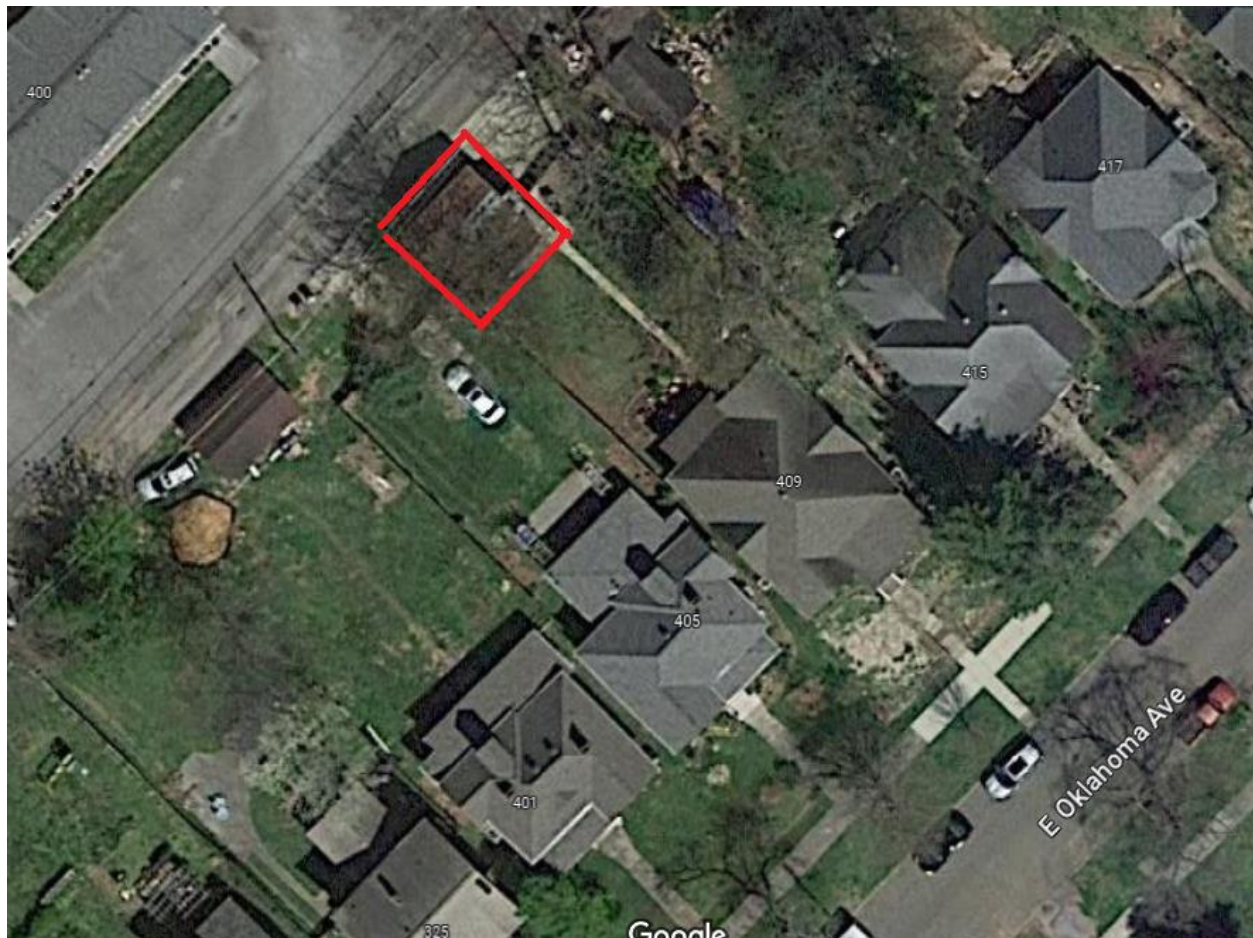
### Structure Location:

Requesting approval to demolish non-contributing accessory structure located in rear of 409 East Oklahoma Avenue. Building will not be replaced with alternative structure.

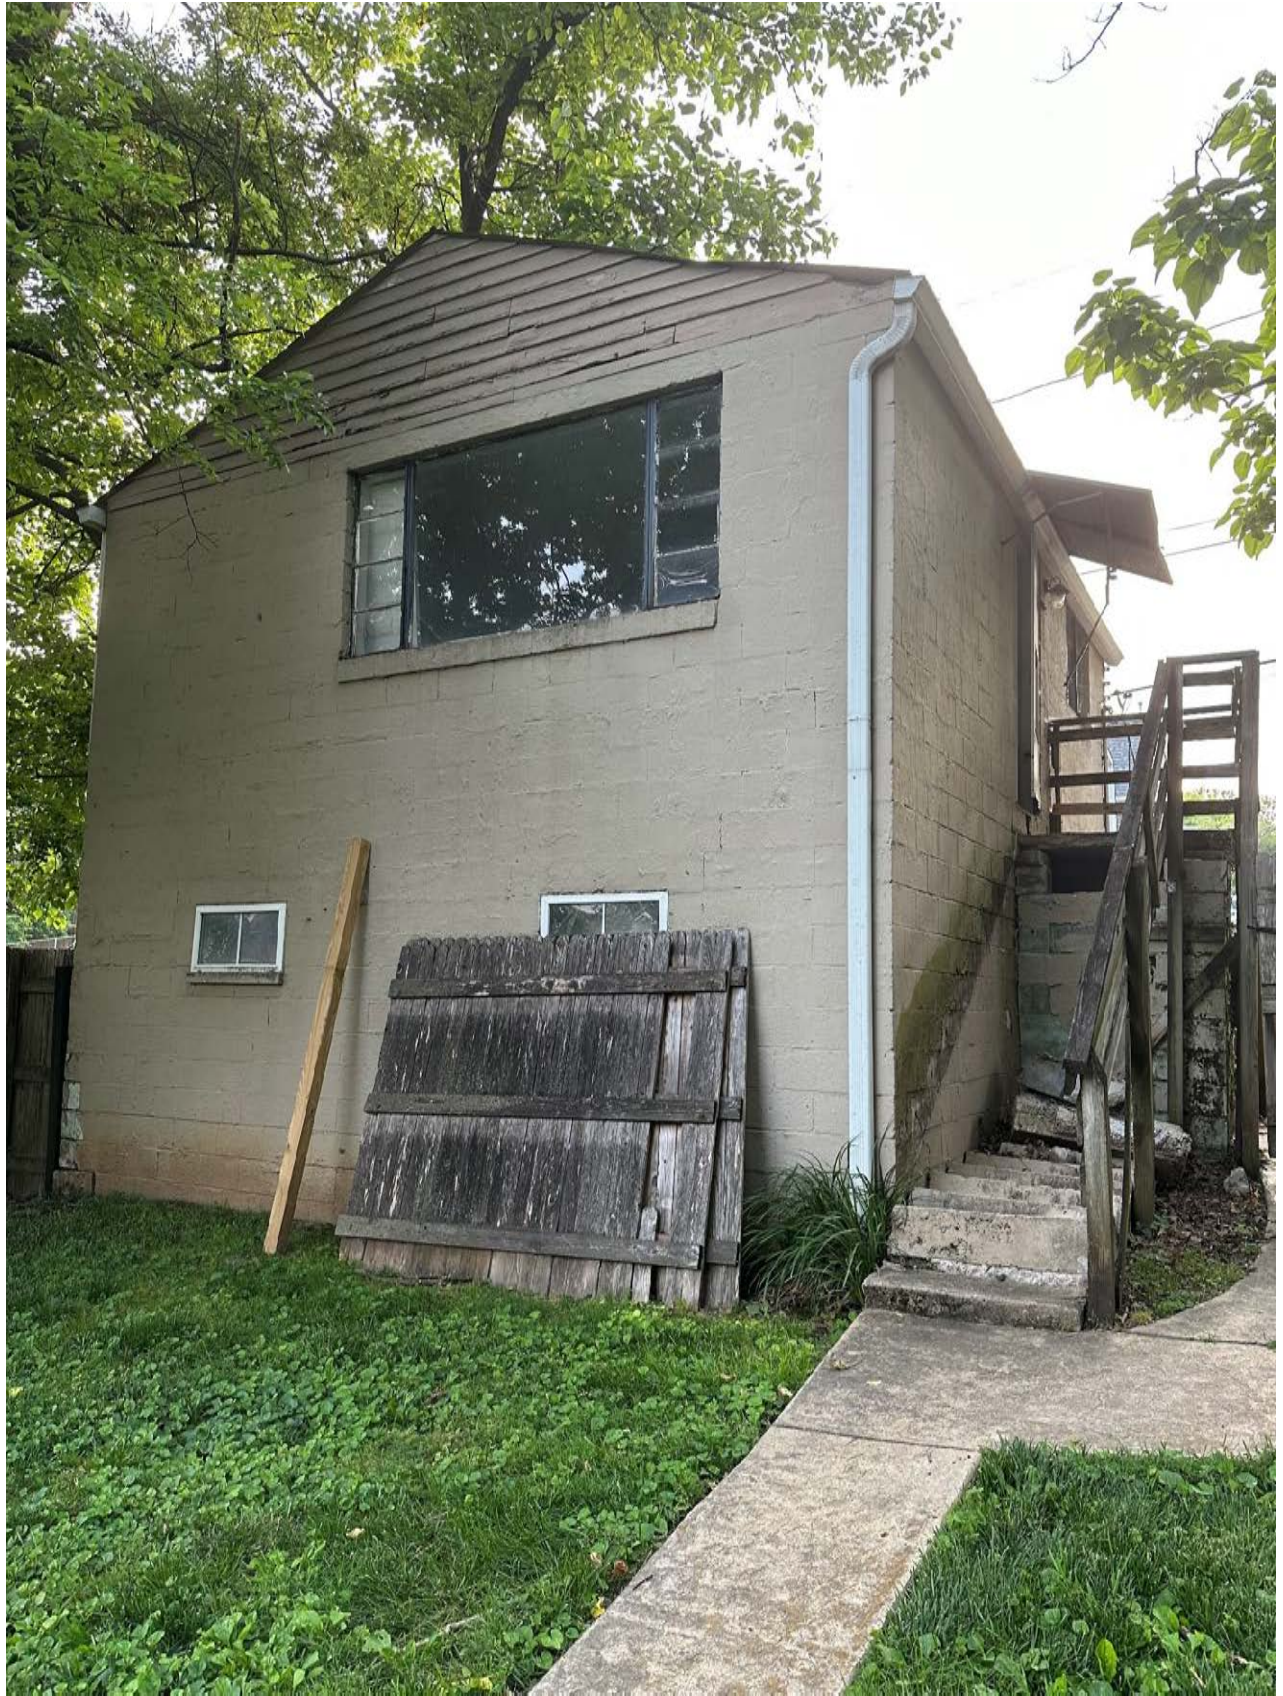
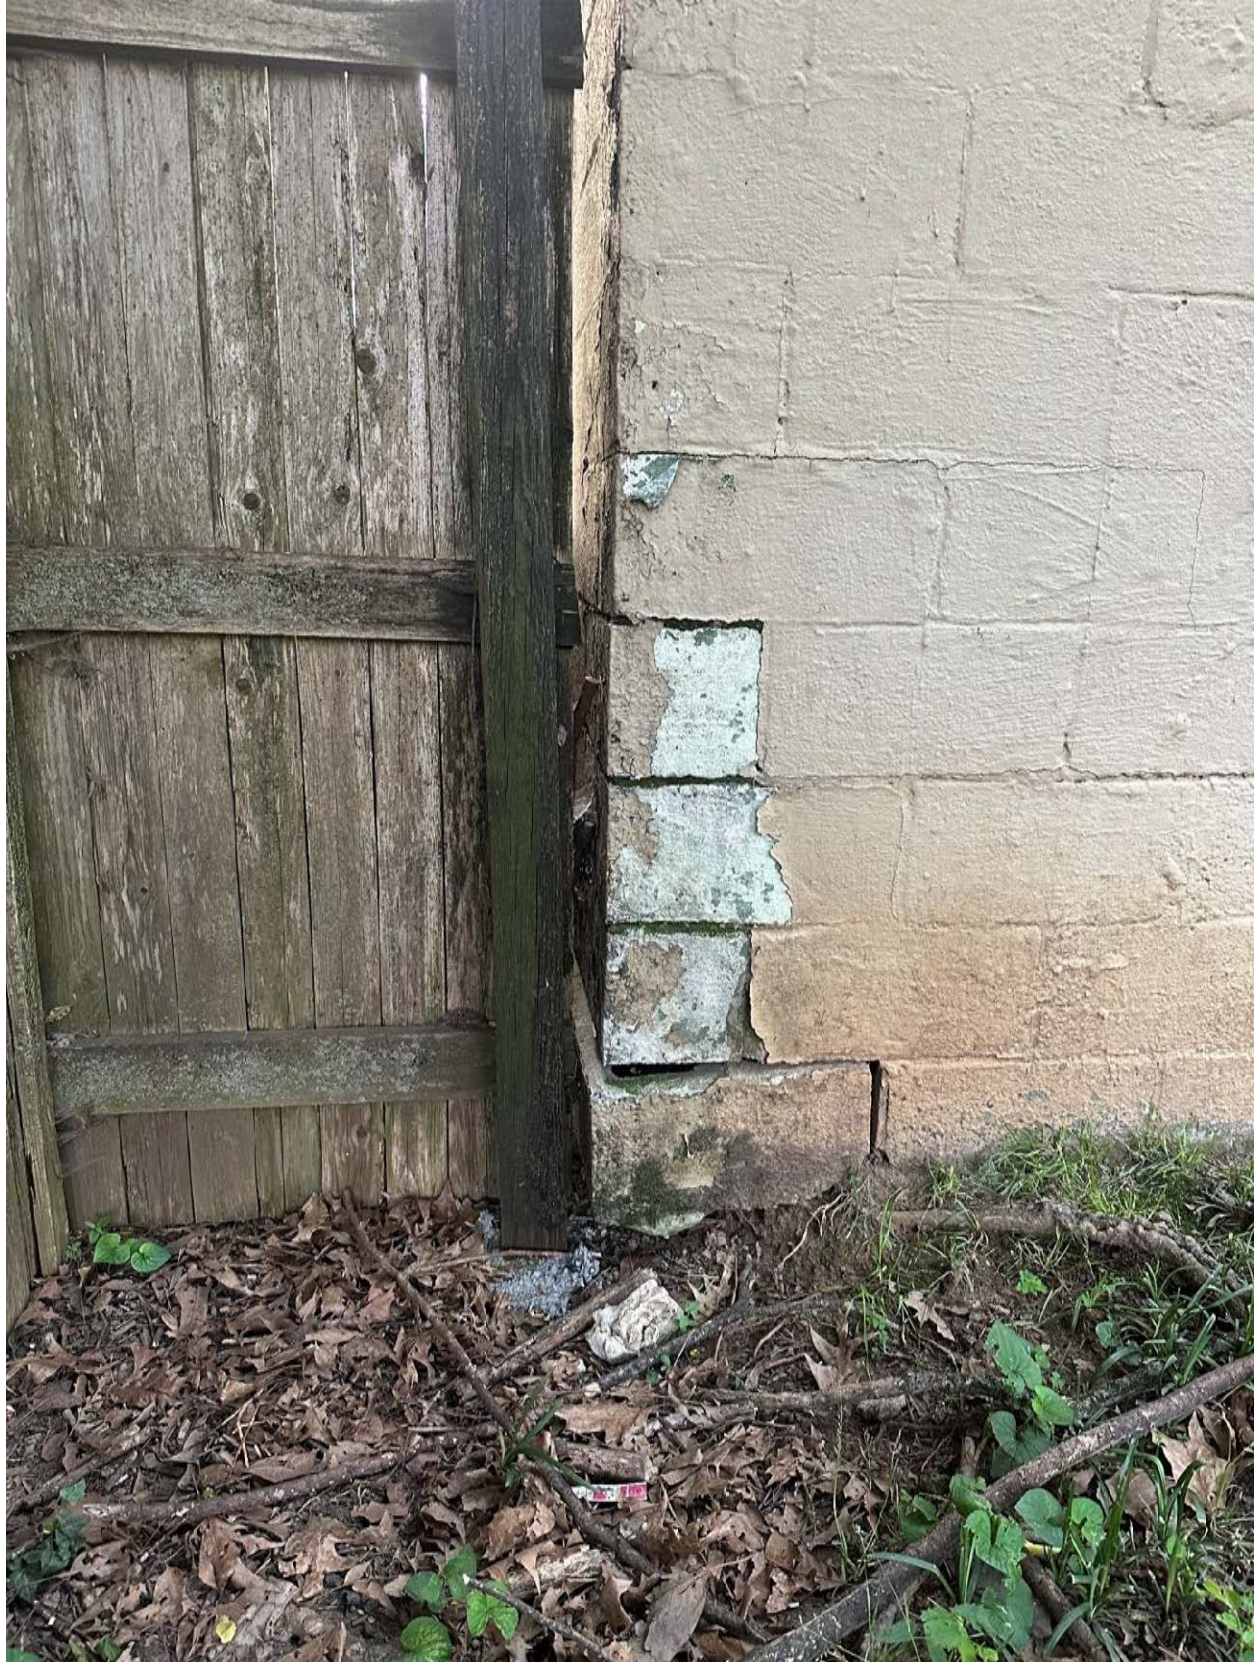
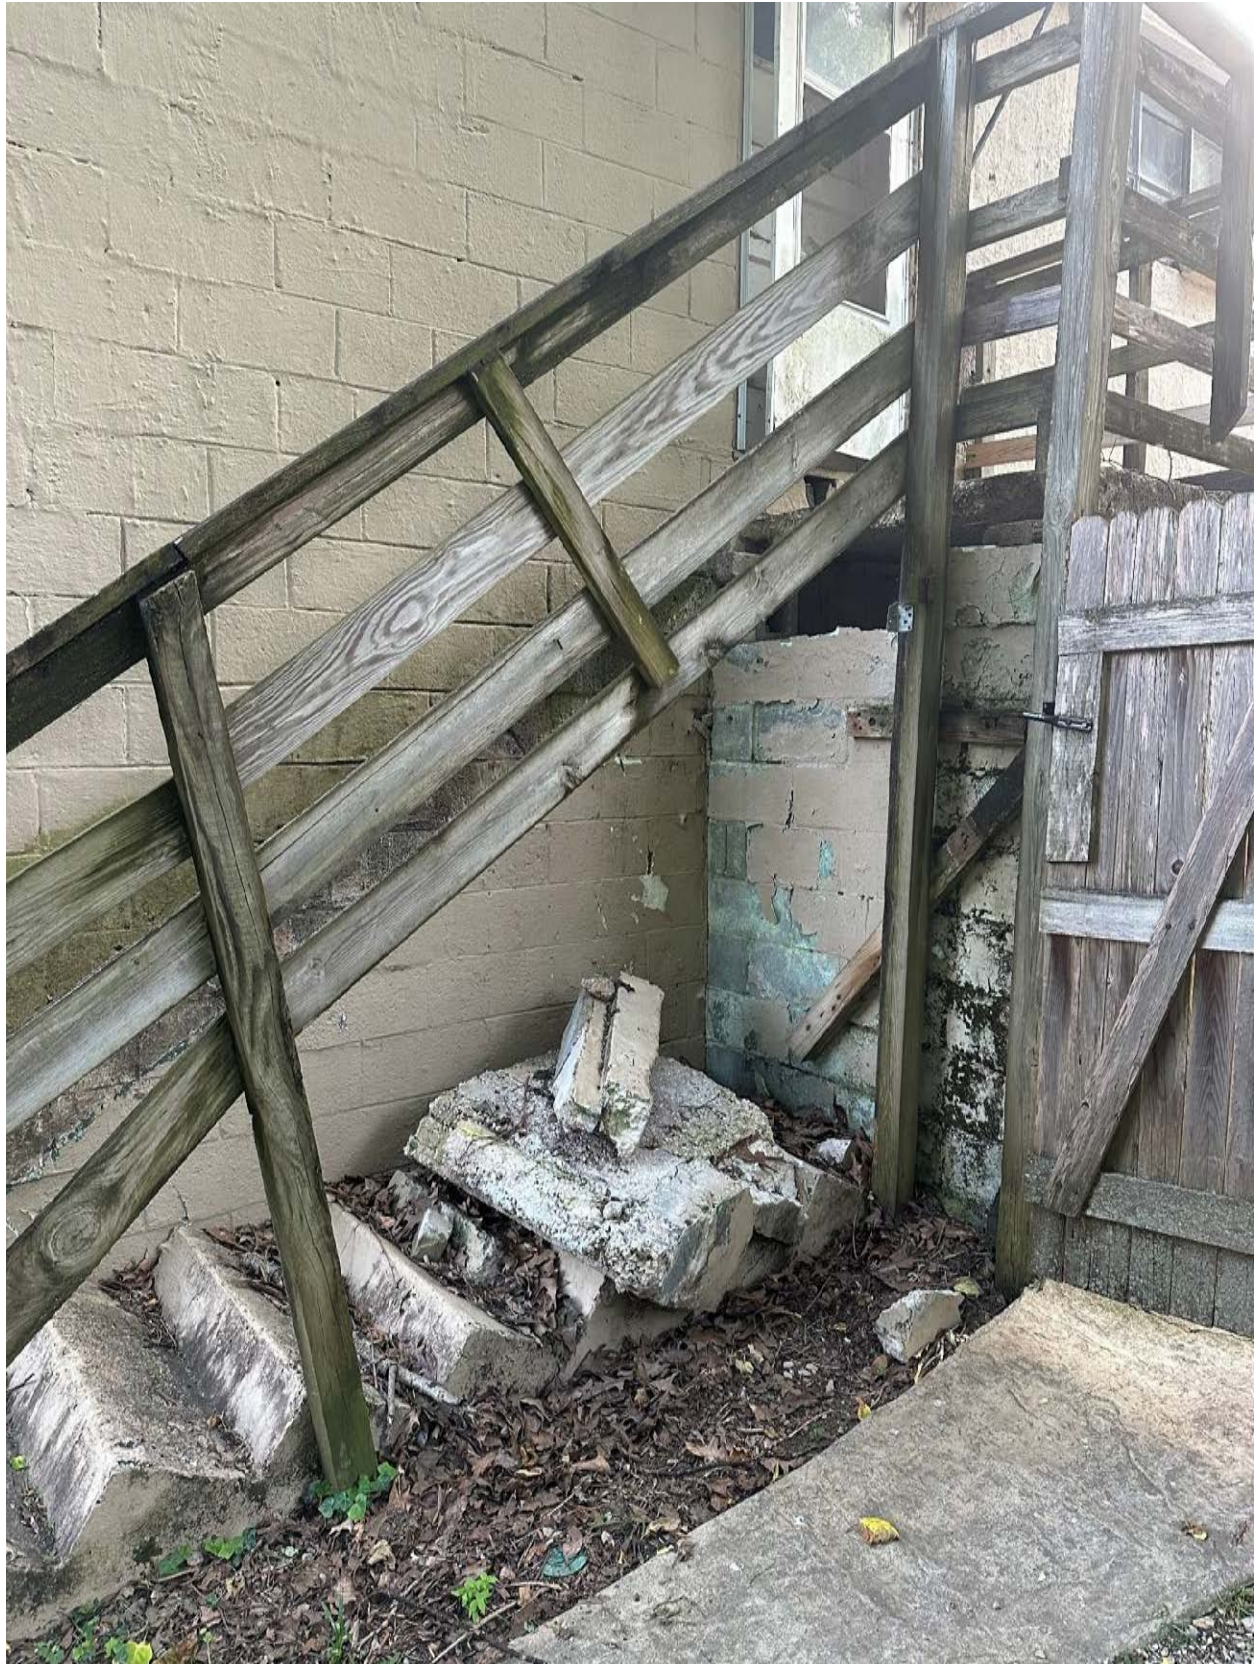
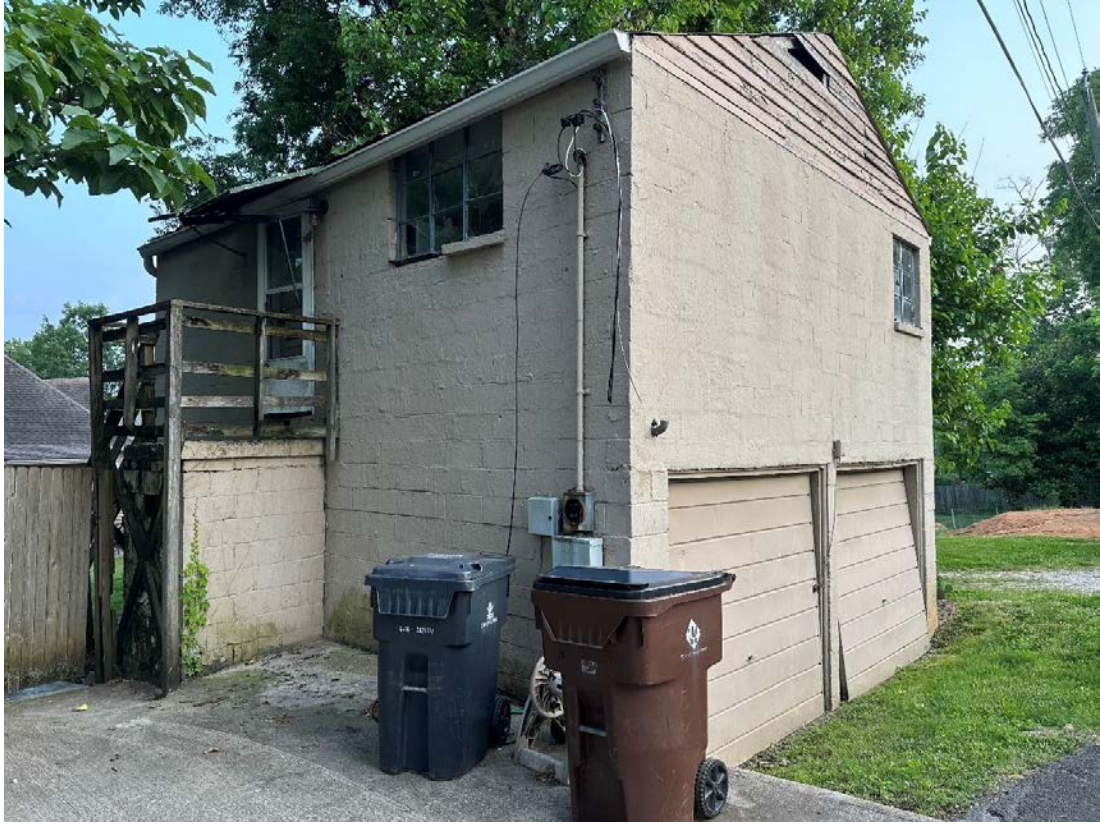
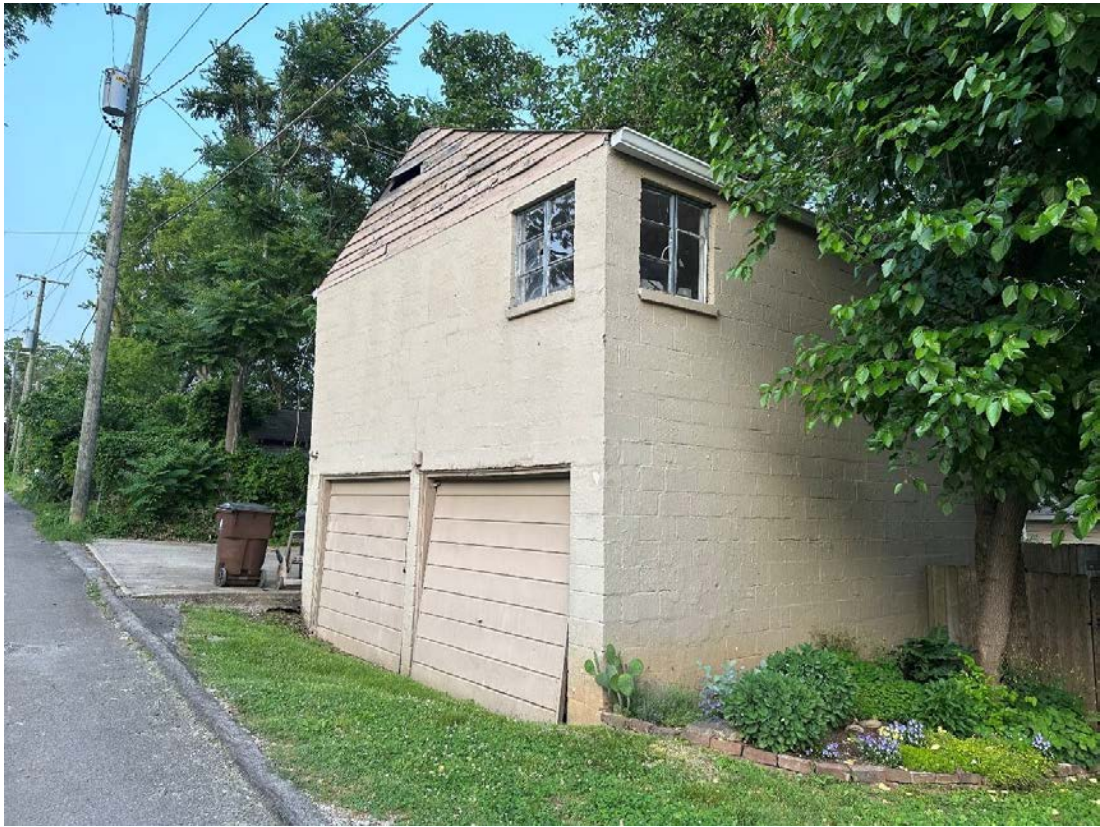
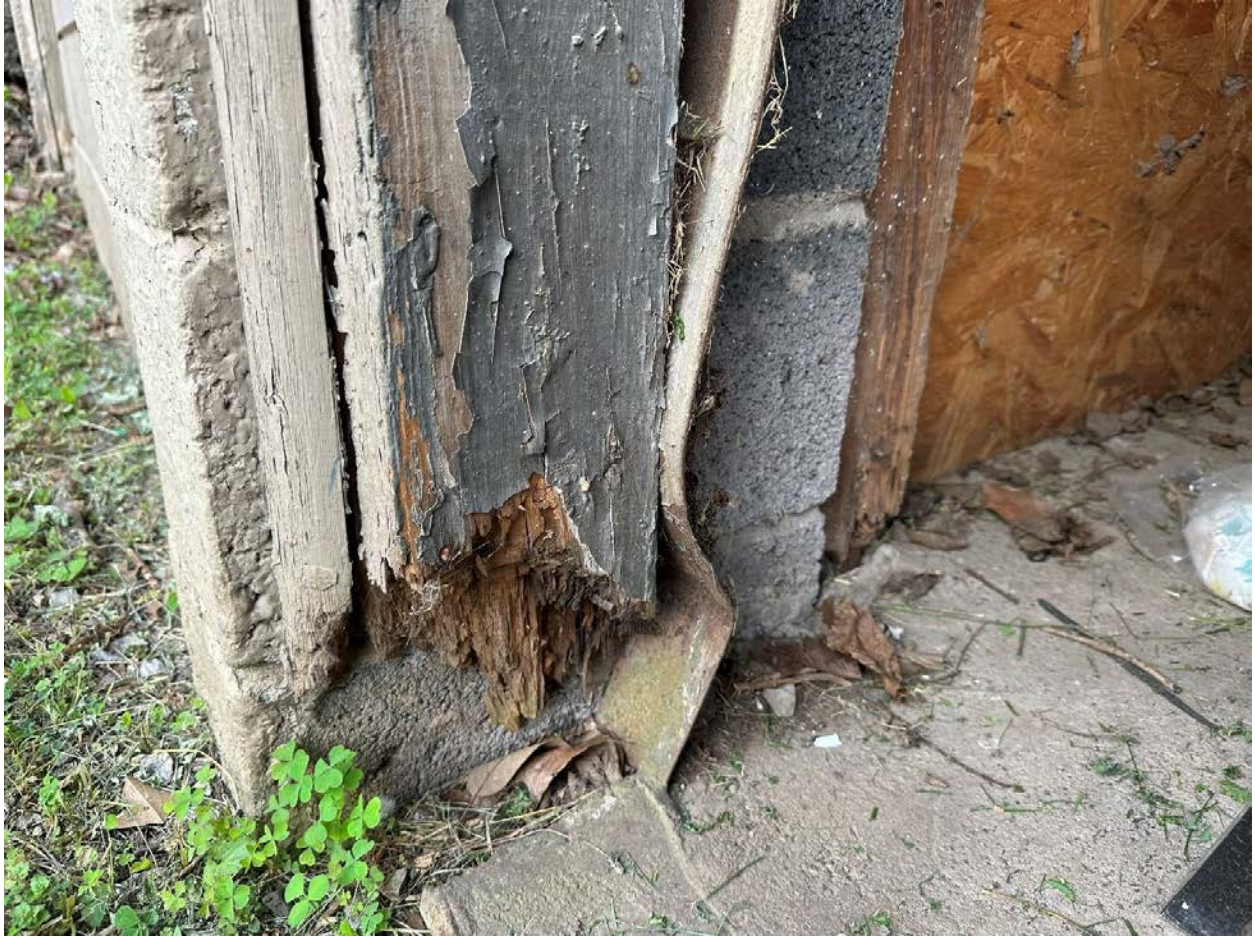
Accessory structure is a 20' x 30' two-story garage with an apartment on top. Building appears to be non-contributing structure as it does not have any historic design characteristics. Exterior is composed of cinderblock brick with a metal roof.

Building exhibits signs of severe deterioration and present immediate safety hazard. Concrete stairs and porch leading up to apartment recently collapsed. Exterior cinderblock showing signs of crumbling and cracking. Concrete flooring on lower level shows cracking and upheaval. Interior wood framing is also severely rotted. Structural engineer confirmed that building is structurally unsound.

Based on the building's non-contributing nature, staff recommends approval of the demolition as proposed.
