10-A-24-HZ APPLICATION FOR CERTIFICATE OF APPROPRIATENESS

1112 Gratz St. 37929

Staff Report

File Number: 10-A-24-HZ

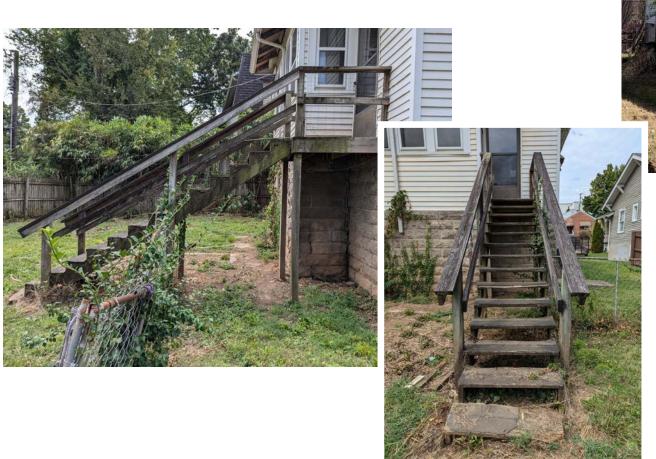
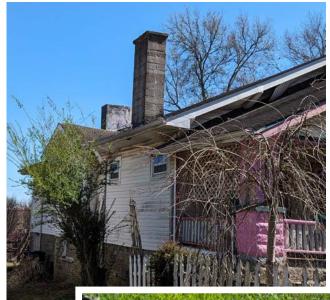
Exterior photos of 1112 Gratz St March 2024

Concrete block chimneys were in poor condition and were allowing water to enter the home. Request retro-active permission for the removal of the chimneys.

Staff recommends denial of the proposed chimney removal, and reconstruction of the two chimneys, with a size and masonry design to reflect the originals or similar houses in the neighborhood, with a detail drawing for both to be submitted to be staff for review. Staff recommends denial of the installed front door, with a revised door to be submitted to staff for approval.

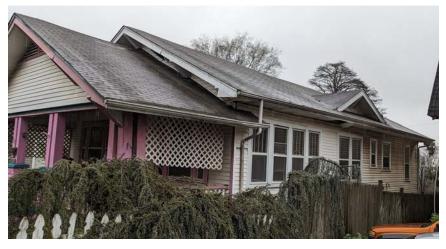
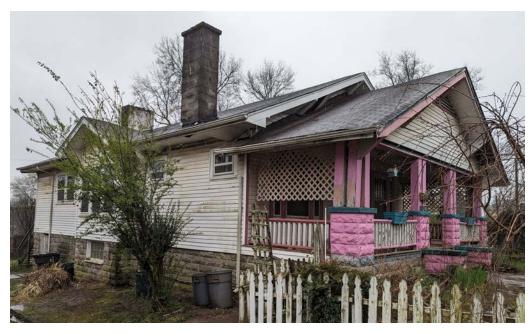
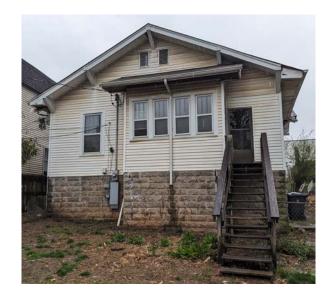
Roofing is beyond its life and is letting water into the house. Requesting approval to have the roofing replaced with architectural asphalt shingles.
