**Meeting:** 5/21/2026  
**Applicant:** Marlow Payant  
**Owner:** Marlow Payant

**Location:** 1321 Armstrong Ave. **Parcel ID** 81 L F 006  
**District:** Old North Knoxville H  
**Zoning:** RN-2 (Single-Family Residential Neighborhood)  
**Description:** Queen Anne with Neoclassical Influence, c.1910

**5-F-26-HZ**  
**APPLICATION FOR CERTIFICATE OF APPROPRIATENESS**

1321 Armstrong Ave. 37917  
 Old North Knoxville H

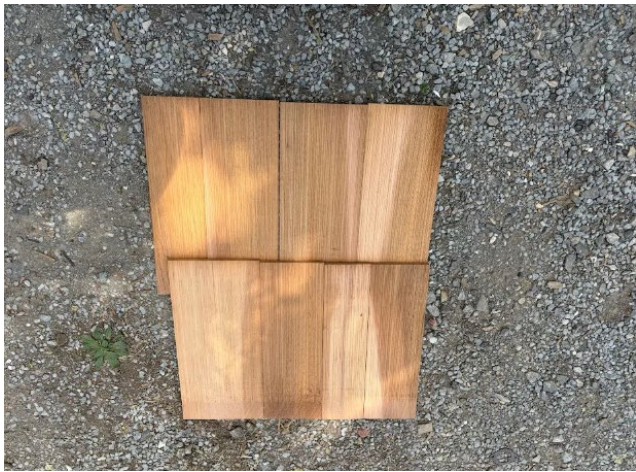
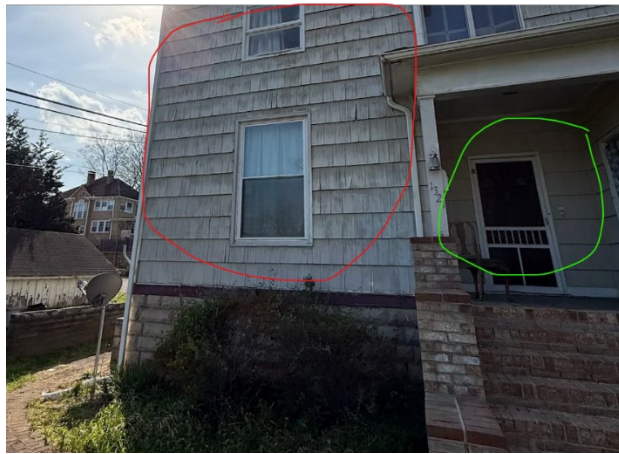
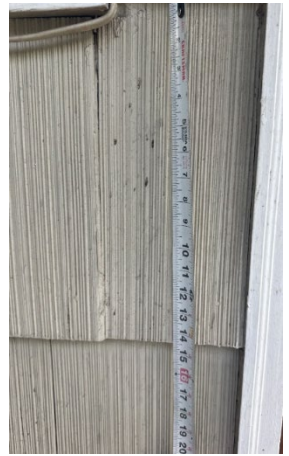
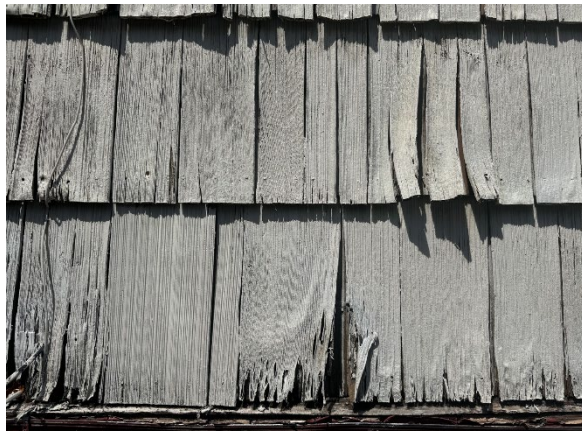
1. Siding: Vendor: Salvage Lumber CO – Cedar siding to match – Repairs in kind application
  - Estimating the need to repair/replace about 60-70% of the existing cedar siding.
  - Some areas are still in good shape and will just be painted.
  - New cedar siding matches existing 14” of exposure
  - Red circle showing area that is bad and green showing an area that is in good condition.

Removal of deteriorated sections of existing cedar shake siding, concentrated on the front elevation. Installation of in-kind cedar shake siding in its place (14" exposure). Repairs to existing cedar shake siding.

1. 1321 Armstrong Avenue is a contributing resource to the National Register district and the local overlay.
  2. The in-kind replacement and repair of the cedar shake siding and the in-kind roof replacement are appropriate. The smaller shingles in the gable fields should be retained.

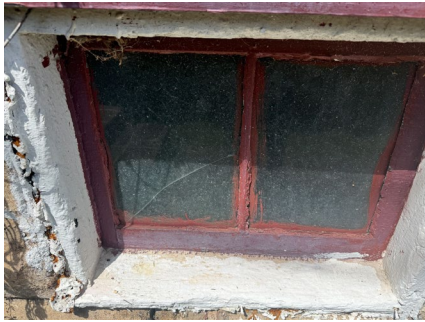
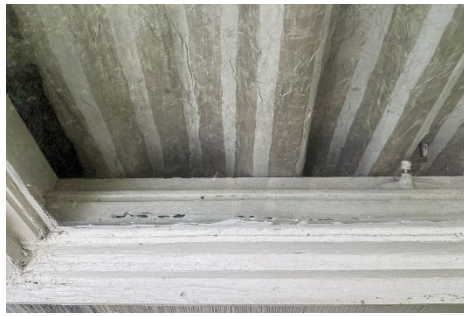
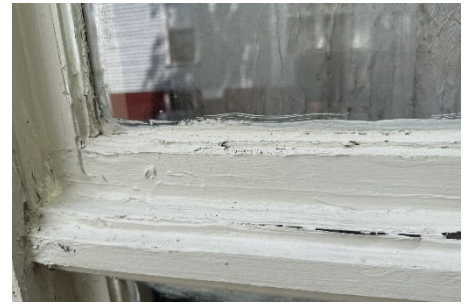
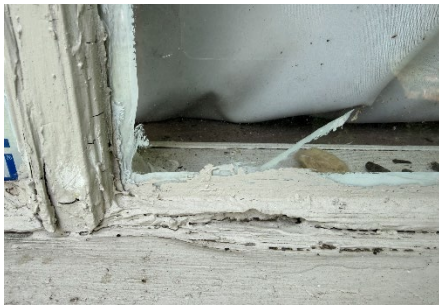
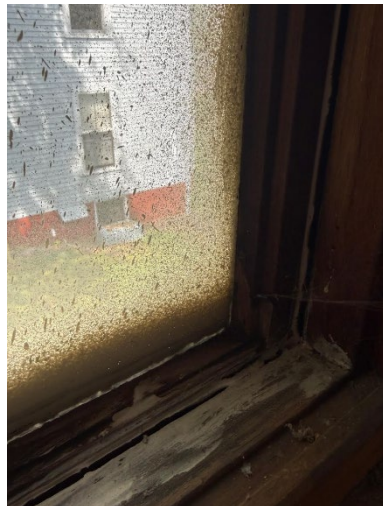
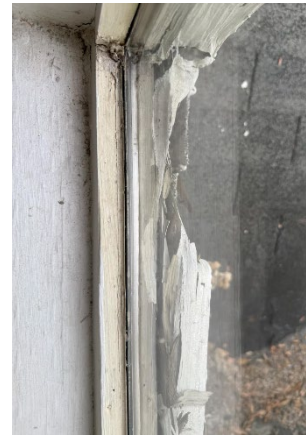
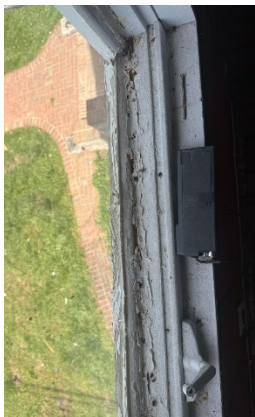
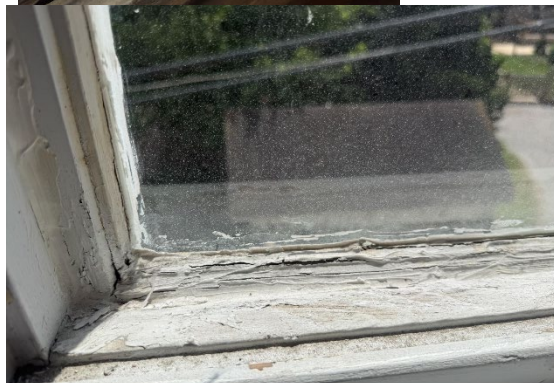
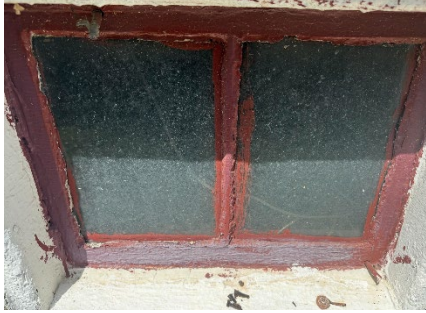
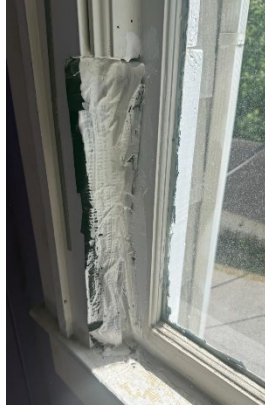
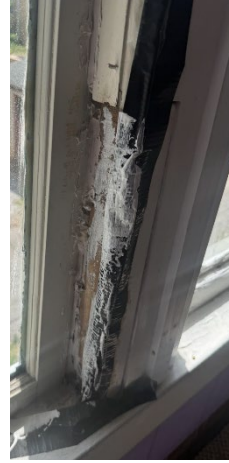
2. Windows:

- a. Only the fully rotten windows are being considered for replacement. Some have a combo of wood rot and are glued shut with layers and layers of adhesives, silicone, and paints.
- b. See current estimate from vendor – (note the estimate is for the whole house but I am only doing the rotten ones.
- c. Brand: Marvin Elevate, painted exterior, bare pine interior

4. The windows to be replaced exhibit severe rot, so replacement is appropriate. The majority of the windows are 1/1 double-hung replacement windows, with isolated examples of various profiles on replacement windows, and some were replaced without permits. Some of the transom windows proposed for replacement could be original, but they exhibit different trim profiles, making it difficult to confirm when they were installed, and are not character defining. The new proposed windows replicate the sizes of the existing windows, but they do not replicate the profiles of the transom windows and multi-lite windows. Some of the 2-lite transom windows could be replacement slider windows that are glued shut. The proposed replacement windows are appropriate because they are consistent with the other windows on the house, and it is not possible to determine the house’s original window profiles.

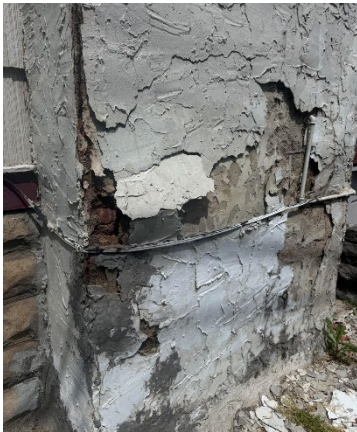
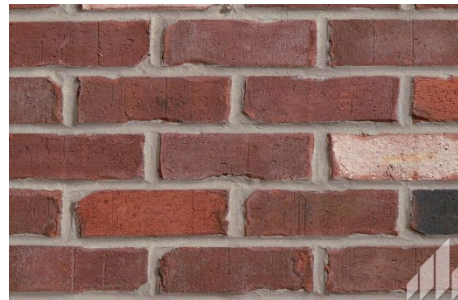
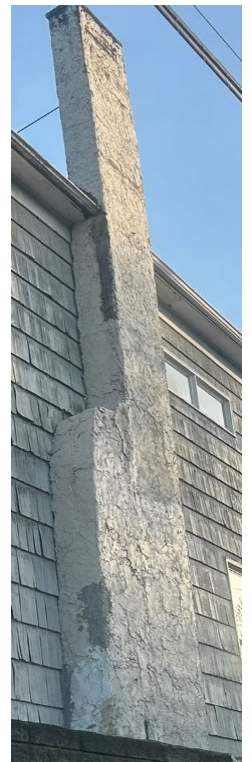
### 3. Chimney:

- a. Chimney has been stucco'd at some point and is falling in pieces all throughout.
- b. Type O Mortar Mix – Historic River Sand
- c. Brick: Vendor: General Shale old Louisville
- d. Dimensions 18" deep x 3' wide x 30' tall

3. The original brick chimney was stuccoed prior to 1992, and the applicant states it is “falling to pieces all throughout.” The guidelines encourage removing and replicating chimneys that are too deteriorated to repair using remaining physical evidence, so removal can be appropriate. However, the new proposed chimney will not match the exact design of the original chimney, which narrows at the second story where the smoke chamber meets the flue, characteristic of operable chimneys from the period. The design of the replacement chimney should be revised to include this narrow section, with final drawings to be approved by staff.
