**KNOXVILLE HISTORIC ZONING COMMISSION
STAFF REPORT - CERTIFICATE OF APPROPRIATENESS APPLICATION**

PROPERTY ADDRESS: 726 Deery St 37917
DISTRICT: Fourth and Gill H-1

FILE NO.: 11-J-13-HZ

Replace one original window on the 1st-level front of the house and two originals on the north side to match the existing 2/2 double-hung configuration, but with wooden simulated divided light windows.

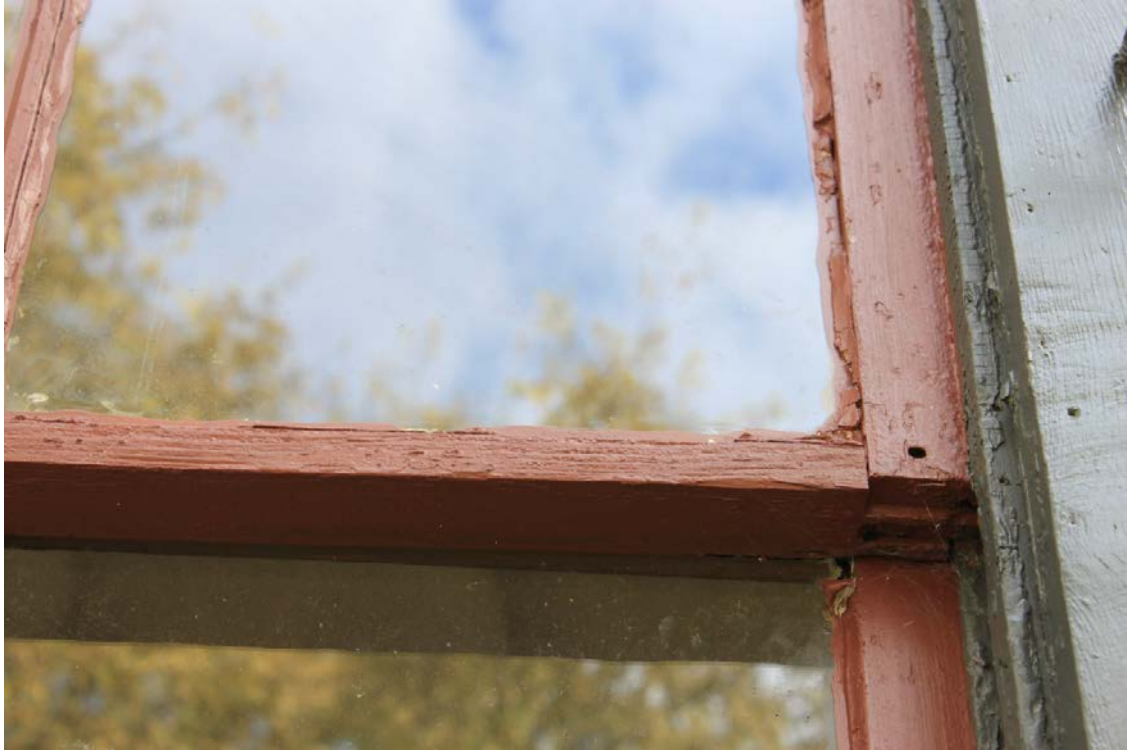
725 Deery – North side window close up

THE SASHES AND FRAMES HAVE DETERIORATED
ALLOWING LARGE GAPS AT ALL WINDOWS. THE
SASHES DO NOT FIT IN THE FRAME WHICH WERE
PREVIOUSLY MODIFIED
