**KNOXVILLE HISTORIC ZONING COMMISSION
STAFF REPORT - CERTIFICATE OF APPROPRIATENESS APPLICATION**

PROPERTY ADDRESS: 1424 Fremont Ave

FILE NO.: 6-F-17-HZ

PROPERTY DESCRIPTION: Craftsman Four-square (c. 1915)

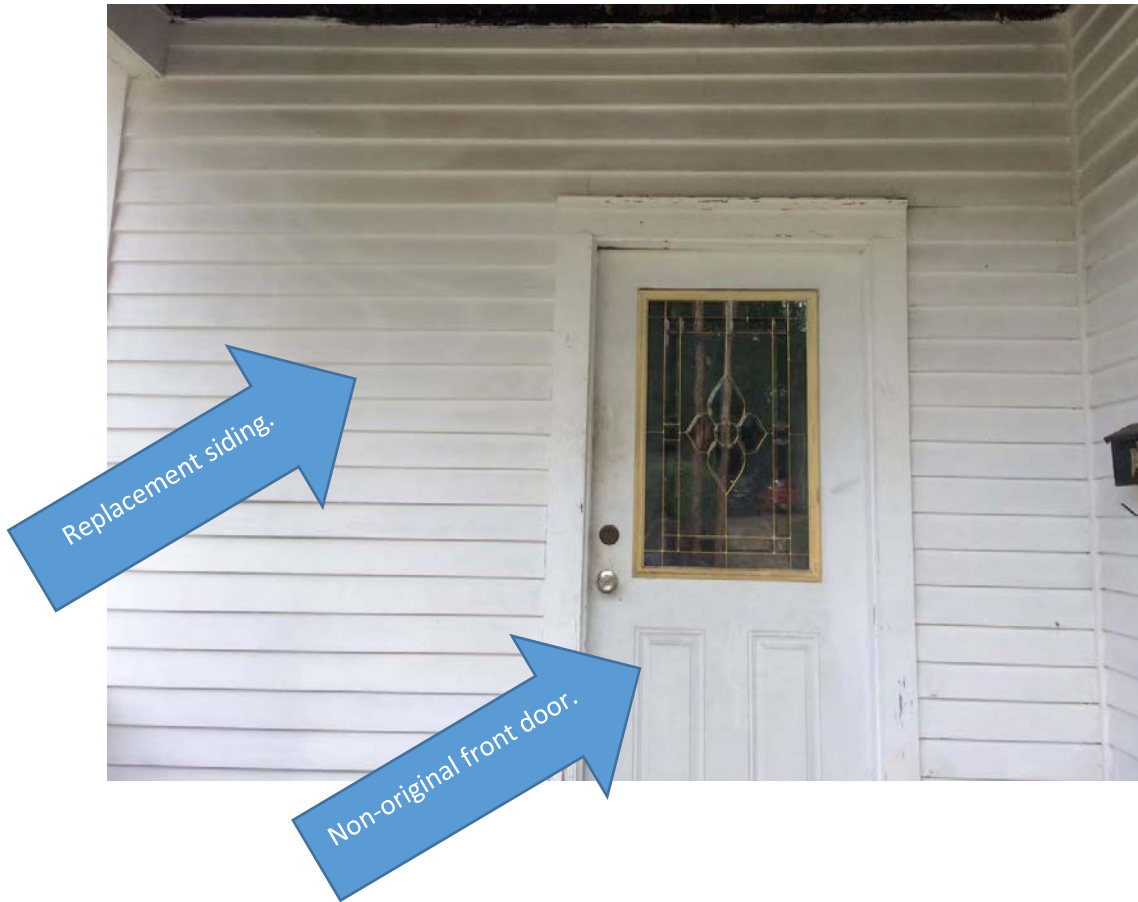
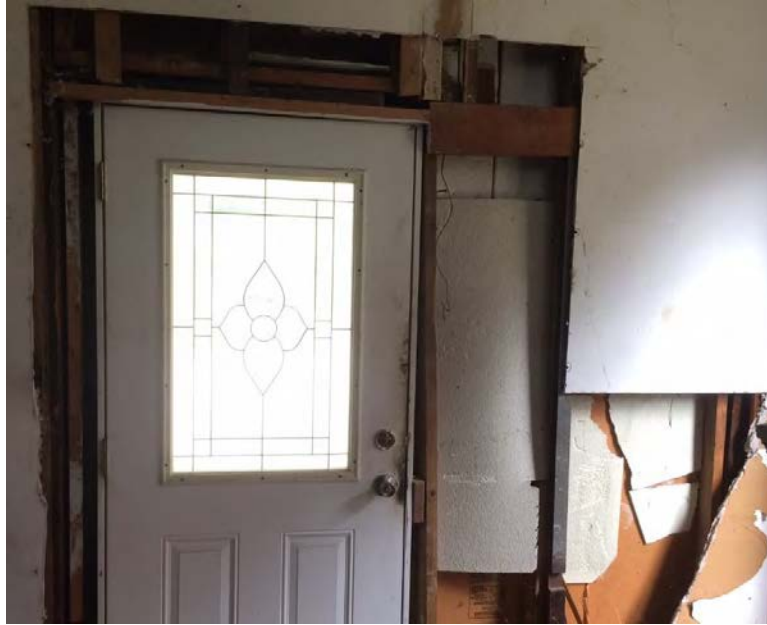
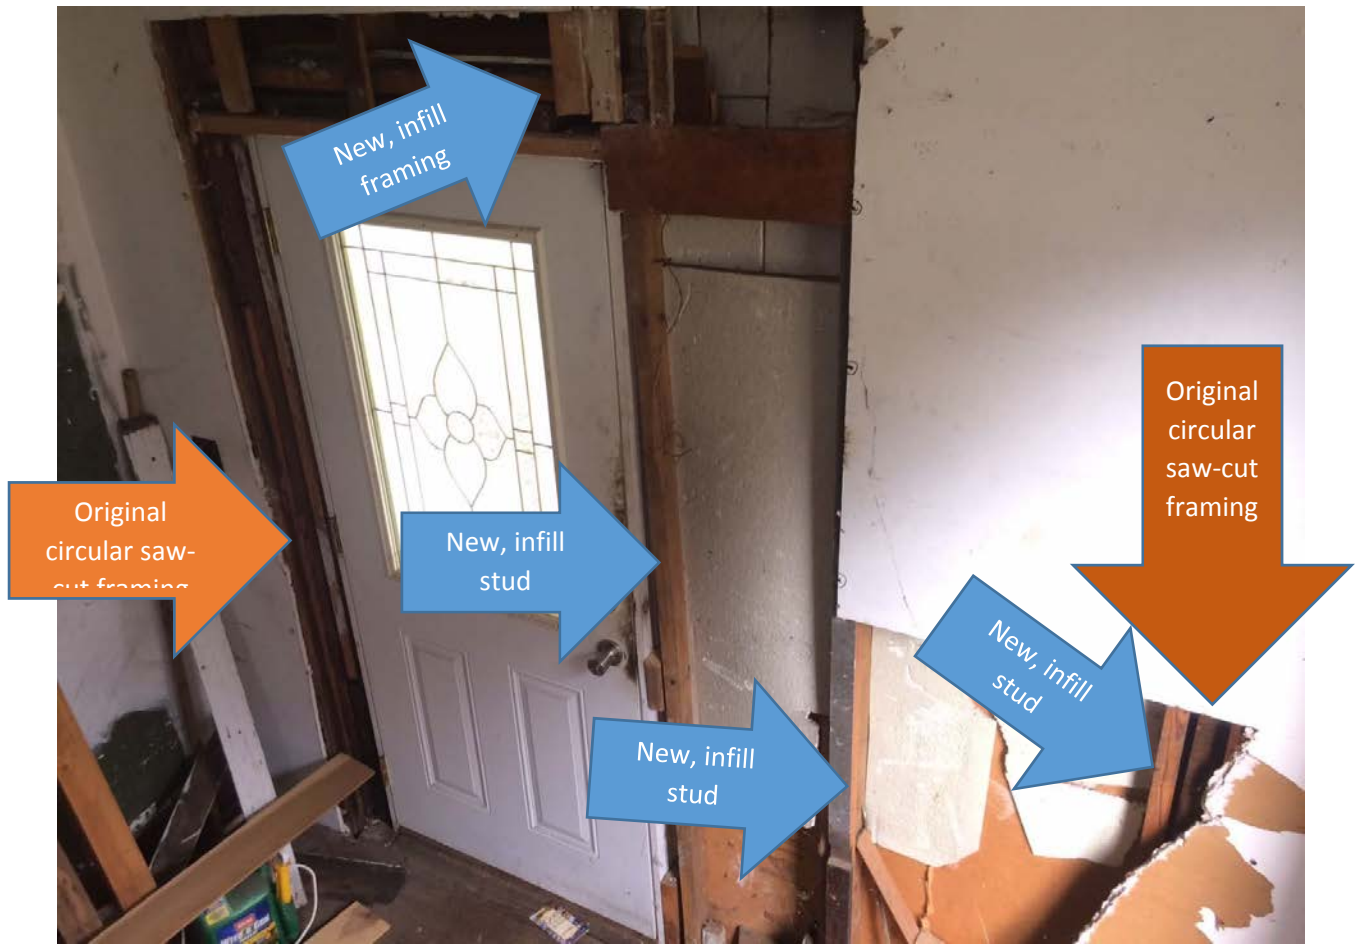
The front door is not original (neither is the siding under the porch) and from the inside we can see evidence that the house originally had a transom and sidelights. This can be seen from the building in of the opening with newer lumber and the rough cut boards outlining the original opening. We would like to return a transom and sidelight configuration.

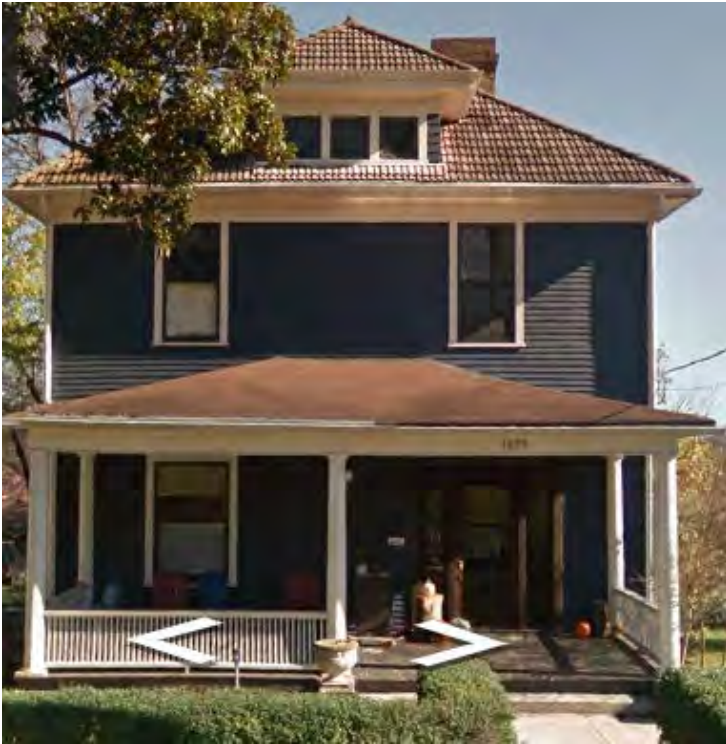
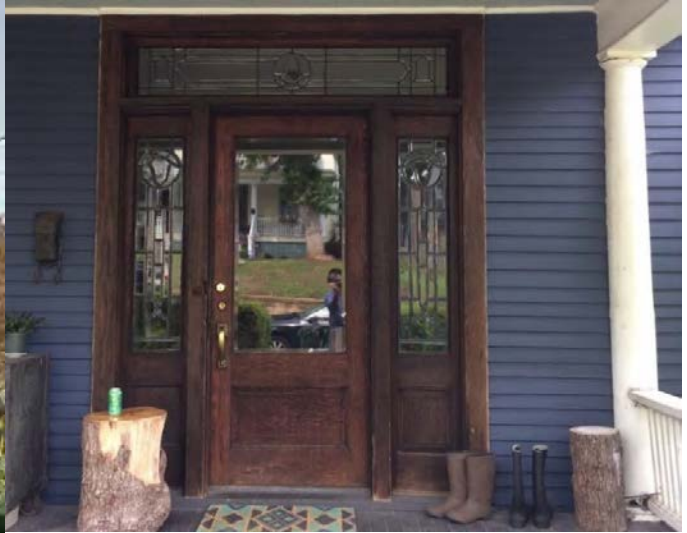
1420 Fremont Ave. – adjacent 4-square

1420 Fremont door --2/3-light with transom & sidelights
(Proposed sidelights and door to have plain glass
(No leaded glass design)

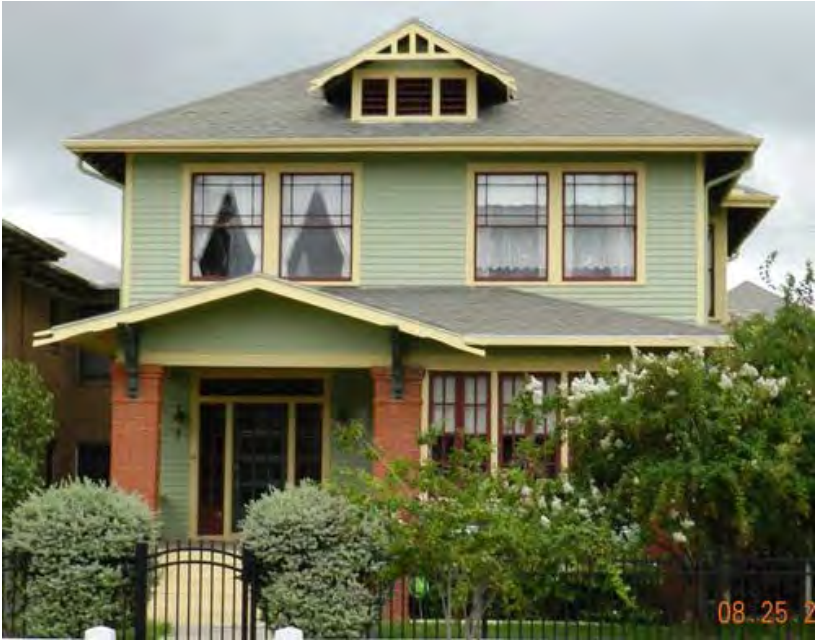
Four-square with off-center front-gabled stoop similar to subject house with transom & sidelights

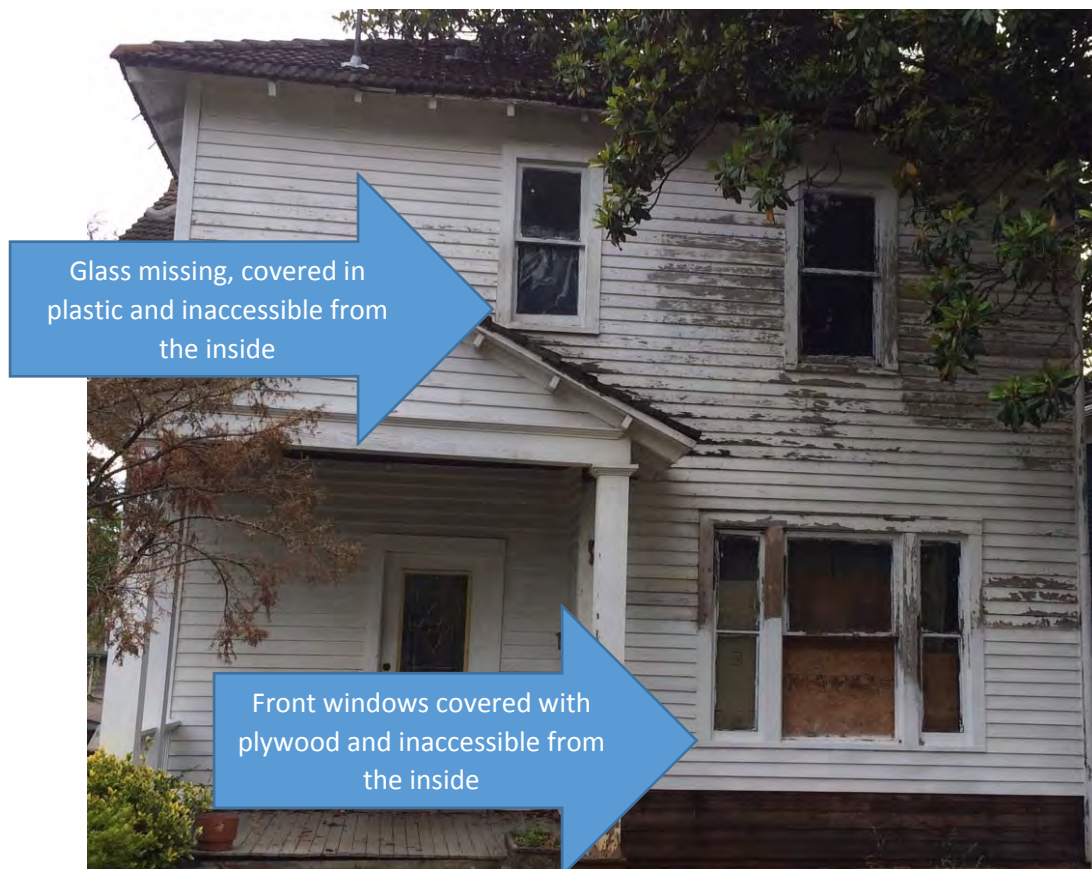
North side windows missing, covered with plywood and inaccessible from the inside

That said, our proposal will be for approval to repair or replace all of the windows. Our intent is to repair all windows that can be repaired, but currently we cannot get a proper assessment of the windows as we simply cannot access them due to being covered with plywood or the previous owners possessions are in the way. Currently we have a contract on the property, but do not own it, so we cannot get greater access at the moment.

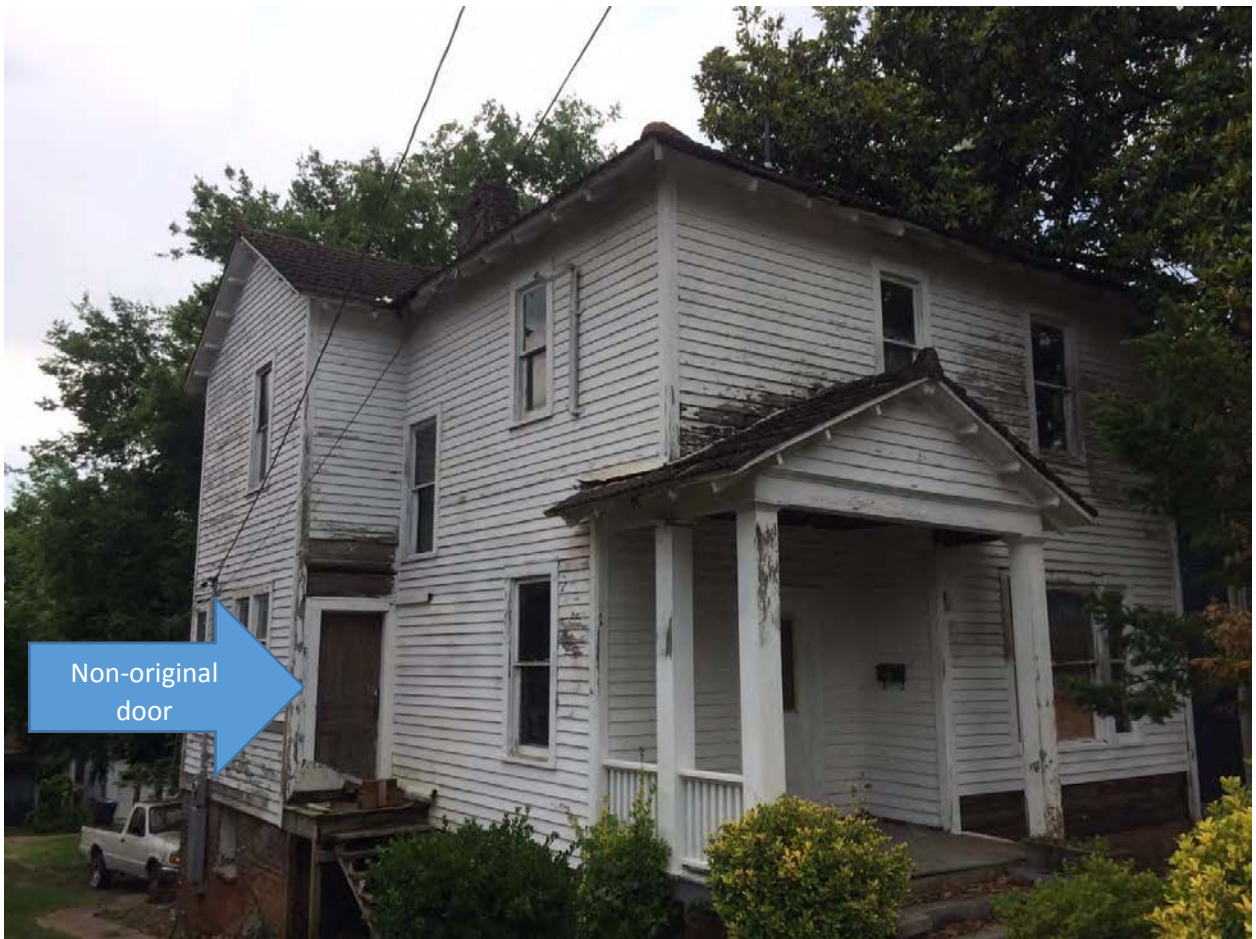
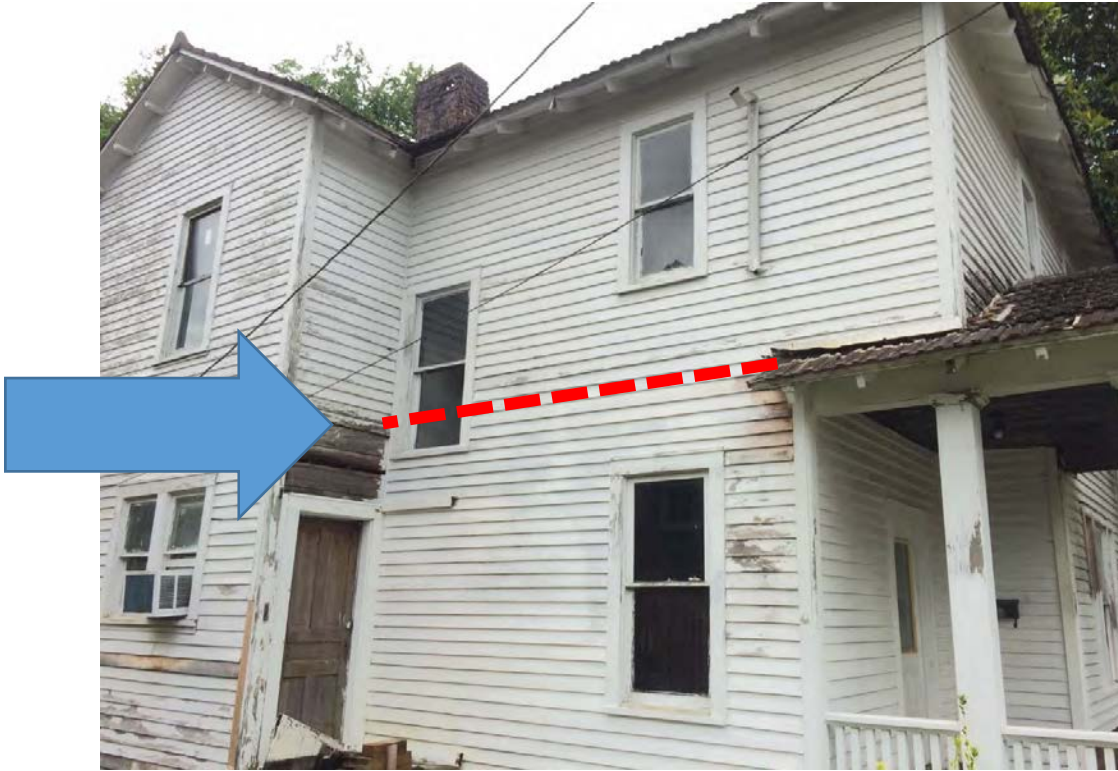
Facing the street, on the left side of the house, is an awkward non-original door. Typically a side door like this would be seen on a wraparound porch, but in that case the porch roof would traverse over the slightly lower staircase window (original). Further, the 1917 Sanborn maps do not show a wraparound porch on the property (the house numbers on the street have changed and the map lists the property as 1322 Fremont Place). Finally, there is no shadow of a foundation that would support a wraparound porch. We would like to remove this non-original door and replace with siding.

A wrap around porch (which would support a side door) would have traversed the lower staircase window.

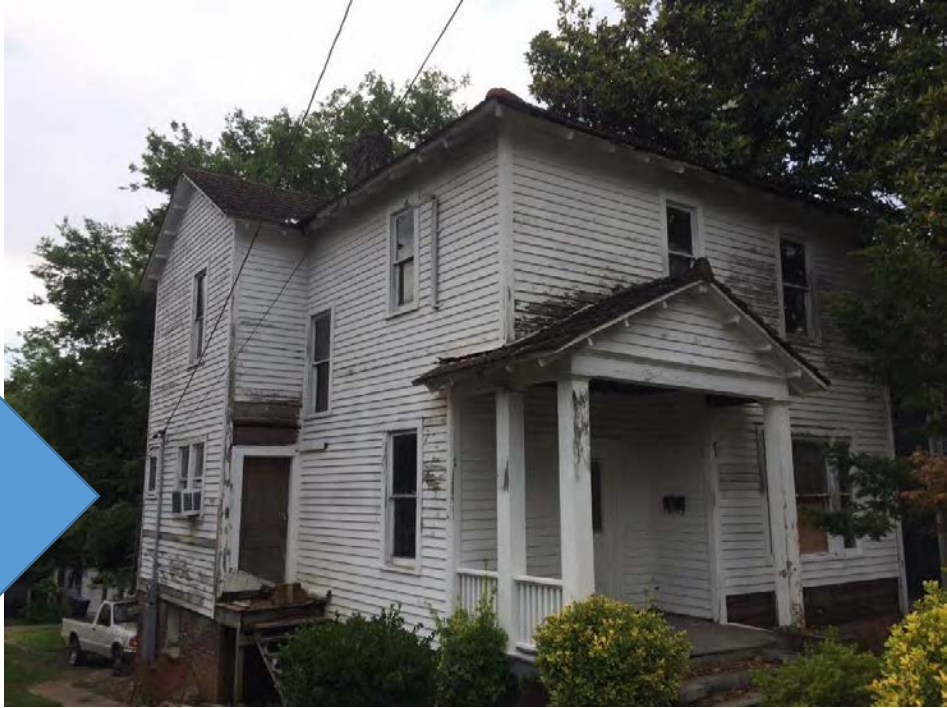
The current addition cannot be seen from the road.

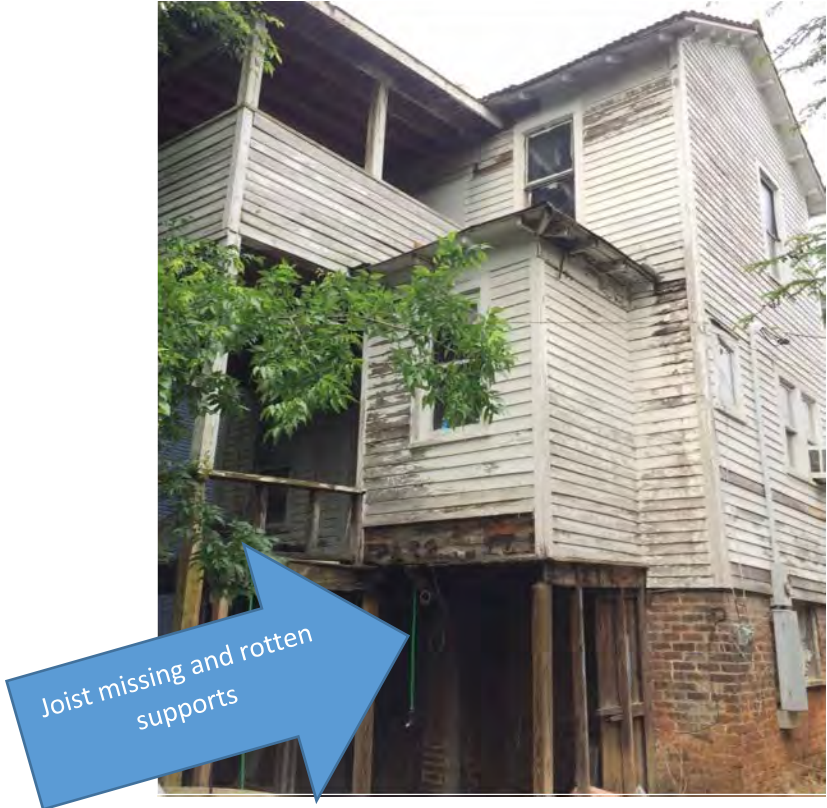
The current rear addition, which houses the only bathroom on the first floor, is pulling away from the house in addition to being fundamentally unstable. We would like to remove this 6'x7' addition and replace it with a slightly larger addition of 10'x14'. As we can see in the Sanborn map above (page 12) this addition is not original. Due to the small footprint of the house there is not any additional space on the first floor where we could locate a bathroom.

Joist missing and rotten supports

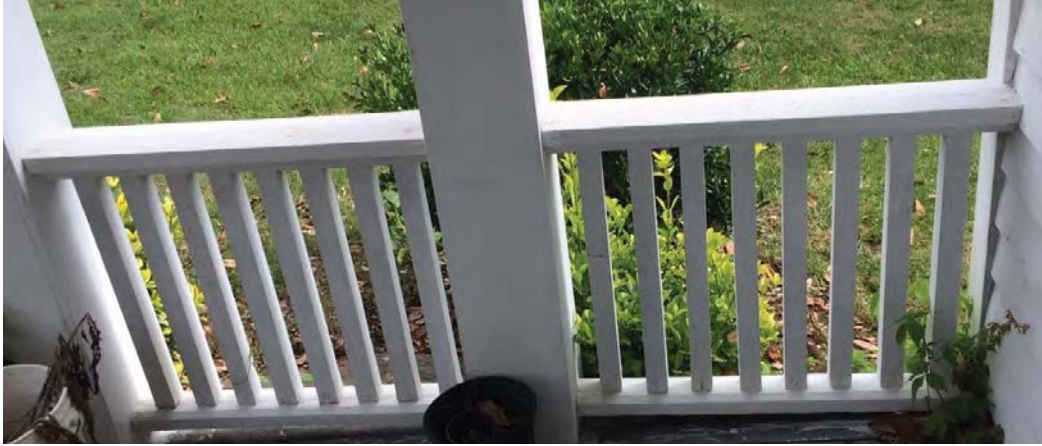
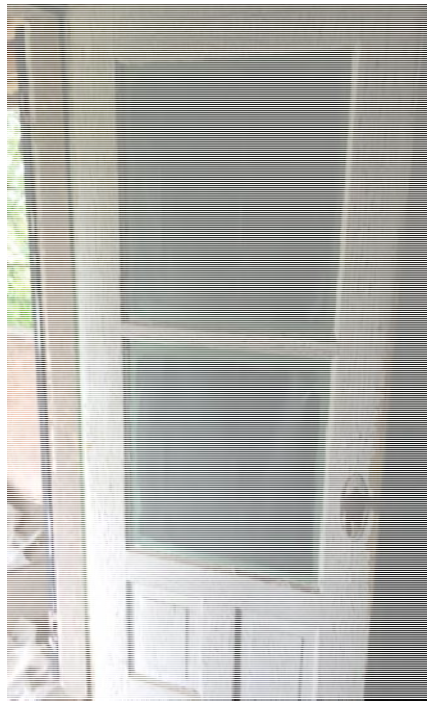
Original brick supports show us the dimensions of the original rear porches.

The original door leading to the upper open air rear porch.

The rear porch railing will be similar in design to the railing on the front porch. The only modification will be the 36" railing height to comply with building codes for drops over 30" in height.

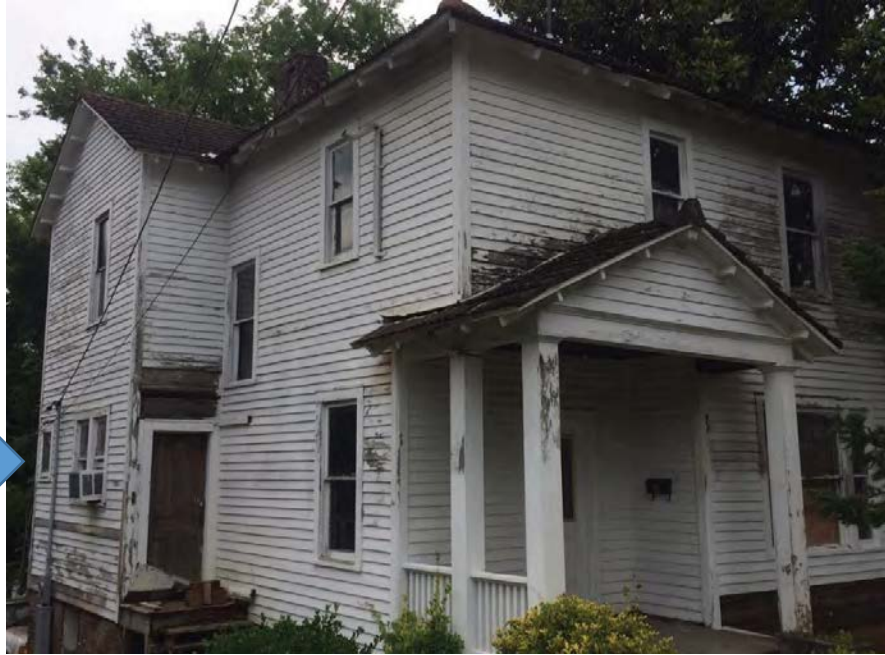
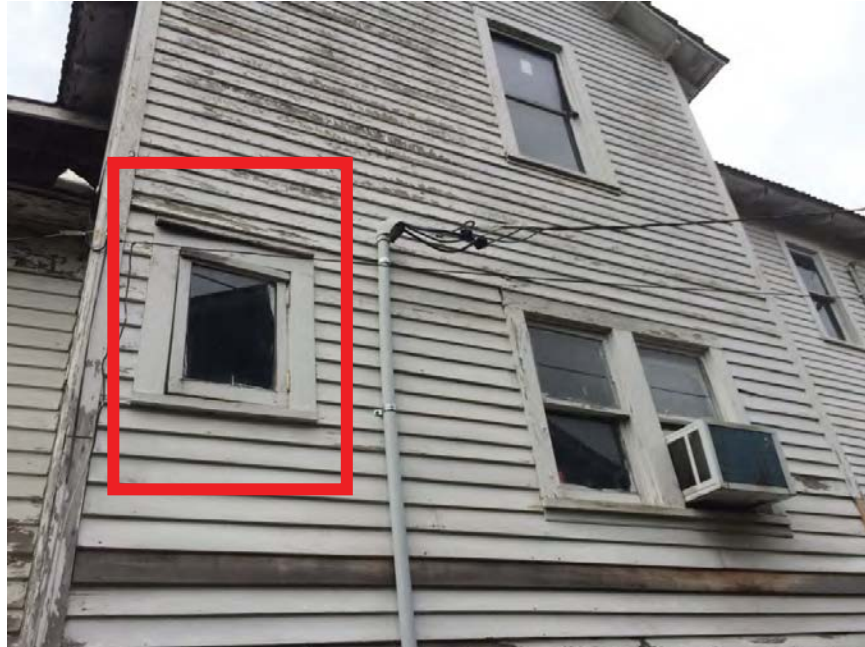
This late addition, casement portal window, is unlike any other window in design, shape or size and we are requesting its removal.

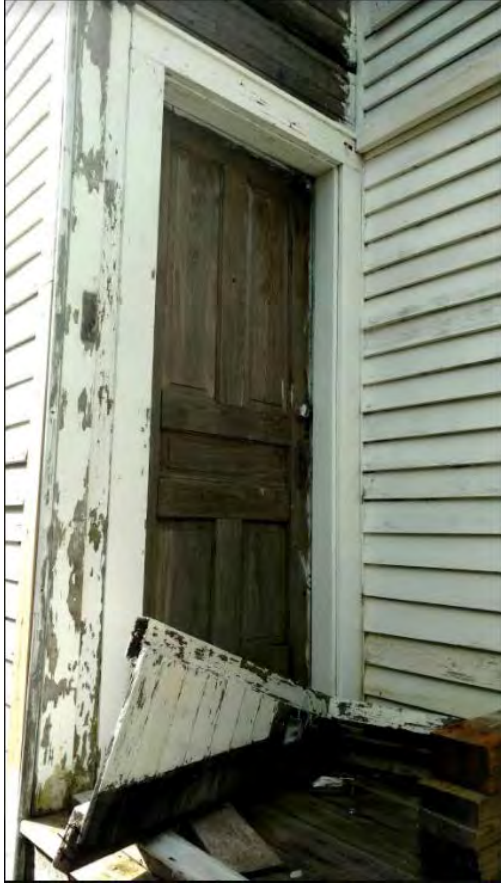
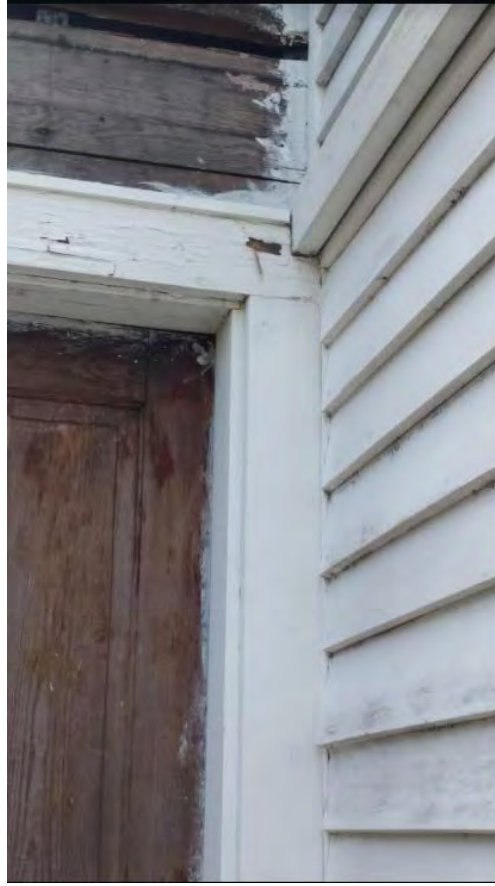
1424 Fremont – Non-original door on north side, facing toward the front. Indication of door inserted into previously existing sided wall projection

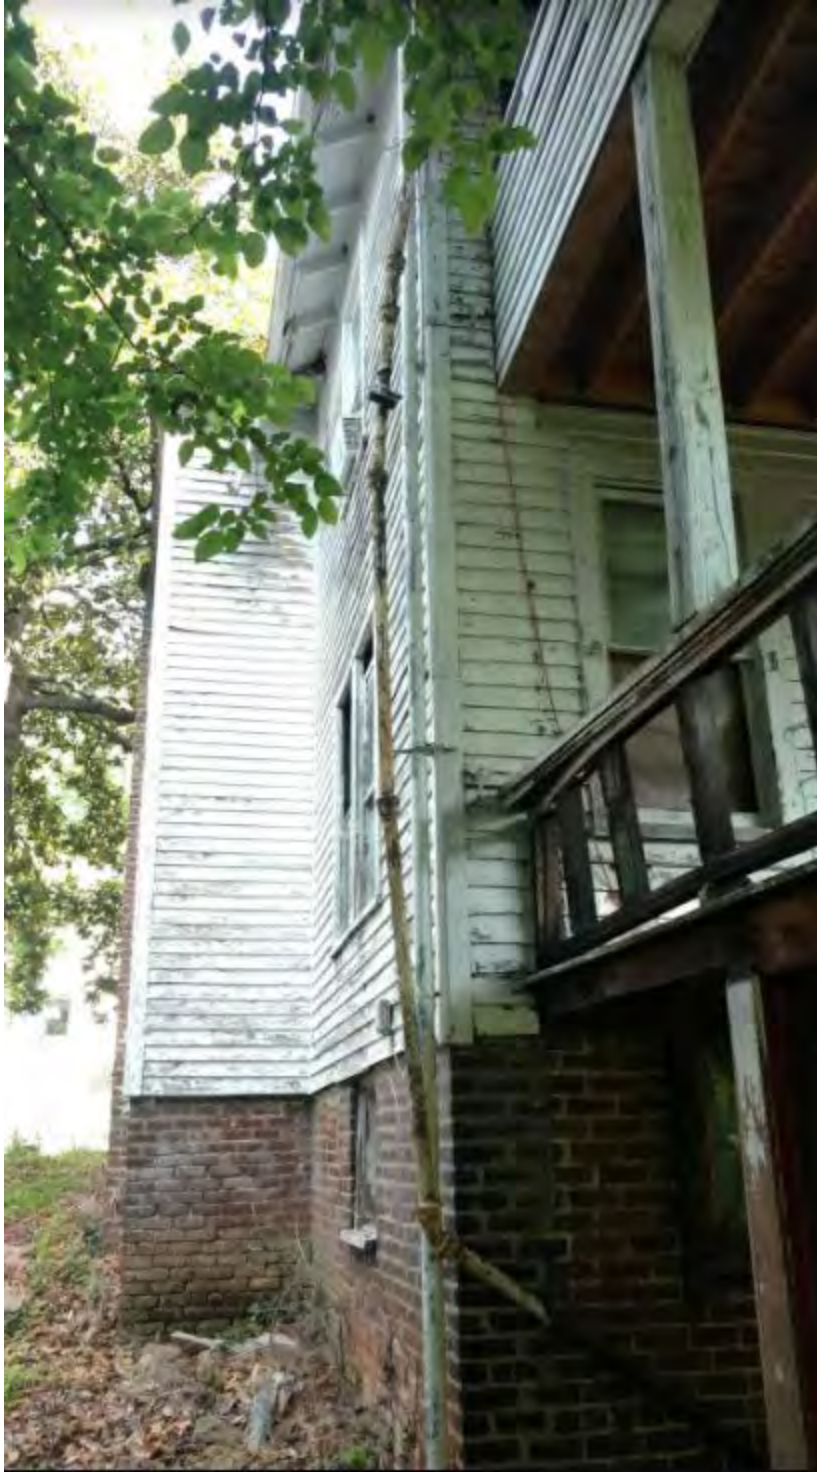
1424 Fremont - View of south side from rear showing tie-in of existing decks
