KNOXVILLE HISTORIC ZONING COMMISSION STAFF REPORT - CERTIFICATE OF APPROPRIATENESS APPLICATION

PROPERTY ADDRESS: 412 E Scott Ave 37917

FILE NO.: 2-B-18-HZ

DISTRICT: Old North Knoxville H-1

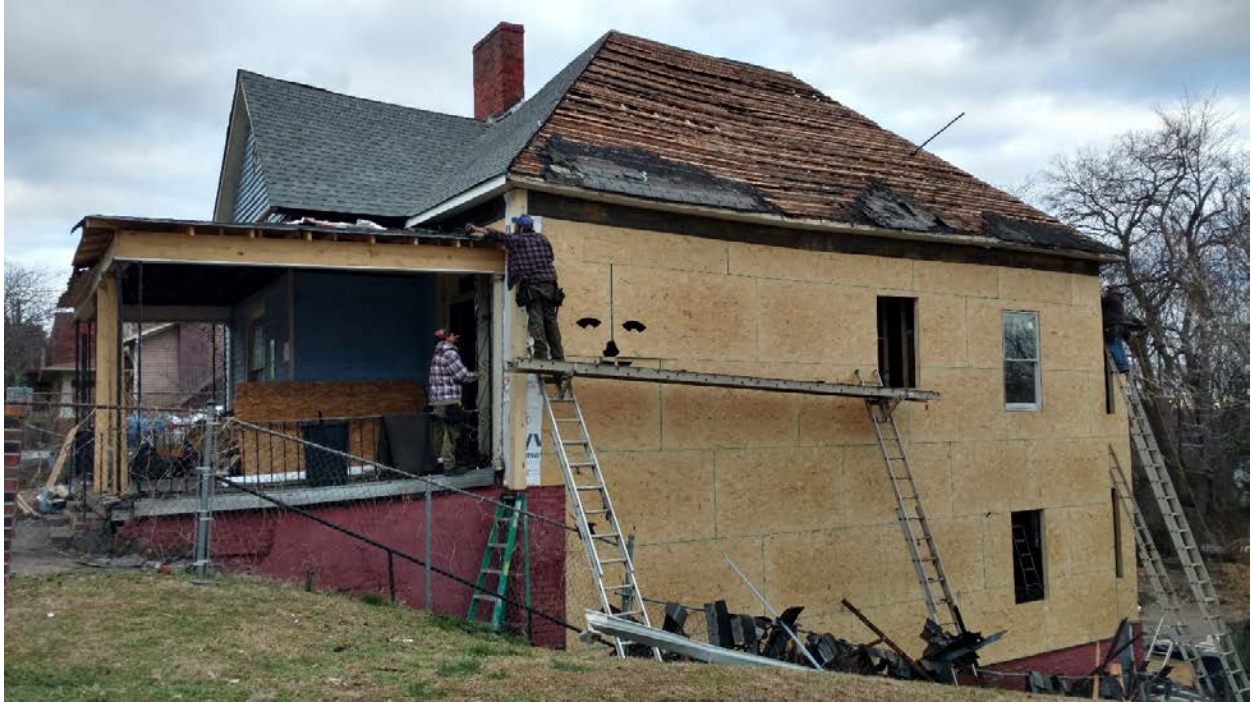
5) The 6"-siding on the south and rear was found to be more deteriorated than originally thought; therefore, instead of repairing and replacing as needed, the entire south and rear walls of sheathing and siding were replaced to match previously existing. The 6-inch replacement siding does not abut the 4-1/2 " siding on the front corner.

412 E. Scott - Re-sheathing in progress on south side

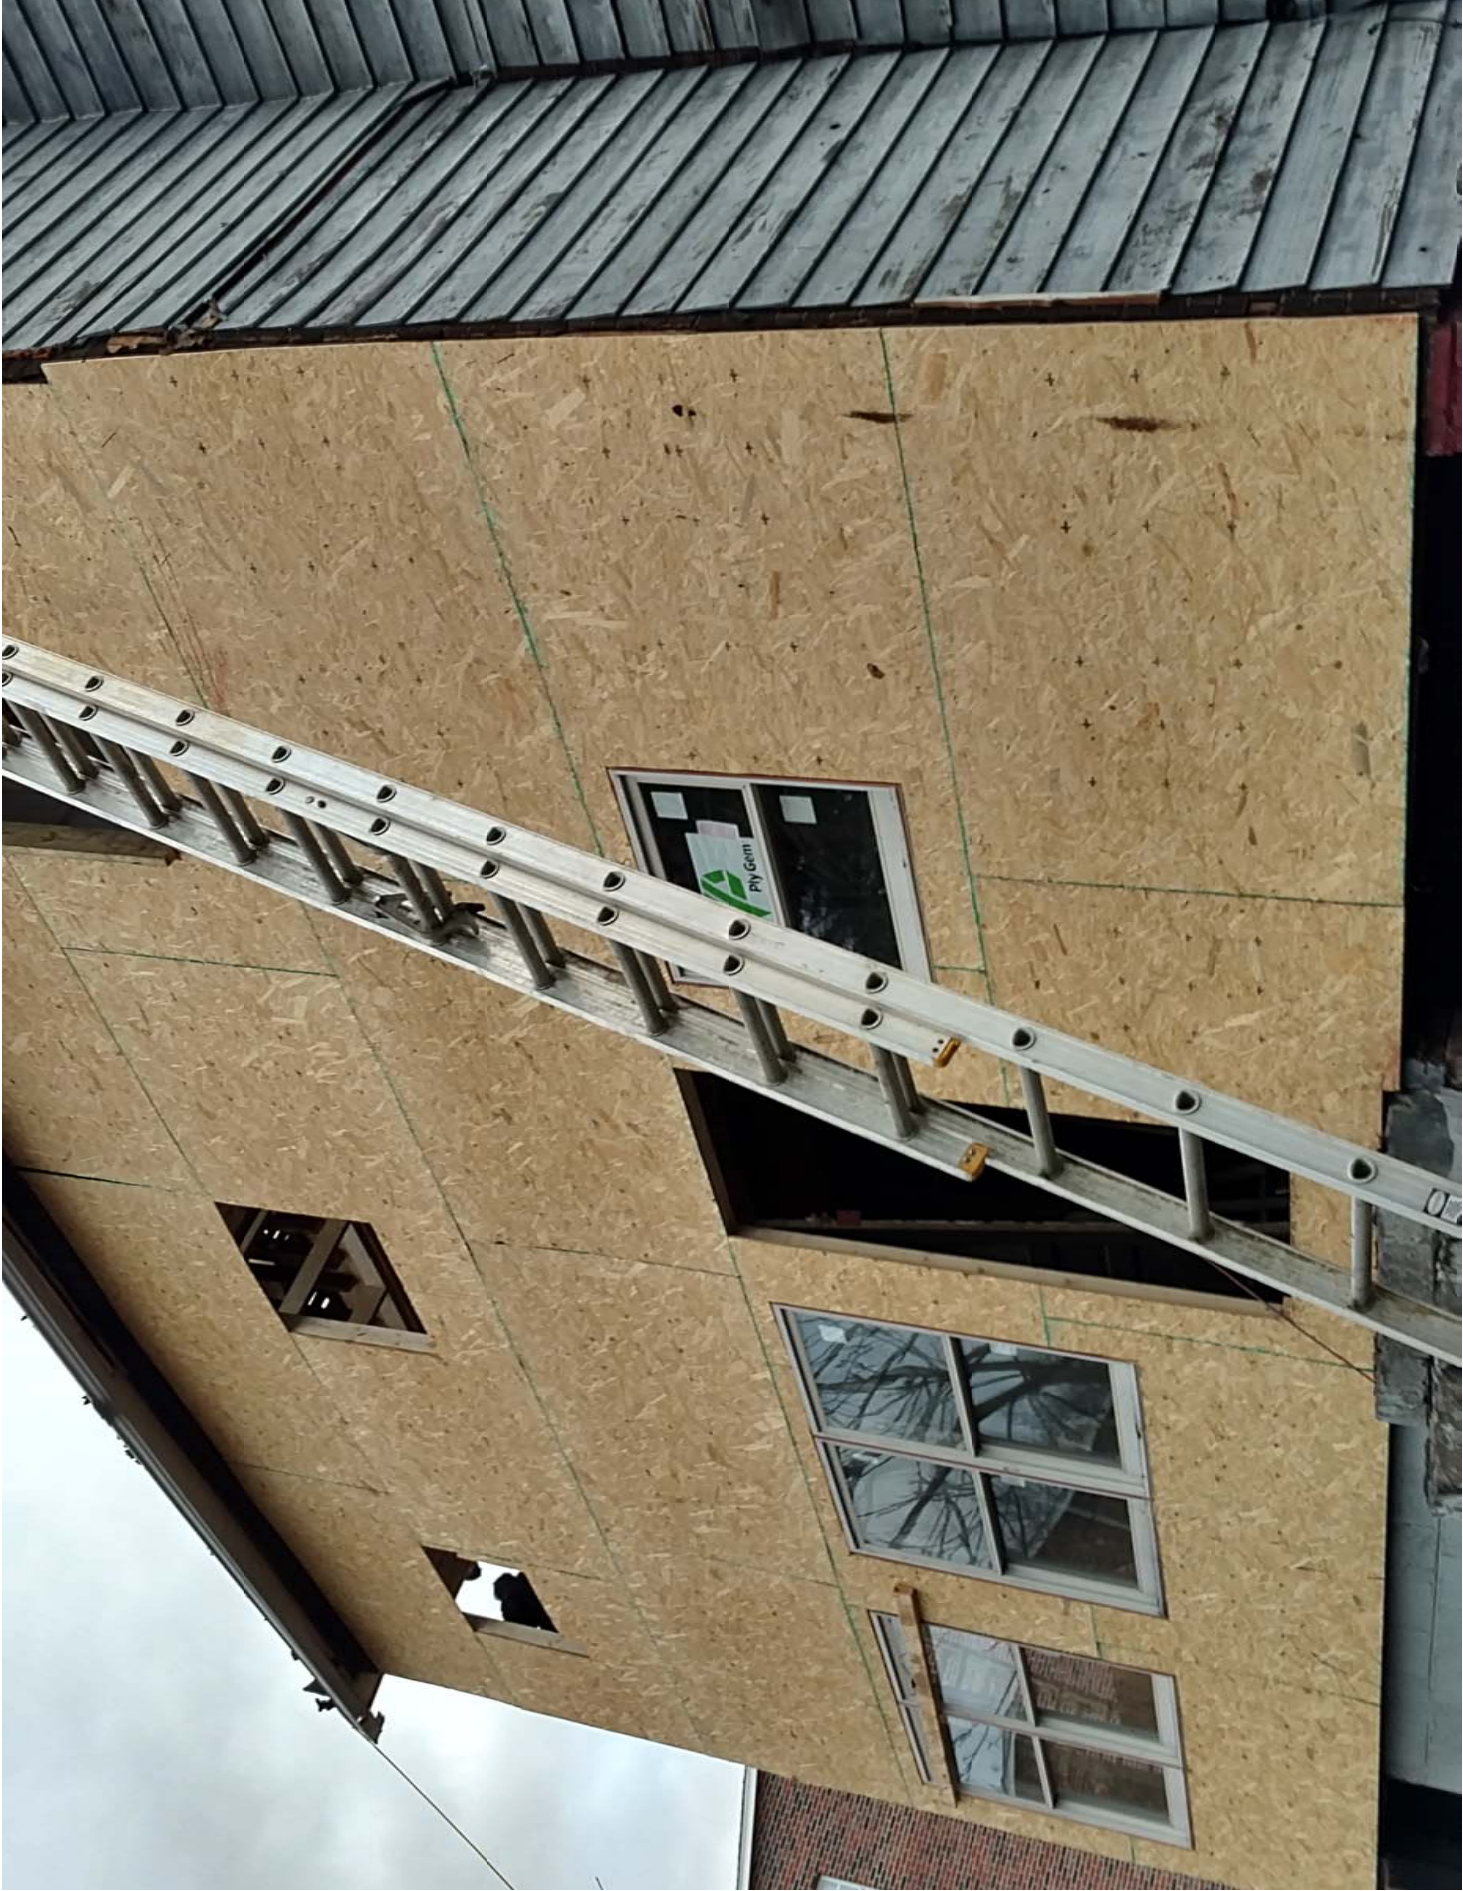
412 E. Scott - rear

- 9) None of the windows on the rear were original, but the replacements to match the previously existing are fairly appropriate given that they are vertically-oriented 1/1s, except for one square double-hung. The framing for the openings of these windows was adjusted as well.

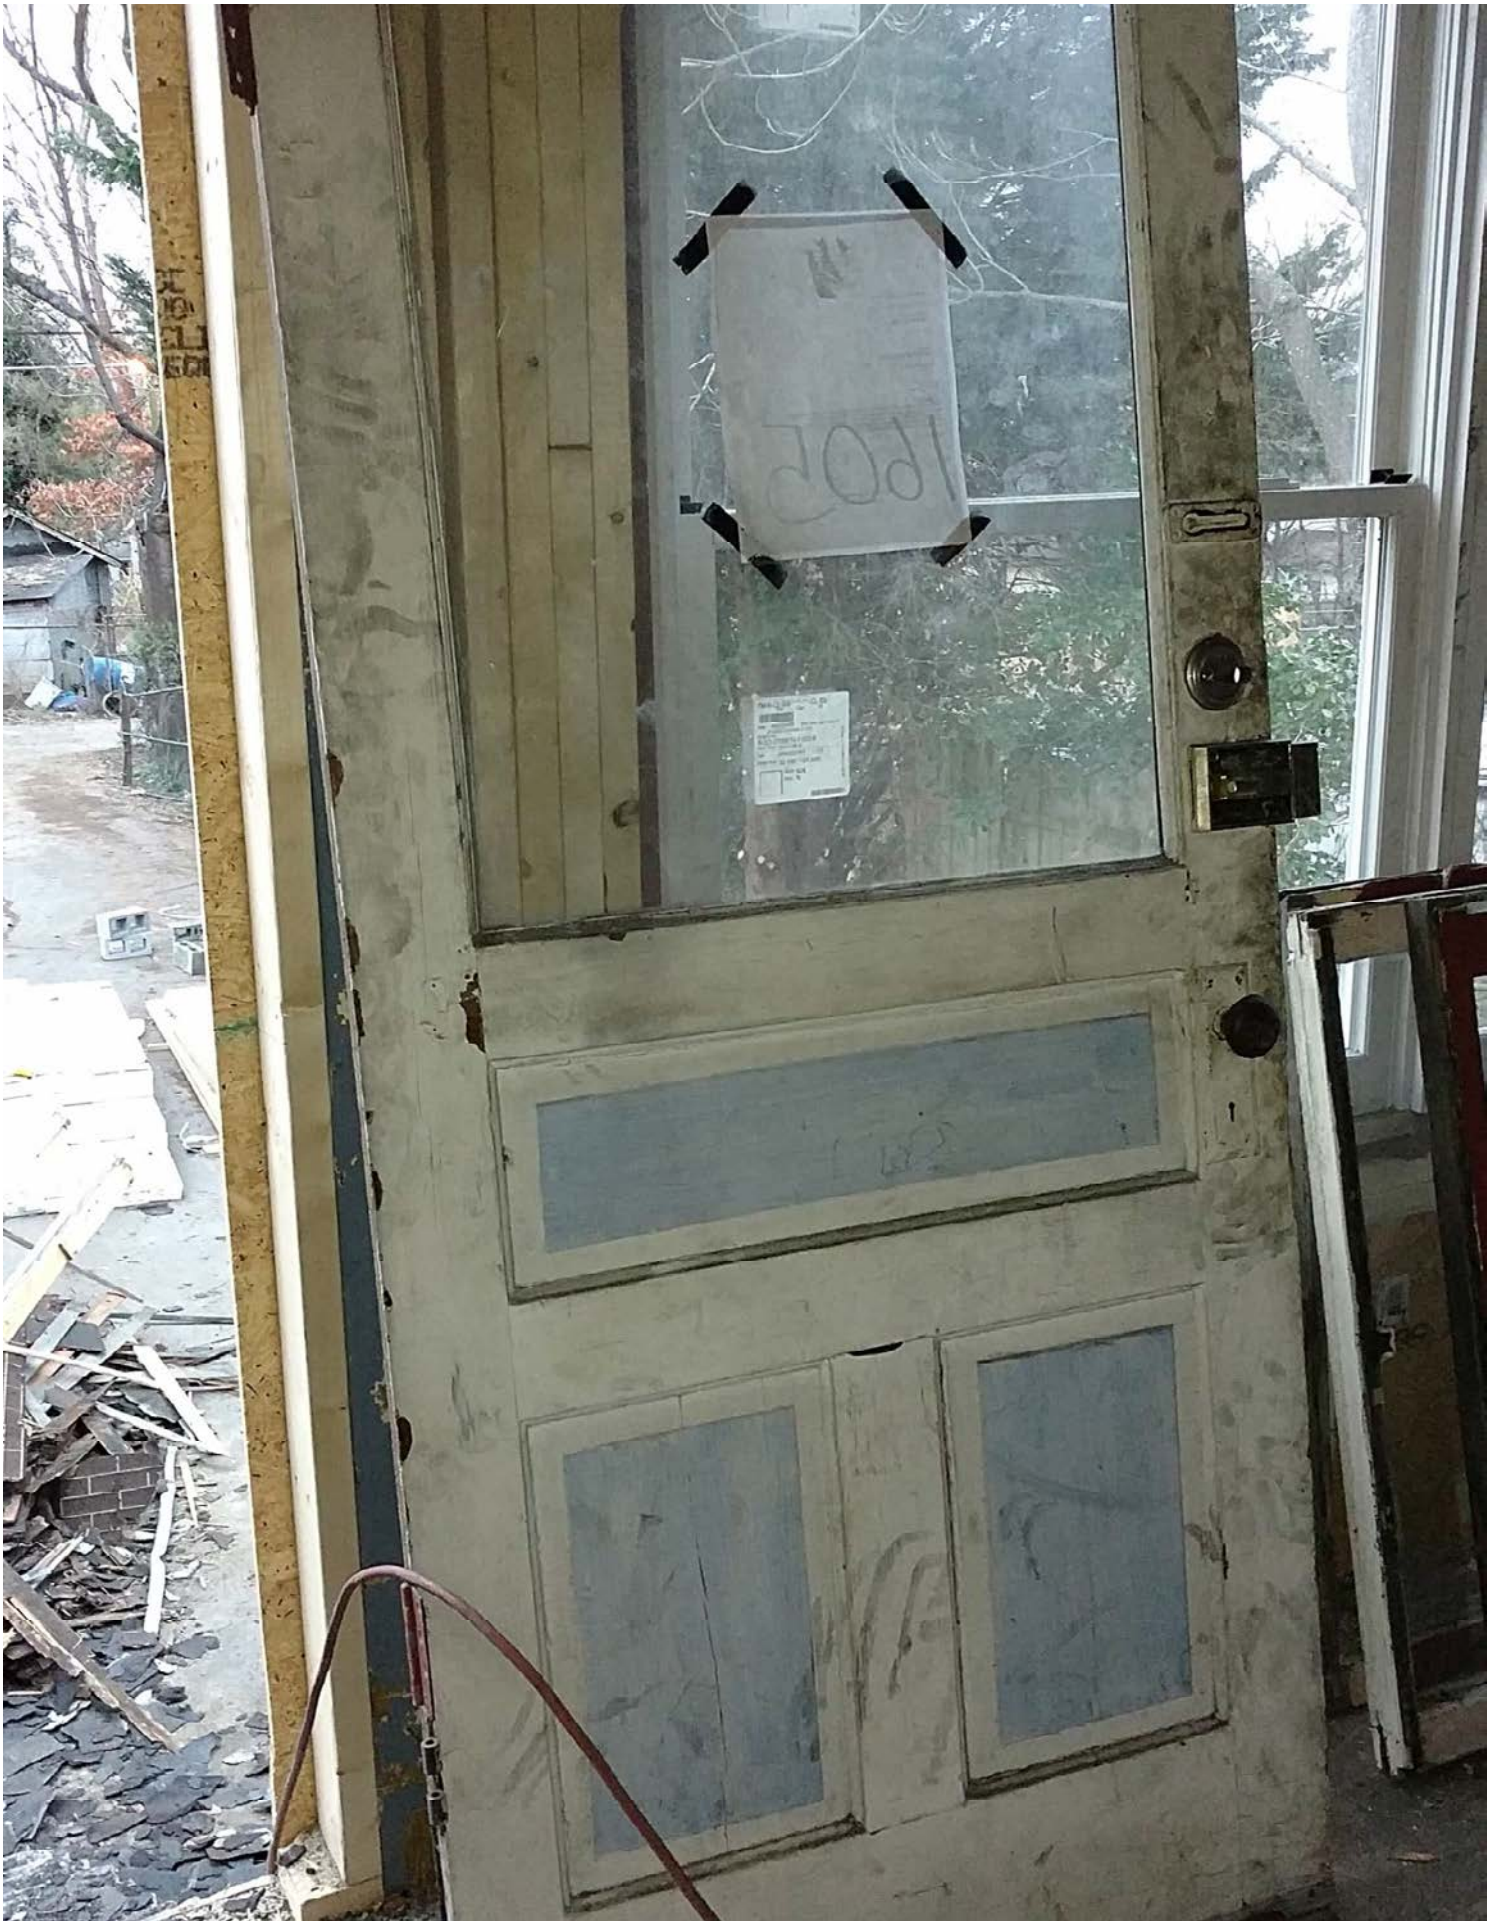
412 E. Scott - Rear door

Door – Replace non-original metal back door with a wooden half glass door
